Primary Heat Transport (PHT) Motor Rotor Retaining Ring Failure

Ali Malik

Ontario Power Generation - Darlington Nuclear

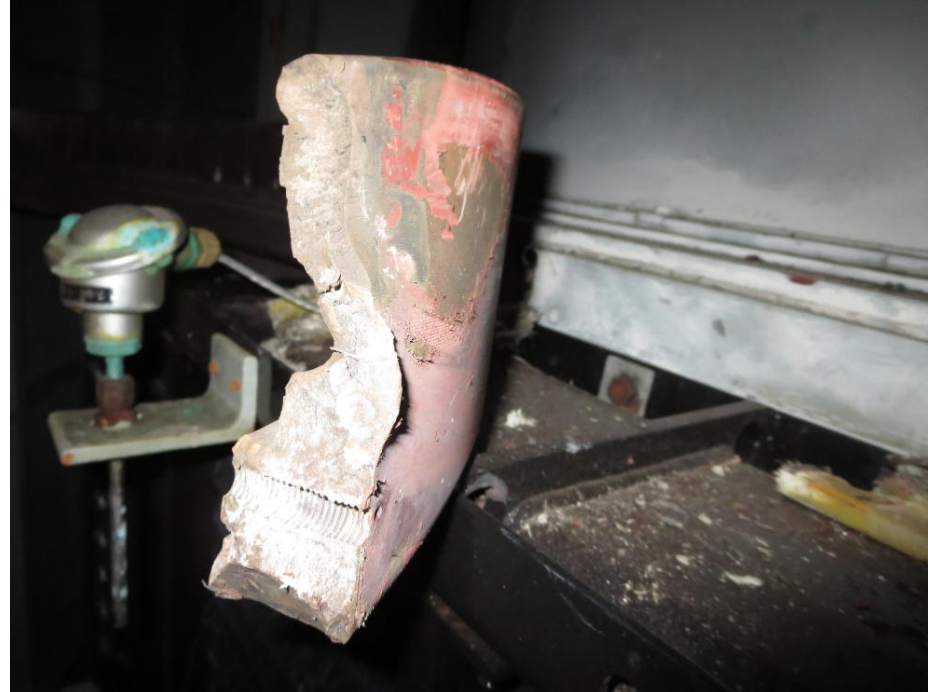
- ❏ On December 04, 2015, Darlington Unit 1 PHT pump motor 1-PM1 electrical protection tripped. Onsite investigation of the failure indicated that the opposite drive end (ODE) rotor stainless steel retaining ring came loose from the rotor in two pieces. One piece of the retaining ring was retrieved onsite from its resting place on top of one of the stator air coolers after its ejection from the rotor. This resulted in a complete winding failure, and a 20-day outage.

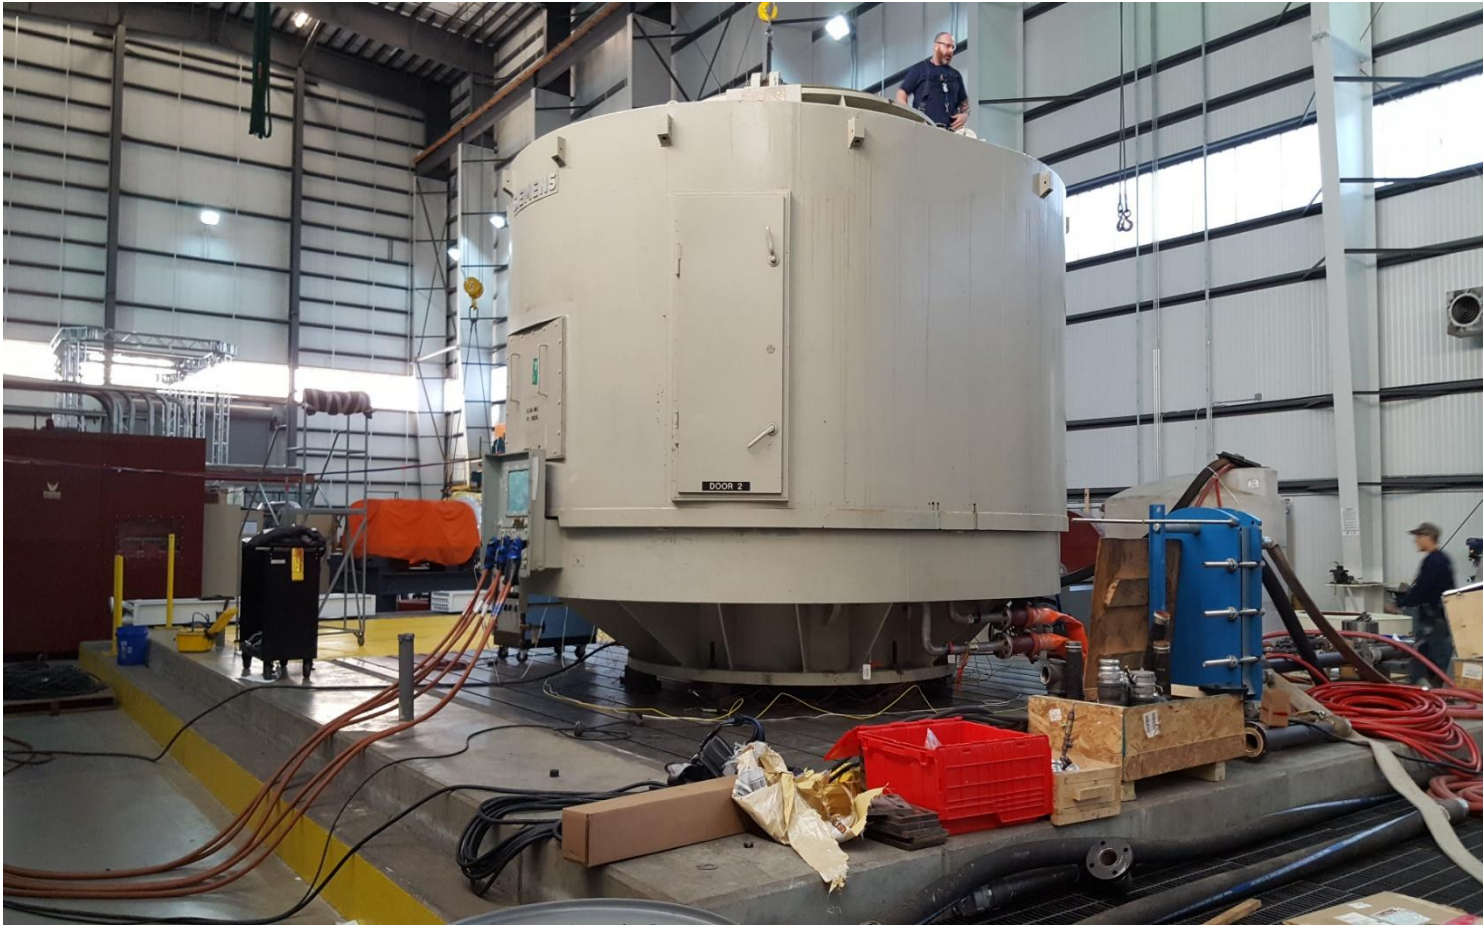
The PHT motors are a Totally Enclosed Water to Air Cooling (TEWAC) design.

The shroud enclosure contained the ejection of the failed rotor retaining ring.

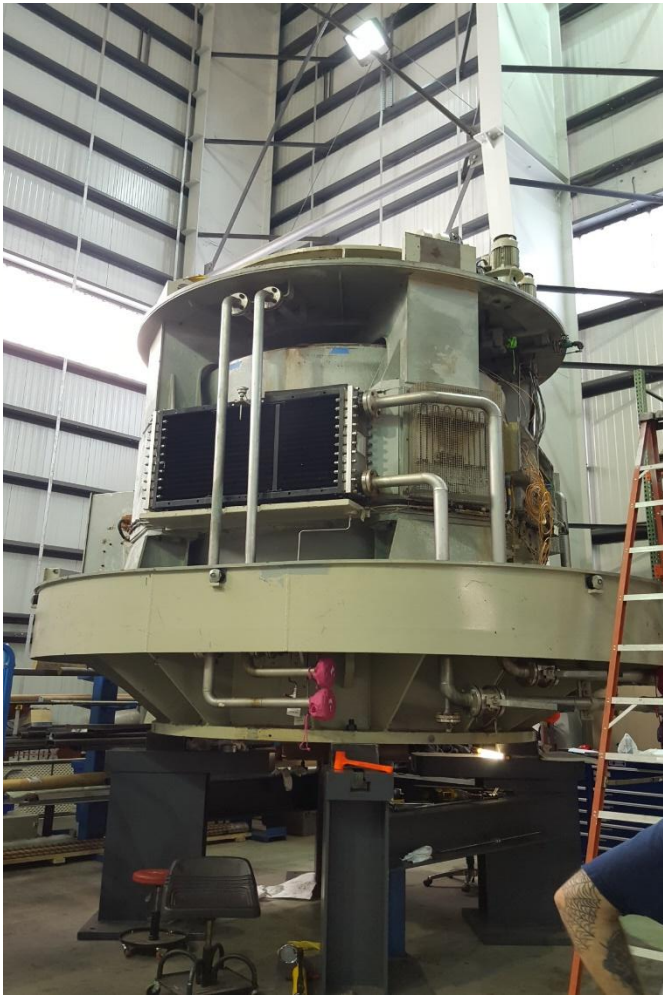
Damaged PHT Motor with Shroud Removed.

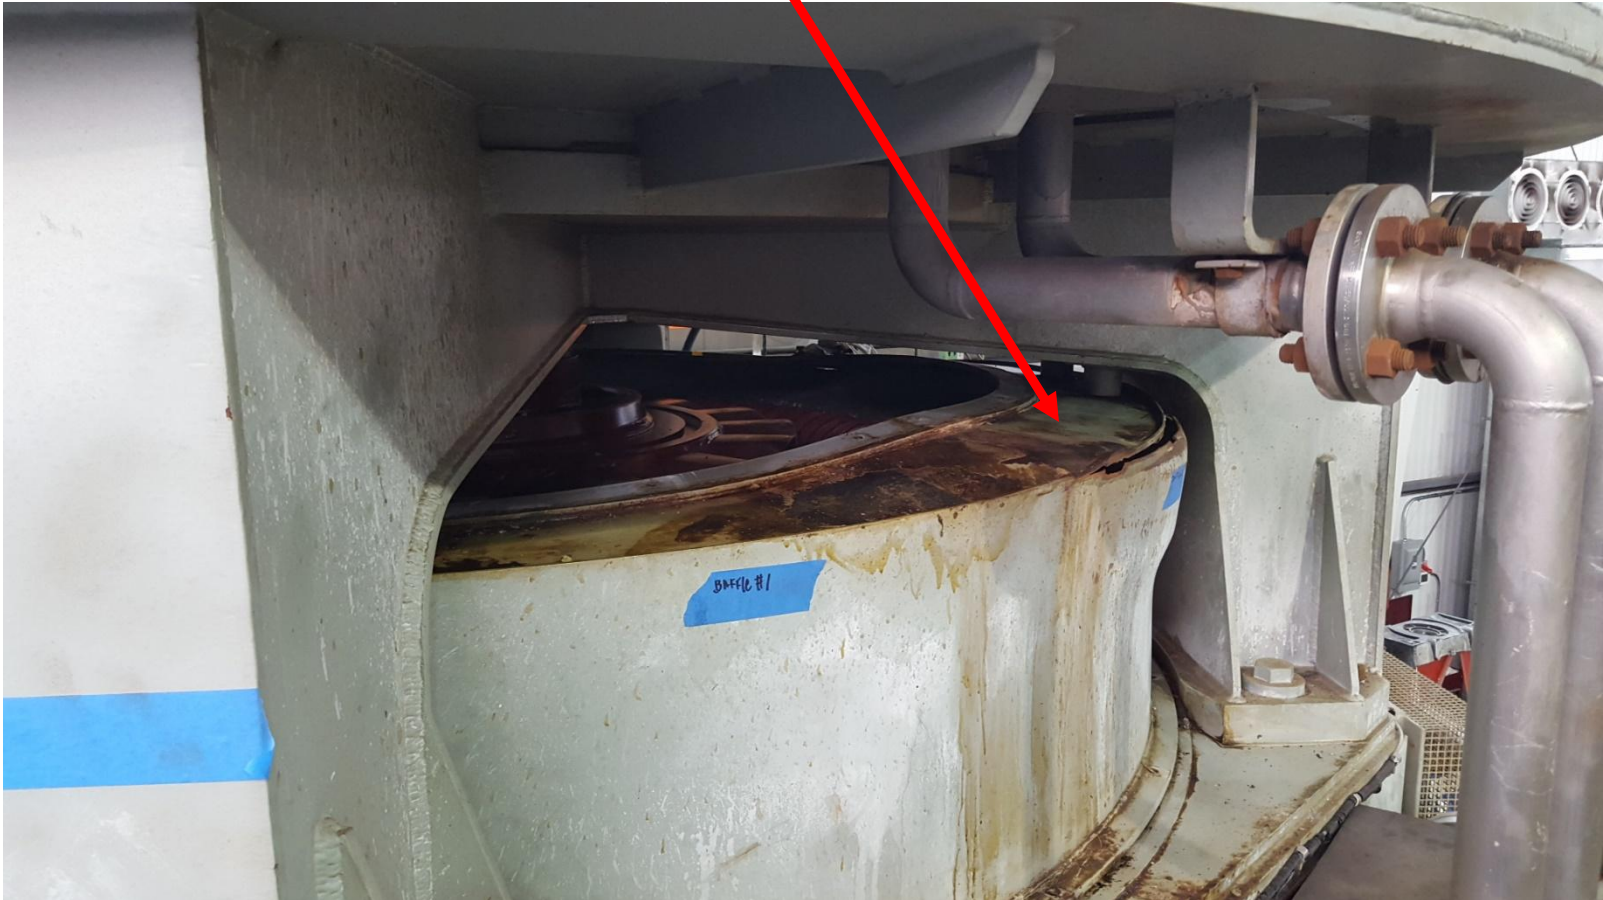
Damaged Endwinding Air Baffle Cover from Ejected Rotor Retaining Ring

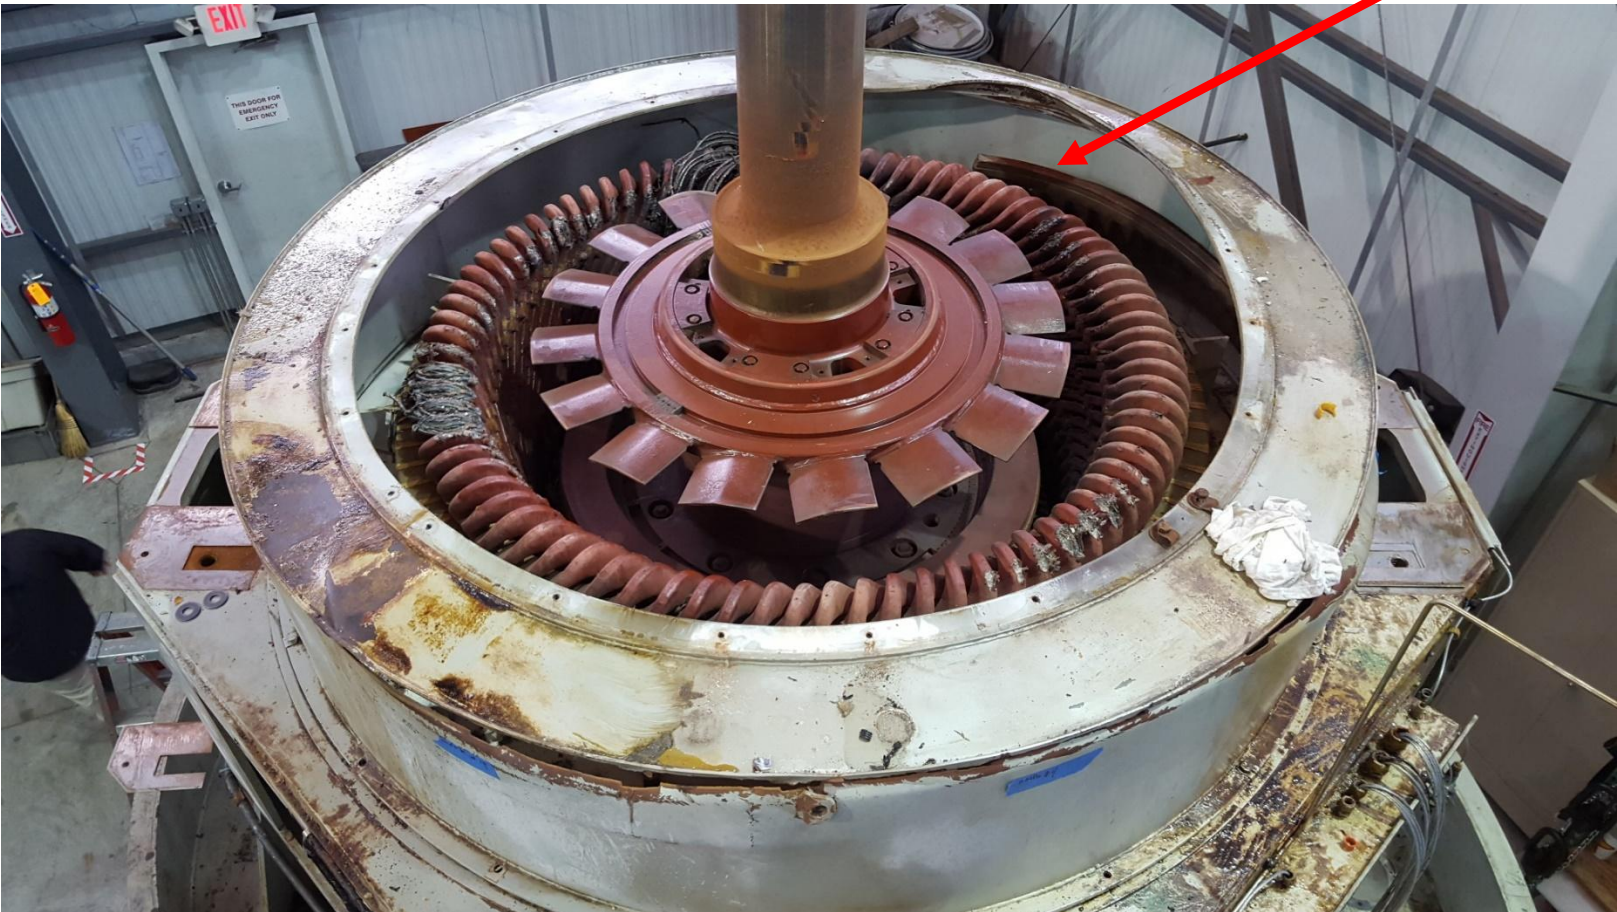
Endwinding Cover and Winding Damage from Ejected Rotor Retaining Ring

Notice half of the retaining ring is inside the endwinding cover

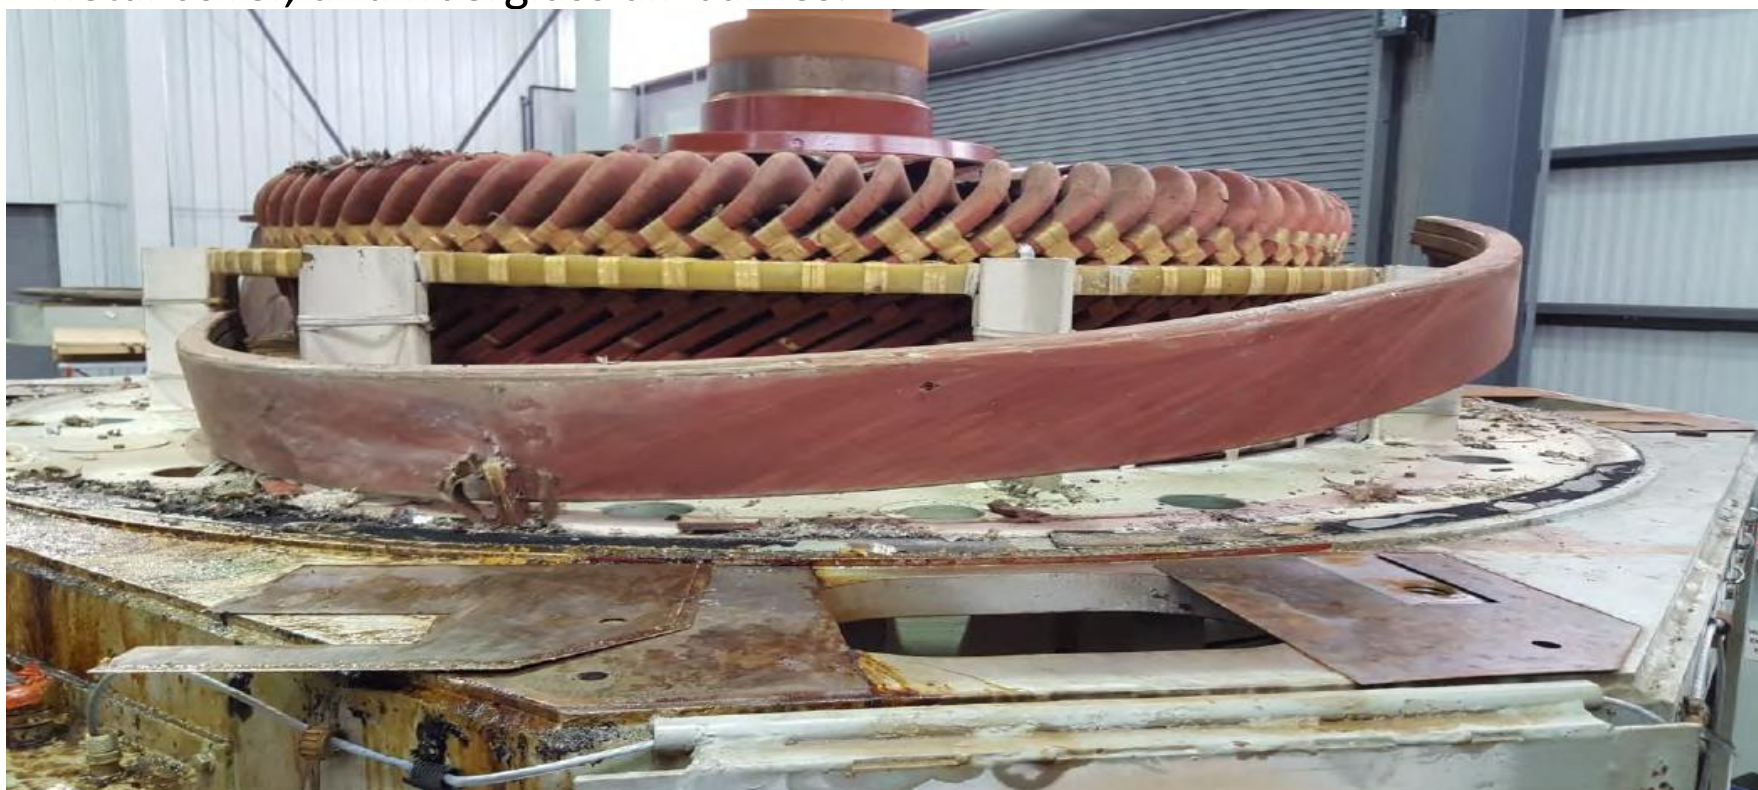
- ❏ The PHT 1-PM1 motor experienced a loss of structural integrity of the ODE rotor retaining ring. The ring broke into two pieces while the rotor was operating at full speed and the motor at full load. The retaining ring was propelled radially outward and axially upward toward the ODE endwindings, the endwinding metal cover, and fiberglass air baffles.

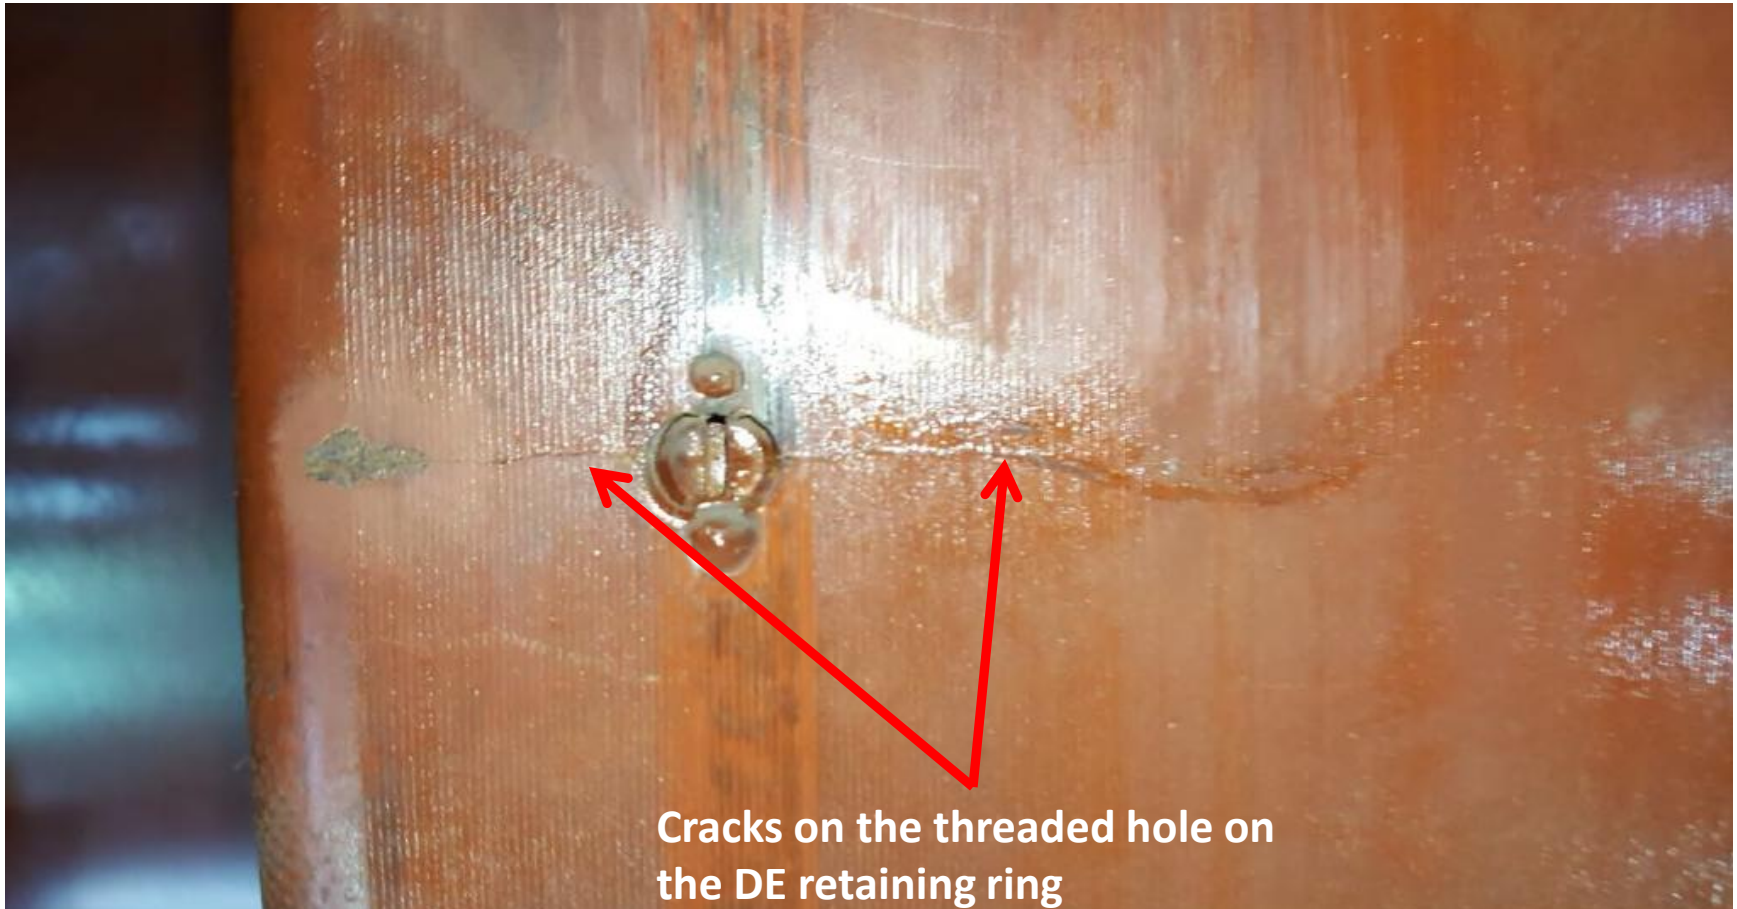
- ⏻ Cracks found on the Drive End (DE) retaining ring set screw areas
- ⏻ Three set screws 120 degrees apart – all had cracks as shown below

Cracks on the threaded hole on
the DE retaining ring

- ❏ Failure analysis concludes that the retaining ring failed due to stress corrosion cracking (SCC). The rotor retaining ring is made of alloy 18Mn-4Cr which is inherently susceptible to SCC. The extent of the SCC depends on various factors including environmental conditions, high stress areas, and operation-induced stresses which is discussed on the next slide.

- ⏻ The threaded holes for the set screws and the two staking indentations per hole created high stress areas.

- ⏻ Operating-induced stress on the retaining ring is found to be high enough to initiate SCC¹ and the expected actual stress would be much higher at the fractured threaded hole due to stress concentration effect.

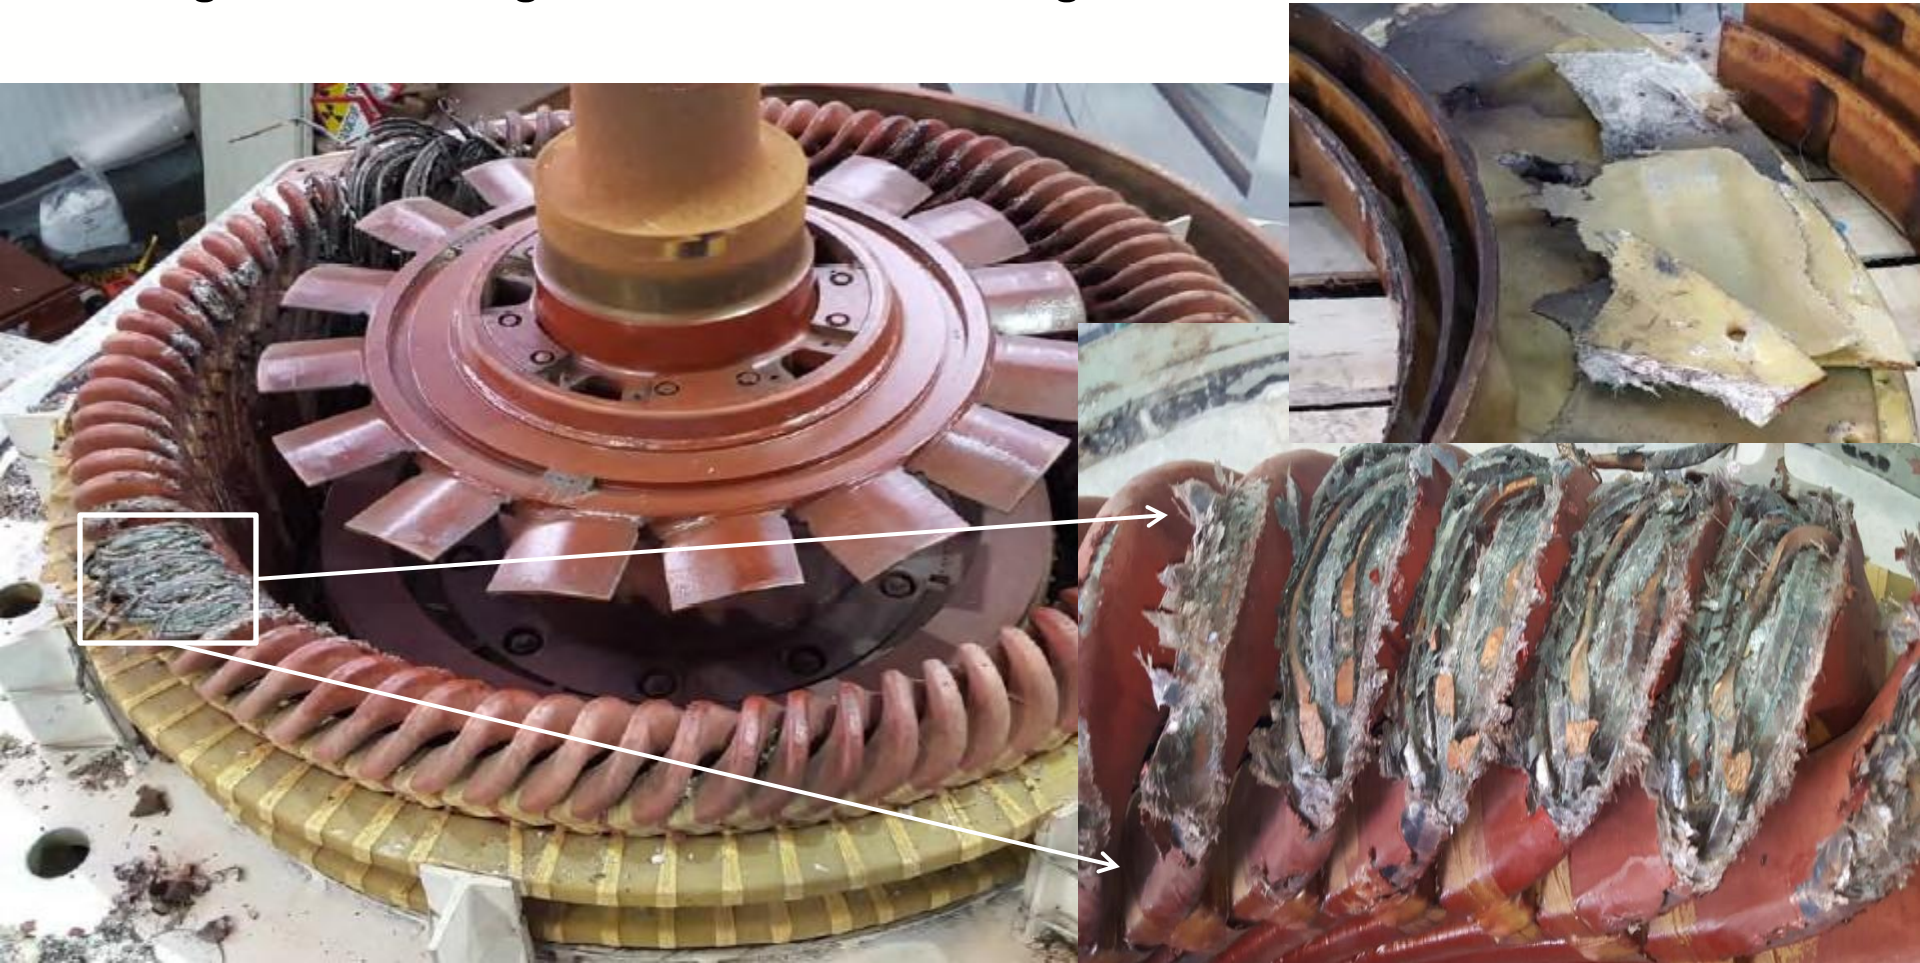
- ⏻ A complete winding failure with extensive damage to the ODE endwindings
- ⏻ Destruction of some of the ODE fiberglass air baffles
- ⏻ Significant damage to the ODE endwinding metal cover

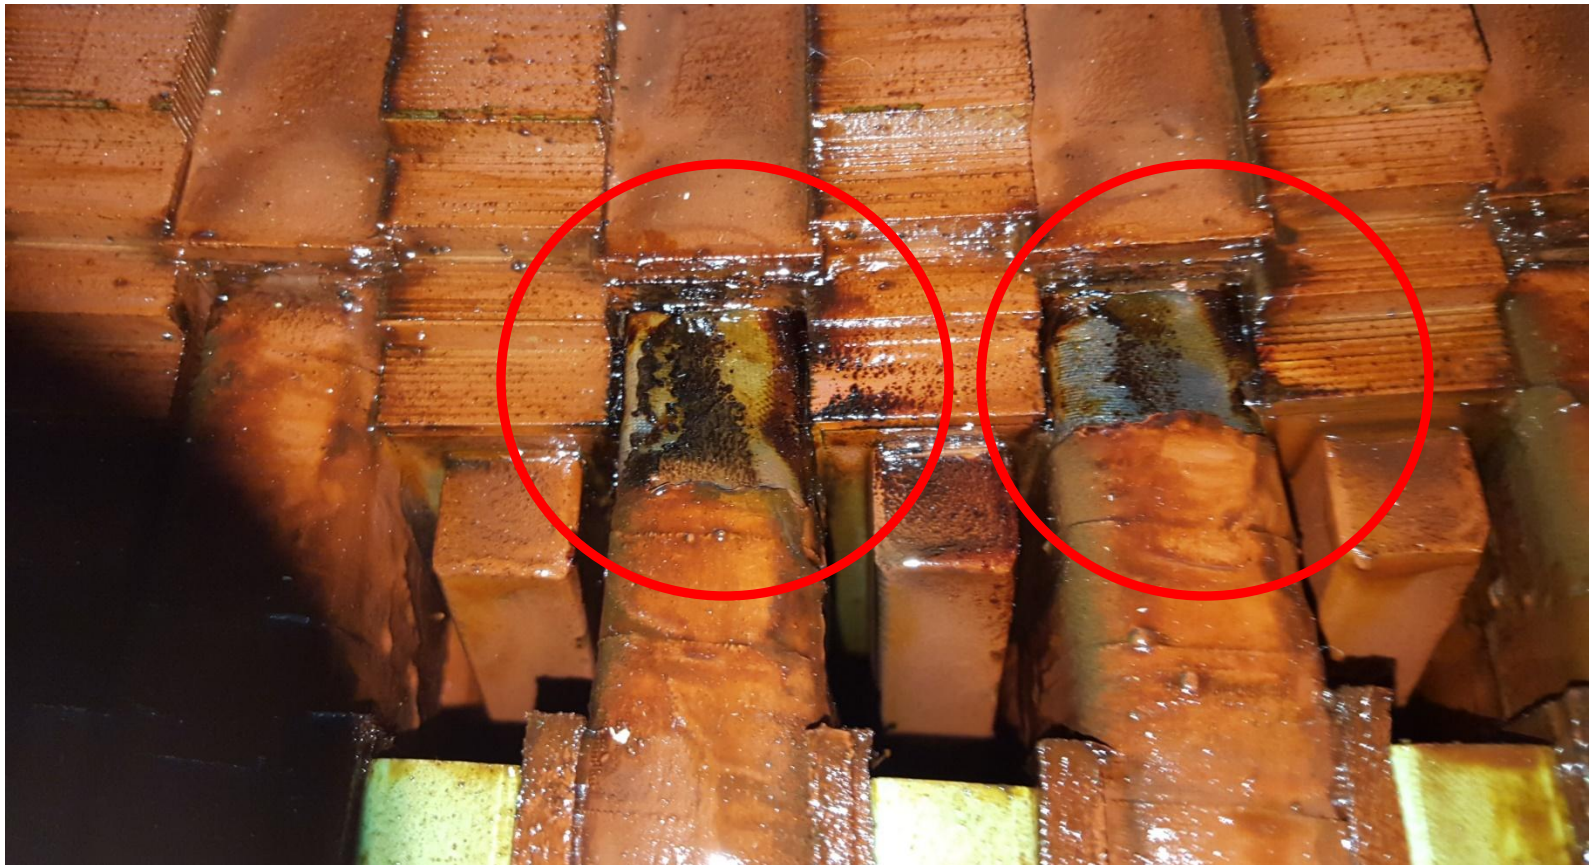
- ⚡ Partial discharge (PD) damage to the semi-conductive (corona) tapes on the line coils (coils connected directly to the bus connections on the line side) of the stator

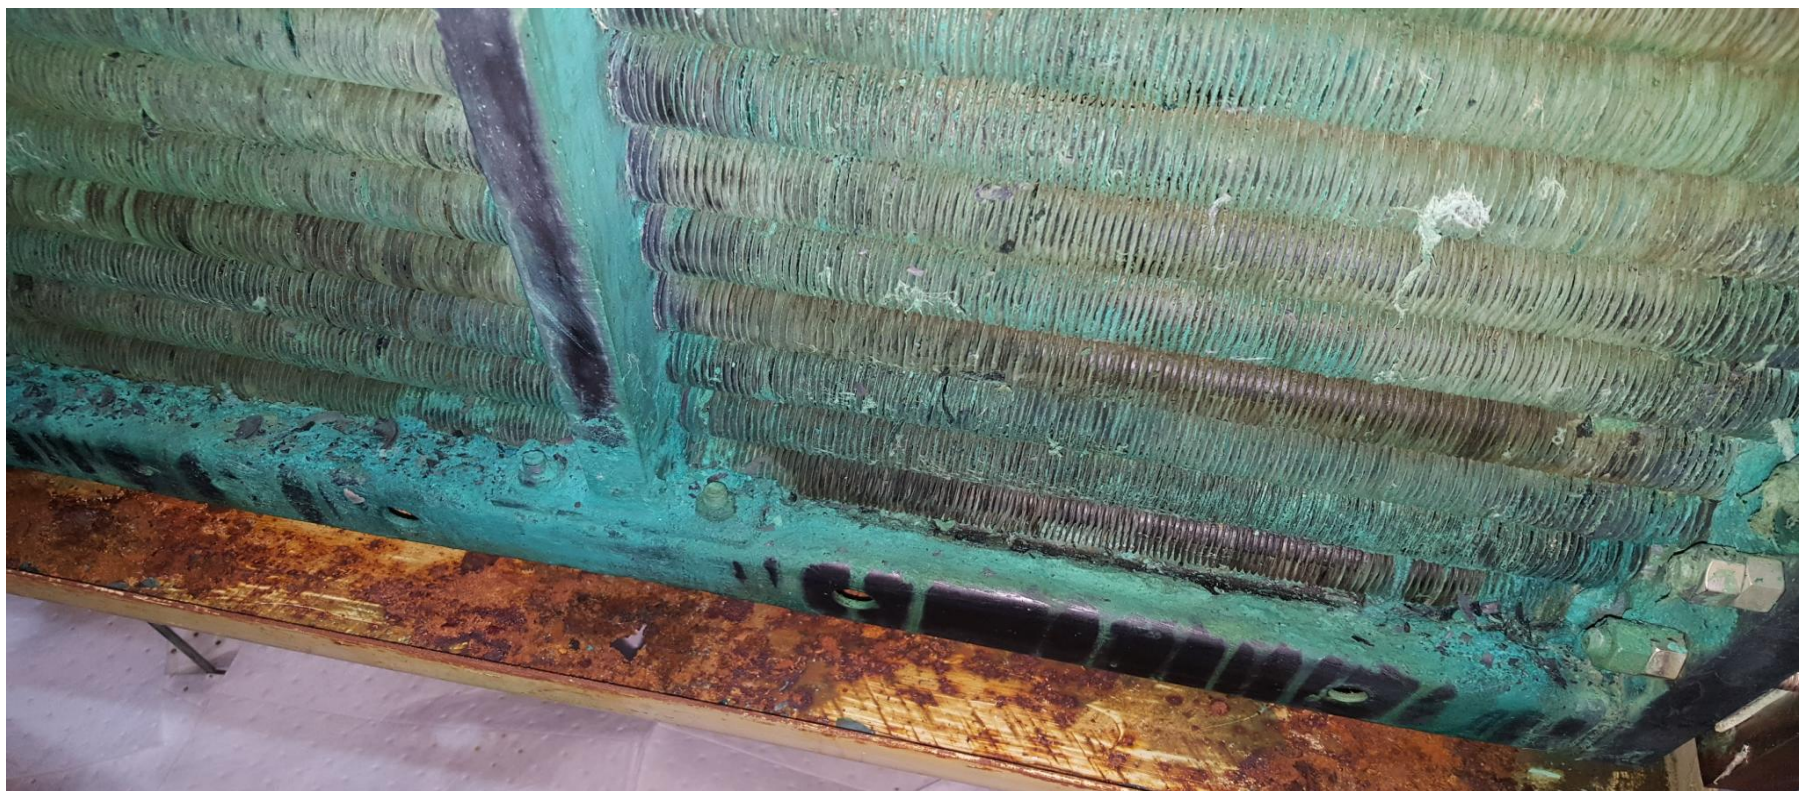
Although the stator air coolers had been recently changed on this PHT motor, the photo below is from another PHT motor and illustrates the ozone/humidity nitric acid deposits that occur on these coolers. The ozone is generated by external partial discharge between the stator coils and stator core. Internal partial discharge does not produce ozone.

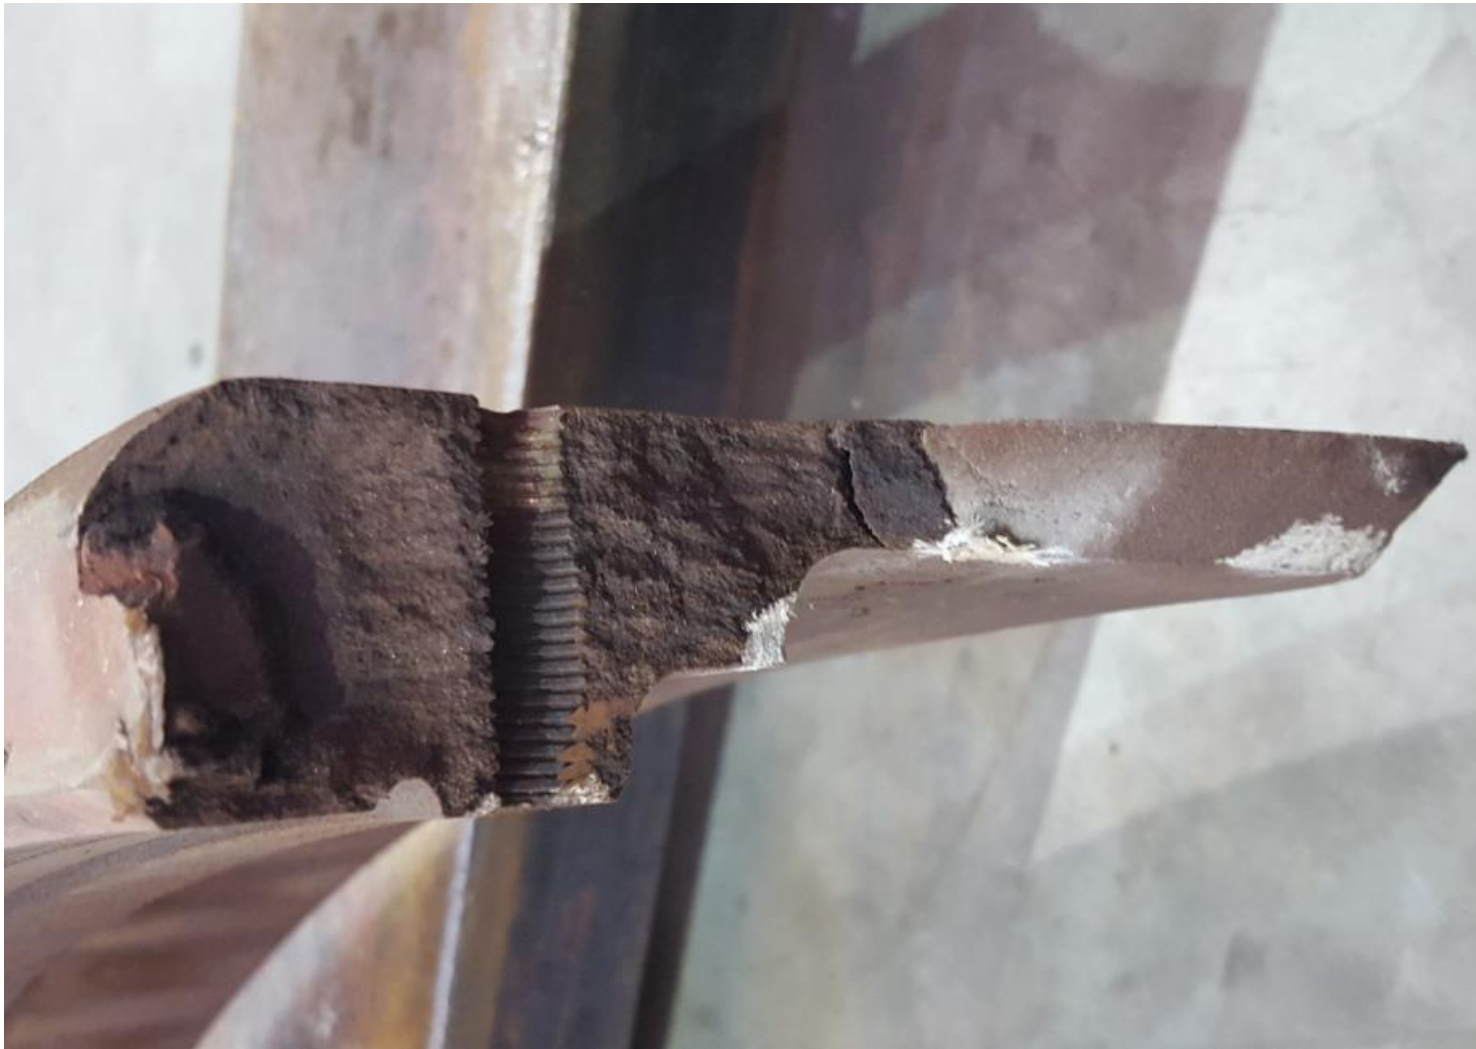
- ⏻ Partial discharge-generated ozone + H₂O (Humidity) = Nitric Acid.
- ⏻ Nitrate was also found at the crack tip.

- ⚡ SCC was a slow process until the ring was weakened sufficiently to break apart from centrifugal forces all at once.
