Double earth fault in a PSP during back to back launching sequence

Jean-Louis DROMMI – EDF Hydro Engineering Center, France

Pump Storage Scheme, back to back launching

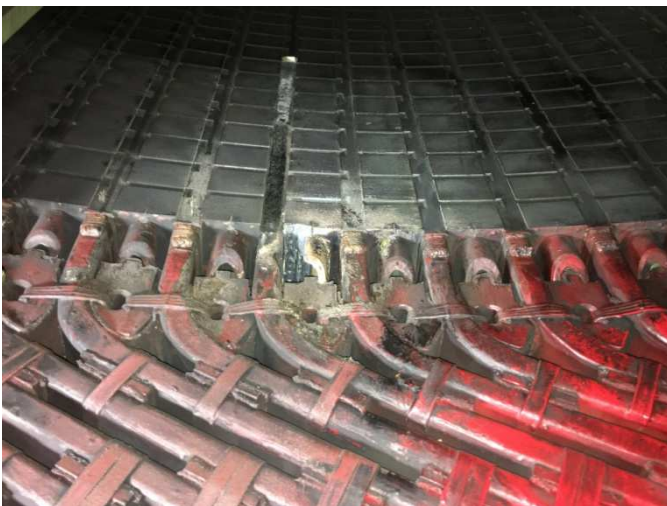
On the driving unit both stator and rotor were severely damaged.

Damaged stator

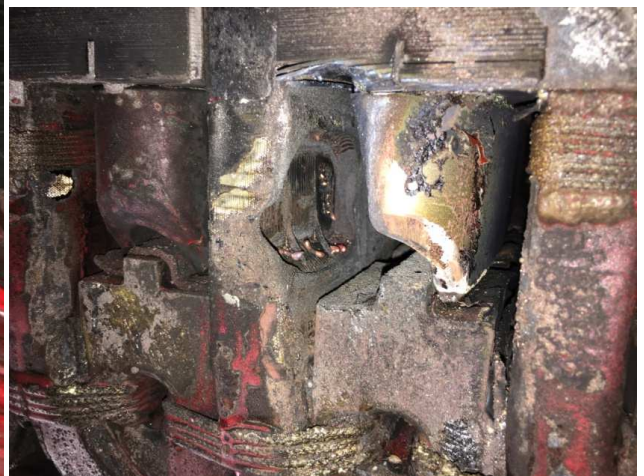
On the stator, a partial melt down of one stator bar was found and the adjacent core clamping finger had also partially melted.

Melted stator bar and finger

The fault was very likely triggered in the driving unit where a forgotten foreign object must have impacted the stator winding. A screw driver end was later found in the bottom of the generator end windings.

Spare Roebel bars were available at the plant, therefore the melted stator bar was replaced with a spare one.

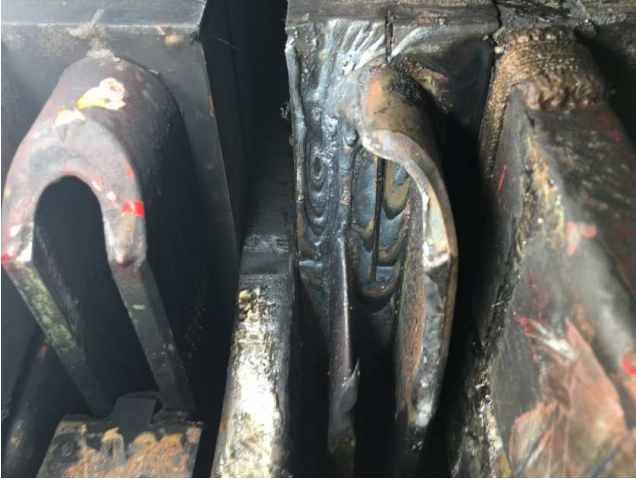
Melted finger and melted lamination

Repairing the melted core clamping finger and part of the lamination was more of a challenge. The shape had to be “rebuilt” with glass fiber and epoxy bonding. And the pressure function and the proper lamination insulation had also to be secured. This was achieved using conic wedges inserted in between lamination. As an extra safety against hot spot, a thermocouple was placed in the repaired area to check the core operating temperature. A specific heat run test was carried out for this purpose.

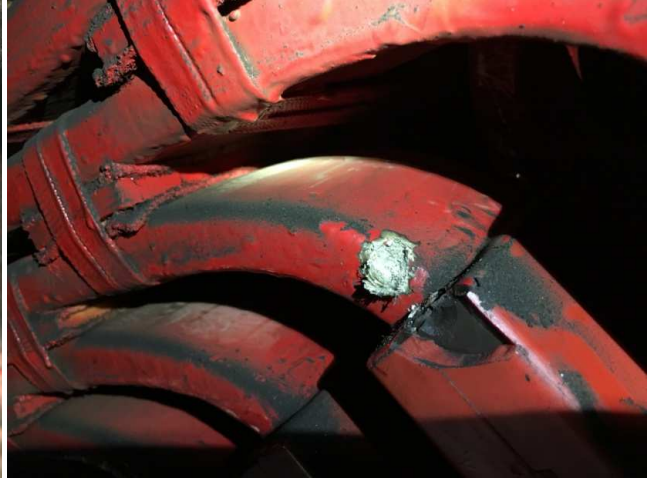
Impact on stator winding

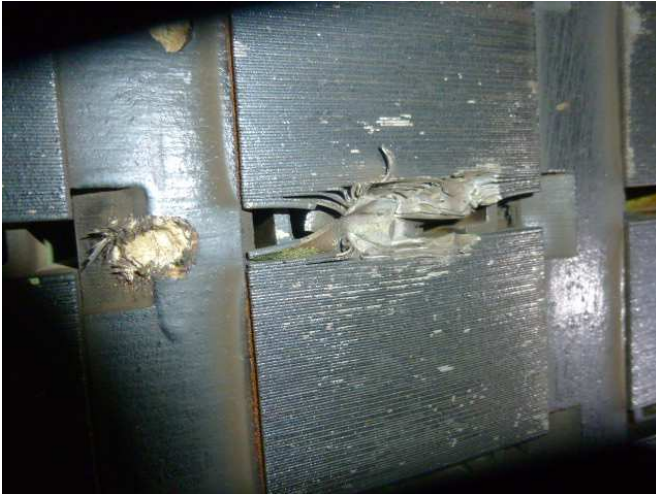
The stator core showed several hits on the lamination

One of the many impacts on core

The core impacts were ground and checked with El Cid for any stray current.

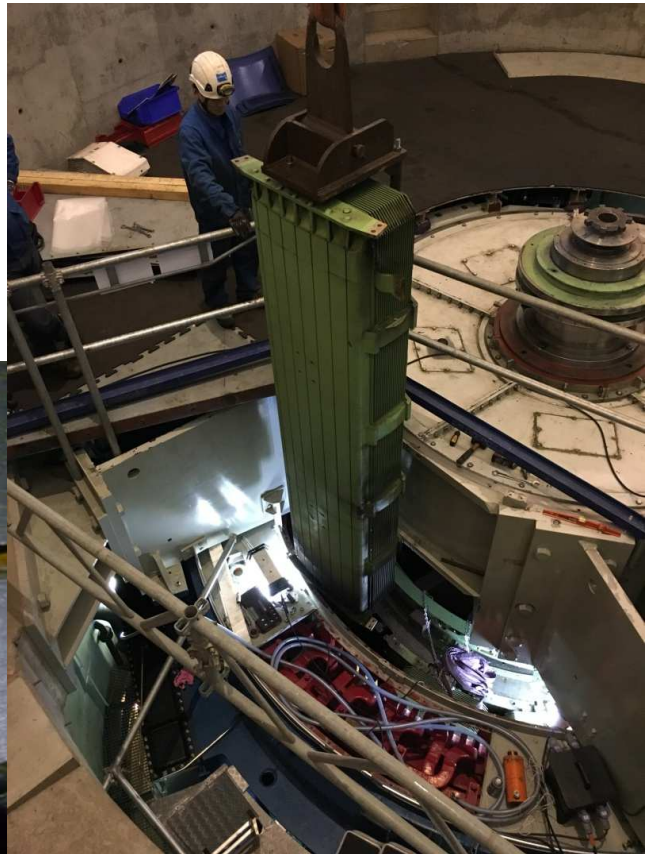
Two rotor poles were damaged, showing zero insulation resistance and interturn faults.

Faulty pole being removed

The two faulty rotor poles were removed. One coil had to be replaced with the spare coil, the second one was cleaned from arcing dust and recovered perfect insulation resistance including interturn insulation.

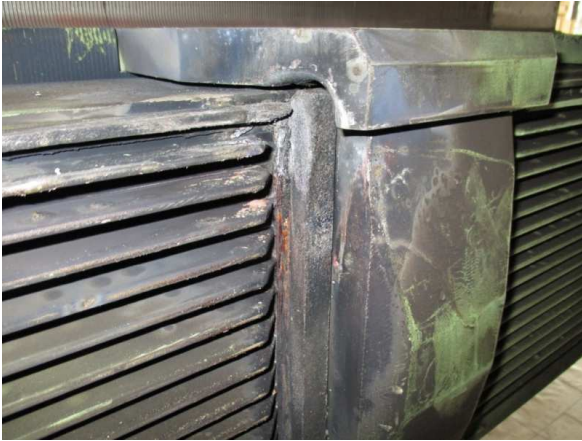
Pole 1 with arcing evidence between winding and body

The almost instantaneous variation of stator current induced a very important voltage on the rotor side, which led to arcing between the 2 poles (input and output poles) and rotor body. The voltage surge was strong enough to damage inter turn insulation on one pole.

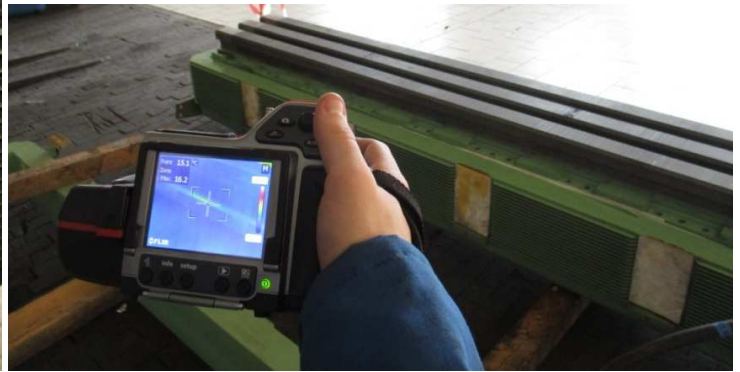
Pole 2 with interturn fault

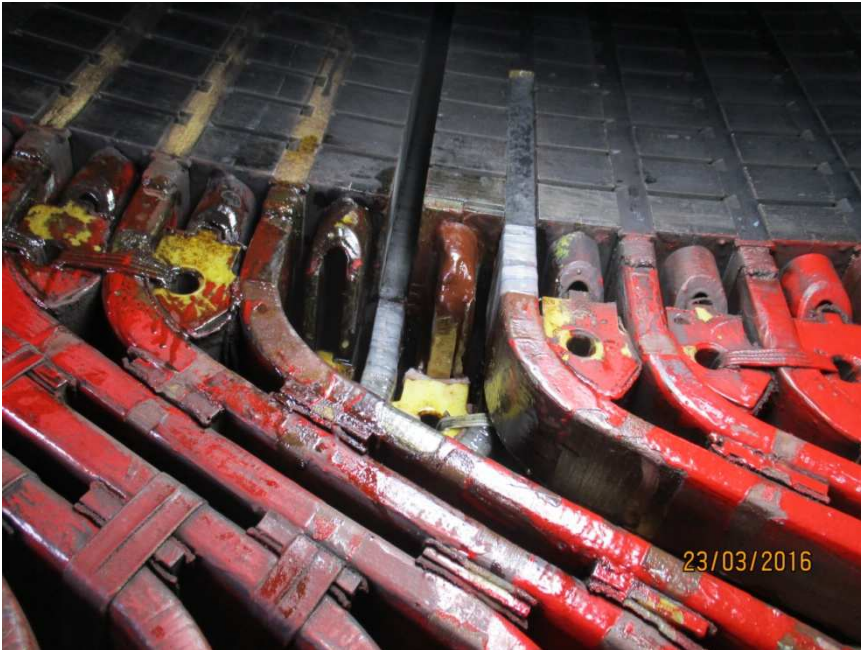
clamping finger repair
