Detection of Stator Winding Stress Relief Coating Deterioration in Conventional and Inverter Fed Motors and Generators

G.C. Stone and H. Sedding
Iris Power - Qualitrol
Toronto, Canada
gstone@qualitrolcorp.com

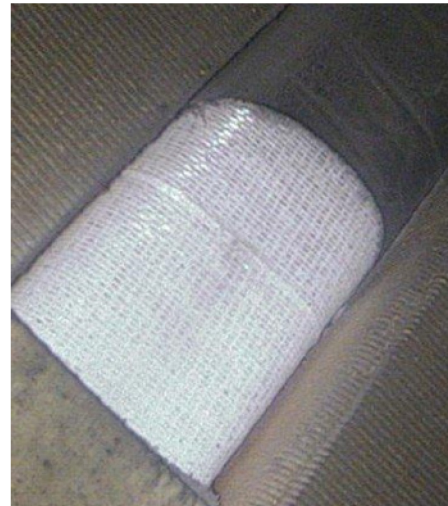
The root cause of semicon coating deterioration is poor manufacturing procedures – most commonly when the semicon surface resistance is too high in localized areas. This is

Once the semicon or the semicon/silicon carbide interface starts degrading, surface PD occurs. In air-cooled machines, the PD will create ozone (O_3). Ozone is a very chemically reactive gas that combines with nitrogen and humidity in air, creating nitric acid (HNO_3). The nitric acid attacks the adjacent semicon and silicon carbide coatings – which expands the area of damaged coatings. Figs. 2 to 4 show examples of degraded coatings.

Fig. 2. Example of the top of a motor stator coil where the semicon was poorly made and has turned white from its normal black color due to the action of ozone produced by the PD. This GVPI stator is only partially wedged. The photo was taken via a borescope with the rotor in situ.

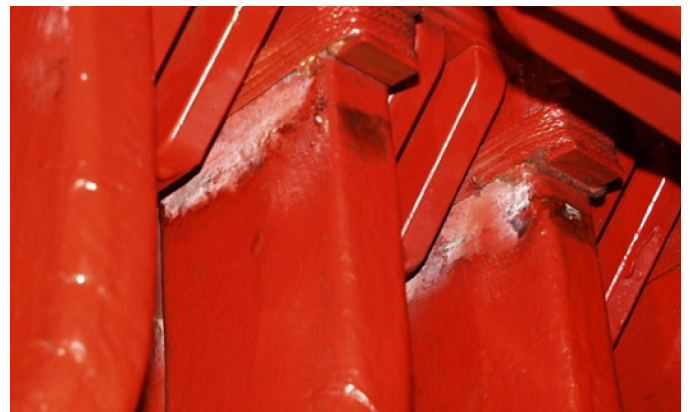
Fig. 3. Surface PD damaged the semicon coatings at the slot end on a 13.8 kV generator stator.

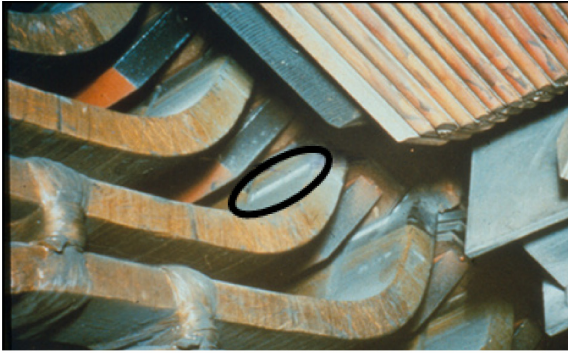
The silicon carbide coating overlaps the semicon coating at both ends of a coil/bar (Fig. 1). In some cases, the electrical connection between the semicon and the silicon carbide coating has too high a resistance. This may be because either the graphite content in the semicon is too low, the silicon carbide particle density is too low, or the overlap area is insufficient to handle the current. The capacitive currents flowing through this high resistance electrical connection can lead to a local high temperature, which further increases the temperature. Eventually, thermal runaway occurs at the connection, which results in the silicon carbide coating becoming electrically

disconnected from the ground, leading to PD across the surface of the insulation.

Fig. 4. Surface PD at the overlap between the semicon and the silicon carbide coating (circled) in a 13.8 kV hydrogenerator.

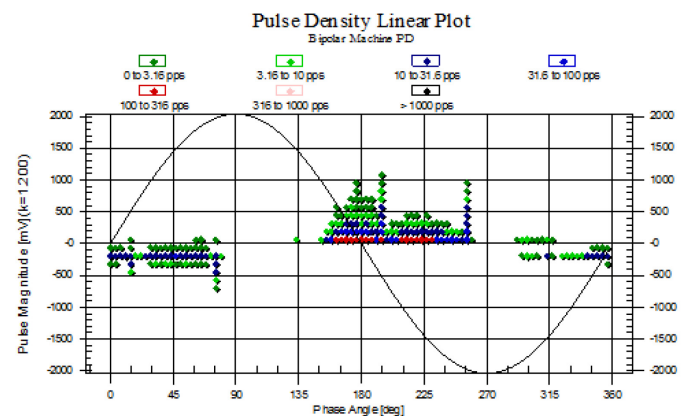
Fig. 5 shows the phase resolved PD plot for a large 13.2 kV motor with a global VPI stator winding. The PD was measured during normal operation of the motor with 80 pF sensors and a TGA-B™ on-line PD instrument. This plot shows the strong positive PD predominance and phase position typically associated with stress relief coating discharge. The positive and negative peak PD magnitude (Q_m as defined in IEC 60034-27-2) is +931 mV and -451 mV. In comparison to the most recent version of a large PD database [5], the PD in this motor is higher than 95% of other similar motors – indicating very high PD activity. This conclusion was verified by a visual inspection of the stator, which showed widespread deterioration of the semicon coatings, and obvious signs of chemical attack by nitric acid throughout the motor enclosure. This motor has been operating for over 20 years, and the high PD is likely to have been occurring since shortly after going into operation. The motor has experienced heat exchanger water leaks, indicating a long term exposure to ozone and nitric acid.

Fig. 5. Recent phase-resolved PD activity from a large 13.2 kV motor with visually confirmed deterioration of the semicon coatings similar to that shown in Fig. 2. The vertical scale is the positive and negative PD magnitude, the horizontal scale is the phase angle of the 60 Hz ac cycle, and the colour of the dots indicates the PD pulse repetition rate.

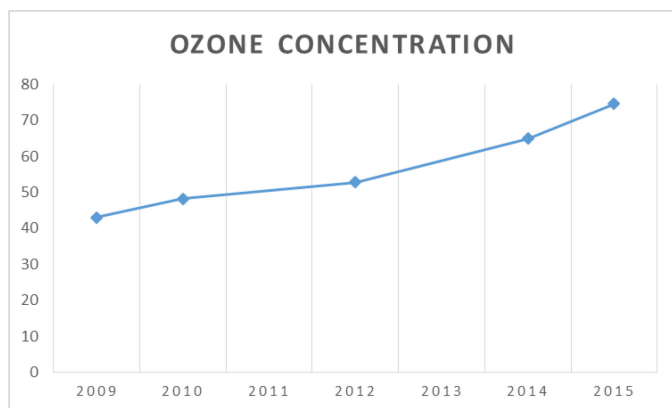
Fig. 6 shows the ozone concentration in ppm over a 6 year period for the same motor discussed above where the surface PD was high. The concentration reached as high as 75 ppm. This is exceptionally high. Reference [1] suggests that a concentration of 1 ppm should be considered high, but this assumed open-ventilated machines. In totally-enclosed machines, the only way to consume the ozone that is always being created by the PD, is when it chemically reacts with other materials within the motor or generator. Thus, in totally enclosed machines, the ozone concentrations are much higher than in open-ventilated machines. It is also the reason that the ozone and nitric acid are more likely to cause water leaks and rotor stress corrosion cracking in totally-enclosed machines.

Fig. 6. Ozone concentration within the same motor as discussed in Fig. 5. The vertical scale is in parts per million of ozone.
