DESIGN AND MANUFACTURING PROBLEMS LEADING TO PREMATURE FAILURE IN RECENTLY MADE MOTOR AND GENERATOR WINDINGS

Copyright Material PCIC Europe
Paper No. PCIC Middle-East ABU-12

Greg Stone
Iris Power - Qualitrol
Mississauga
Canada

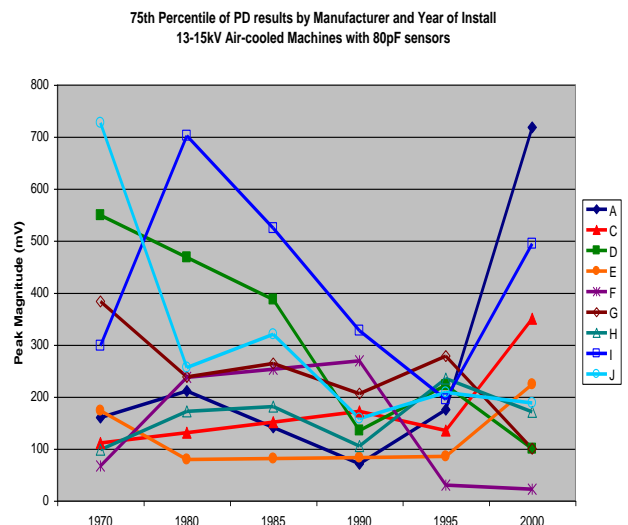
As part of the analysis of on-line partial discharge (PD) data performed on thousands of motors and generators, it has been noted that stators made by some manufacturers in the past decade have much higher PD than stators made by the same manufacturer more than 10 years ago [1]. For example, Figure 1 shows the peak PD activity vs. winding manufacturing date for 9 of the world's largest manufacturers of air-cooled motors and generators. This figure shows that for on-line PD readings measured in recently, four manufacturers are exhibiting much higher PD on recently made stators, than they typically experienced on their machines made before 1995. Since high PD can be often associated with rapid aging of the stator winding insulation system, the high PD in recently manufactured stators is of concern.

Figure 1: Peak PD data vs year of manufacture

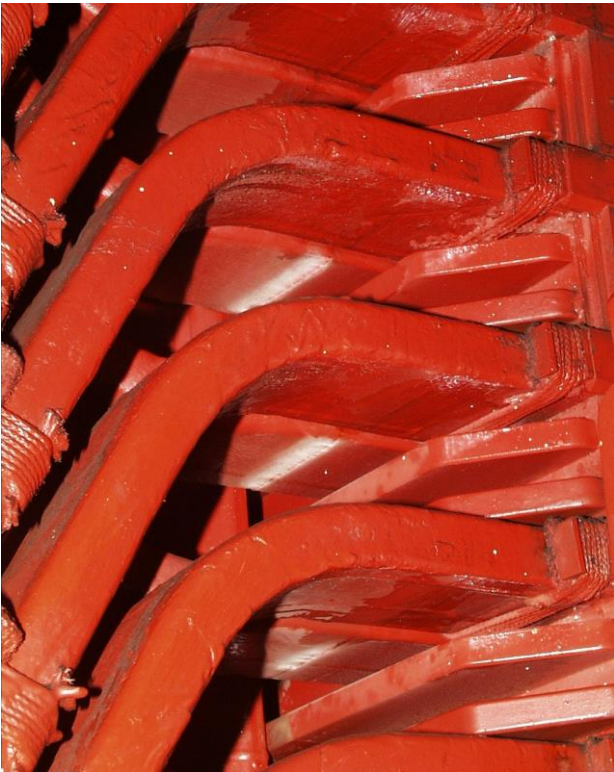
Figure 2 shows a generator stator where a very noticeable white band is visible at the junction of the semicon coating and the silicon carbide coating. Figure 3 shows a winding where the semicon has virtually disappeared in the slot due to poor application of the semicon coating. Figure 4 shows the PD resulting when a 6.6 kV motor stator was now equipped with PD suppression coatings.

Figure 2: Semicon and grading coating overlap deterioration (white powder) due to poorly applied or inadequate coatings

- The electric stress control problems may be caused by poorly applied coatings. The deterioration process is accelerated in winding design that cause the insulation system to operate above about 120C and/or with an average groundwall electric stress above 3 kV/mm.

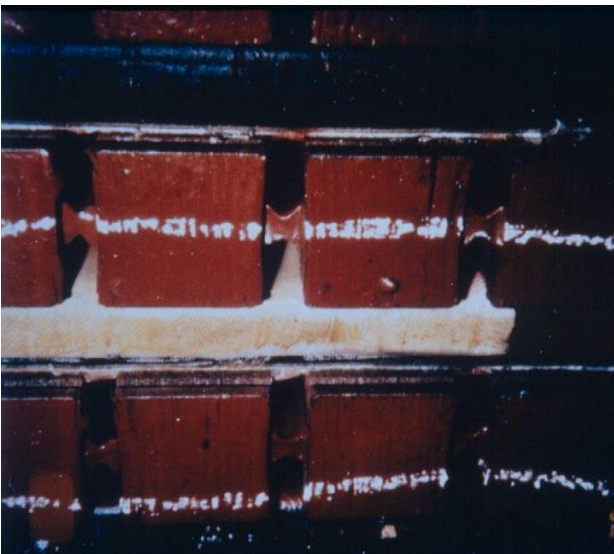
Figure 3: Destruction of the coil semicon coating in the stator slot due to PD and ozone. The wedges have been removed from the slots

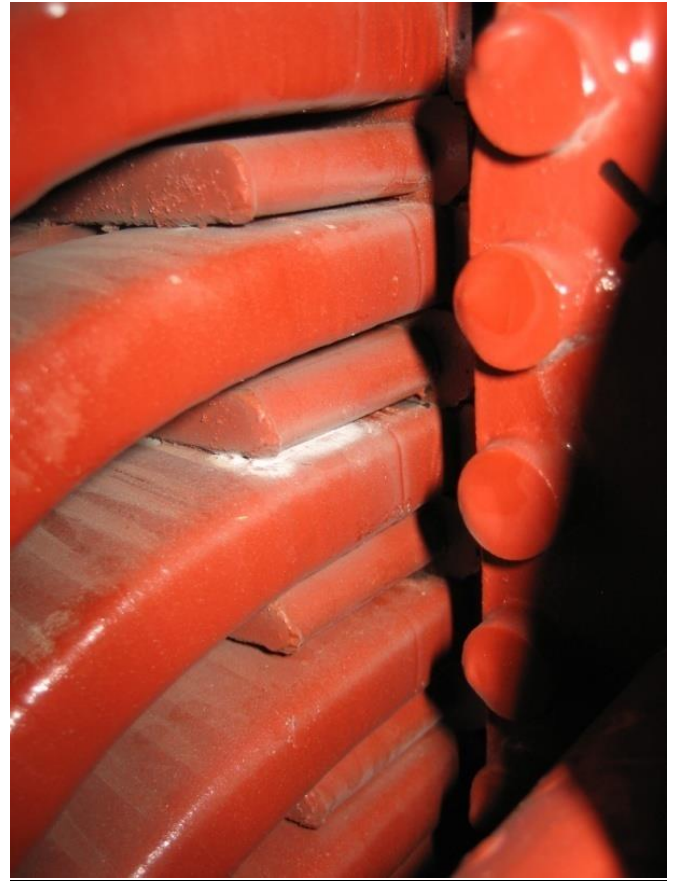
Figure 4: Motor stator where the stress relief coatings appear to be missing – resulting in PD (white powder) between the pressure finger and the surface of the coil

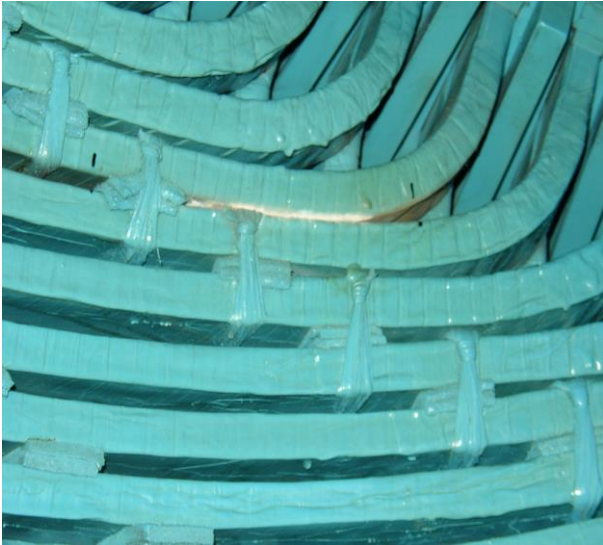
Unfortunately, in many motors and generators we have noted inadequate spacing in machines rated 11 kV and above and consequently high PD (and ozone). Figure 5 shows the white residue caused by ozone resulting from PD between two coils in different phases that were installed too close to one-another.

Figure 5: PD occurring between high voltage coils in two different phases, where the spacing is insufficient to prevent the PD. Note that the spacing between adjacent coils is irregular, as a result of poor manufacturing processes.

- The endwinding PD is probably caused either by: (a) poor dimensional control of the coil and/or inconsistent alignment of adjacent coils in the slots; (b) too short an endwinding which does not allow enough circumference at the coil ends for sufficient air spacing between the connections; and/or (c) inattention to the air space and creepage distances needed when blocking and bracing are installed.

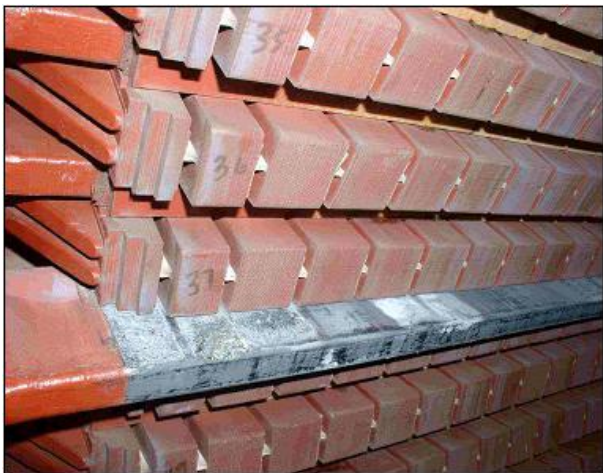
groundwall insulation (Figure 6). The mechanism is sometimes referred to as slot discharge, because once the semiconductive coating is abraded, partial discharges occur between the coil surface and the core, further increasing the rate of deterioration.

Figure 6: Bar abrasion due to loose windings in the slot of a turbo generator that did not have sufficient sidepacking or a radial follow-up wedging system. The bar is in the process of being removed after failure.

- The loose coil in the slot problems may be due to a slot content design that does not take into account the gradual shrinkage of insulating and wedging materials, or where the need for tight coils has been sacrificed to make the coils easy to install in the slot.

- For non-global VPI stators, require the use of a wedging or sidepacking system that contains a follow-up restraint that ensures tightness as the slot contents shrink. This could include the use of two or three part wedges, ripple springs and/or conformable materials such as silicon rubber. Alternatively consider requiring a clearance between the side of the coil and the core to be no more than 0.1 mm or so.

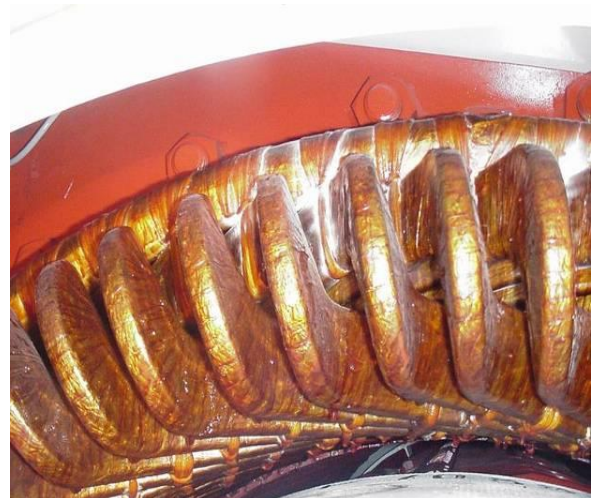
Figure 7: The white powder (fretting) on this motor stator endwinding is caused by relative movement between the coils and the endwinding support ring.

- Insufficient attention paid to the endwinding design so that there are natural vibration frequencies close to the 100/120 Hz magnetically-induced forces.
