# Experience with Stator Insulation Testing & Turn/Phase Insulation Failures in the Power Generation Industry

May 7, 2018

**Heedong Kim, Taesik Kong**

Korea Electric Power Company  
Research Institute, Daejon, Korea

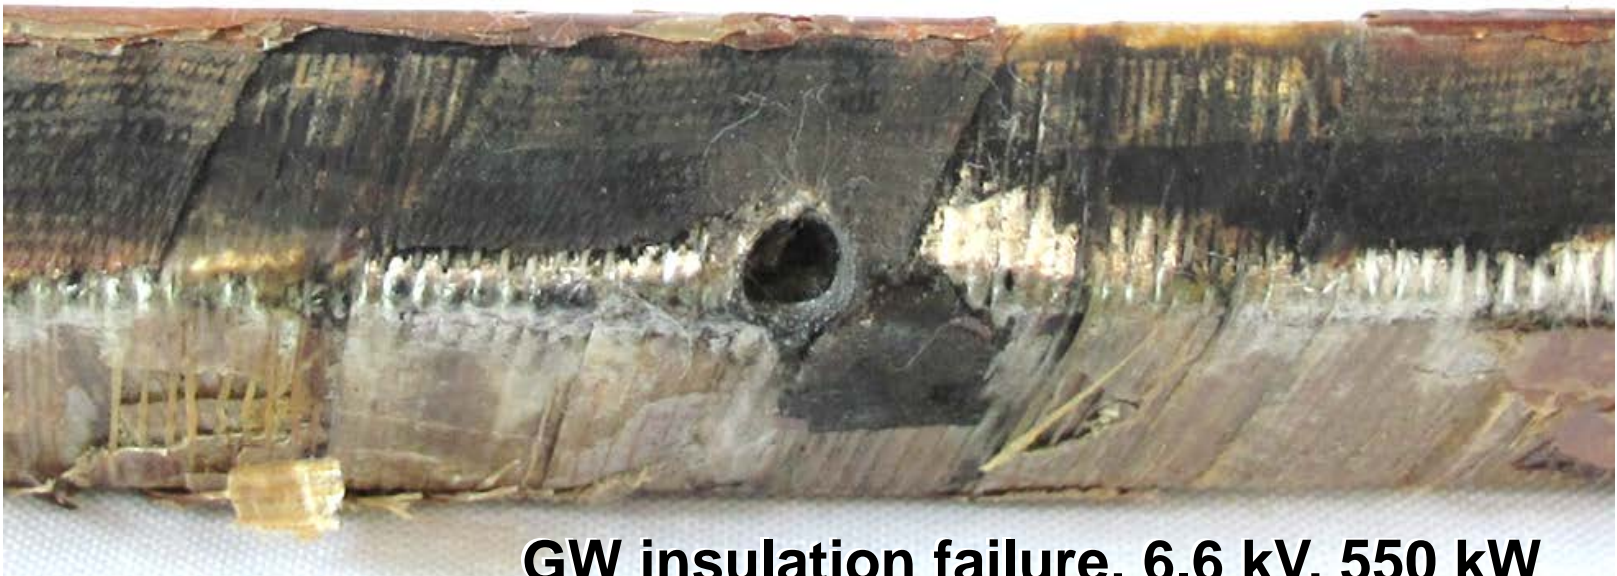
**GW insulation failure, 6.6 kV, 550 kW**

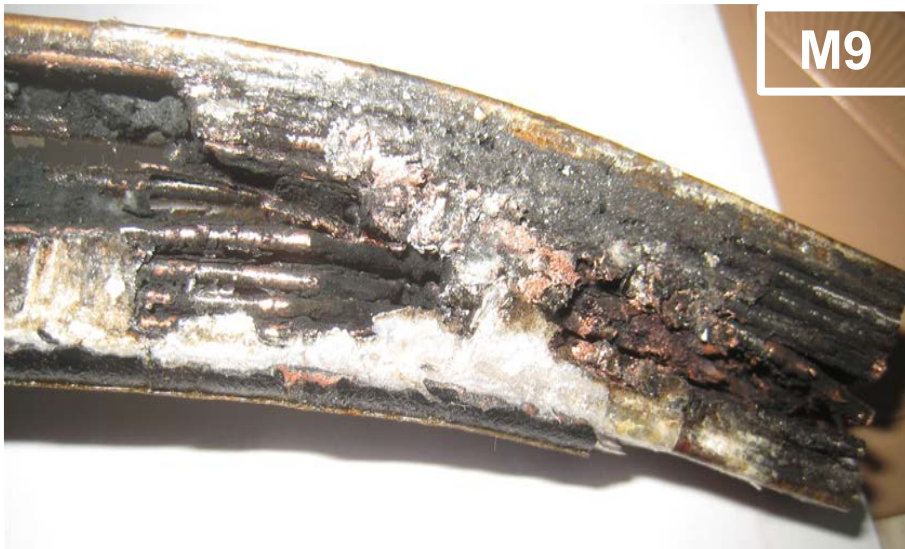
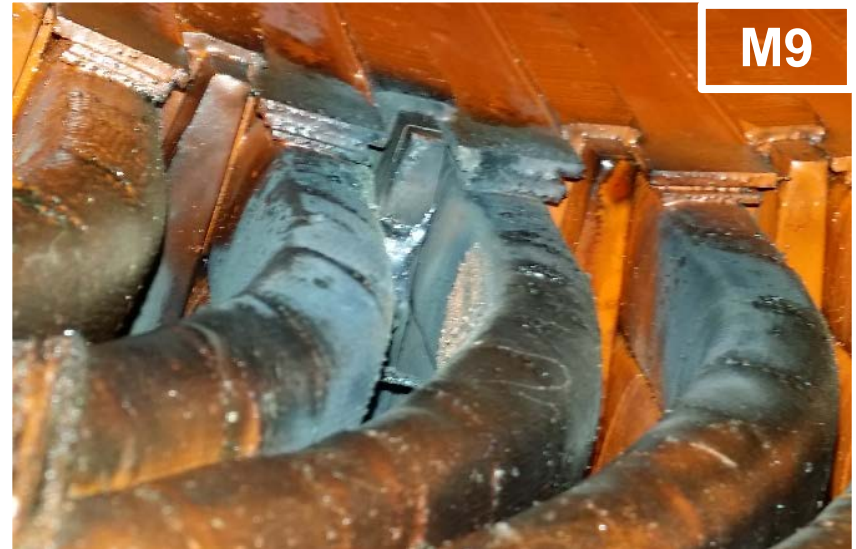
- Induction of high amplitude circulating fault current in shorted loop
  - Localized heating: melted copper & damage over wide area
  - GW insulation failure (and/or stator core damage)
- Tripping of motor: forced outage

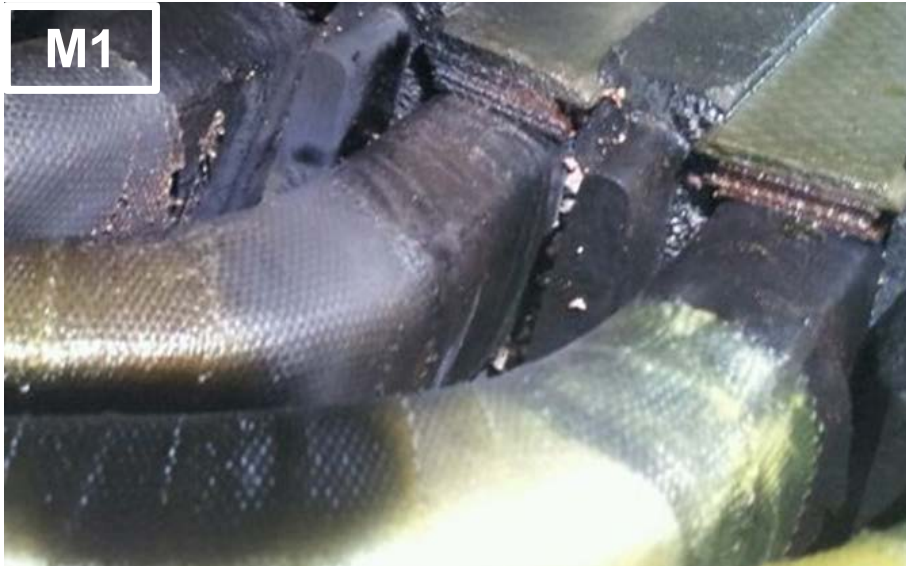
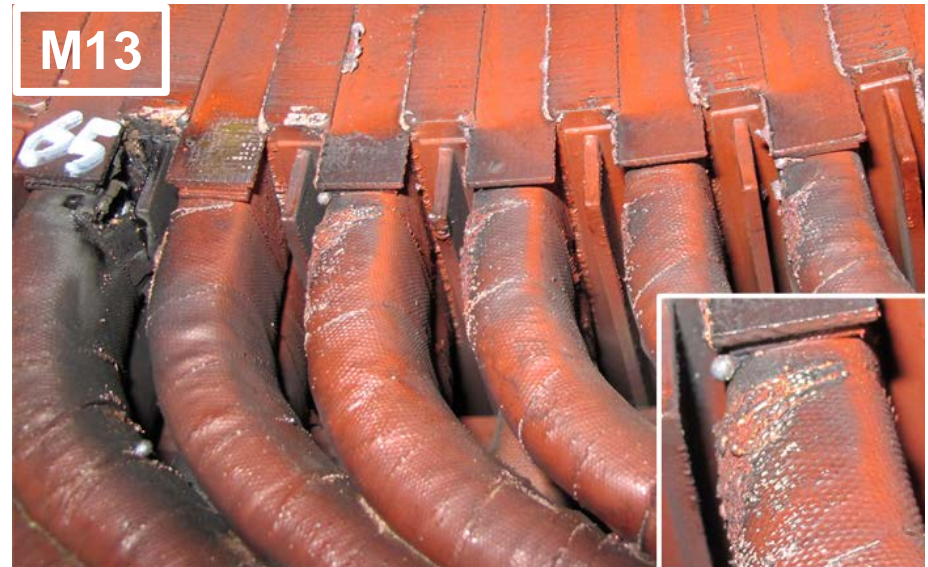
- ▶ No noticeable trend in correlation between turn failure & application, rated power, number of poles, years of service
- ▶ 7 of 13 failures occurred at motor startup
  - 6 of 7 failures located at EW slot exit (M1, M2, M4, M5, M6, M9)
  - 2 of 3 failures in 1<sup>st</sup> or 2<sup>nd</sup> coil (M5, M9)
  - Typical failures: fast risetime voltage surge & mechanical forces
- ▶ 6 of 13 failures occurred during operation >12 hrs after startup

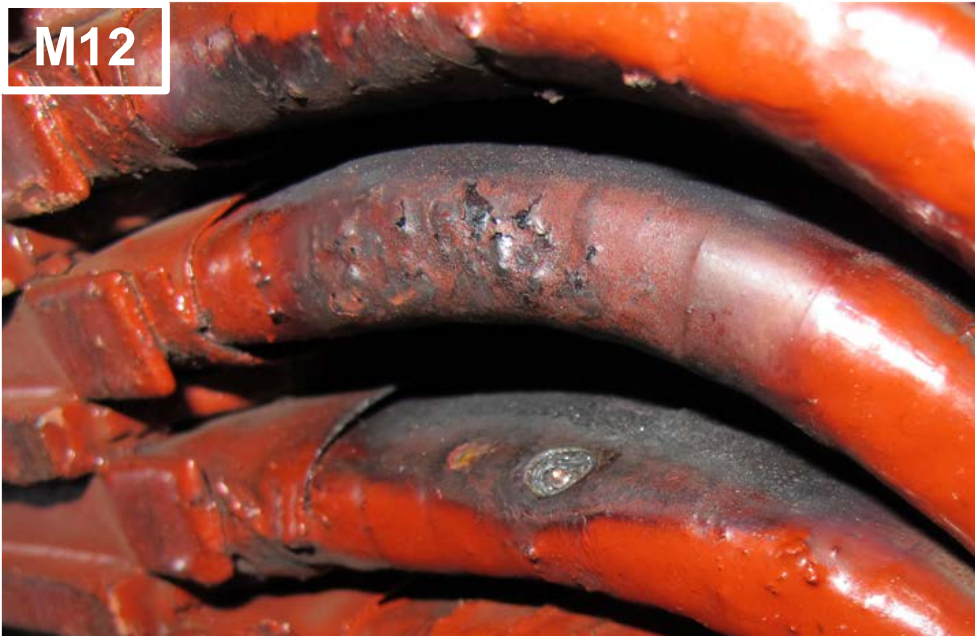
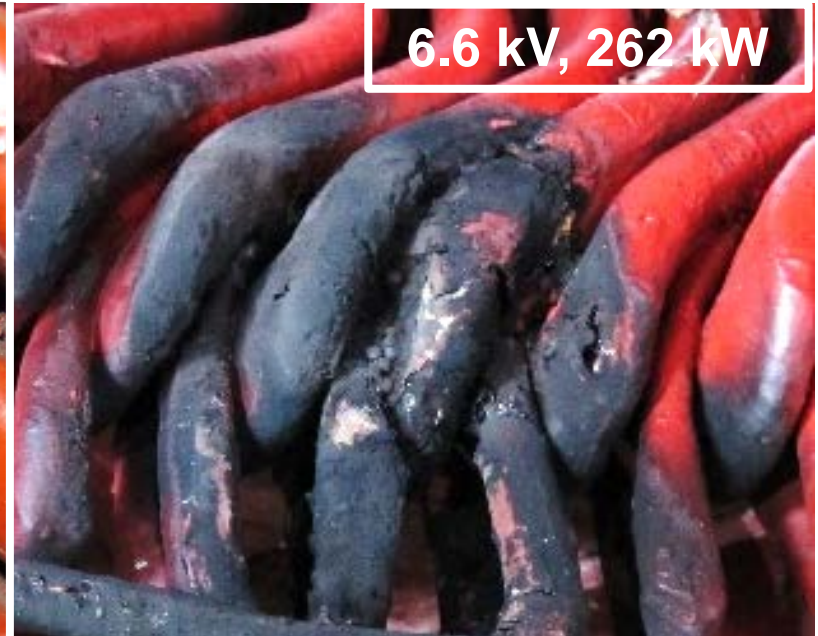
- ▶ Melted copper & burning over wide area observed for ALL cases
- ▶ Turn failure does not necessarily cause GW insulation failure
  - Turn fault can cause tripping of open phase, imbalance, phase current relays before GW failure
  - M12: no visual signs of GW current path + high IR value
  - Turn failures in the tip of EW common w/ crossover coil designs

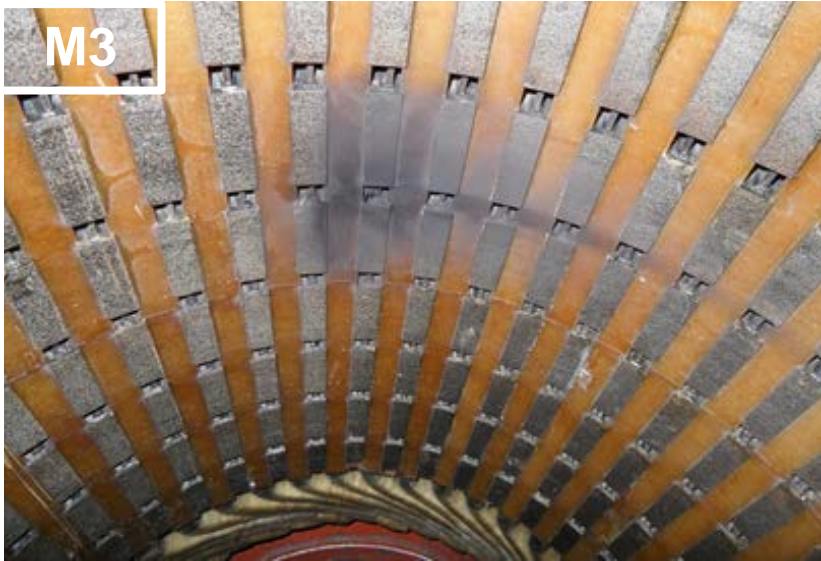
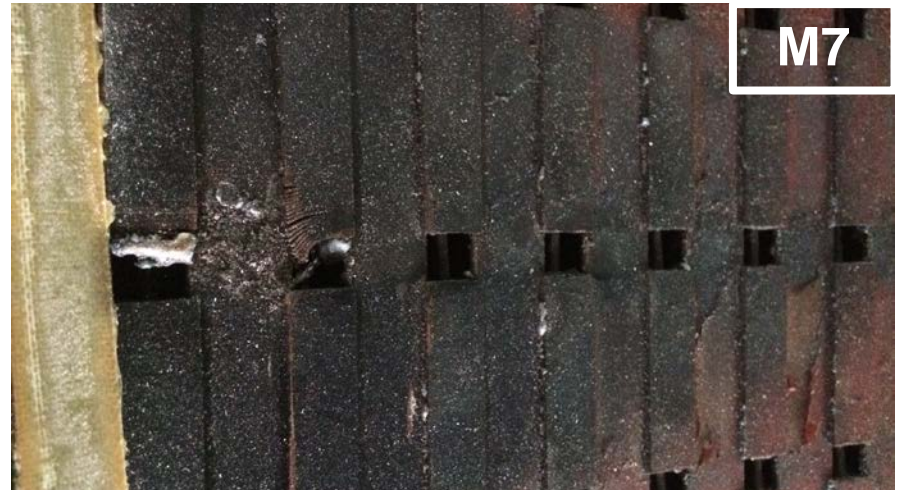
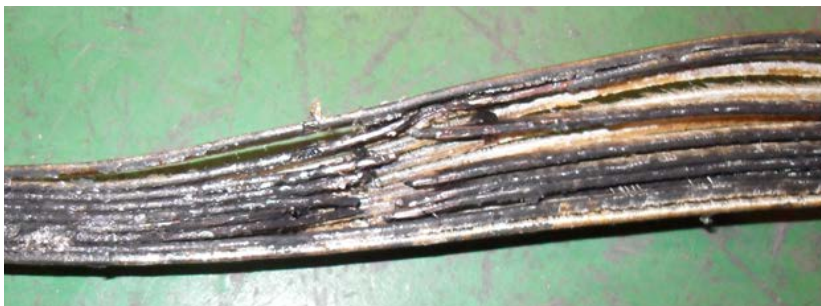
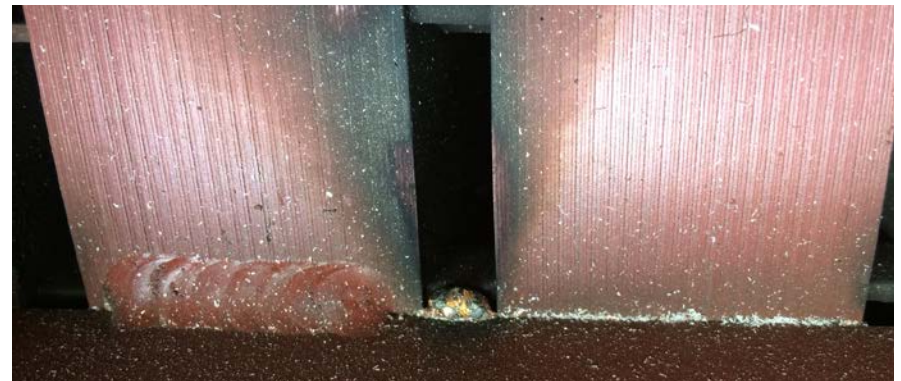
- ▶ 4 of 13 failures near center of slot
  - Clear signs of melted copper and ground current path

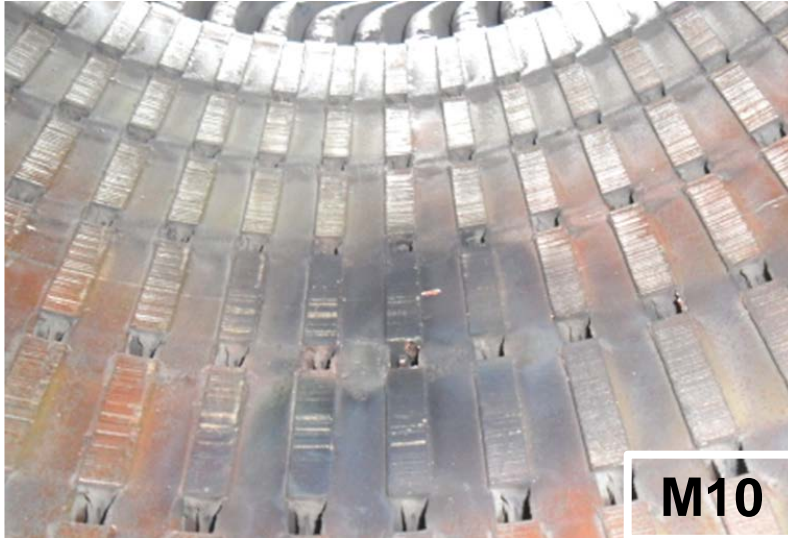
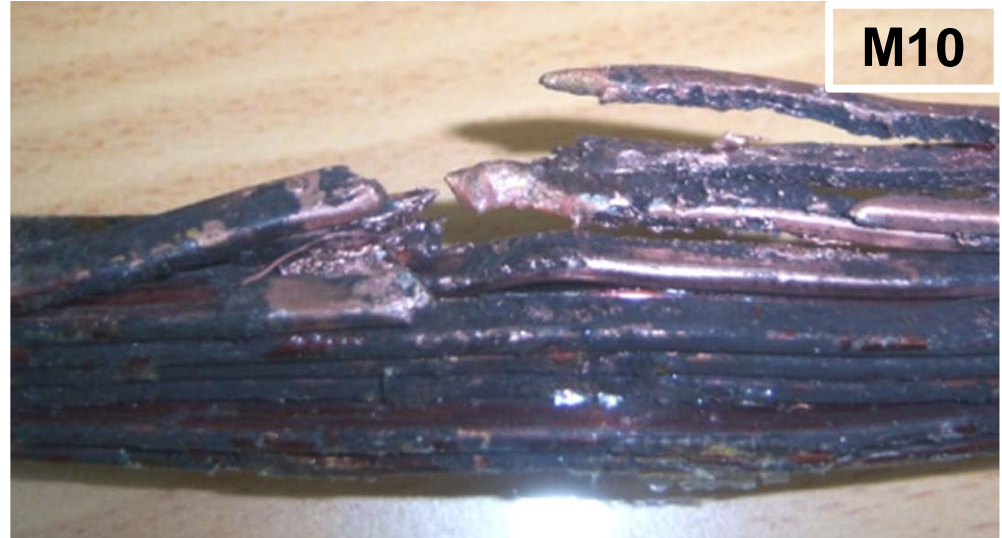
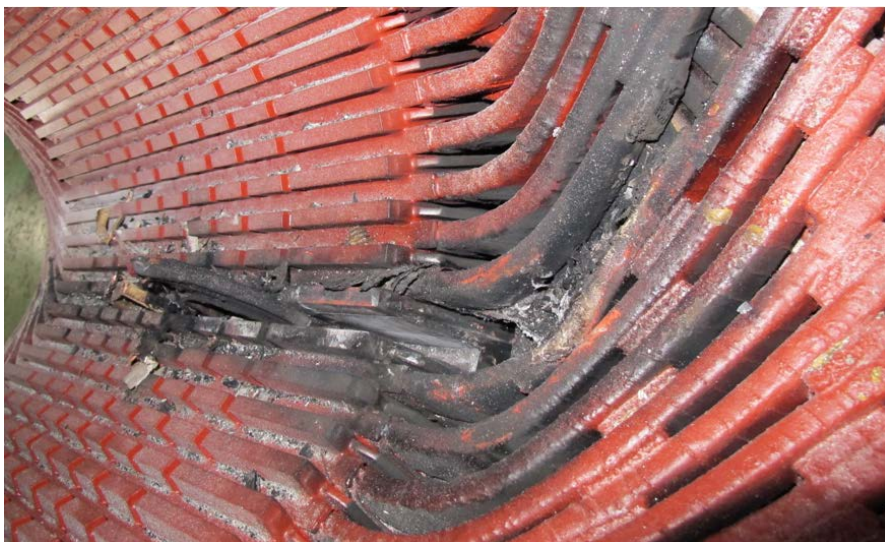
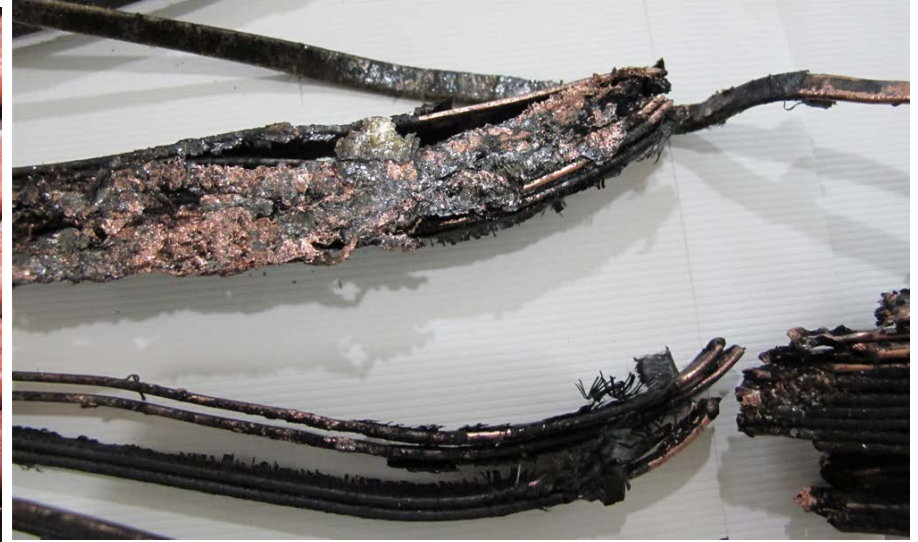
- Clear signs of melted copper and ground current path

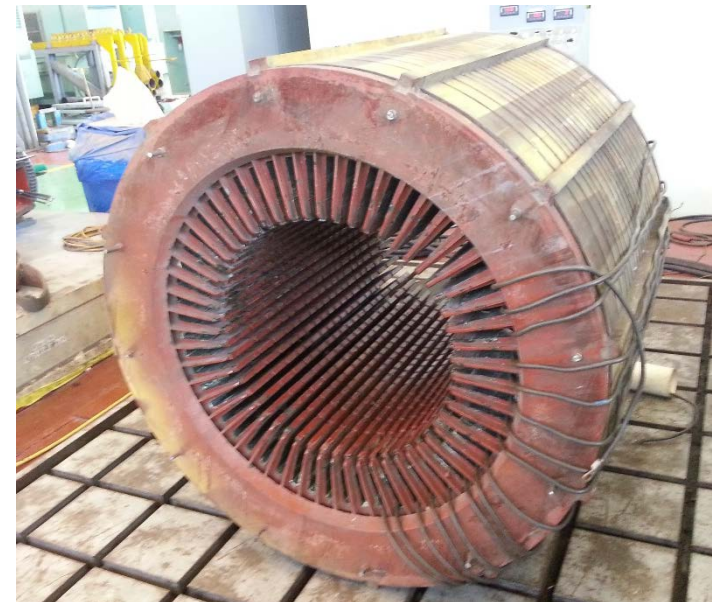
- ▶ Core inter-laminar insulation failure not observed for any of the 13 cases
  - Visual inspection, core loop test performed during rewind
  - Relays act fast enough to prevent core damage even with large ground current with solid grounding in domestic power plants
  - Not all faults result in ground current through stator core
    - EW failure not close to core (M13, crossover coils)
    - Trip caused by asymmetry or open circuits
    - Ground current flow through core end plate

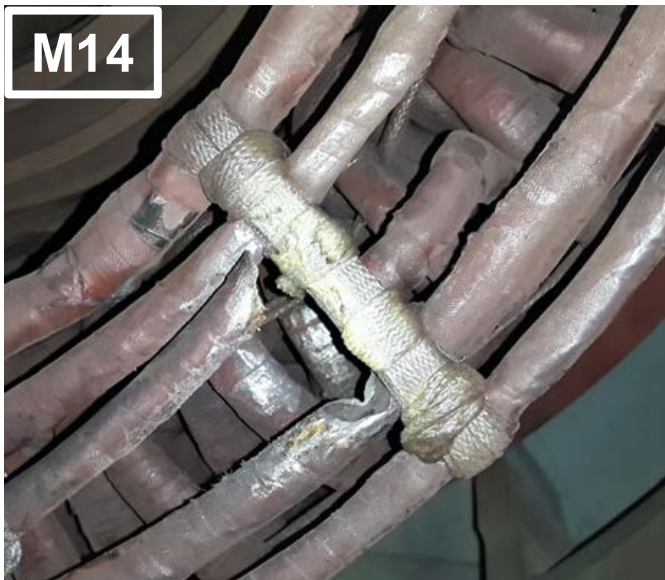
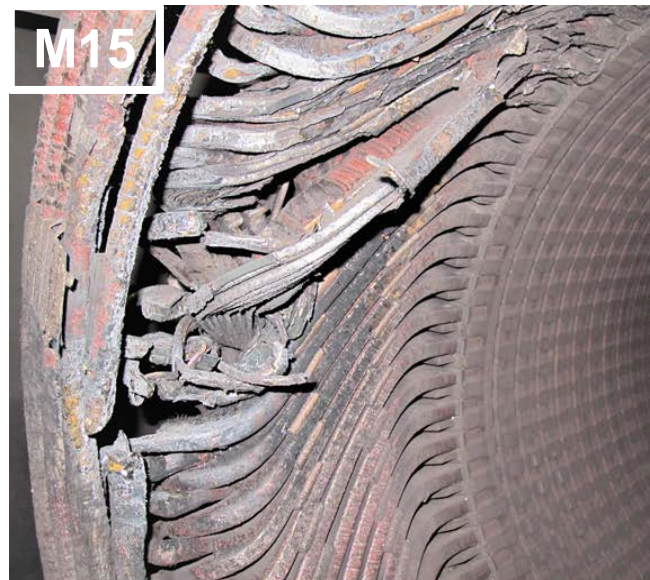
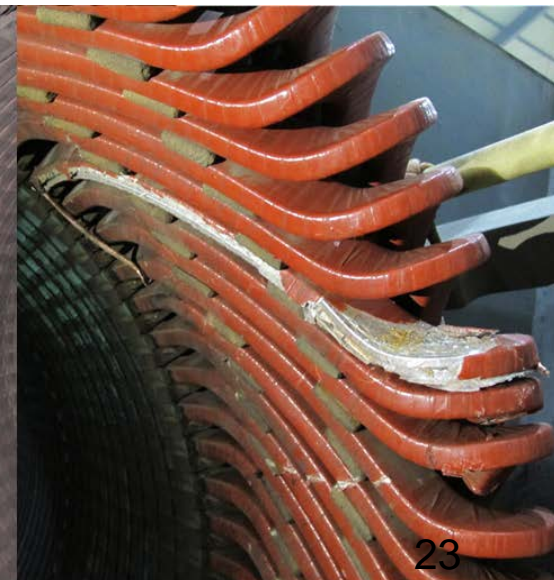
- ▶ M14
  - Open phase failure due to phase insulation failure b/w lead cables
- ▶ M15
  - Significant damage due to insulation failure b/w lead cable & terminal end EW
- ▶ Cause of failure: surface leakage current & arcing due to insufficient spacing & coal dust contamination
