# LOOSE STATOR CORE DIAGNOSTIC METHODS

## SUMMARY

Increased partial discharge was observed on a vertical, 25 MW, Kaplan, umbrella type unit. The decision was made to perform additional diagnostic measurements. A detailed slow-roll air gap and vibration measurements were performed and the loose stator core problem was detected. The loose core vibrations were related to the increased partial discharge.

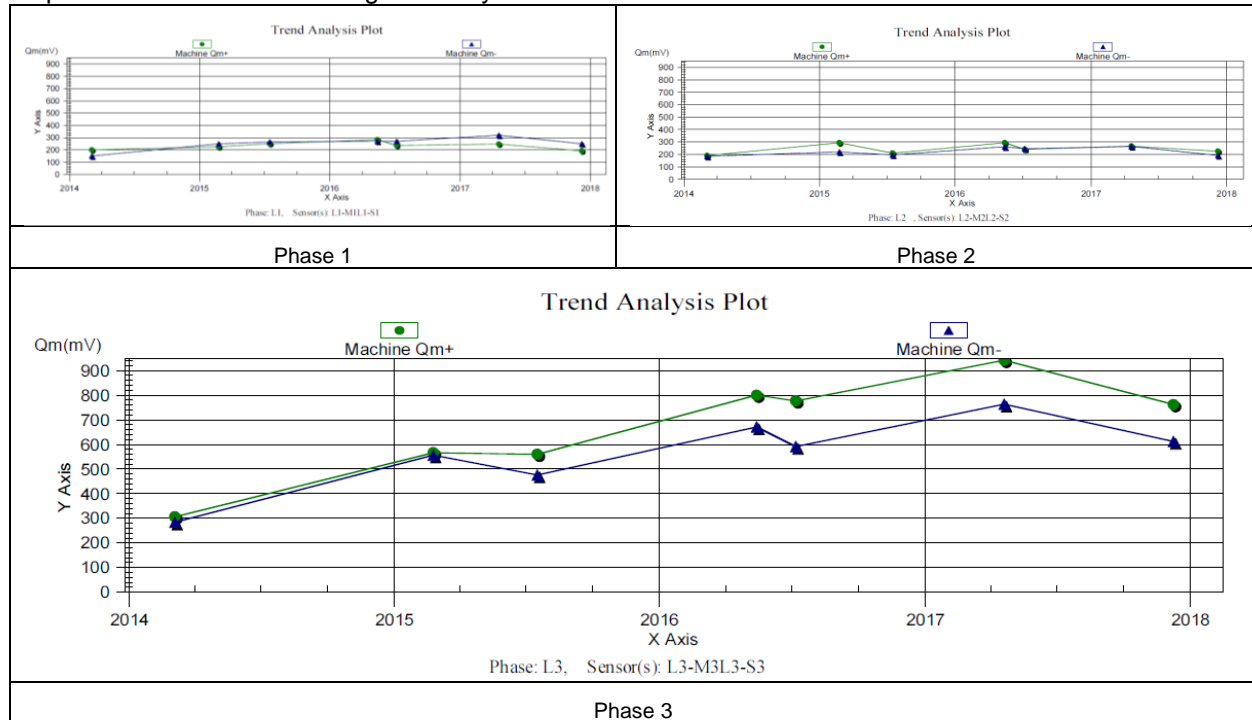
The first indication to the existence of the problem were the PD measurements. When the unit was assembled, and during the first PD measurements in 2014 it was already known that there are 90 % similar units with smaller PD levels. By monitoring (trending) the PD through Qm it was shown that in the L3 phase there is an increasing trend. By 2018 the values have increased ~3 times.

**Fig. 9 Measured Qm [mV] for all three phases. Qm+ (green), Qm- (blue). Phase 3 Qm values have increased ~3x from 2014.**

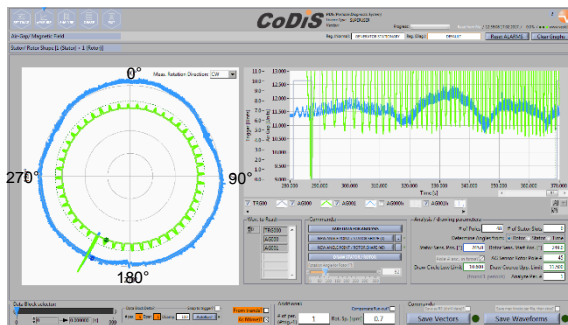
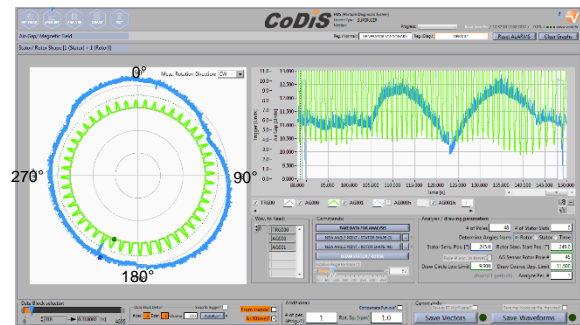
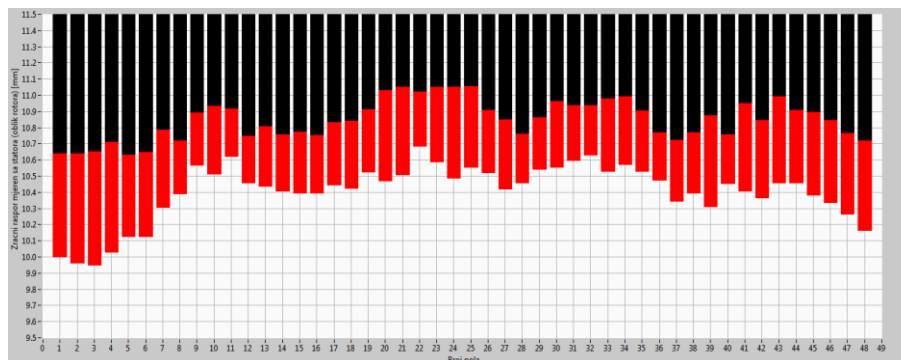
**Fig. 11 Stator and rotor shapes in two measurement planes.**

Stator (blue) and rotor (green) shape measured in a plane at the **bottom** of the stator core.

Stator (blue) and rotor (green) shape measured in a plane at the **top** of the stator core.

Rotor shape (air gap) by the pole numbers. Lower plane – black, upper plane – red.

From Fig. 11 it can be clearly seen that the stator shape is, approximately, elliptical. Also, it can be seen that the segmented stator was not assembled exactly round as there exist abrupt changes in the shape exactly at the angles where the stator segments are attached (stator joints). This is especially visible at the  $\sim 60^\circ$  angle (from the direction of water in the direction of rotation) on Fig. 11 measured at the top of the stator core. Also, in between joints, there exist relatively large deviations in stator shape. The largest deviation is (Max – Min)  $\sim (12.2 - 9.9) \text{ mm} \sim 2.3 \text{ mm}$  which is  $\sim 22.1 \%$  (regarding the average air gap in this plane, which is  $10.407 \text{ mm}$ ). The fact that the stator is, mostly, 'elliptical' reduces the unfavorable Unbalanced Magnetic Pull effect<sup>3</sup>. The assembly has a direct influence on the entire stator stiffness and its natural frequency as it will be seen from the vibration measurements.

Regarding the rotor shape, using the numbers shown on Fig. 11 it was calculated that the deviation from round shape is  $\sim 3.9\%$  in the lower and  $\sim 7.1\%$  in the upper stator plane. These numbers are acceptable.

It is, however, more important to notice the existence of a rotor 'zone' which covers ~9 poles (from poles numbered 46-48 and 1-6) which are ~0.5 mm more prominent than the rest of the rotor. They are, in fact, related to the magnetic unbalance as established from the vibration measurements and shown in the next paragraph.

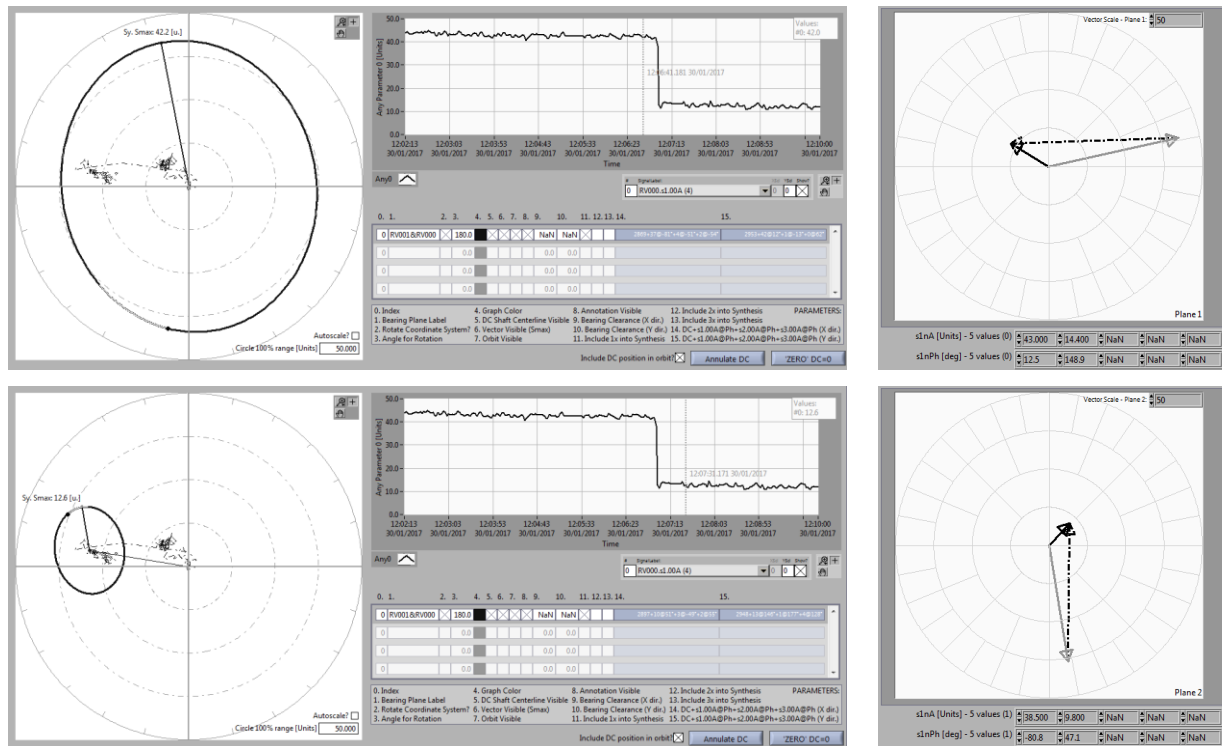
TOP: Shaft centerline and 1x synthesized orbit for unit on nominal speed, no excitation  
 BOTTOM: Shaft centerline and 1x synthesized orbit for unit on nominal speed, excited  
 Outer circle radius (left side of the figure) is 50  $\mu\text{m}$ .

Vibration vectors (Ampl. & Ph. at 1x)  
 Gray: nominal speed, no excitation  
 Black: nominal speed, excited  
 Black dotted line: difference between excited and no excitation

**Fig. 13 Generator bearing – shaft centerline + synthesized orbit data. 'Statical' part of the orbit is included into the plot, as seen from bottom orbit on the left side of the plot. On the right side, vibration vectors are shown as is the change with excitation.**

So, there is some amount of magnetic unbalance but, generally, the vibrations are not large and the unit operates in zone A (according to ISO 7919-5).

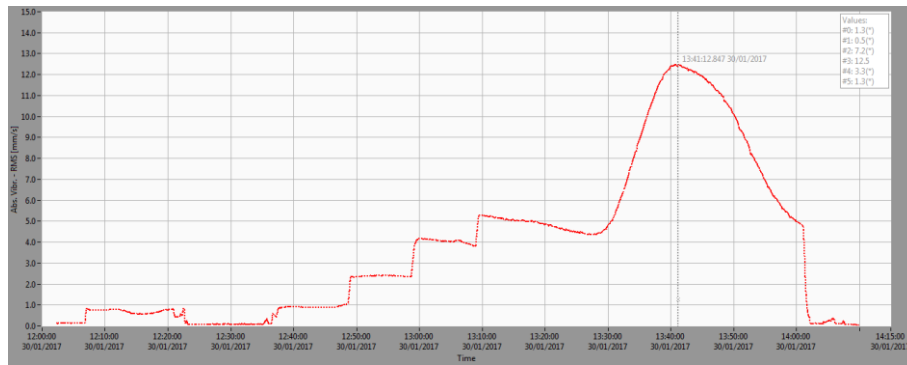
**Fig. 15 The RMS value of vibrational velocity during the measurements.**

From this figure, it can be clearly seen that in mechanical rotation, no excitation (up to ~12:07 h) the overall (RMS) vibrations are, practically zero. At 12:07 h the unit was excited and it was then that the stator core started vibrating, due to magnetostriction<sup>4</sup>. Again after synchronization and load increase (around ~12:35 h) one can clearly see vibrations increasing after each load increase (compare Fig. 12 and Fig. 18). This is due to the increased forces (which are due to the current through windings increase) between the two windings. The excitation frequency is 100 Hz.

As it was already mentioned, the regime remained unchanged from ~13:10 h to ~14:00 h. This means that the amplitudes of the excitation forces (and, of course, the frequency) remain unchanged in this time period. But, from the RMS of vibrations (Fig. 15), it can clearly be seen that in this period, the vibrations are, at first, slowly decreasing and then, around 13:30 h they start increasing again and pass through a maximum value beginning to decrease again. Since the excitation forces remain the same, the vibration should remain the same if the mechanical characteristics (stiffnesses) of the construction remain the same. Therefore, one can conclude that **something has changed in the construction** and, based on the dynamics of the process it's related to the temperature dynamics (Fig. 14).

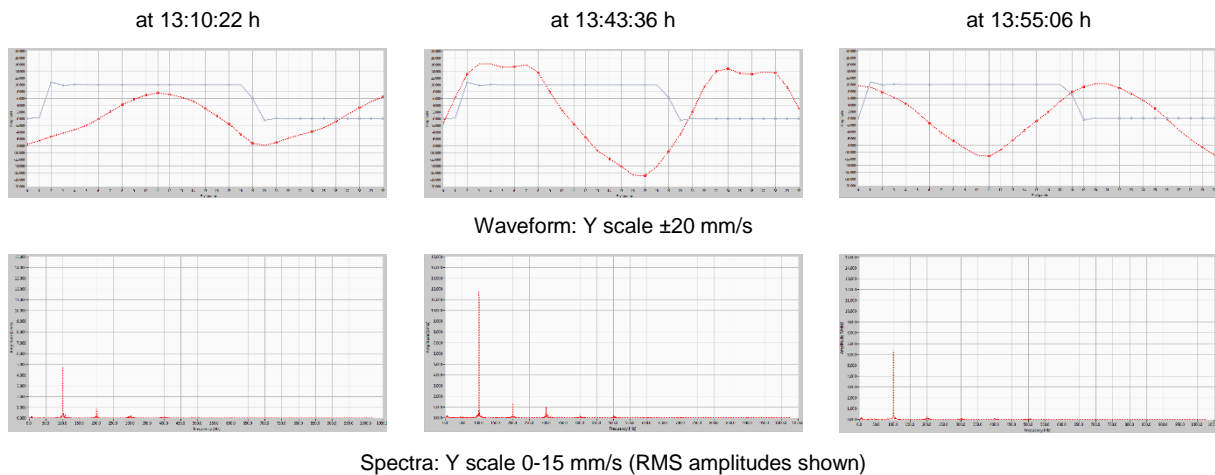
**Fig. 16 Waveforms and spectra at noted times.**

From the waveforms and spectra it can be clearly seen how the amplitude on 100 Hz increases, reaches maximum value, then decreases. In fact, the most important contribution to the overall (RMS) – Fig. 15 value is that from 100 Hz which means that one can, practically, look at the RMS plot as an 100 Hz amplitude RMS plot. From the waveforms, one sees that the phase of vibrations relative to trigger changes for 180°. This behaviour is typical for vibrations in a resonance. At any given point in time, the

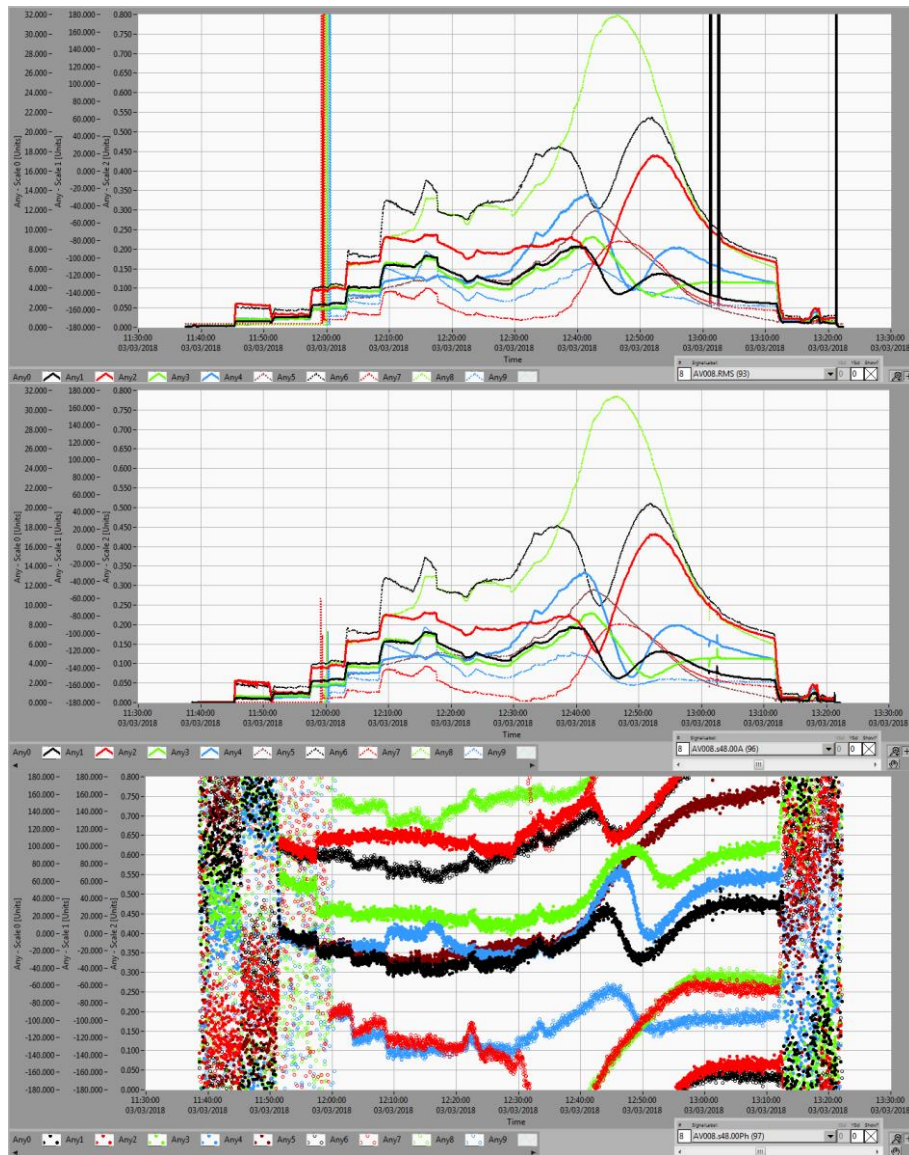
**Fig. 21 TOP: RMS of vibrational velocity. MIDDLE: 48x harmonic amplitude RMS. BOTTOM: 48x harmonic phase.**

Comparing Fig. 15 and Fig. 21 it can be seen there are similarities in vibrational behaviours. The maximum vibrations are noticed around  $\sim 43^{\circ}\text{C}$  which is somewhat higher than the temperature at which they occurred on 30.01.2017. but the vibrational behaviour shows a similar trend. After approximately half an hour the stator core temperature increases for  $5^{\circ}\text{C}$  and the vibrations decrease rapidly which is a sign that the natural frequency moved above 100 Hz.

From the trends, it is clearly seen that the vibrations are dominantly occurring on 100 Hz frequency (48x harmonic of rotational frequency) which is the frequency at which the magnetostrictive and electromagnetic forces in the windings are exciting the construction.

The resonant response time period of the stator frame and core is clearly seen as the sharp and large changes in vibration amplitudes and phases on 100 Hz frequency. This is due to the fact that there are changes in the stator frame and core vibration shapes when the system passes through resonant response.

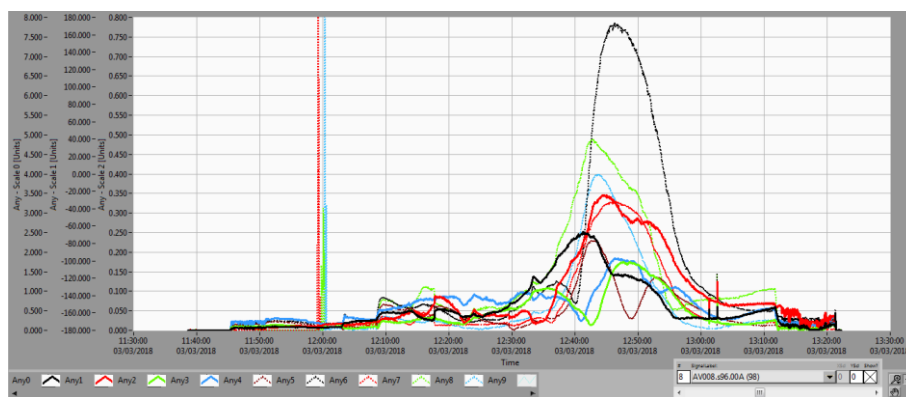
**Fig. 22 96x harmonic amplitude RMS (corresponding to 200 Hz).**

From this trend diagram, it can be seen that in the time period from 12:45 h to 12:55 h, when the vibrations are the largest on 100 Hz, they also increase on 200 Hz. It should be noted that from 12:35 h to the end of the measurement the active and reactive power didn't change, which also means that the electromagnetic forces on the stator core remained unchanged.
