MOTOR AND GENERATOR WINDINGS

Recent problems experienced

BY G.C. STONE, M. SASIC,
D. DUNN, & I. CULBERT

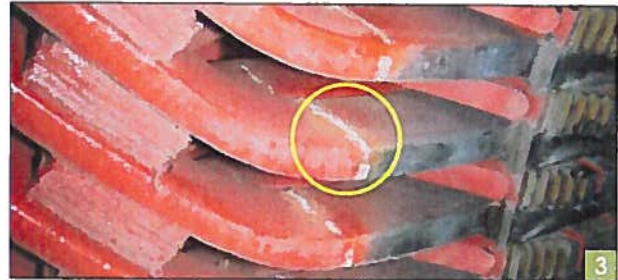
Figure 3 shows a turbine generator stator where a very noticeable white band is visible at the junction of the semicon and silicon carbide coatings. Figure 4 shows a winding where the semicon has virtually disappeared in the slot due to poor application of the semicon coating that then lead to PD and ozone, subsequently causing the original problem area to extend. This will normally only occur in air-cooled machines rated 11 kV or more. However, the introduction of voltage source converter drives has shown that these problems can occur on motors rated 3.3 kV or more [3], [4].

Semicon and grading coating overlap deterioration.

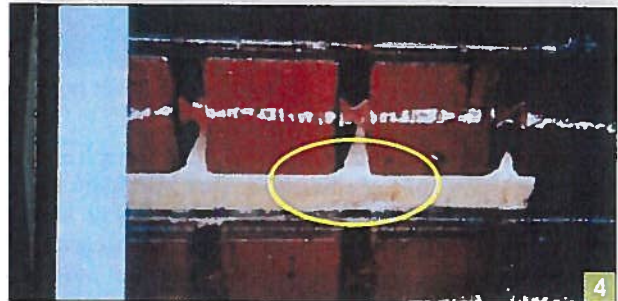
Destruction of the coil semicon coating in the stator slot due to PD and ozone.

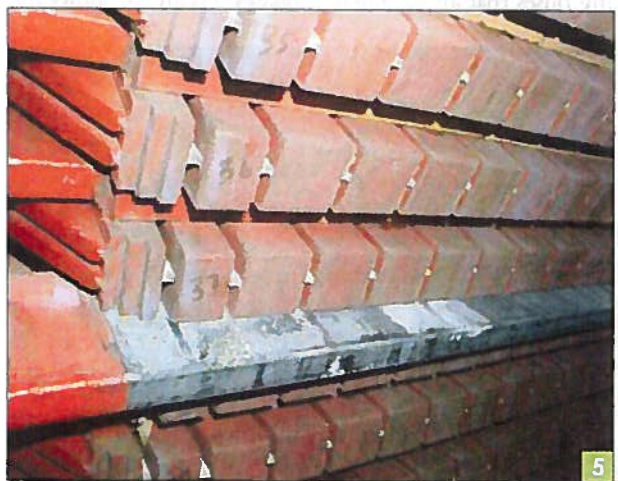
Figure 5 shows a coil in the process of being removed from a stator where the semicon and about 30% of the ground wall thickness have been abraded away. The manufacturer had not mechanically secured the coils in the slots by means such as side packing, ripple springs, two-part wedges, conformable restraint in the slots, and so on.

Coil abrasion due to loose windings in the slot of a turbo generator. The coil is in the process of being removed from the core.

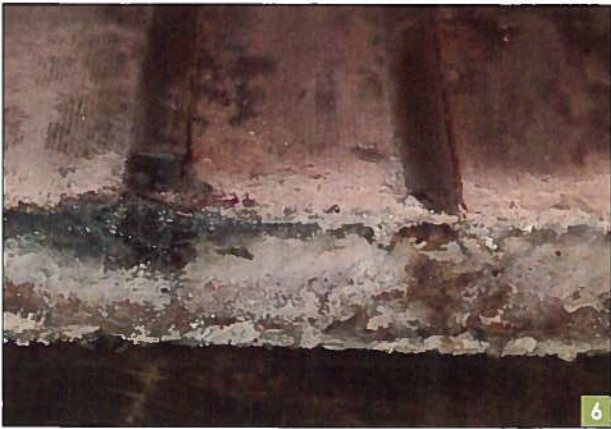
Normally, one would not expect loose coils to be a problem in a global VPI stator since the coils are effectively glued to the stator core. However, if the coils are made too small for the slot and subjected to frequent load cycling that creates shear stresses between the coils and stator core, then loose coils and slot discharge may occur in some GVPI designs (Figure 6).

Damaged bar surface due to loose coils in the GVPI stator.

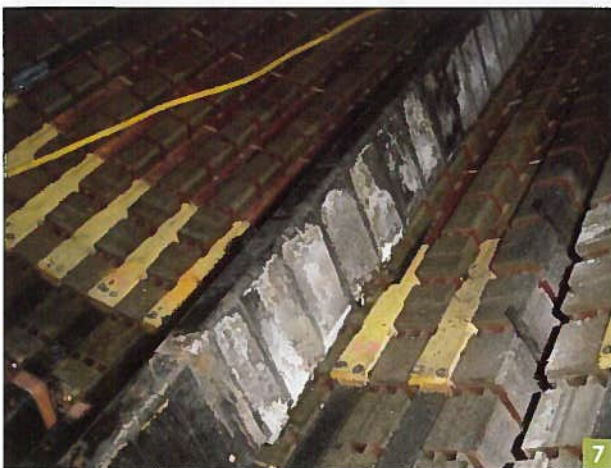
This failure process can be very aggressive, resulting in failure in a short time of about five years. Although most manufacturers are careful about making the semicon have a minimum resistance, there is a set of turbine generators made in the past ten years where the material is too conductive and failures occur (Figure 7). Vibration sparking is driven by the magnetic flux, and thus damage can occur anywhere within the winding, unlike the surface PD and loose coil problems described previously, which can only occur near the phase terminals.

A neutral-end stator bar damaged by vibration sparking. The bar is in the process of being removed from the slot.

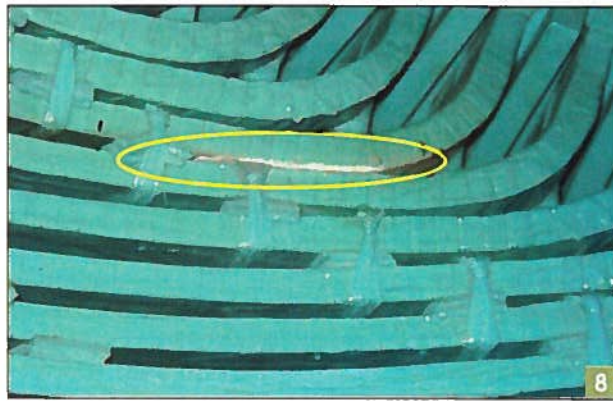
Unfortunately, in many motors and generators rated 6 kV or more, we have noted inadequate spacing and, consequently, high PD and ozone. Figure 8 shows the white residue caused by ozone resulting from PD between two coils in different phases that were installed too close to one another. Figure 9 shows the same situation but between two circuit ring buses that are in different phases. Figure 10 shows the

The PD occurring between high-voltage coils in two different phases.

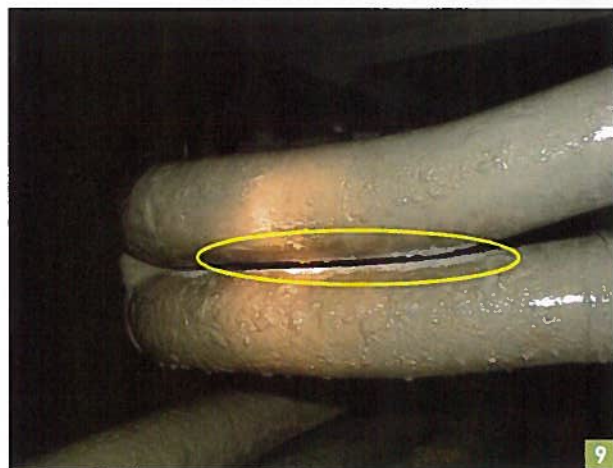
The PD between circuit ring buses that are too close together.

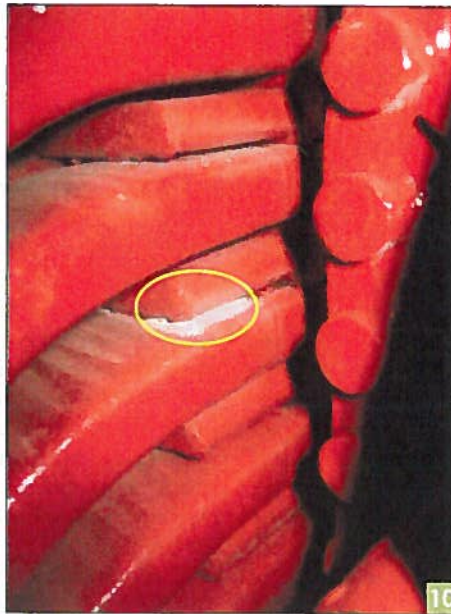
PD between the grounded pressure finger at the end of the core and side of a coil where the manufacturer did not extend the semicon stress-relief coating far enough into the end winding. This resulted in a high electric stress between a line-end coil and the pressure finger, and hence PD and ozone. In all three cases of inadequate spacing, the failure process is purely by PD and ozone attack, which may take several years to result in failure if the insulation is composed of epoxy mica. However, if such PD occurred between phase leads in the motor terminal box, failure could occur much sooner since such leads often have only rubber insulation, which is much less resistant to PD attack.

The PD occurring between a core pressure finger and a high-voltage coil.

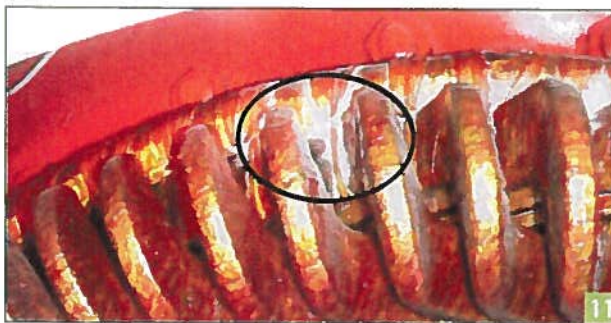
to move (also at 120 Hz). The relative movement between the coils and support rings and at the blocking between coils leads to fretting of the insulation and a characteristic white powder (Figure 11). Note that this white powder is not the same as the one that occurred from PD (Figures 8–10). The powder due to fretting can occur wherever the coils are loose, including the neutral-end coils, whereas the powder due to PD will only occur on coils at or near the phase terminals. If the fretting problem is not corrected, then eventually the insulation will be abraded down to copper, where there is a high risk of a ground fault.

The white powder due to fretting at interfaces caused by stator end-winding vibration.

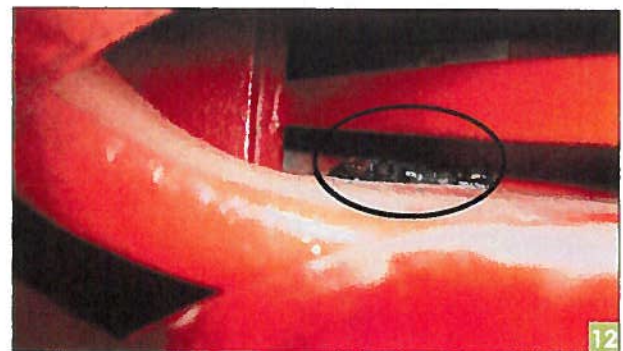
Figure 12 indicates one such failure, on a 13.8 kV, 40 MW air-cooled generator installed in an industrial power plant. In spite of the very high temperature that melted the core, the stator coil insulation did not fail, and there was no indication of this problem. The melted core was discovered during a low-power core test con-

ducted during regular maintenance using the electromagnetic core imperfection detector [8] test.

Melted stator core as a result of overfluxing events.

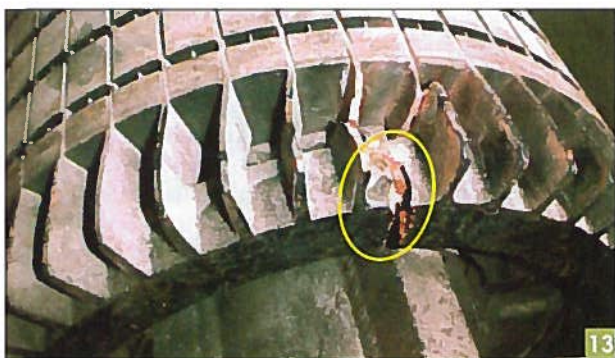
forces during every direct online start. These stresses are higher if the driven equipment has a high inertia since the thermal stresses are much greater due to the fact that the high starting current is present in the rotor winding for a much longer time. With frequent starting, if these stresses are high enough, breaks may occur in rotor bars or in the short-circuit ring (Figures 13 and 14). Breaks may also occur in brazed or welded joints. Fabricated aluminum rotor windings are more susceptible to failure from this cause, especially for high-inertia drive applications. This is because the mechanical properties of aluminum are poorer at higher temperatures, which can be a few hundred degrees celsius at the tops of the bars due to the skin effect. In addition, aluminum has a lower thermal conductivity than copper that further contributes to higher end-winding temperatures during start. However, fabricated copper/copper alloy windings can also fail in this phenomenon.

Breaks in rotor bars and the short-circuit ring.

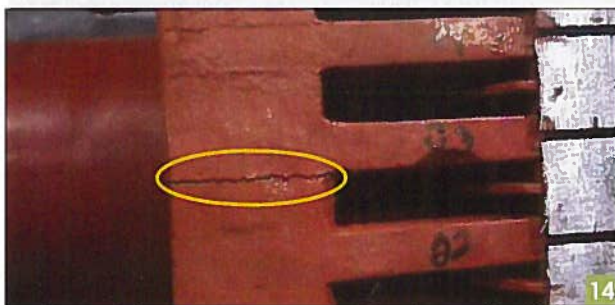
Cracked short-circuit ring. (Photo courtesy of EASA.)

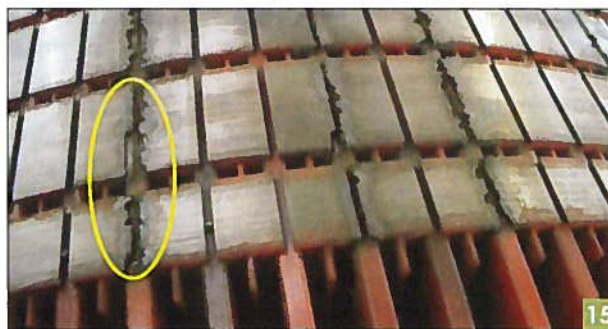
Another common problem with fabricated squirrel-cage rotor windings results from loose rotor bars. During the motor start, when the rotor current can be five to six times the full-load running value, the loose bars vibrate under the influence of the resulting high electromagnetic forces. This causes arcing between the rotor bars and ridges at the tops of the rotor slots that retain the bars and resultant core burning (Figure 15). This arcing weakens the core slot bridges and can eventually lead to the bars coming out of the slots and striking the stator core or winding. Loose rotor bars can also result in migration of the complete cage winding in one direction if there are no mechanical stops between the ends of the rotor core assembly and cage winding short-circuit rings. Such cage movement can lead to rotor bar breaks in the sections between the core and short-circuit ring, at the end where they have become shorter, due to increased thermal stresses during starting the motor.

Damage to an induction motor rotor core due to loose bars in the slot. (Photo courtesy of EASA.)

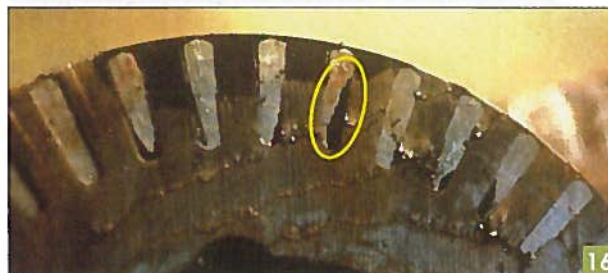
Figure 16 shows the cross section of the rotor slots in a cast aluminum rotor that has voids due to poor casting. Such voids can produce the same effects as cracked or broken bars on the motor performance [6].

Voids in cast aluminum rotor bars in rotor slots due to poor manufacturing. (Photo courtesy of EASA.)

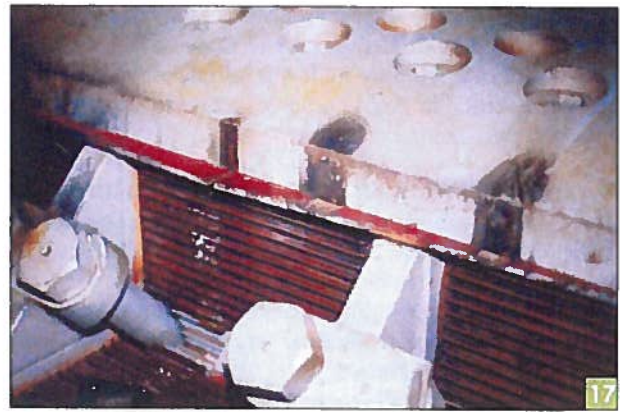
The radial and tangential centrifugal forces imposed on rotor winding insulation system components tend to distort the coil conductors and intercoil connections, and crack the coil insulation if the rotor winding is not adequately braced. Figure 17 gives an example of a top pole insulating washer that failed under such forces.

Top pole washer failure from mechanical forces.

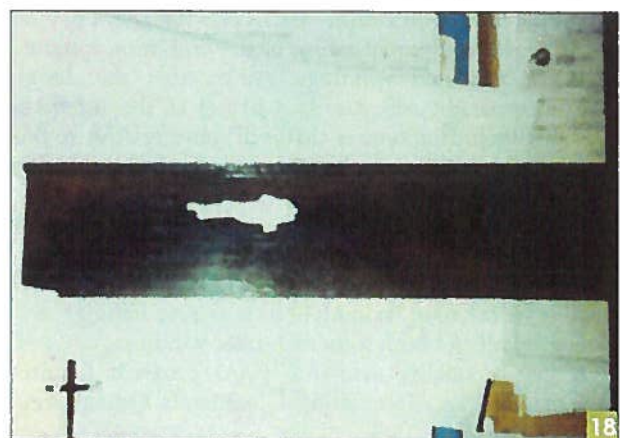
This type of winding can mainly be found in turbine generators but is also used in some high-speed two-pole compressor motors fed from variable voltage and frequency drives. Figure 18 shows abrasion of slot cell (ground) insulation due to relative movement of components caused by load cycling. This can be minimized by the use of materials that provide slip planes, which allow relative motion between components.

Slot cell electrical failure to ground.
