Vibration Sparking and Slot Discharge in Stator Windings

G.C. Stone
Iris Power
1 Westside Drive, Unit 2
Toronto, Ontario M9C 1B2

C. Maughan
Maughan Engineering
246 Juniper Drive
Schenctady, New York 12306

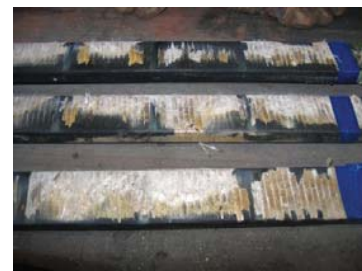
Fig. 2 Stator bar where the slot conductive coating degraded, as a result of poor manufacturing.

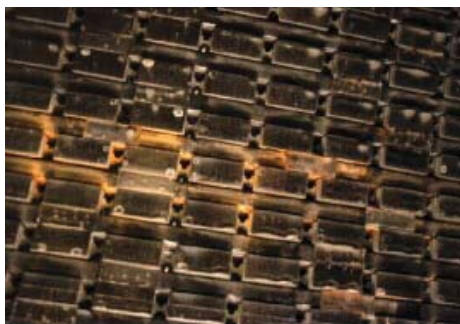
Fig. 3. Wedges destroyed by slot PD.

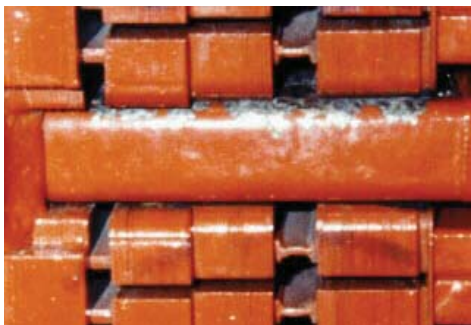
Fig. 4. Major slot PD due to inadequate slot conductive coating system.

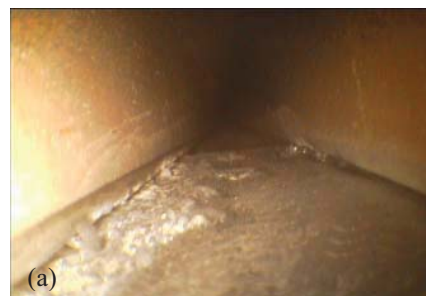
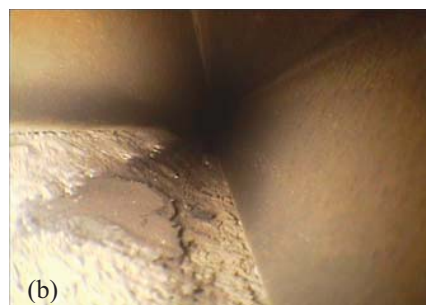
Vibration sparking is a relatively fast deterioration mechanism and has caused service failure in a relatively short time. Figure 5 shows borescope pictures of damage to a modern epoxy-mica groundwall insulation caused by vibration sparking. The stator winding of a generator of similar design failed in service after about 4 years of operation.

Fig. 5a. and b. Borescope vibration sparking damage to stator bar insulation.

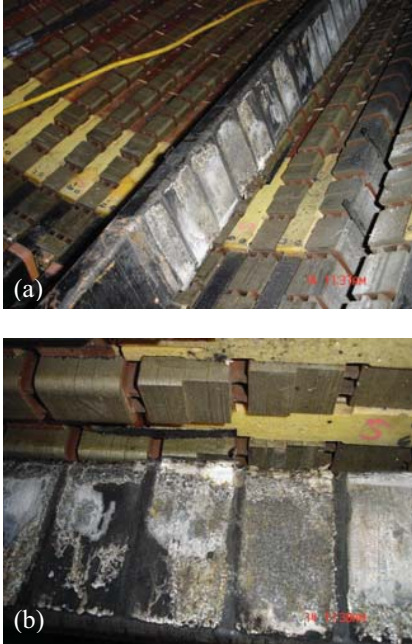
As previously stated, it may be difficult to distinguish the evidence of VS and slot discharge PD. If a bar is a high voltage bar, there may be no way to be certain, but if a deteriorated bar is from a low-voltage portion of the winding, it is certain to be VS. Figure 6 show bars that appear to have both VS and PD damage.

Fig. 6 a. and b. Bars removed from an air-cooled turbine generator suffering from both VS and the loose-coil form of slot discharge.
