# Impact of Slot Discharges and Vibration Sparking on Stator Winding Life in Large Generators

**Key Words:** slot discharge, vibration sparking, spark erosion, stator winding

*Slot discharge has long been known to be a common failure mechanism of stator winding insulation. Less well known is the fact that vibration sparking can result in very rapid failure, and has many of the characteristics of slot discharge.*

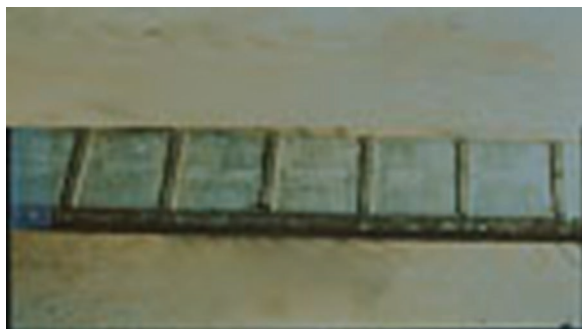
If a bar is not tightly held, and starts to vibrate, the bar insulation system moves relative to the stator core, primarily in the radial (i.e., up and down in the slot) direction. The bar movement abrades first the slot conductive coating, and then the groundwall insulation (Figure 1).

Figure 1. Photo of the side of a bar that has been abraded by movement caused by looseness in the slot.

Bars that are allowed to vibrate in the slots will inevitably have worn insulation. Because the slot conductive coating is applied as the last coating on the outside surface of the bars, this coating will inevitably be damaged. The first priority of corrective action must be to stop the vibration. Rewedging, adding side pressure to the bars, and/or bonding the bars to the core iron can accomplish this. But the damage to the slot conductive coating that has resulted in the slot discharge cannot be easily or fully repaired. Thus, if bar vibration has resulted in slot discharge, there probably will not be a permanent and complete fix. After the best repair possible, the level of PD may be substantially reduced but PD will remain. If the levels of PD and/or ozone remain excessively high, a stator rewind may be the only viable option.

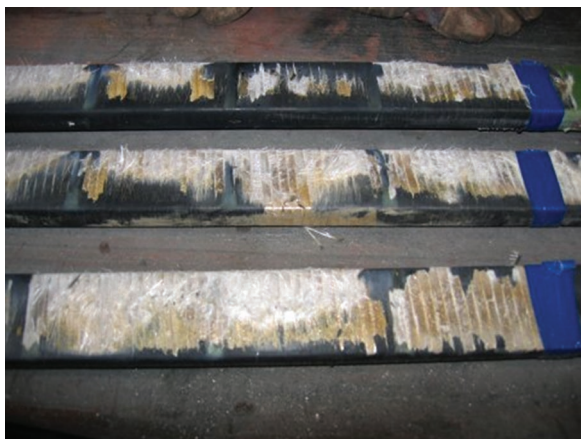
Figure 2. Slot discharge primarily due to poor slot conductive coatings.

When slot discharge is the result of a defective slot conductive coating, permanent correction will probably not be possible, short of winding replacement. *In situ* repair in the slot includes injection of conductive paints, silicon rubbers or epoxies into the slots. However, experience shows that the injected conductive material will not reach all areas where the slot conductive coating is defective, and thus some PD will still occur. Defective slot grounding systems may be confined to isolated bars in the winding, and will only be a problem in bars operating at the upper end of the phase. If the ozone becomes excessive, bar replacement will probably be required. In a few situations, users have

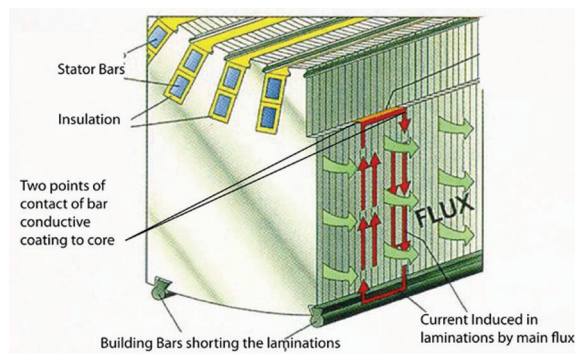
For a particular machine, the interrupted current will depend on the length of the bar along the slot that has become isolated from the core (Figure 3). The longer the axial distance for which the slot conductive coating is not in contact with the core, the greater will be the area enclosed by the current loop, and thus the greater will be the induced current. This, in turn, roughly depends on how loose the bars are in the slot. Consequently, for a given slot

Figure 3. Sketch of the current loop formed by the flow of current through the core lamination, the building (or key) bars and the slot conductive coating on a stator bar.

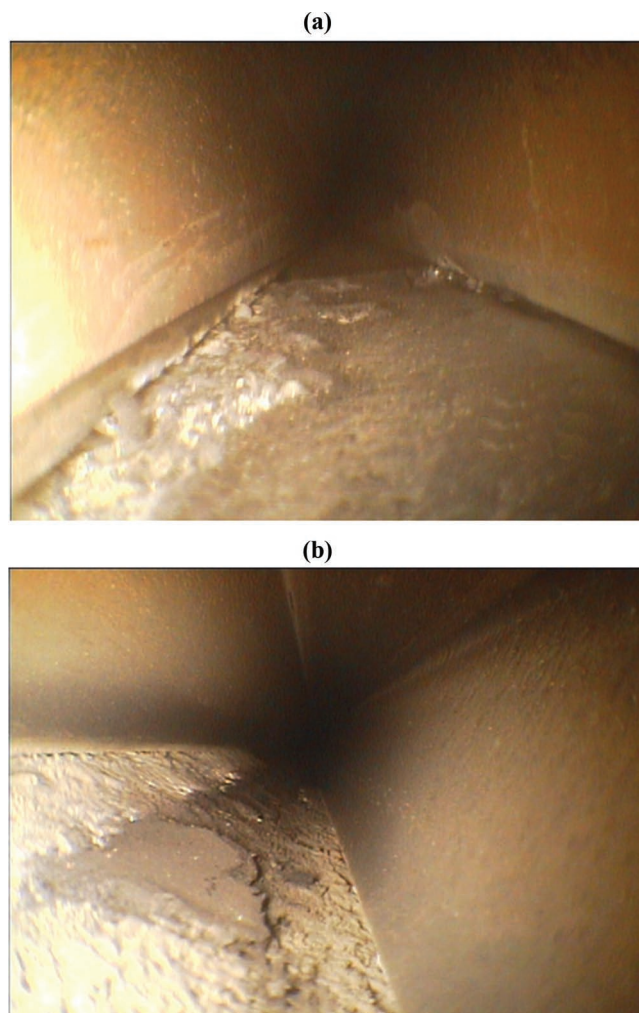
Figure 4 shows some damage to the epoxy mica groundwall insulation caused by VS. As for the slot discharge mechanism caused by a stator bar being isolated from the core slot discharge Section C, VS seems to involve a high intensity spark that has sufficient power to cause bars to fail relatively rapidly, in as little as 4 or 5 years. The sparking intensity is enough to damage both the stator bar insulation and the steel core laminations (Figure 5). The VS on the air-cooled machine shown in Figure 5 occurred on several bars throughout the stator, presumably because the slot coating was too conductive, and the bars were loose sideways in many slots because side ripple springs were not used. The appearance of the bar side abrasion in Figure 5 is similar to that seen in Figure 1 caused by slot discharge, however, unlike slot discharge, VS can occur at the neutral, winding midpoint, or phase end bars, because it is driven by the magnetic flux, and not the electric field.

The air-cooled turbine generator shown in Figures 4 and 5 was rated about 160 MW, 18 kV and was manufactured in 2001. This unit had been operating for about 30,000 hours. Such VS has been noted on several bars in the stator. This particular stator also appeared to have slot discharge caused by loose bars.

Figure 4. Borescope images of the side of a stator bar surface damaged by VS, looking from the bore down a core vent duct.

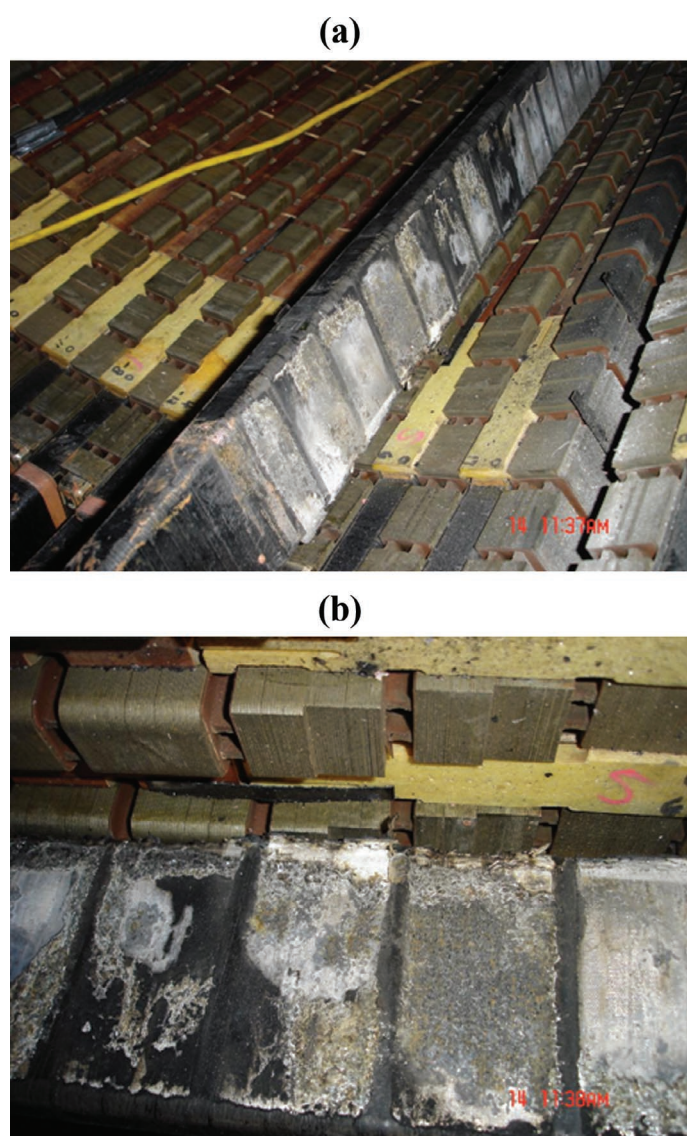
Figure 5. Bars being removed from an air-cooled turbine generator suffering from both VS and the loose coil form of slot discharge.

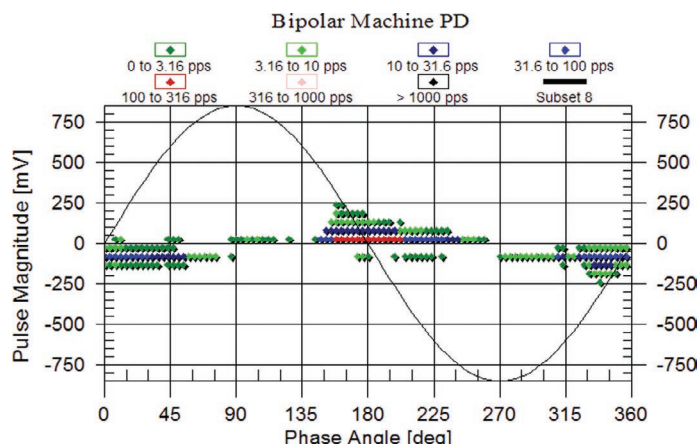
Figure 6 shows the pulse pattern obtained with an on-line PD monitor on an air-cooled machine that is known by visual examination to be experiencing both advanced VS as well as the loose bar form of slot discharge. Note the pulse pattern is shifted about 90 degrees to the left of the normal position for pulses caused by slot discharge [1]. Such a “left shift” in a pattern was observed on another machine with suspected VS. However, it is still too soon to determine if this phase shift is a normal aspect of VS. Note that because VS does involve abrasion of the insulation and slot conductive coating, VS in bars operating at high voltage will eventually produce PD as a symptom.

Figure 6. On-line “PD” detected by means of 80 pF capacitive couplers mounted on the turbine generator terminals.
