Experience With Stator Insulation Testing and Turn/Phase Insulation Failures in the Power Generation Industry

Heedong Kim, Taesik Kong, Sang Bin Lee^{1b}, Tae-June Kang, Namyoun Oh, Yeongjae Kim, Sanguk Park, Chaewoong Lim, and Greg C. Stone^{2b}

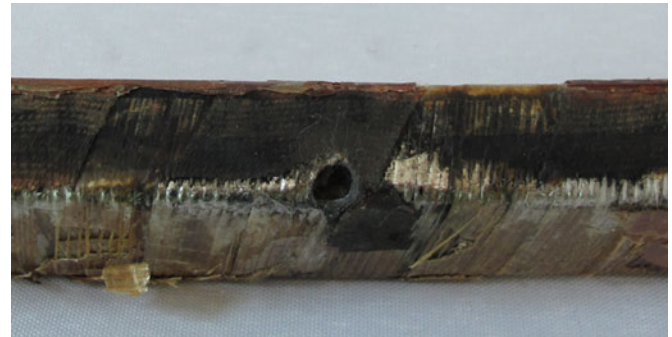
Fig. 1. Ground wall insulation failure in 6.6-kV, 550-kW circulating water pump induction motor.

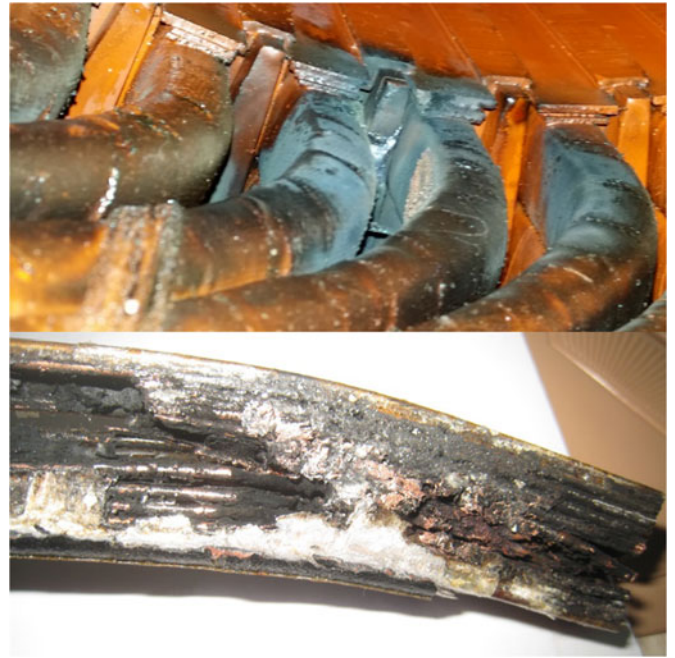
Fig. 3. Turn insulation failure in EW slot exit of 6.6-kV, 205-kW transport blower motor (M9).

Nine out of thirteen turn failures were located in the EW at or near the slot exit, as shown in Figs. 3–5 (M9, M1, M13), except

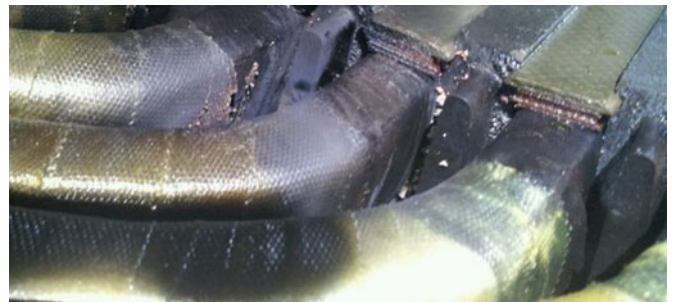
Fig. 4. Turn insulation failure in EW slot exit of 6.6-kV, 310-kW condensate extraction pump motor (M1).

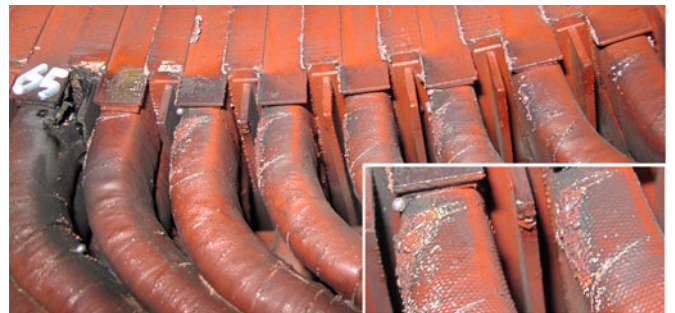
Fig. 5. Turn insulation failure in EW slot exit of 6.6-kV, 1678-kW primary air fan motor (M13) with zoomed in view of melted copper.

for 1 case where the fault was located at the bent portion of the EW, as shown in Fig. 6 (M12). Melted copper that erupted from the EW copper conductor through the insulation was observed near the slot exit along with burning of insulation in Figs. 3–6. For the M12 and M13 failures, small particles of melted copper splattered over the EW could be observed (Figs. 5 and 6). An IR value of 0 M Ω was measured and possible paths from failure location to the core were observed for M1, M9, and M13. However, a nonzero IR was measured for M12 and a GW path was not visually observable, as can be seen in Fig. 6. Although it is stated in many resources that a turn fault eventually causes a GW failure and is mistaken as a GW insulation failure [12]–[16], an exception was observed. Turn failures in the knuckle (tip) of the EW described separately in Section V is also common in stators with crossover coil design [17]. The two cases show that it is not necessarily a direct GW path that causes motor trip for these failures, since winding asymmetry or open phase due to a turn fault can also trip the relays.

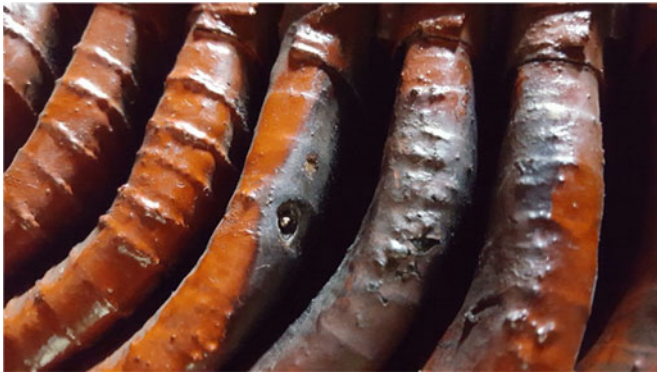
Fig. 6. Turn insulation failure in EW bend of 4-kV, 485-kW primary air fan motor (M12).

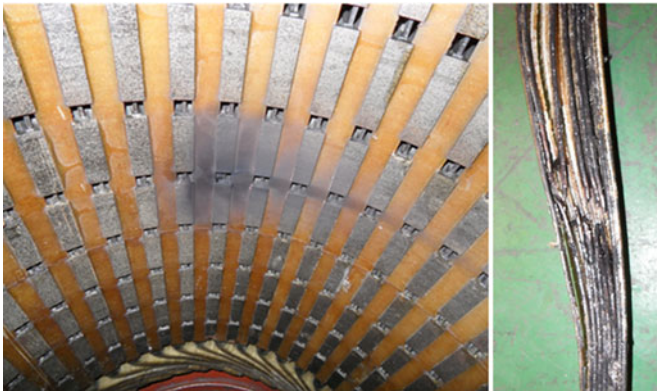
Fig. 7. Turn insulation failure in slot portion of 6.6 kV, 350-kW condensate pump motor (M3).

There were four cases of turn insulation failures in the slot portion of the winding (M3, M7, M8, M10), where the failures were not located close to the slot exit. For all four cases, burning of the insulation and core surface, and melted copper were observed, as shown in Figs. 7 and 8 for M3 and M7, respectively. The turn insulation failed in the first coil from the terminal end during operation for two of the four known cases, which implies that electrical stress on the turn insulation is the likely cause of aging and failure of the turn insulation. Although surge arrestors and capacitors are installed in the motor control center for all MV motors in power plants for limiting the risetime and amplitude of the voltage, the turn failure for 4 of 7 cases occurred in the first or second coils from the terminal end.

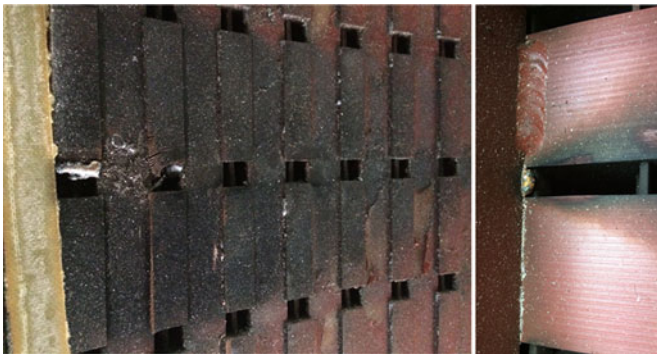
Fig. 8. Turn insulation failure in slot portion of 6.6-kV, 4300-kW induced draft fan motor (M7).

The motors M7, M8, M12, and M13 are drive fans that provide cooling for the generator. Their failure resulted in a 50% reduction of the generator output capability. The rewind-cost for M7, M8 (4300 kW) was US \$130 000. The cost of rewind increases with motor size—it was US \$26 000 for M1, M2 (310 kW). The loss of profit for the power plant due to lost power generation can be between US \$25 000 and US \$100 000 per hour for a 500-MW generating unit (according to the 2011–2016 domestic per day minimum and maximum cost per kWh [System Marginal Price]). Considering that installation of a spare motor takes approximately 12 h, the loss of 50% generation capability will result in a loss of US \$150 000 to US \$600 000. This changes with the cost of electricity, which fluctuates with cost of fossil fuel and “supply and demand” that has daily and seasonal variations.

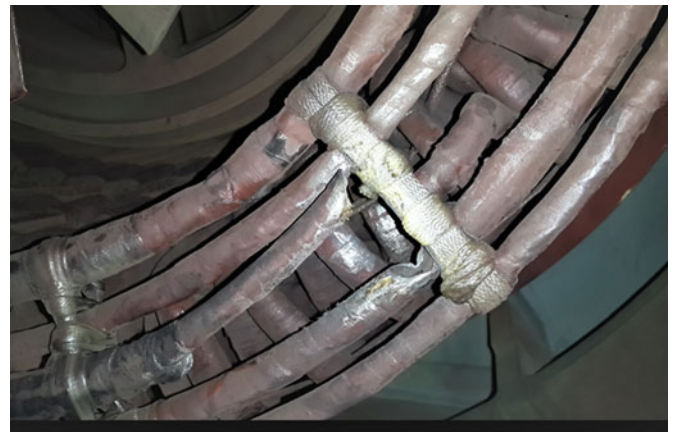
Fig. 9. Phase insulation failure in lead cable of 6.6-kV, 3800-kW boiler feed pump motor (M14).

Phase insulation failure leads to very high current flow causing significant damage to the stator winding. Two cases of motor outages due to phase insulation failure have occurred since 2015 at domestic power plants. The application, motor ratings, and information on the phase insulation failures and test records are summarized in Table V. An open-phase failure during operation of a 6.6-kV, 3800-kW motor that resulted from a phase insulation failure between lead cables is shown in Fig. 9. In Fig. 10, a case of failure between the lead cable and EW insulation of different phases is shown for a 6.6-kV, 4500-kW motor. It can be seen in Fig. 10 that the high-phase current caused significant damage in the stator winding. The high mechanical vibration that is proportional to the square of the current caused cracking of the insulation on the other axial end of the same coil. Surface leakage current and arcing due to a combination of insufficient EW spacing and contamination due to coal dust is suspected as the cause of the failures. Both failures occurred in the lead cables at the terminal end of the winding where the phase voltage is the highest.

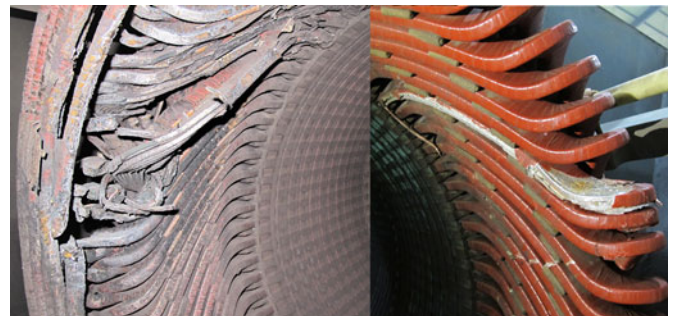
Fig. 10. Phase insulation failure between lead cable and EW of 6.6-kV, 4500-kW boiler feed pump motor (M15).

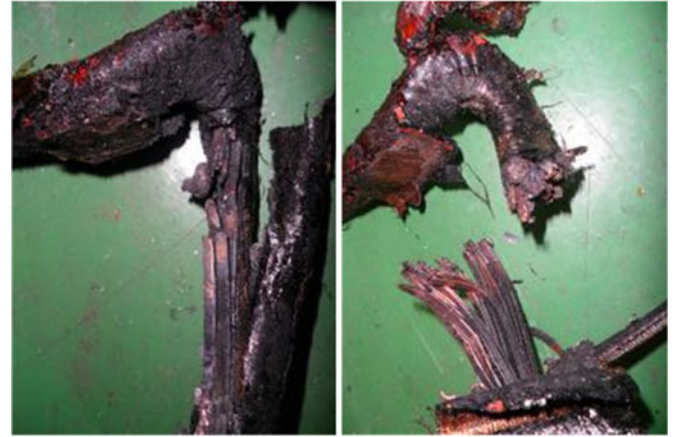
Fig. 11. Turn insulation failure near knuckle of EW of 3.3-kV, 190-kW motor.

that occurred in the petrochemical industry is reported in this paper, many turn insulation failures similar to that of Fig. 11 have been observed at power plants. They were similar in that the failed motors were MV motors with relatively low power rating that have crossover coil design, and that the location of the failures was near the knuckle of the coil EW.

The increased likelihood of turn insulation failures in crossover coils is well known by motor manufacturers, and modified winding design and/or manufacturing procedures are employed in some cases. Introducing the coil bend at different winding locations for the different turns, or using sectionalized coils, where sections of the coils are insulated and connected in series, are options for improving the reliability. However, the increased cost due to additional or nonuniform manufacturing steps limits the application of the alternative designs.
