END-WINDING DISCHARGE SIGNIFICANT REDUCTION IN PD LEVELS AFTER REPAIR

Company: BC Hydro
Ratings: 239 MVA, 13.8 kV, Air Cooled Hydro Generator
Manufacturer: Confidential
Related Info: 37 years old
PD Sensors: Six PDA Couplers per phase

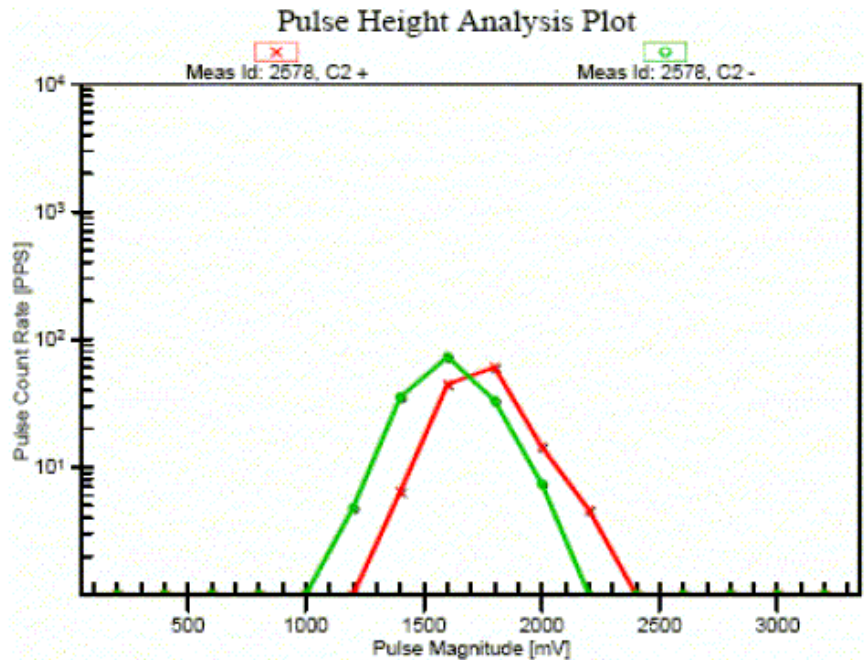
Figure 1. 2D PD Plot Showing Hump at High Magnitudes – Phase C

Details:
 "... This winding was subjected to PD activity in the end-turns of the winding... In the 2D PD plot, it can be seen that a large hump appeared at high magnitudes in both the positive and negative PD activities... The winding was repaired by cleaning the 10 bars closest to the PD couplers; these bars were coated with red glyptal epoxy. After the repair, trending of HydroTrac data showed a significant reduction in PD levels as shown in Figure..."

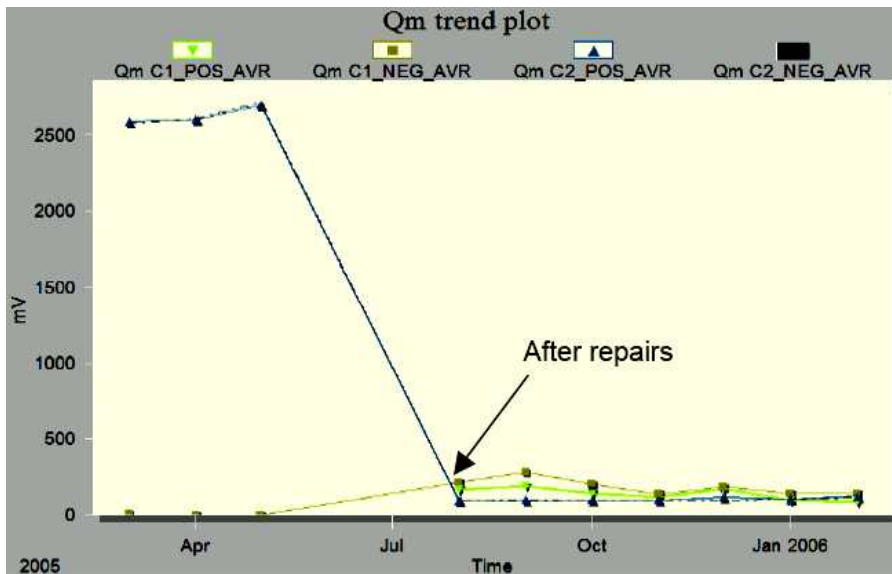
Figure 2. Trend of PD activity – Phase C
