Company: BC Hydro
Ratings: 457 MVA, 16 kV, Air Cooled Hydro Generator
Manufacturer: Confidential
Related Info: 30 years old
PD Sensors: Four PDA Couplers per phase
Details:

Excerpt from paper “Partial Discharge Measurements on Hydro Generator Stator Windings Case Studies”, by S. Li and M. Chow” in IRMC June 2006

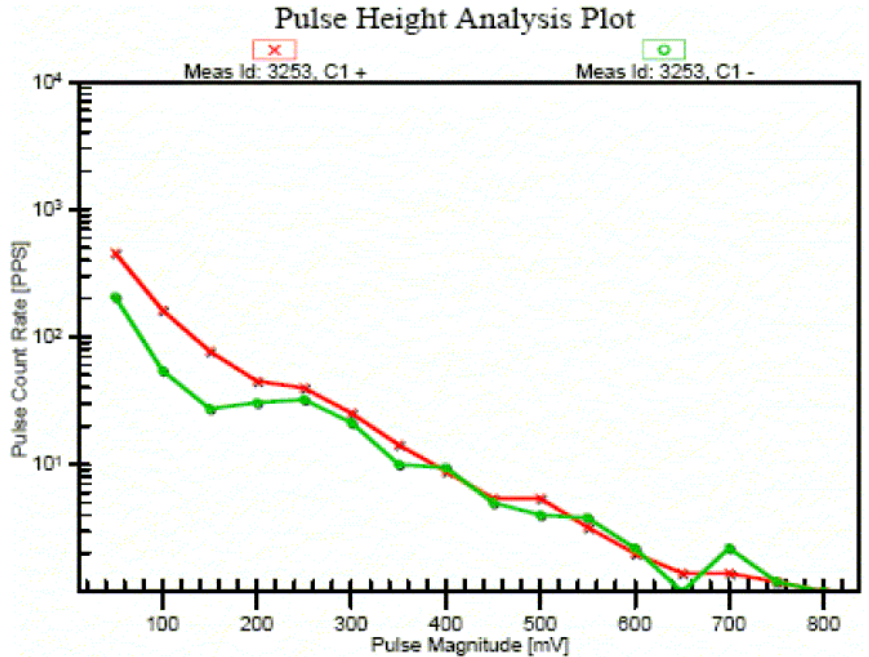
GRADING AREA DISCHARGE WHITE POWDER & GRADING PAINT DAMAGED

“...This winding was subjected to severe discharge in the grading paint area. White powder and grading paint damaged due to PD were observed at both the top and bottom ends of the bars... These bars were at high potential... In the 2D plot, the PD pattern showed no polarity predominance between the positive and negative pulses. Also, a linear decrease in pulse density with increase in pulse magnitude was shown....”
