FAULT DETECTION IN SYNCHRONOUS MOTOR

Company: Petrobras, Brazil
Type of Machine: Synchronous Gas Compressor Motor
Year of Manufacture: 2002
Ratings: 3 MW; 13.8 kV; 4 salient poles
PD Couplers: BUS EMCs (80 pF sensors)
Instrument: TGA-B

Excerpt from paper “Fault Detection In Components Of Synchronous Motors Through Online Partial Discharge Measurements”, by G. Castro, Petrobras, et al in the 2016 IRMC

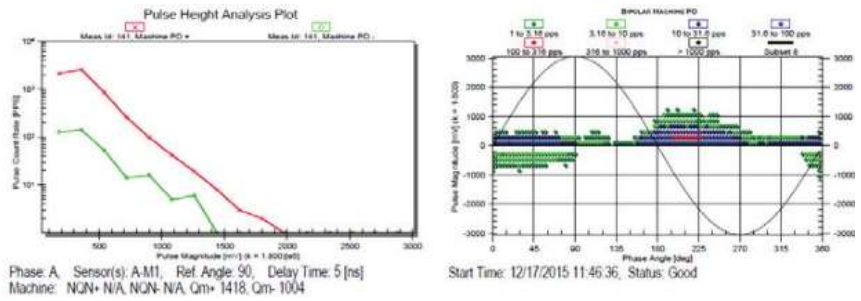
Figure 1 –PD data showing high surface PD collected with a TGA-B instrument
