# **ROTOR PULL PROVED UNNECESSARY USING RIV AND EL CID**

**Company:** Manitoba Hydro  
**Ratings:** 300 MVA, 13.8 kV, Hydrogen Cooled Synchronous Condenser  
**Manufacturer:** Confidential  
**Instrument:** EL CID, RIV (Robotic Inspection Vehicle) and Camera

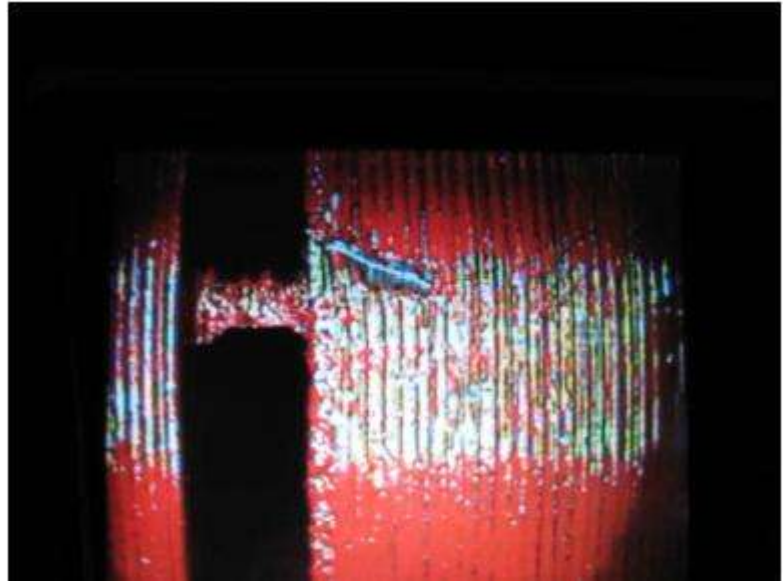
*Figure 1. Stator core affected area as seen with EL CID camera*

“...A stator ground fault occurred in a hydrogen cooled synchronous condenser rated 300 MVA. This was as a result of a small metallic object that had been left in the rotor during an overhaul. The object had entered the air gap and damaged the end arms of three stator bars, one of which failed... There was concern about possible damage to the stator core and the field poles. A robotic inspection vehicle and camera were rented to examine all 132 teeth of the core over its 3.95 m length as well as the poles. Areas were observed and photographed where there was visual evidence of possible damage. The inspection vehicle was used to move the sensing coil of our digital EL CID along stator core teeth where there was the most evidence of damage. The information obtained indicated that the damage was not sufficient to warrant removing the rotor. This decision greatly reduced the duration and cost of the repair...”
