Damage at Slot Exit IN GRADING COATING INTERFACE

Company: Western US Utility
Type of Machine: Combustion Turbine Generator
Ratings: 206 MW, 15 kV, 3600 rpm
Manufacturer /Year: Confidential /2002
PD Couplers: BUS EMCs (80 pF sensors)
Instrument: TGA-B

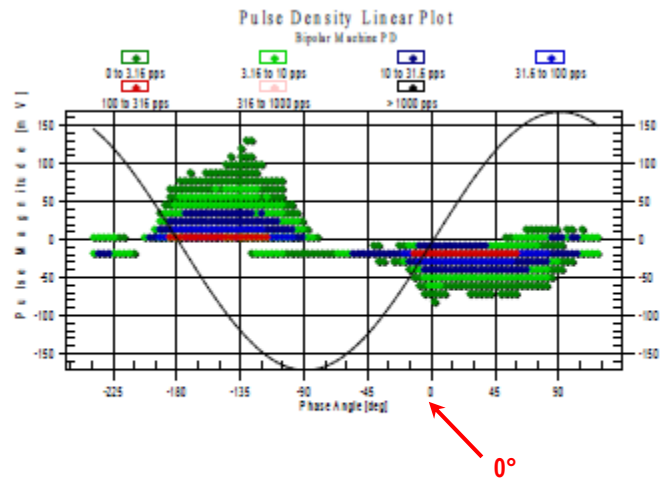
Figure 1. PD Analysis Plot –Activity at 0° Before Outage

Phase: C, Sensor(s): C-M3,C-S3 Delay 57ns, Status OVR
Machine: NQN+: -, NQN-: 186, Qm+: 126, Qm-: 80

- “... Zero crossings (0° and 180°): Phases B & C have a pattern that is normally indicative of sources of activity that are mechanically dependent, such as would occur just at the slot exit involving the voltage stress coatings...This activity is relatively minor in nature at this point in time; further testing will monitor this activity as it develops...” *From Partial Discharge Test Report (dated 2014-Dec-23).*
- Figure 1 from the above mentioned report, shows PD activity at 0° before outage. Note there is positive predominance indicating the PD is on the surface of the bar.
- Figure 2 corresponds to a picture taken during an outage in March 2015, showing the initial stages of surface PD at the stress relief coatings at slot exit.
