EFFECTIVE MAINTENANCE IN GENERATOR STATOR WINDING

Company: West Canadian Plant
Type of Machine: Gas Turbine Generator
Year of Manufacture: 2010
Ratings: 13.8 kV; 90 MW; 3600 rpm
PD Couplers: BUS EMCs (80 pF sensors)
Instrument: TGA-B

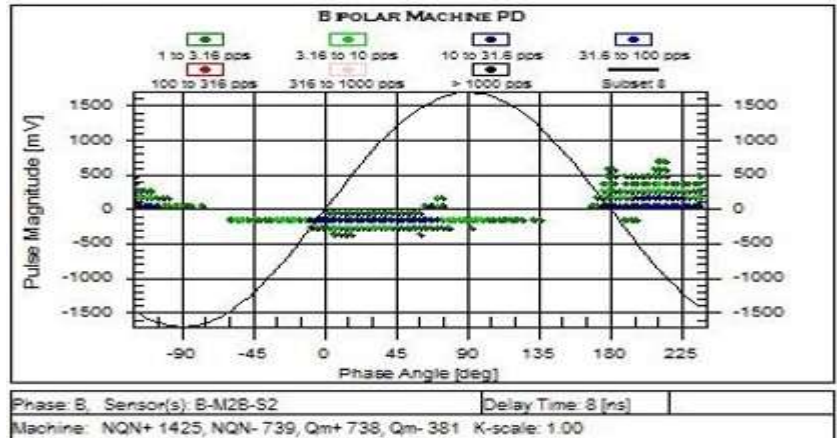
Figure 1 – PD data showing high surface PD

Details:
 “... The overall ‘Very High’ level causes some concern. The PD clusters indicates presence of slot area, the slot exit and interphasal discharges...” *Excerpt from Partial Discharge Test Report from data taken in April 2015. Figure 1 from the report shows high PD activity.*

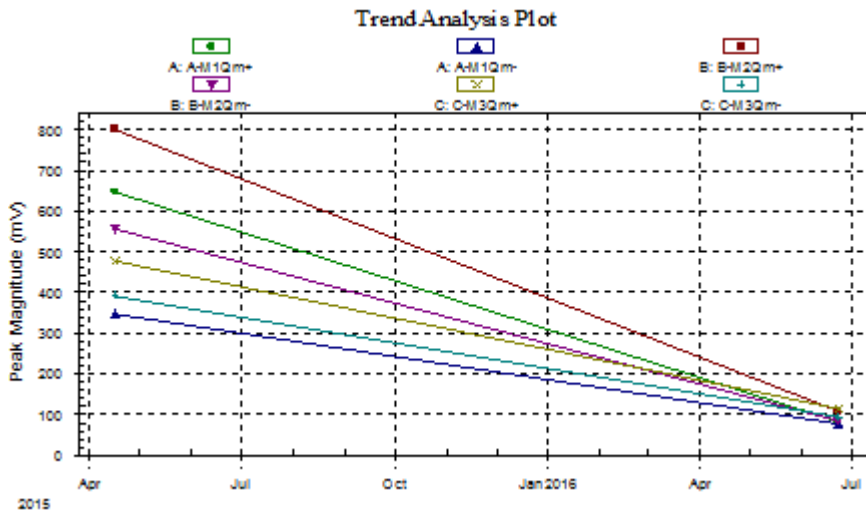
“...The PD levels in all three phases are significantly lower than in the first readings. Apparently the maintenance in 2015 (repairs to the stress relief coatings) has been successful. This is the second test done in this machine and the trend shows significant decrease in level... The LOW levels of PD compared to other air cooled windings of similar voltage class means this asset does not, as yet, have any significant problems...” *Excerpt from Partial Discharge Test Report from data taken in June 2016. Figure 2 from the report shows the trend with significant drop in PD activity as result of the maintenance work.*

Figure 2 – Trend showing significant drop in PD activity after maintenance
