Results of Destructive Analysis of Service-Aged Hydrogenerator Stator Winding Insulation

G.C. Stone¹, H.G. Sedding¹, R. Wheeler¹ & A. Wilson²

**Qualitrol-Iris Power¹, CEATI International²
Canada**

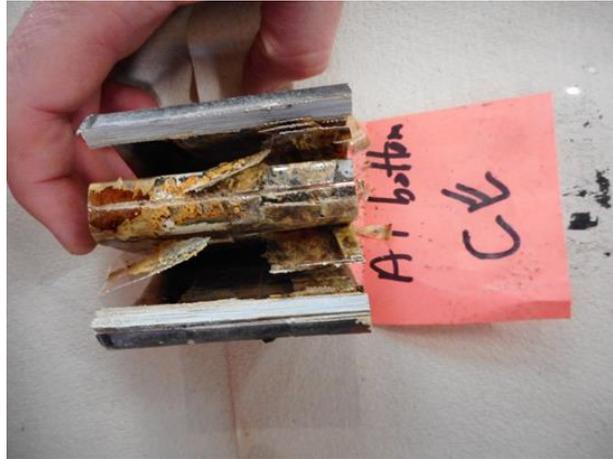
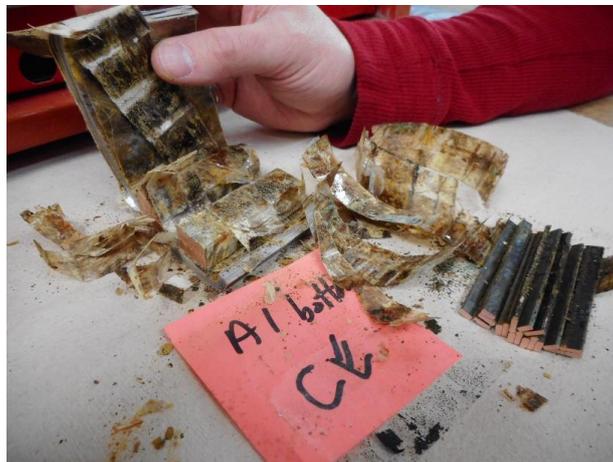
Figure 1: Photographs from the dissection of a segment from Coil A1 from Machine 1. Machine 1 had seen 56 years of base-load operation, but did not experience an in-service failure. Once the axial cut through the groundwall was made, the turns and strands from Coil A1, slot exit (connection end) fell apart. The turn insulation was burned and there was extensive PD attack.

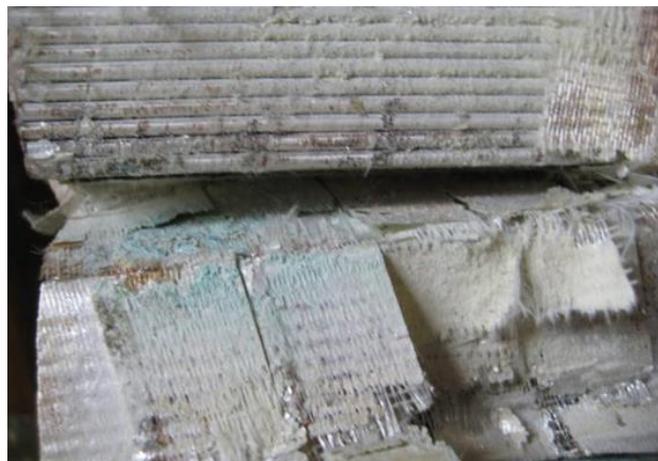
Figure 2: View of turn insulation and conductor stack of coil LC1 from Machine 6. Note that the delamination at the turn resulted in heavy partial discharge attack that further damaged the turn insulation. The green powder is from oxidation of the copper by ozone from the PD.

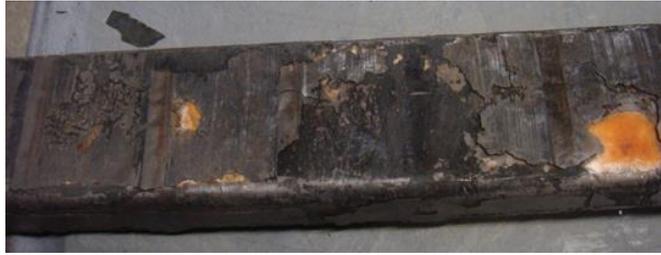
Only one machine (No. 5) exhibited significant deterioration of the stator bar surface in the slot (Figure 3). Aging, leading to abrasion of the groundwall due to vibration of coils/bars in the slots, or PD acting on the stress relief coatings, was not present in the 9 of the hydrogenerators. This low percentage of stators with surface insulation problems is in contrast with the findings of hydrogenerator failure surveys [3,4] that showed that issues in these locations are common.

Figure 3a: Observation of the degradation of the semicon coating of Bar L3-1 from Machine 5 (a motor-generator), which had the lowest PDEV and the highest PD magnitudes. This image also shows local burning and PD attack on the bar surface.

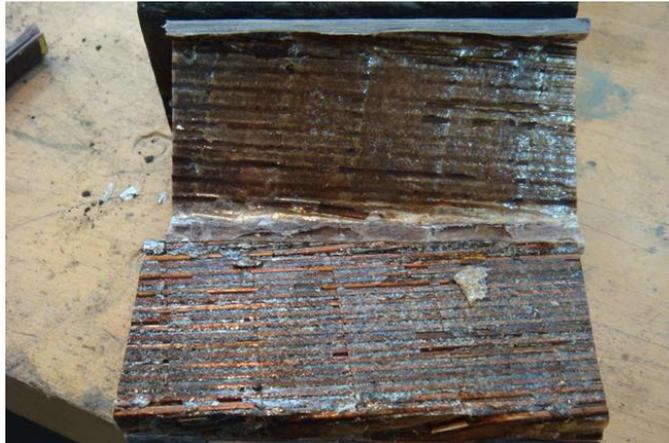
Figure 3b: Burning and PD attack between the groundwall and the copper stack. The green areas are where the PD has corroded the bare copper strands (half the strands were not insulated in this machine).
