THERMAL EXPANSION IMPACT ON VIBRO-DYNAMIC PROPERTIES OF BULB HYDROGENERATORS

SUMMARY

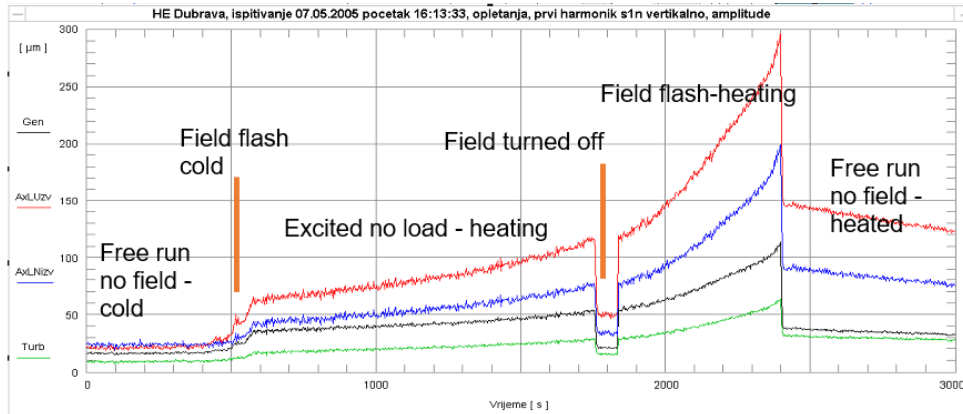
Figure 3 – vibration amplitudes in vertical direction on first harmonic, S1n in vertical direction (dir 2), recorded in first run after rotor replacement on Unit B in May 2005 / Red= Thrust bearing upstream; Blue= Thrust bearing downstream, Black= Generator, Green= Turbine

The first recorded event with high vibrations on Unit B was detected in May 2005 during the first run after a rotor replacement scheduled after 30 years in operation. The trend data of the shaft displacement amplitude at the machine rotating frequency, S1n (first harmonic) are shown for vertical probes on turbine bearing, axial bearing downstream, axial bearing upstream and generator bearing in Figure 3. The system also has radial vibrations measured on the axial bearing, both radial bearings, and inside the air gap using the air gap probes and data analysis that enables accurate S1n Amplitude and Phase calculation removed from air gap signal. This enables the plot of the dynamic shaft centerline from the turbine to the generator. This generator has a 6mm air gap, which is relatively small for a hydrogenerator. Therefore, the generator is very sensitive to magnetic unbalance. This first recorded event shows the following:

The heating process influenced the vibration response and in combination with the magnetic field the vibration amplitudes increased. In addition, at speed no-load after the heating process, the vibration amplitudes were much higher comparing than when the machine was in the cold condition, 150 µm peak compared to 60 µm peak on the axial bearing. The amplitudes reduced as the machine cooled down spinning at speed no-load. The conclusion was that thermal bowing (thermal rotor line deformation) was

causing the unbalance, both mechanical and electrical. After re-aligning the machine and additional balancing the machine was commissioned successfully.

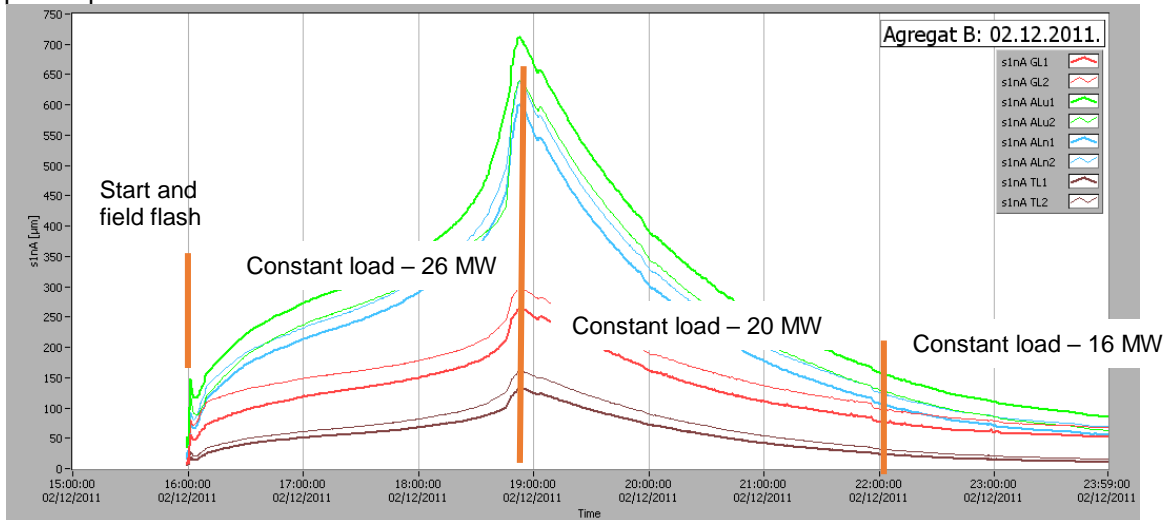
Figure 4 First harmonic of shaft displacement during Unit B machine operation in December 2011

Figure 4 shows a similar such event recorded by the monitoring system after a regular start up in December 2011. The graph shows S1n amplitudes on all bearings. Shaft displacement on the Axial bearing (no radial clearance) increased up to 720 µm peak. The machine operating conditions were constant (both active and reactive power) during whole period. During an overhaul in January 2012 cracks were found in the shaft-to-rotor rim, likely related to this event, leading to longer downtime during this overhaul. Overhaul on bulb units include dewatering and taking the rotor out is quite complicated, so overhauls take long and are quite expensive.

The cracks were fixed, rotor centered, and the machine was put back in operation with no root cause identified. After this event, a similar instability was detected by the monitoring system shown in Figure 5 with lower displacement amplitudes than in Figure 4. The shaft displacement on the Axial bearing upstream and downstream (ALU and ALN) started to rise while the machine was operating in steady state conditions. The vibration amplitude increase was constant even when the load was reduced, and the stator temperatures started to decrease. The rate of change was not linear and lowering the load had no effect on the amplitude rise. After this event, during steady state operation the vibration amplitudes reduced to normal condition at 50 µm peak. The first diagram in Figure 5 shows the axial bearing shaft displacement, the second shows the Active power and stator winding temperatures, the third diagram shows the S1n amplitudes of the rotor displacement inside the air gap, obtained from the air gap probes around the stator

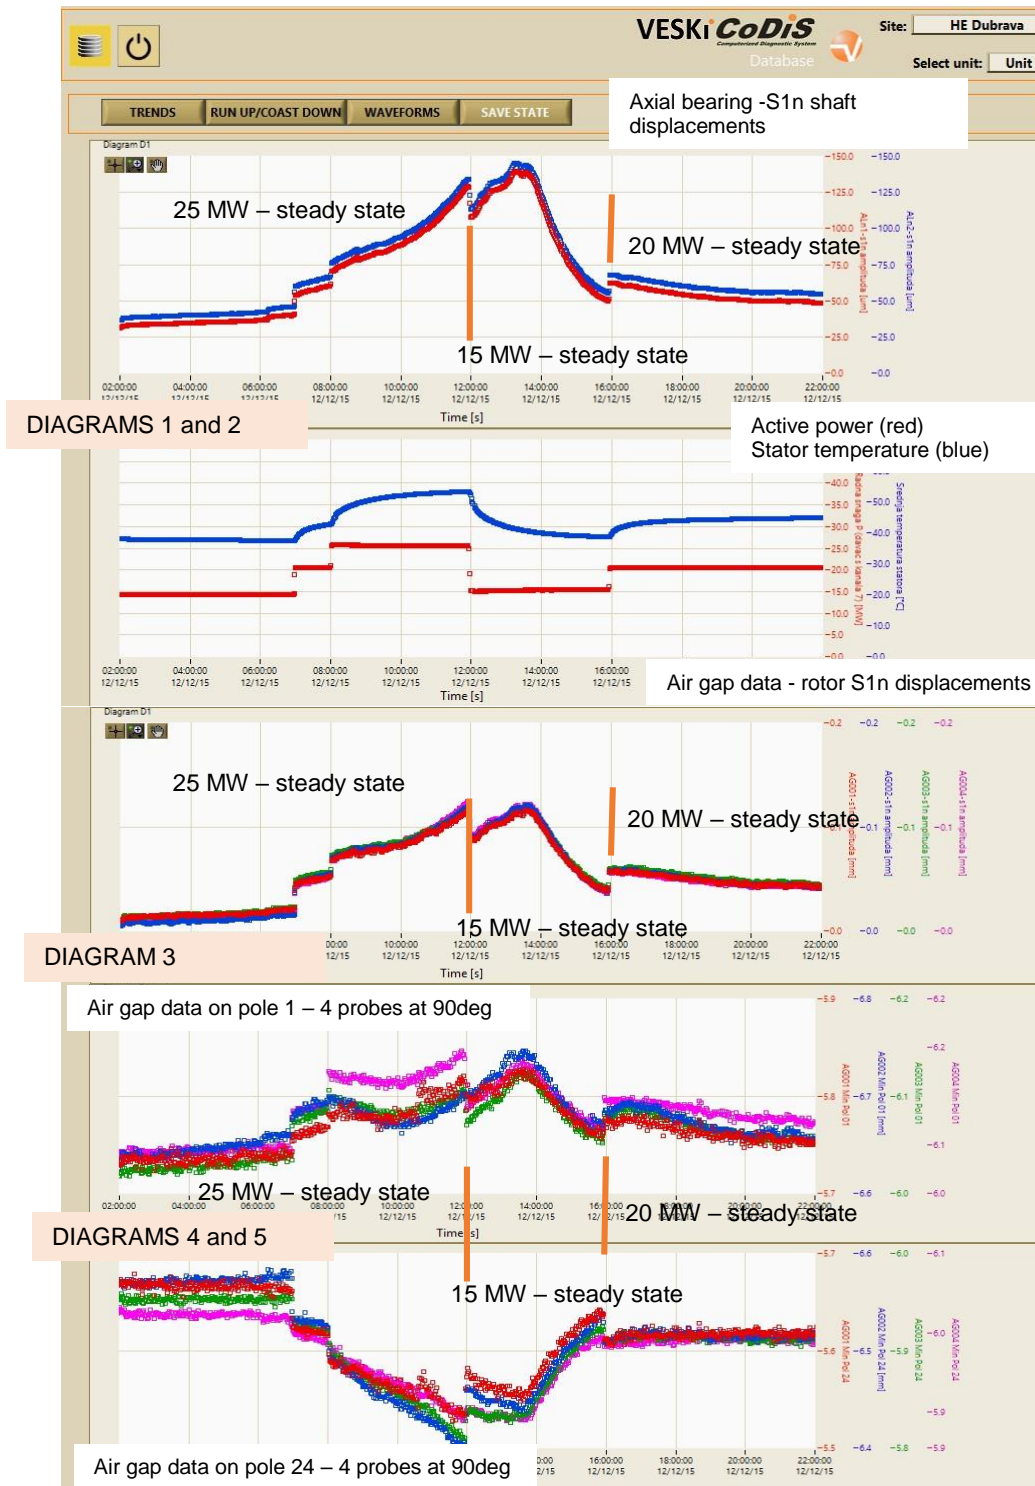
Figure 5 – trend diagrams for several cross-correlated values on Unit B

circumference at 90°. The rotor displacements corresponded well with the axial bearing displacements. Any thermal bowing should be visible in the air gap data with consistent results at different poles.

The fourth diagram shows the minimum air gap trend on pole 1 and the fifth on pole 24. The monitoring system records the pole profile data for each probe which will have 48 minimums for each data set since there are 48 salient poles in this machine. The trends in diagrams 4 and 5 represent the air gap value for each probe at pole 1 and 24 because they display opposite results. For this event, the deflection was largest in direction from pole 1 to 24 since the minimum air gap value was smallest at pole 24 at the same time it was the largest at pole 1 indicating the rotor was closer to pole 24 during this event. It should be noted that for some of the other events the thermal bowing was in different directions. This data indicates that the shaft was bowing during these events, but the cause of the bowing is still unknown.

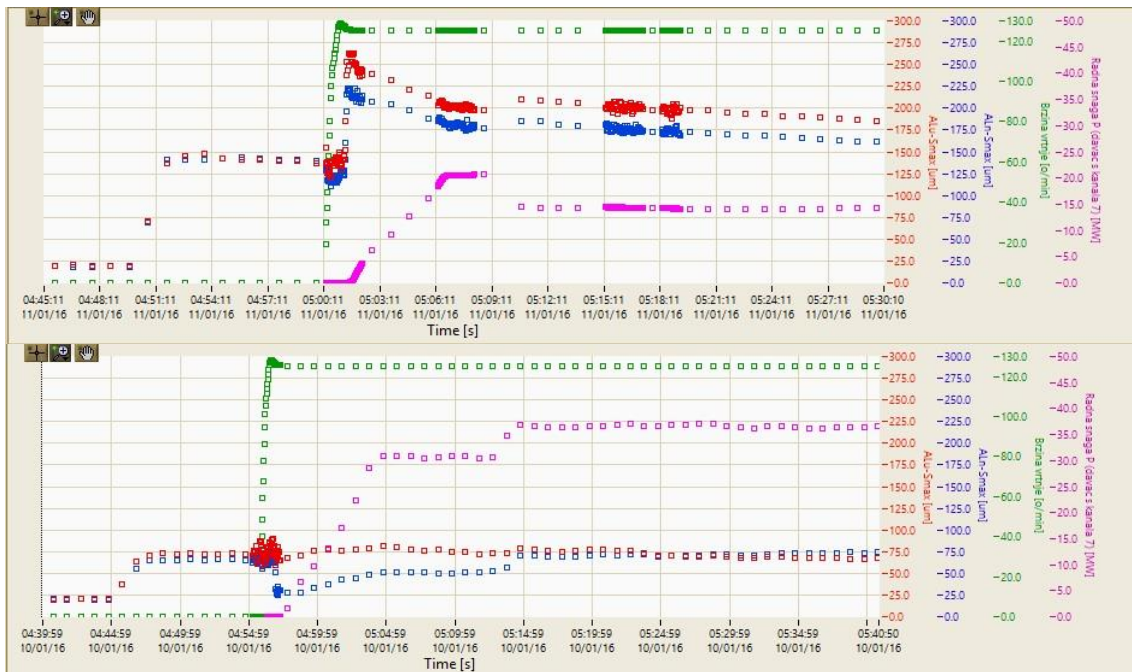
Figure 6 – Vibration response during two start up events recorded automatically by monitoring system

Figure 6 shows the trend data for S_{max} on the Axial bearing upstream (ALU – red curve) and downstream (ALN-blue curve), Active power (green curve) and shaft Speed (Magenta curve) during two start up events on 10.01 and 11.01. 2016. The upper diagram represents the start-up on 11.01. The machine was turning in slow roll for 15 min before it went up to full speed and was connected to the power system and loaded. During slow roll, the monitoring system recorded high amplitude S_{max} on the axial bearing at approximately 120 μm that increased to 270 μm when the machine started to speed up. During the start-up on 10.01 shown on the lower diagram, the S_{max} during slow roll was much lower in comparison and there were no significant vibration amplitudes present when the machine sped up. This indicates that when thermal bowing is present during slow roll, the field flashing causes magnetic unbalance resulting in high vibrations during start-up. If the thermal bow is not present, then the vibration amplitudes remain low while the machine is speeding up.

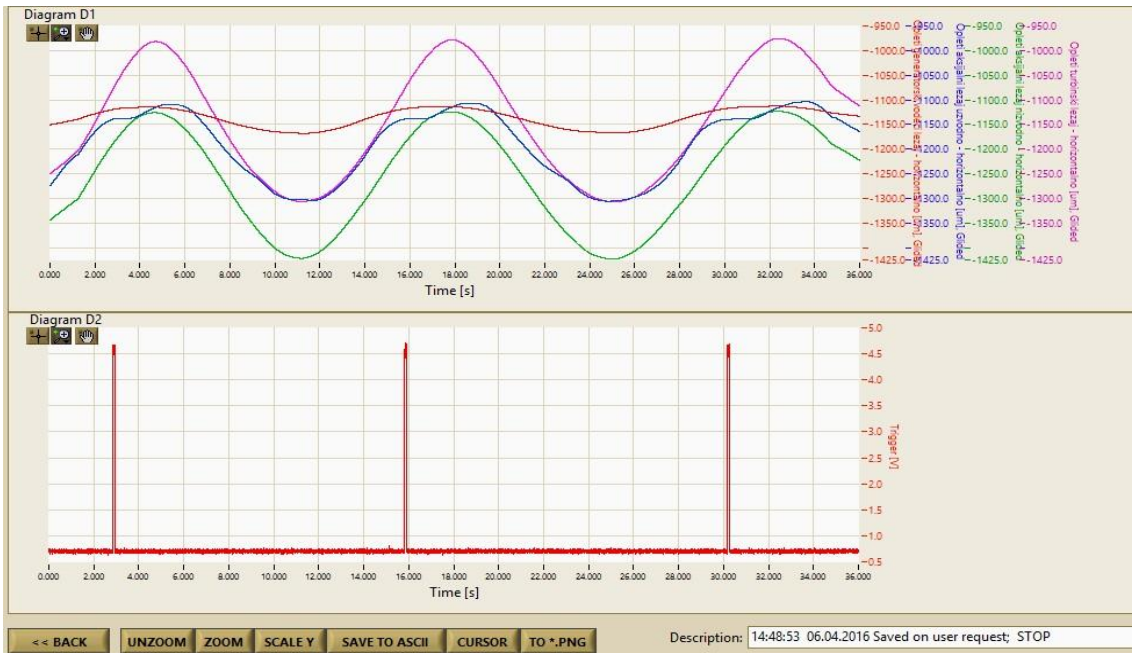
Figure 7 – Raw data recorded during slow roll, before machine start up.

The slow roll shaft displacement was detected several times by the monitoring system automatically when the shaft vibration amplitudes triggered an alarm while the machine was speeding up. During alarm events the software captured raw data from all the probes for 36 seconds for post processing. One such event is shown in Figure 7, which represents the raw data from horizontal probes on all four bearings (TL – turbine / magenta curve, ALU – axial bearing upstream / blue curve, ALN – axial bearing downstream / green curve, GL – generator bearing / red curve). On the lower diagram is a shaft trigger – showing 1 turn in 14 sec ~4RPM. Even though machine had no dynamic forces present for such a low speed, it is visible that shaft displacements were relatively high. This indicates the shaft Run Out measured at slow roll was caused by thermal bowing. This bowing was not always the same since shaft geometry irregularities such as centerline Run Out would not always be present.

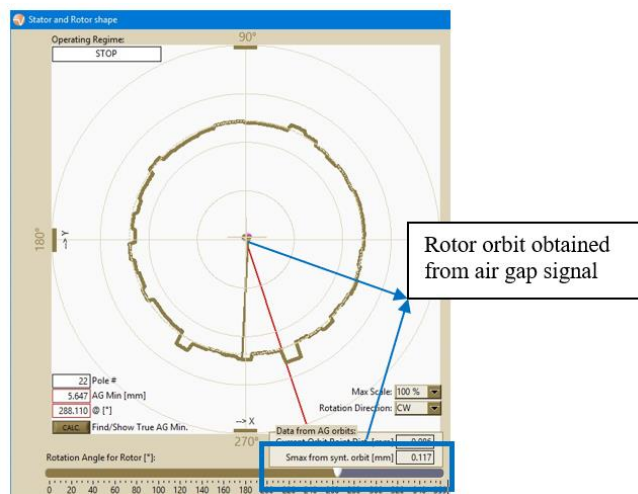
Figure 8 - Air gap polar plot at 4RPM consisting of air gap rotor pole/rim geometry and eccentricity

To support this, air gap vibrations were observed during the same slow roll event as shown in Figure 8. The monitoring system treated this as a STOP condition, since the machine was turning at only 4 RPM. The polar rotor shape consists of the rotor pole distribution inside the air gap, recorded by each probe, with the rotor dynamic eccentricity extracted. The dynamic eccentricity is shown as the rotor center orbit on the first harmonic of rotational frequency, S_{1n} , on the same plot as a center of the rotor. The rotor dynamic eccentricity maximum displacement, S_{max} was 117 μm . That number was calculated from two perpendicular air gap probes in the same manner as the orbit and S_{max} were calculated from proximity probes. The peak-to-peak movement measured from the air gap would be equivalent to 190 μm , while machine was turning at only 4 RPM, and no significant dynamic forces were applied to it. This is consistent with the data measured by proximity probes and in line with the bowing shaft theory.

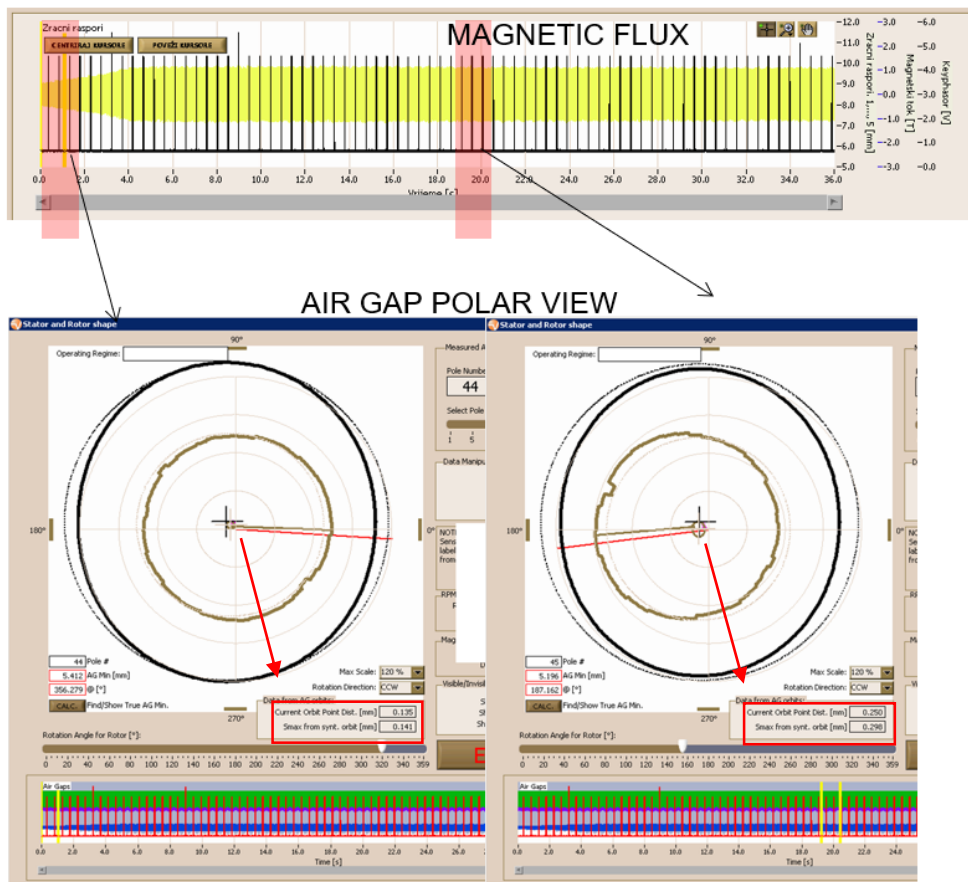
Figure 9 – Comparison between field flash and minimum field during start up and synchronization event

To further support that the cause of high vibrations during field flash was related to the shaft bowing, a comparison between the data before and after field flash was conducted during one run up and synchronization event recorded by the monitoring system, shown in Figure 9. The upper diagram represents the raw data of the Magnetic Field and the trigger signal. The lower two diagrams represent two events in time with a clear indication of the Magnetic Field impact on generator vibrations. The orbit plot inside the air gap indicates dynamic instability caused by the magnetic field, because the rotor bowing was present before the field flash event.

This is also visible as an orbit inside the air gap. In the cases where there was no bowing present on this machine, there was no sudden increase in vibrations with field flash.

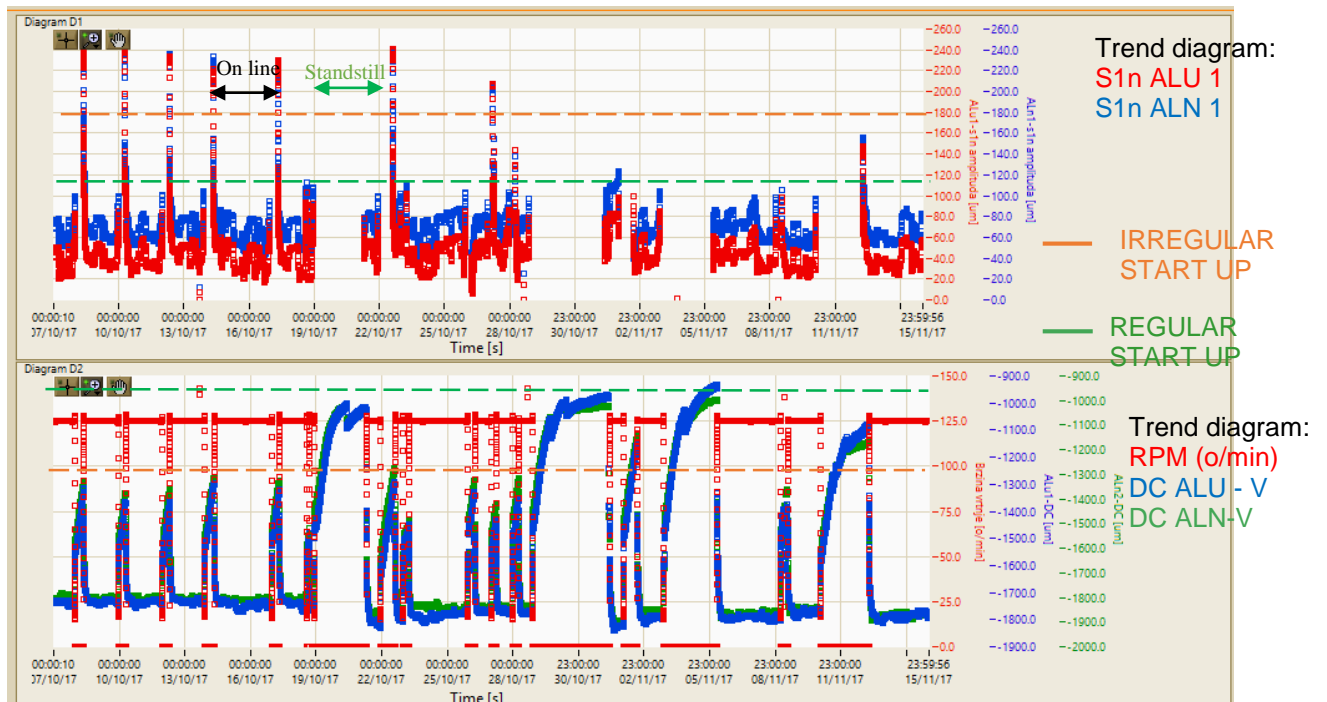
Figure 10 – Trend diagrams of multiple start and stop conditions on Unit A

In order to determine the root cause of the high vibrations due to thermal bowing multiple starts and stops were observed in an attempt to find a pattern. The upper diagram of Figure 10 shows shaft displacement, S1n on Axial bearing in vertical direction, both upstream on ALU (red curve) and downstream on ALN (blue curve) of Unit A. Both units show similar behavior, Unit A was chosen because of the clear distinction between standstill and running events which helps in understanding the mechanism of the described problem. The lower diagram shows machine speed (red curve), shaft static centerline, vertical direction on ALU (blue curve) and horizontal direction on ALU (green curve).

The largest changes of shaft static position was in the vertical direction during 48 hrs of stand still where the vertical shaft center position changed by 0.9 mm (900 μm) compared to only 0.25 mm (250 μm – not shown on this diagram) in the horizontal direction. The vertical sensor was above the shaft so the signal decreased as the rotor shaft lifted. This shows that during machine heating and cooling process there was significant change in the rotor line sagging in the vertical direction.

Figure 10 also shows the correlation between the shaft DC position signal and the high vibrations. The orange dashed line represents the threshold where this shaft DC signal had not reached the final levels, and the machine was experiencing high vibrations. The green dashed line represents those conditions where the shaft DC reached final levels and the machine did not experience high vibrations.

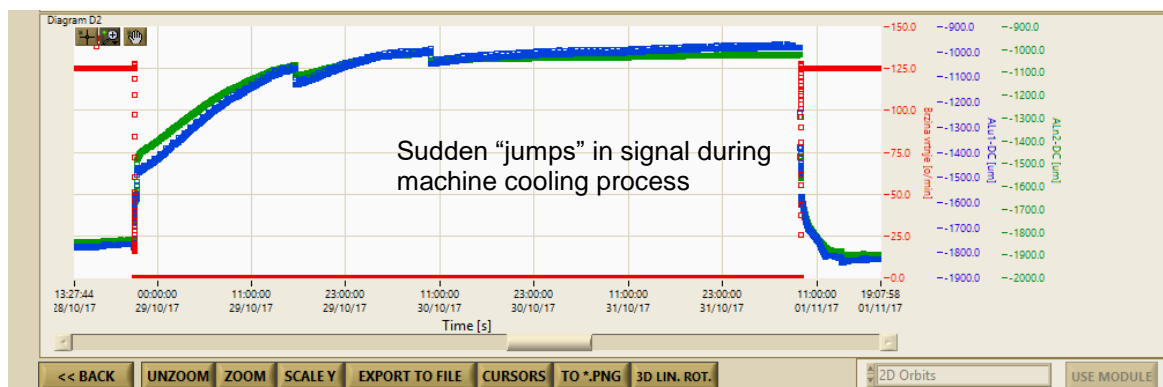
Figure 11 – Shaft DC position during stand still condition, on ALN – vertical direction

The Shaft DC signal (lower diagram of Figure 10) shows sudden amplitude fluctuation during this process. It seems that suddenly a force was applied on the shaft center and it repositioned itself. However, the cooling process continued and so did the shaft centerline movement upward to the sensor as the thermal bow straightened. It is clearly visible in Figure 11 during one of the longer standstill conditions from Figure 10.

This indicates a resistance to reverse thermal dilatations during the cooling process as if something on the rotor resisted the shrinking process as the temperature decreased. During the “regular” startup condition 19/10/17) the static shaft DC amplitude showed that the shaft was approximately 250 μm closer to the probe when compared to the previous start-up. Comparing the vibration amplitudes to S1n amplitude difference on ALU1 (red curve), between that two starts show a similar measured value (difference in S1n is approximately 200 μm). The conclusion is that the residual rotor line sagging was present as a thermal bow during those irregular startups. Similar behavior was present during other events.

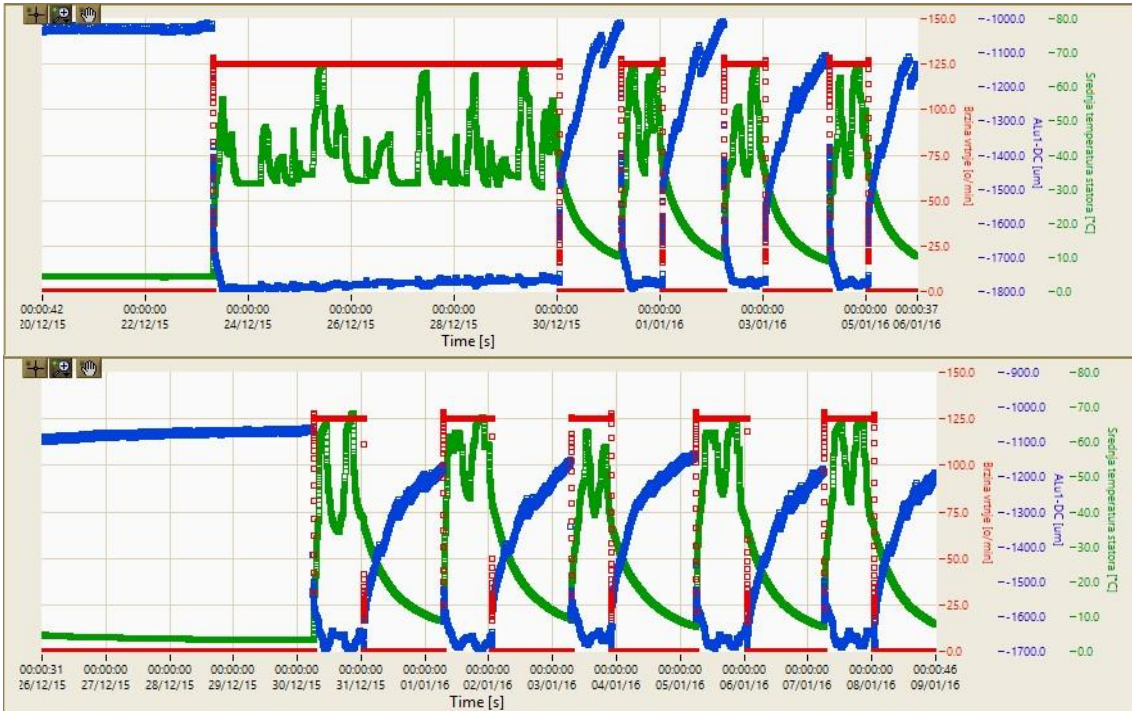
Figure 12 – Shaft DC position on Axial bearing and machine speed on Unit A (upper diagram) and Unit B (lower diagram) in same time period

During operation at load, the rotor pole temperature was approximately 35-40°C higher than the rotor rim. Therefore, uneven rotor rim to pole heating and cooling could be one of the reasons for the bending forces to appear. This phenomenon is present on both units. The upper diagram in Figure 12 is for unit A and lower for Unit B of the same signals, Shaft DC position on ALU in the vertical direction (blue curve), shaft speed (red curve), and average stator temperature (green curve). Both time periods were selected when the starting point was taken after several days of standstill, during which the machine had a chance to completely cool down and stop re-positioning. Both machines had similar environmental conditions and cooling time should be similar to both machines for the selected time periods.

The Shaft DC values can be used as a reference for comparison on each graph in Figure 12. Unit A shaft position reached a similar value in two stops, however not every time. Also, vibrations during those start-ups were low in amplitude, similar to the behavior shown on Figure 10. Unit B did not reach the same starting position even though the standstill lasted for 24 hours or more. As mentioned, both machines had the same environmental conditions (same time period, same water and air temperature) but they did not behave in similar manner. It can be concluded that the reason for this behavior lays in the different resistance to thermal deformations on both units. That resistance may be much higher on unit B, hence the larger amplitudes that resulted with the two mentioned events.

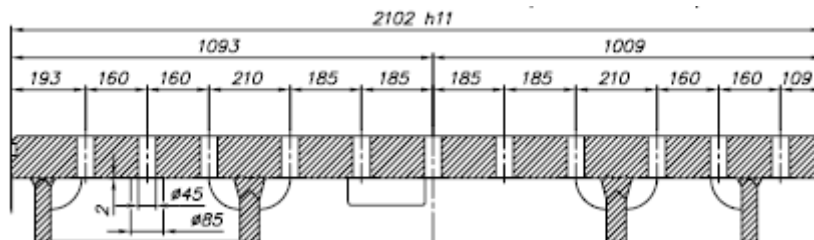
Figure 13 -Rotor rim cross section

The cause of these deformations is still unknown. Considering the diagrams displayed and the machine design the conclusion is that the problem comes from the pole to rim attachment. The rotor rim cross section is shown on Figure 13. The poles on these machines are attached to the rim using 11 bolts. This type of attachment requires extreme caution during the tightening to ensure that poles are allowed to stretch and shrink adequately when heating and cooling.

If all the poles do not stretch or shrink equally, due to friction or inadequate tightening, an uneven force distribution may occur around rotor circumference, resulting in the rotor shaft to bow. This conclusion must be verified, but the data and conclusions in this paper can be used by OEM as a baseline for further investigation and eliminating the root cause.
