# A 30 Years Reliability Survey of a Generator Family

**Relu ILIE**

**Iris Rotating Machine Conference**

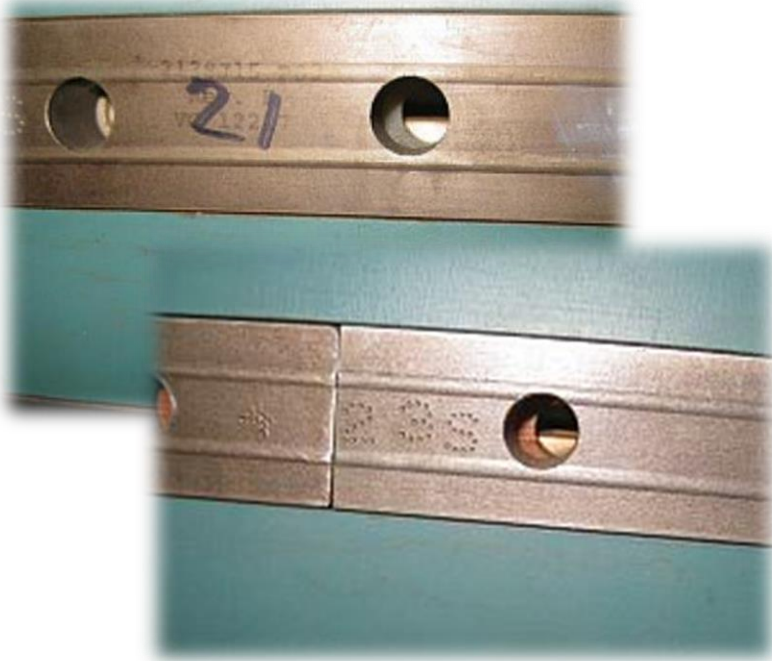
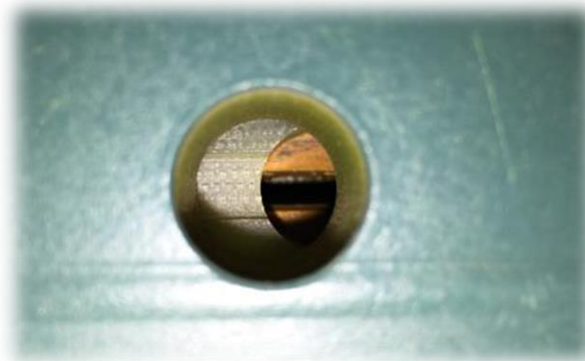
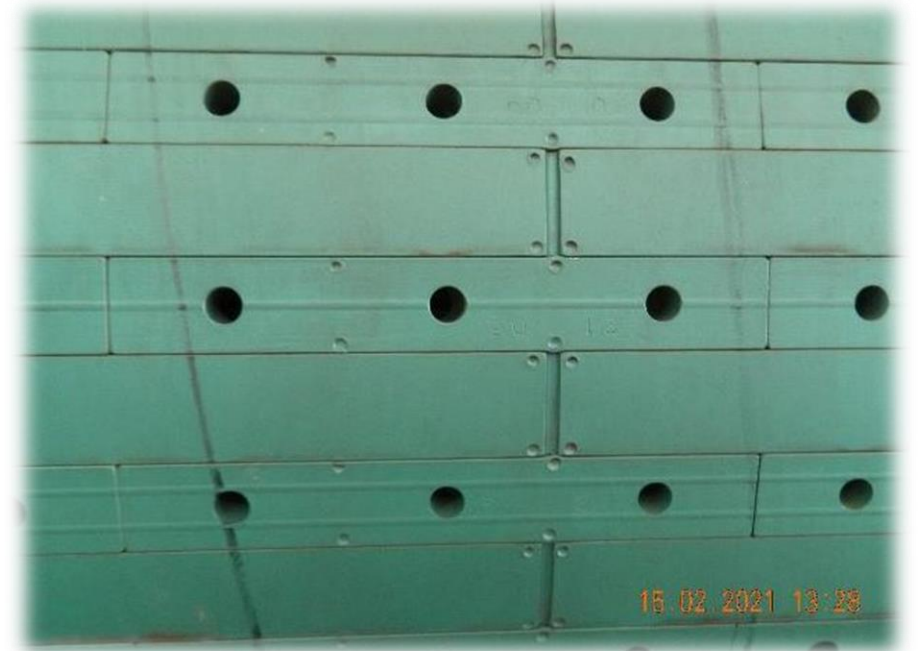
- **Creepage block migration**

- Blocked cooling vents induced thermal sensitivity and abnormal vibrations
- Appeared in 6 generators, as soon as after 1400-1800 starts or 10-13 years
- In severe cases of blocked cooling passages the solution was full rewind

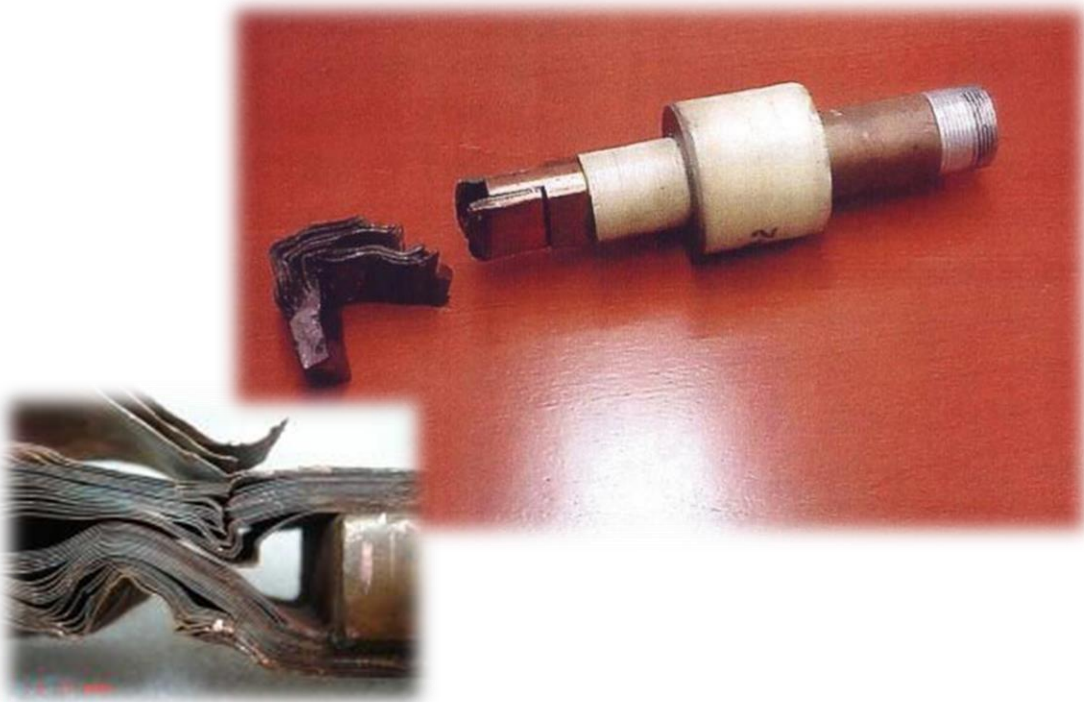
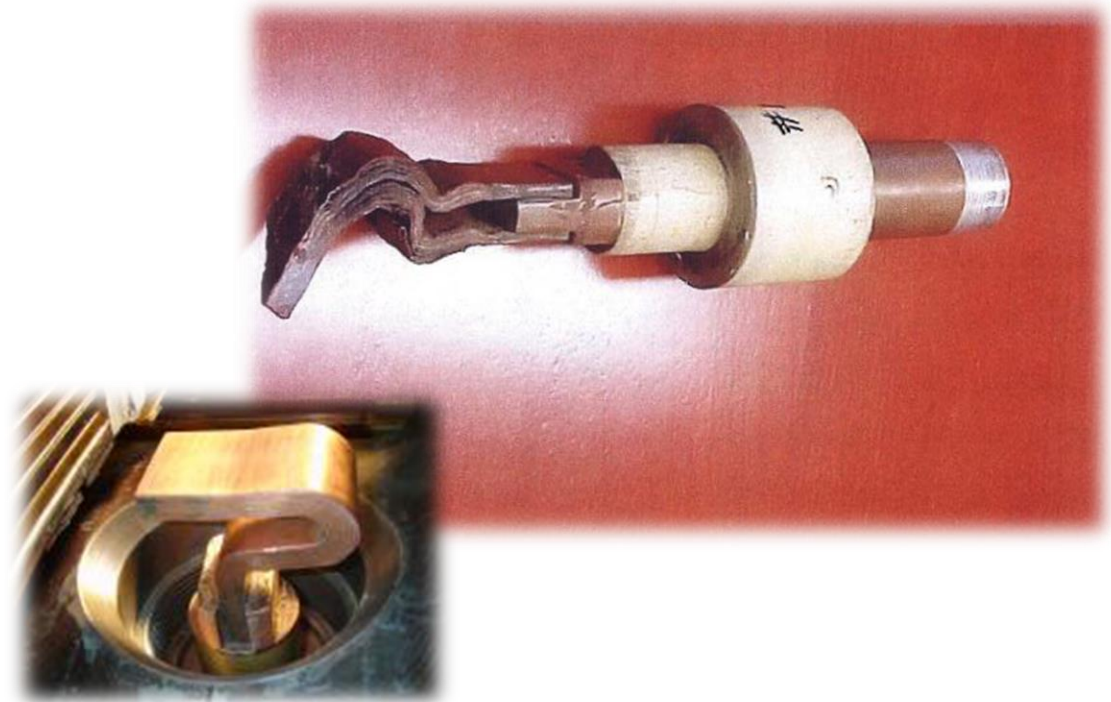
- **Terminal stud leaves**

- Cracked / broken copper leaves may lead to excitation circuit interruption
- Occurred in 4 generators, as soon as after 1100-1500 starts or 5-7 years
- Once tripped loss-of-field relay. Solution: replacing the stud (partial rewind)

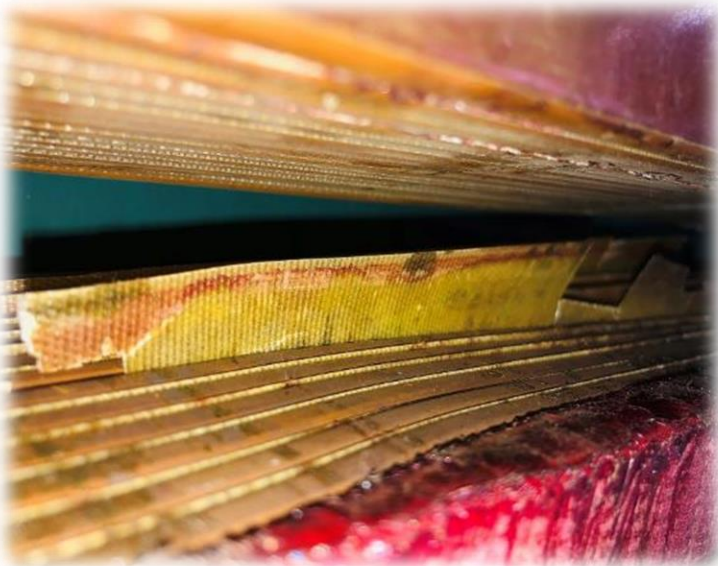
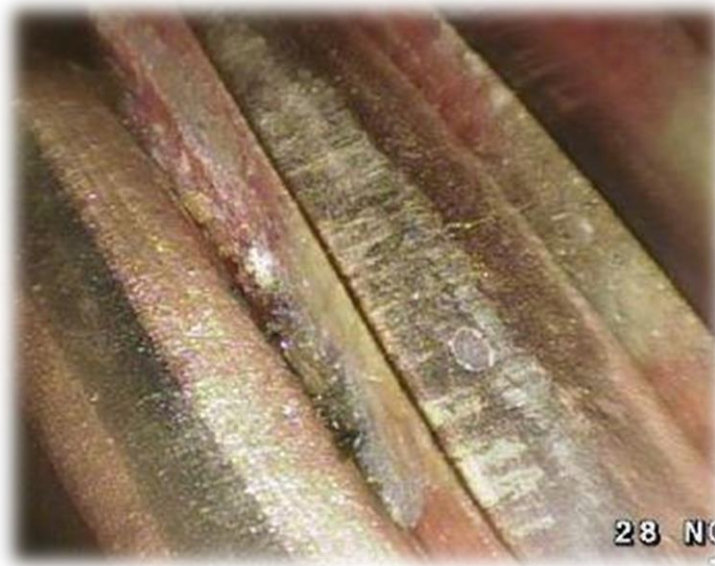
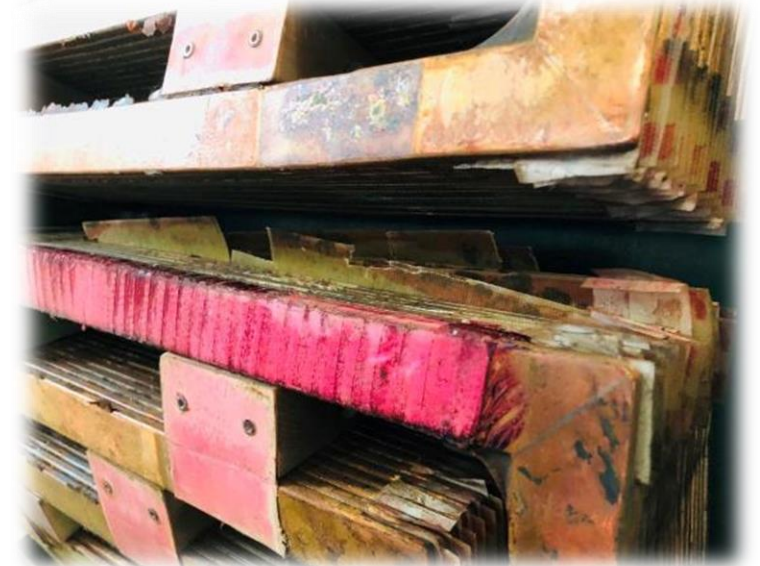
- **Dislocated turn insulation**

- In the end-winding, may lead to shorted turns and thermal sensitivity
- Found in several machines, for instance after 2200 starts and 11 years
- Can be only addressed during a partial or complete rewinding work

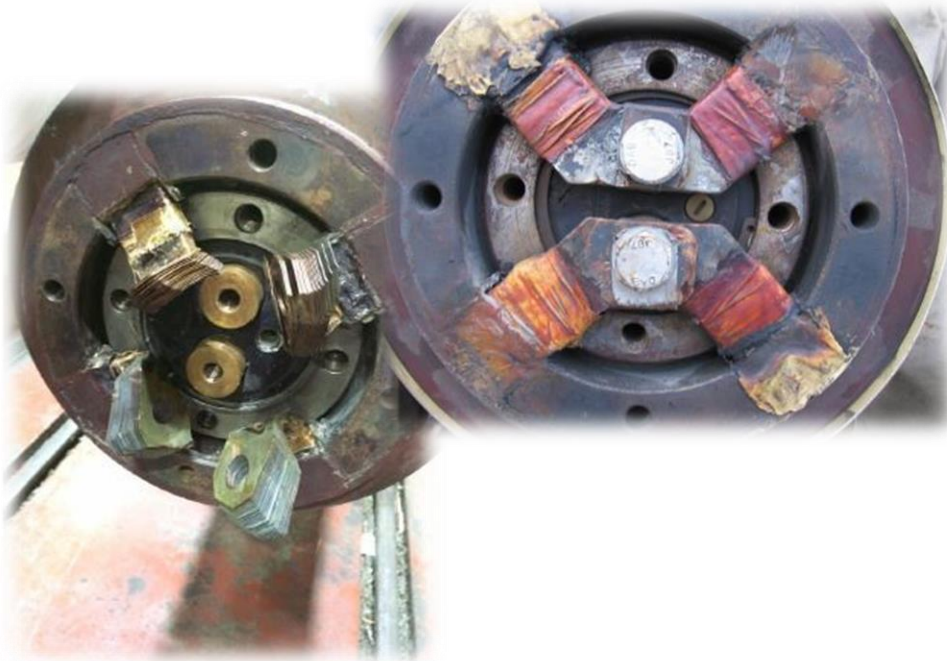
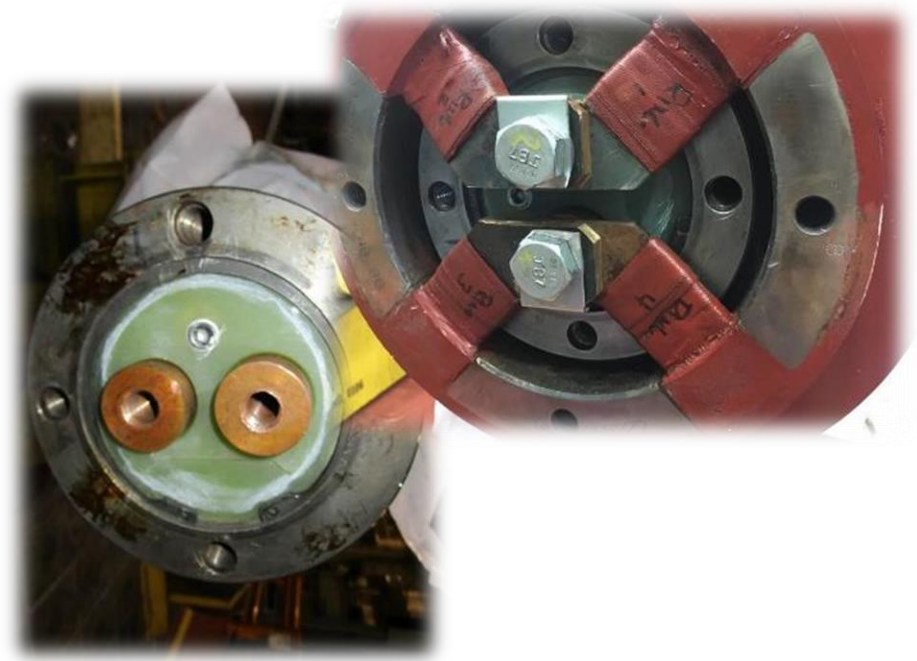
- **Collector leads insulation**

- Damaged +/- insulation may lead to ground faults or be related to H<sub>2</sub> leaks
- 3 occurrences, e.g. after 2300 starts (12 years). Once tripped ground relay
- In some cases can be repaired in the field, in others rewind necessary

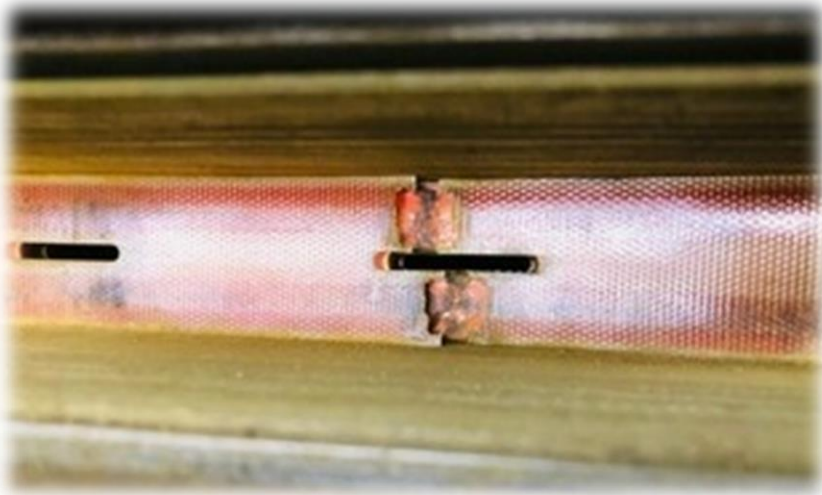
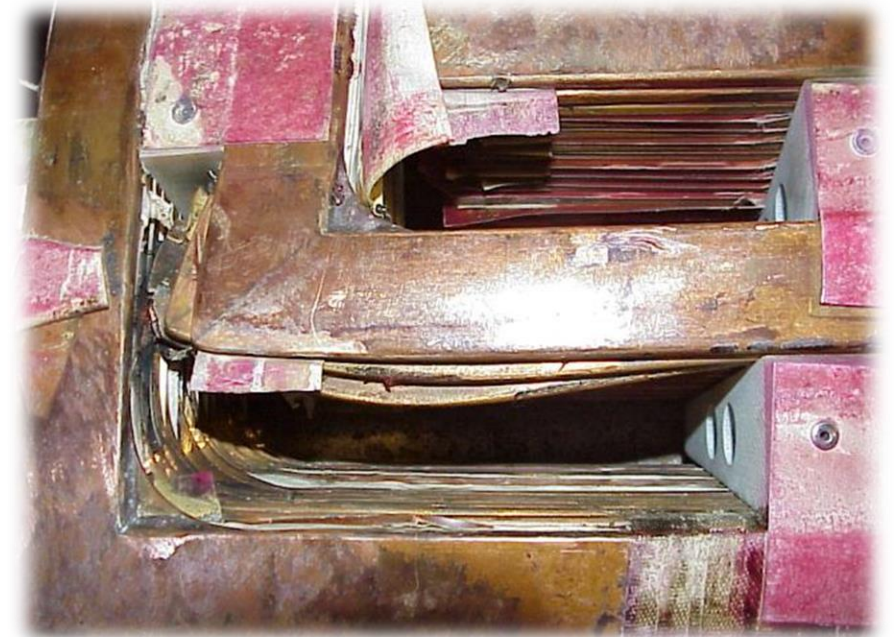
- **Shorted turns or coils**

- May lead to thermal sensitivity and vibrations
- Shorted coils case after 1500 starts (15 years), following copper deformation
- Shorted turns case after 2500 starts (14 years) because damaged interturn insulation

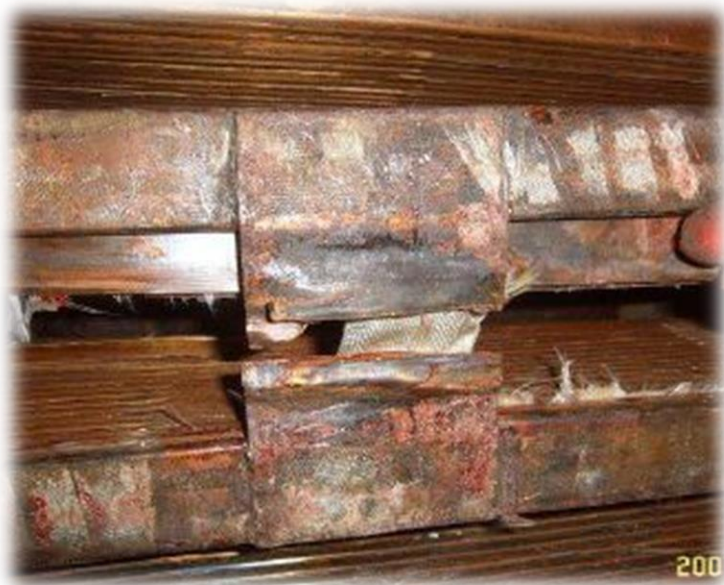
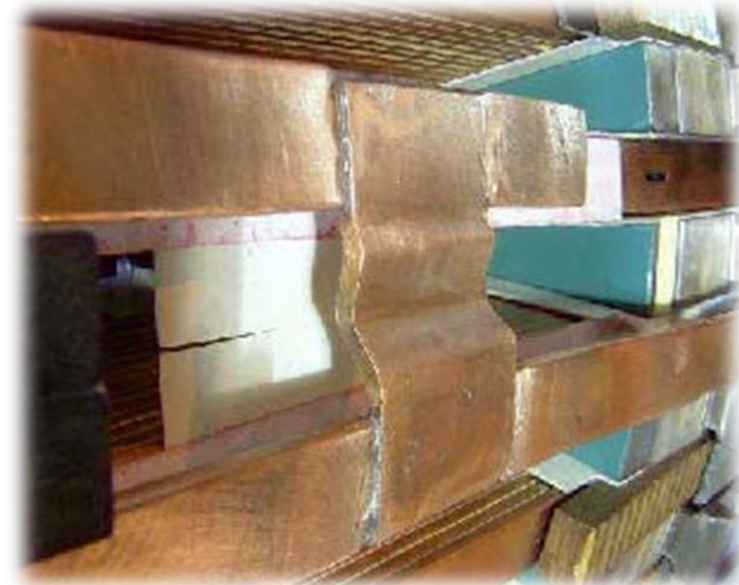
- **Pole crossover event**

- Broken pole-to-pole connector resulted in loss-of-field protection trip
- Occurred after 2800 starts and 14 years, because copper fatigue failure
- The solution was a complete rewind (following additional findings)

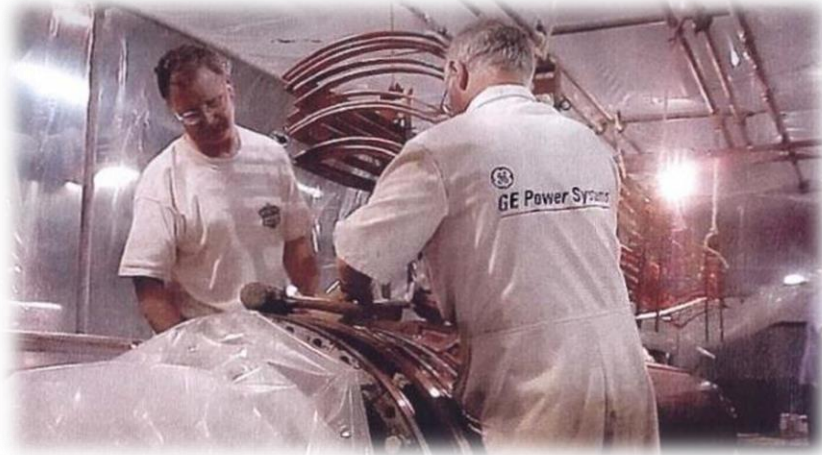
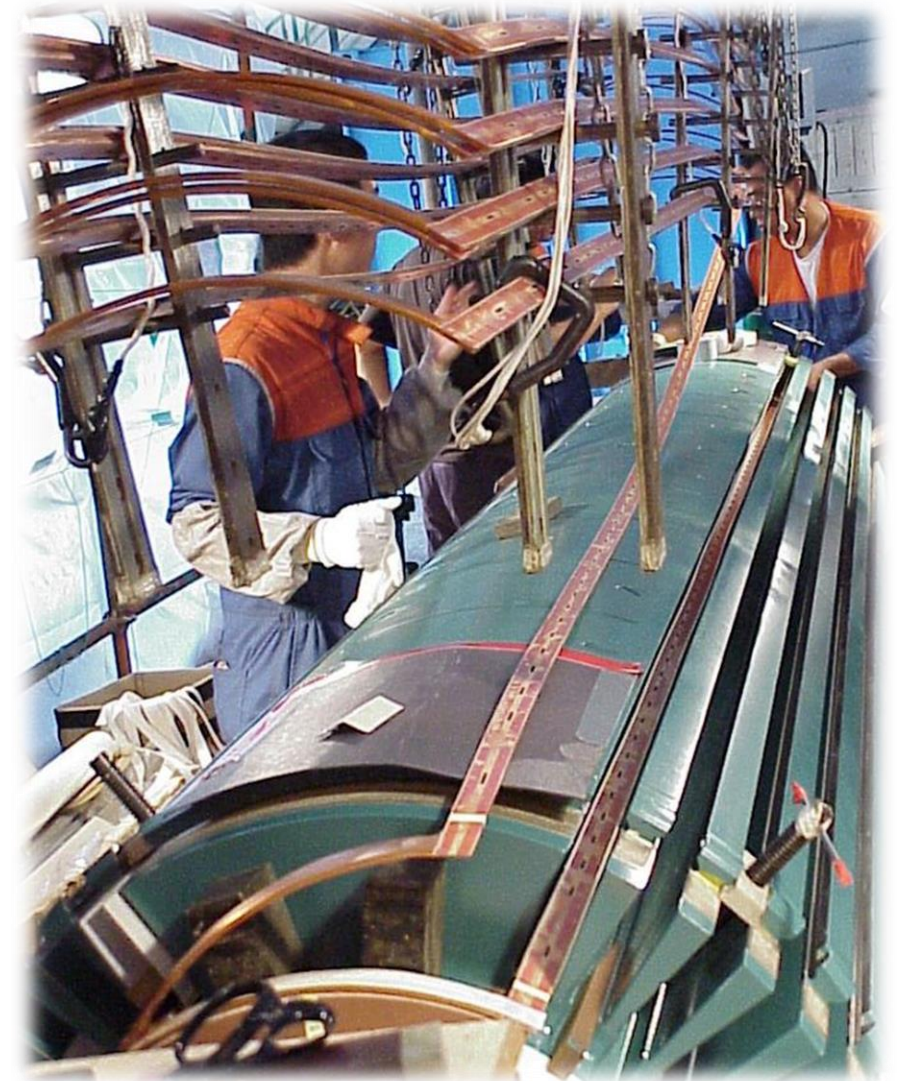
- **Rotor rewind summary**

- During the years, 5 complete and 2 partial rewinds have been performed
- Most rewinds done in our power plants, with old copper and without high speed tests
- In other 3 cases, the faulty rotor replaced by spare and repaired in contractor's factory

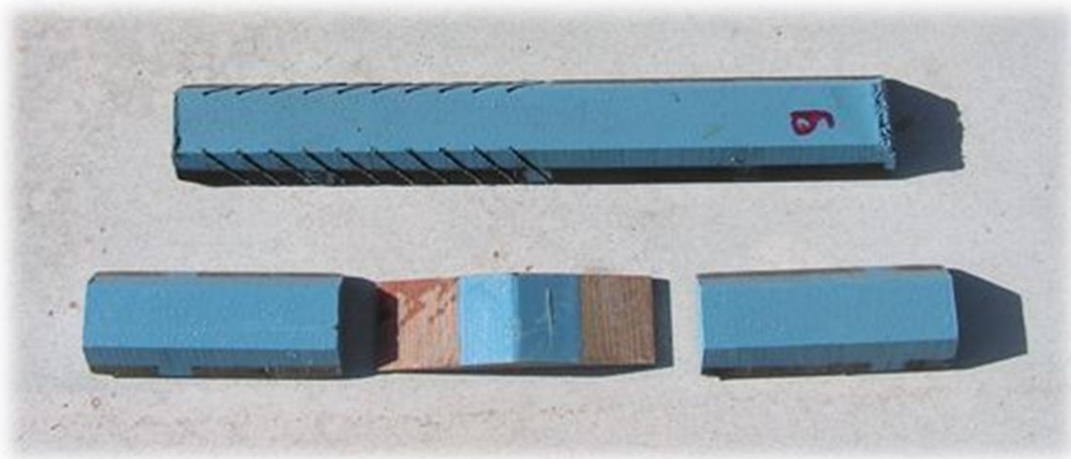
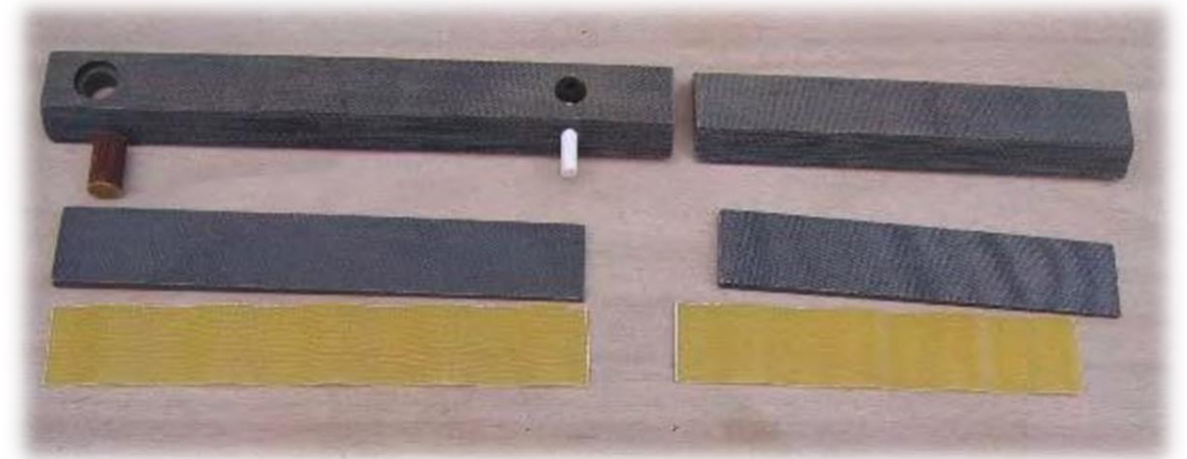
- **Loose slot wedges**

- Most probably related to two-shift operation / vibrations / oil contamination
- Occurred in all machines, as soon as after 13-14 years or 1400-1500 starts
- Solution: partial or full replace of Camel Back wedges by Piggy Back (inclined plane) & top ripple springs

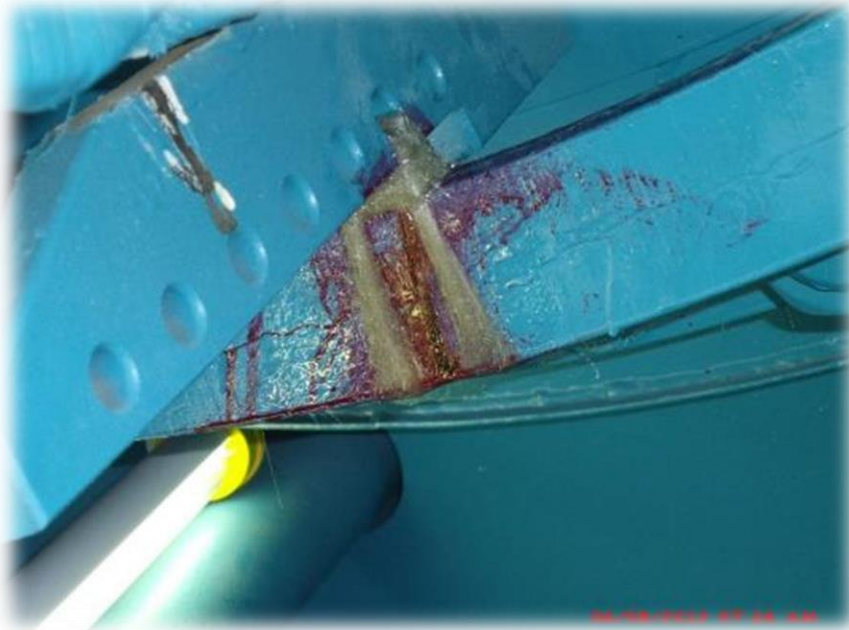
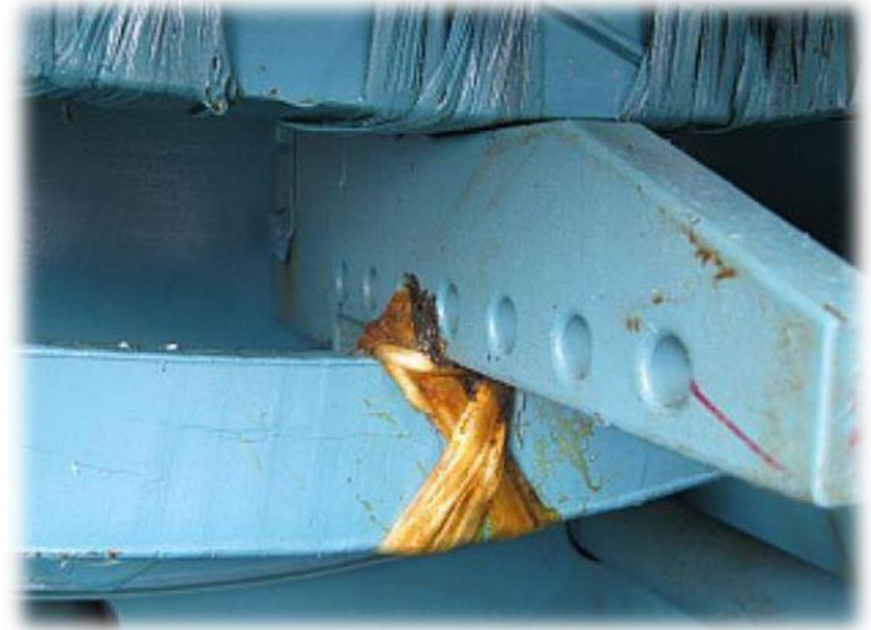
- **Greasing and loose ties**

- Greasing results from end-winding loose ties / blocks, oil contamination
- Found in some generators, for example after 18 years and 3300 starts
- All loose ties have been removed and replaced, or retighten / repaired

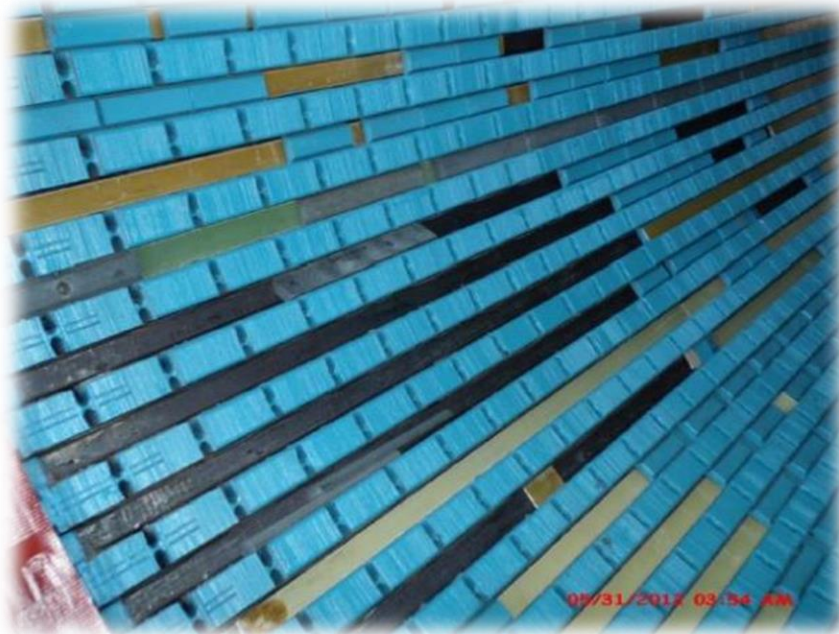
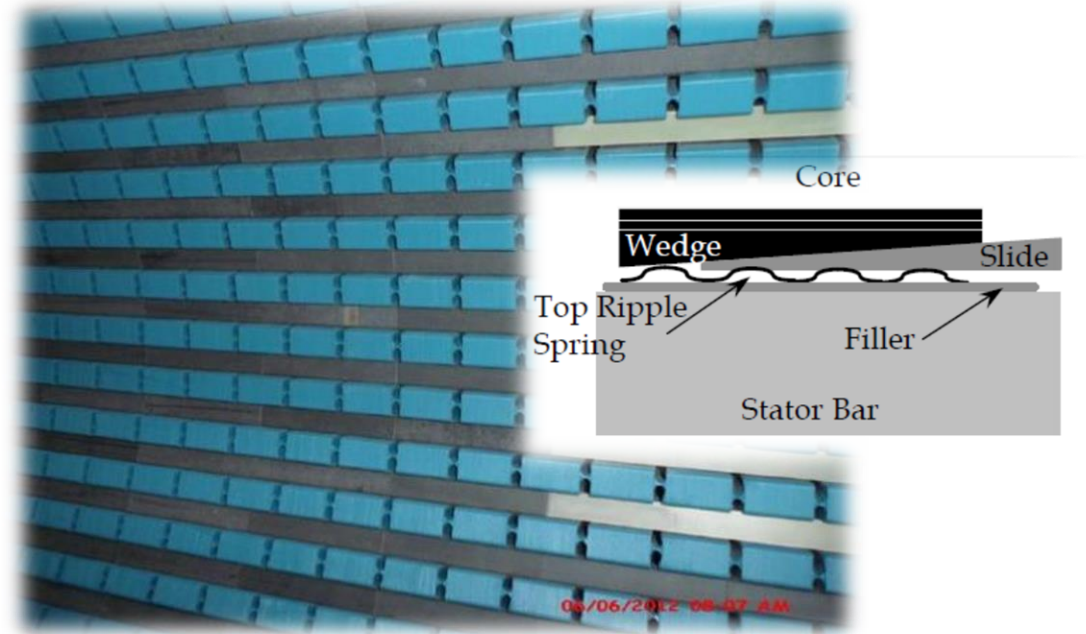
- **Stator rewedge summary**

- During the years, full rewedge was done in 6 machines
- Partial rewedge was performed in other 4 generators
- Rewedge extent according to wedge tightness test & acceptance criteria

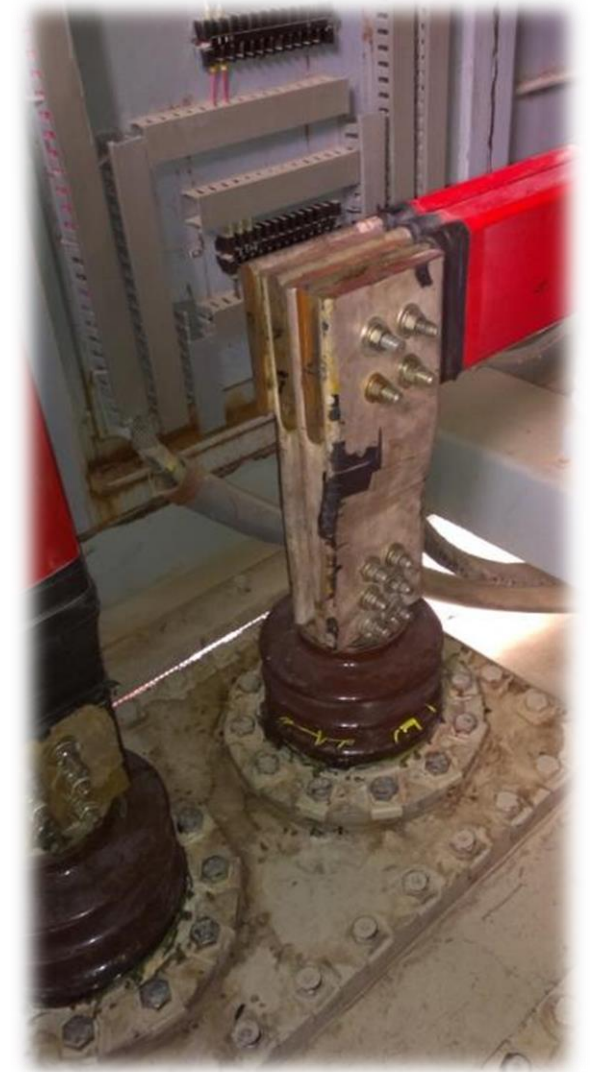
- **Bushing damages**
  - In 2 generators, after 13-17 years or just 1300 starts
- **Increased vibrations**
  - Occurred in 4 machines from various reasons:
  - One case related to thermal sensitivity (closed vents)
  - Another case was a result of misalignment condition
  - In other cases may be difficult to find the root cause
- **Static excitation**
  - Voltage regulators based on solid-state analogue electronic cards, original and still in operation
