# Challenges of Rewinding Old and New High Voltage Generator Stators

Virtual Iris Rotating Machine Conference

June 24, 2021

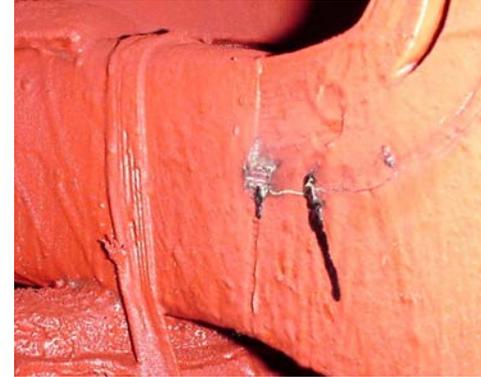
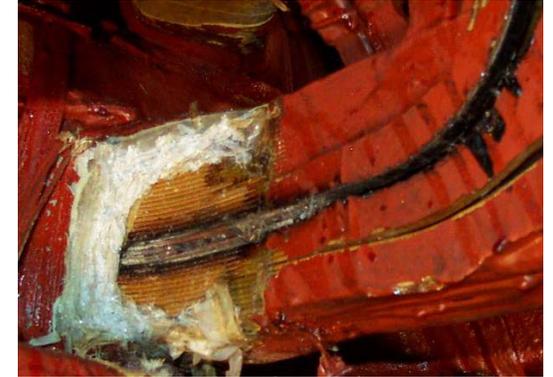
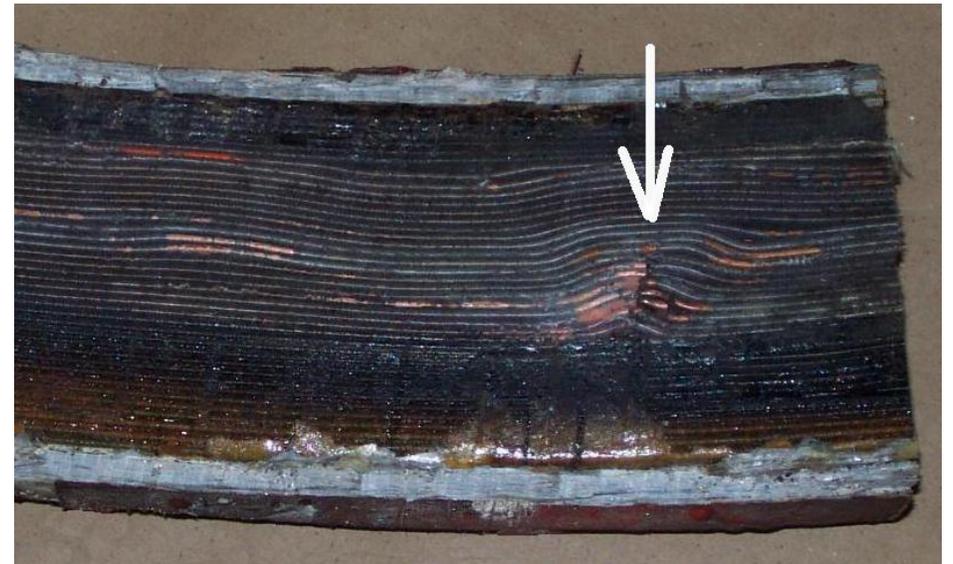
- High vibration in the stator end arms
- Fleet issue with lead group transpositions and broken / shorted strands

“Surprise” with stator core condition

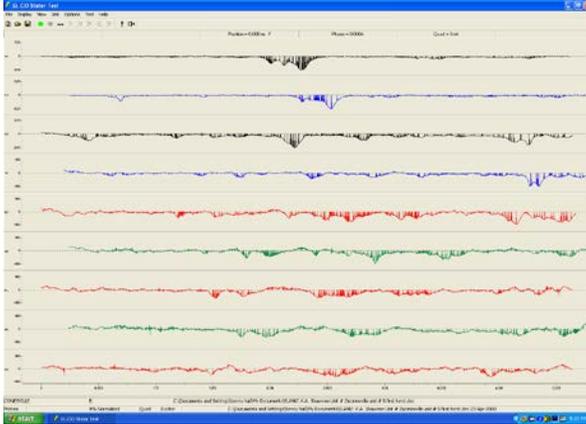
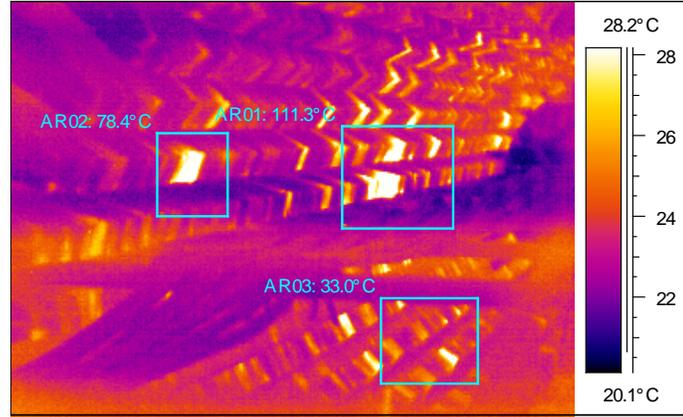
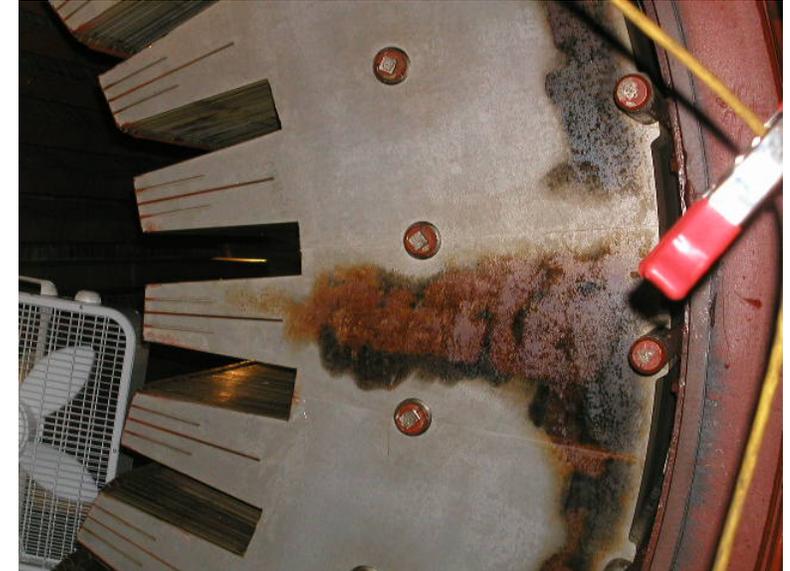
- Original El Cid test had multiple areas of concerns (areas under the curve)

- Core Loop Test Numerous hot spots
  - 90 degrees C temperature spike in 2 minutes
  - 140 degrees C temperature spike in 10 minutes
  - Scheduled one hour test - had to be stopped after 10 minutes

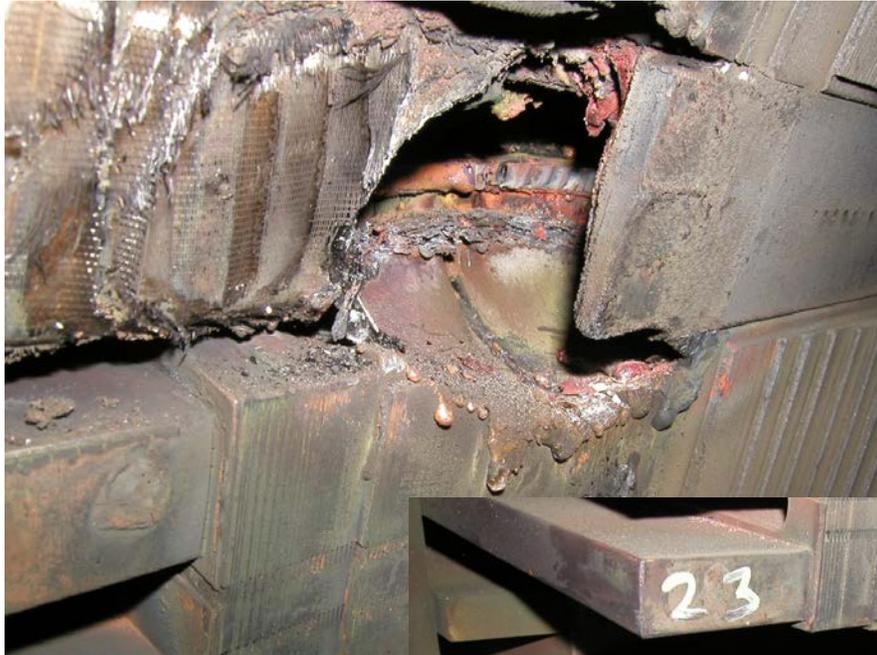
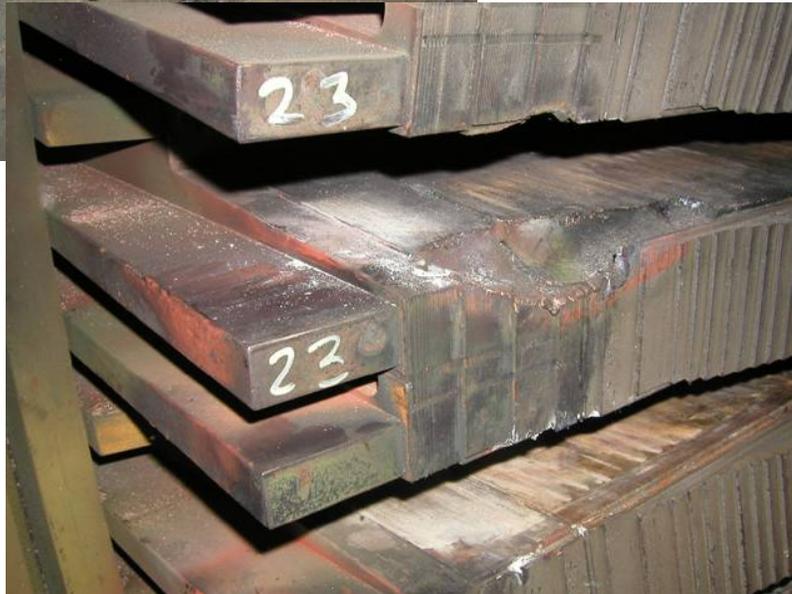
# Coil Failure and Core Iron Damage

- Stator coil ground fault
- TE core damage
- Repair Stator Core
- Clean and Refurbish the Rotor & Exciter

- Stator Coil Failure
- TE Core Iron Damage
- Rotor Contamination
- High Internal Operating Temperature
- Partial Discharge / Corona

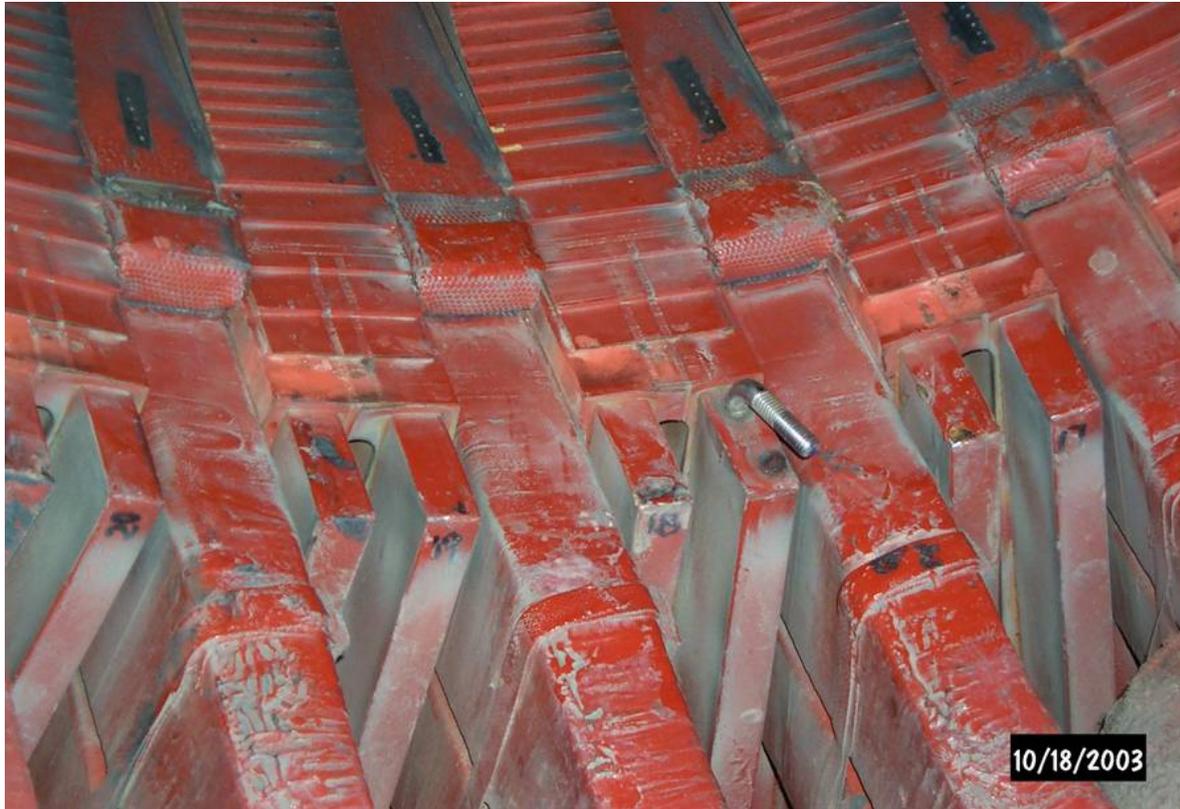
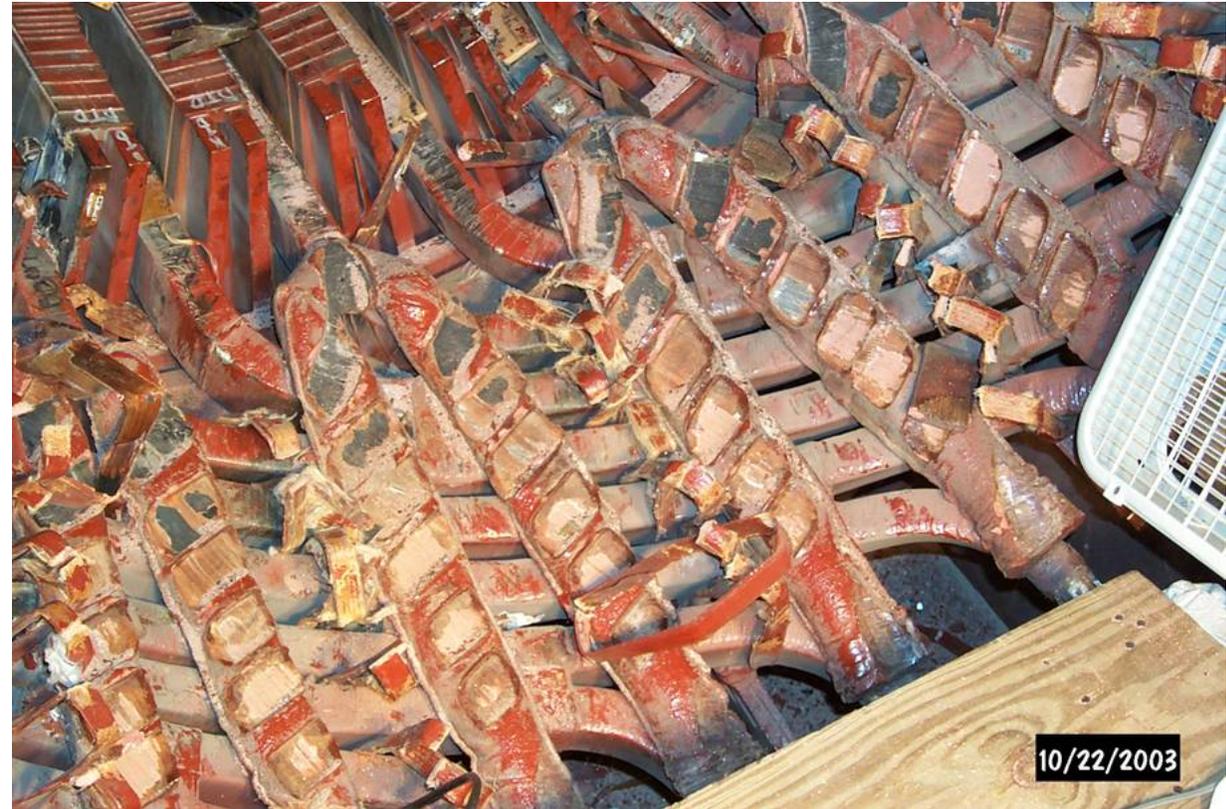
# Existing filler and Blocking

(fire hose & sausages)

- No fire hoses in slots or sausages in end arms.  
Upgraded end winding support system - more effective blocking and ties
- Improve slot Compression – Add Side & Top Ripple
- Reposition air RTD's to provide more accurate hot air temperature readings
- Reposition slot RTD's to provide more accurate readings
