DISCOVERING / RESOLVING REWIND PROBLEMS

USING PDA BASELINE DATA ANALYSIS

IRIS ROTATING MACHINE CONFERENCE 2021

Sean Brosig, PE
Senior Electrical Engineer
USACE – Hydroelectric Design Center
Date: 22 June 2021

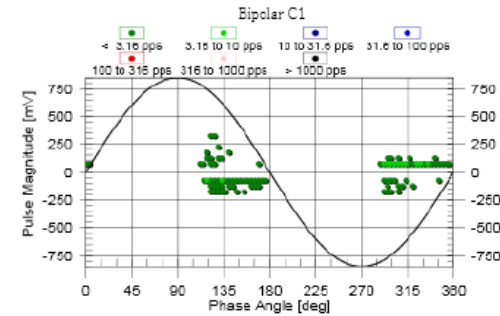
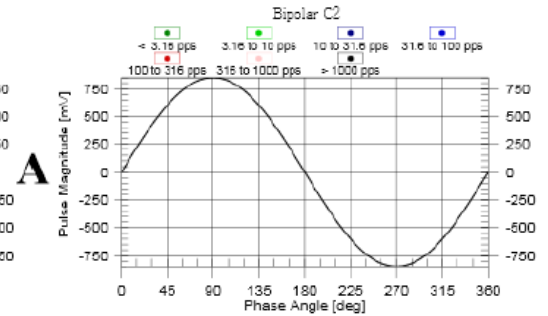
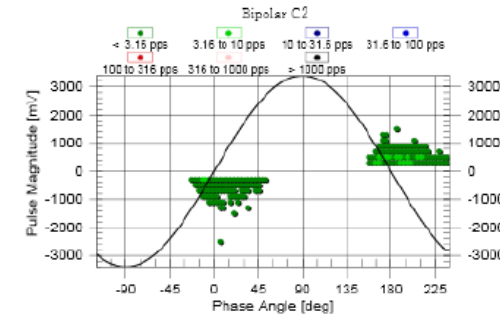
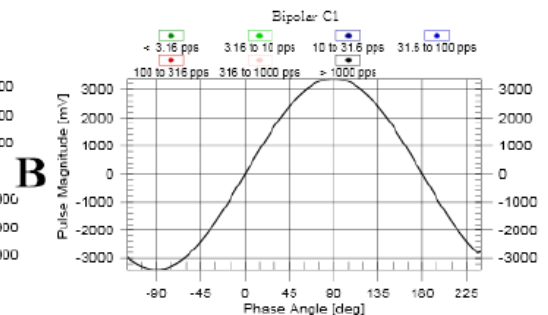
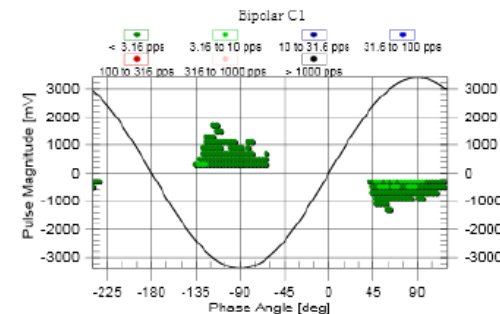
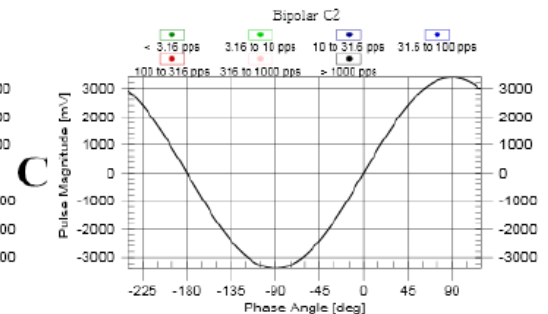
PDA “baseline” report which was provided indicated:

- High inter-phase PD in end-winding (B and C phases)
- Some cross-coupling on A phase (not indicative of problem, though can obscure other issues)

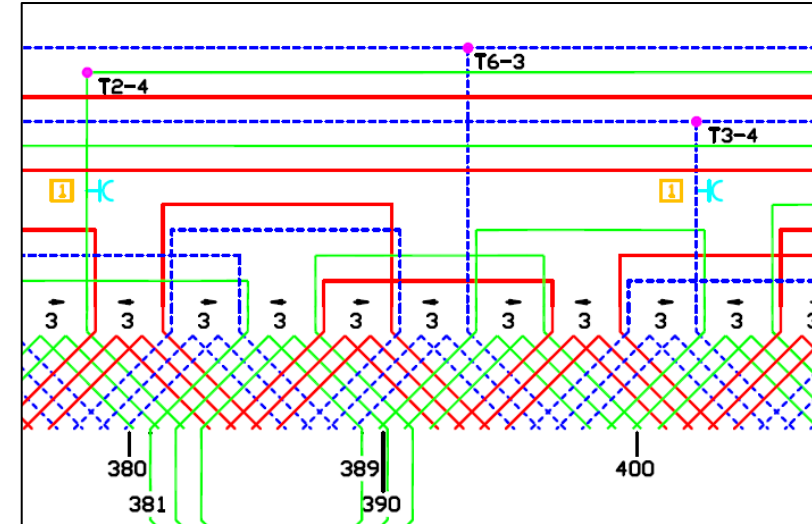
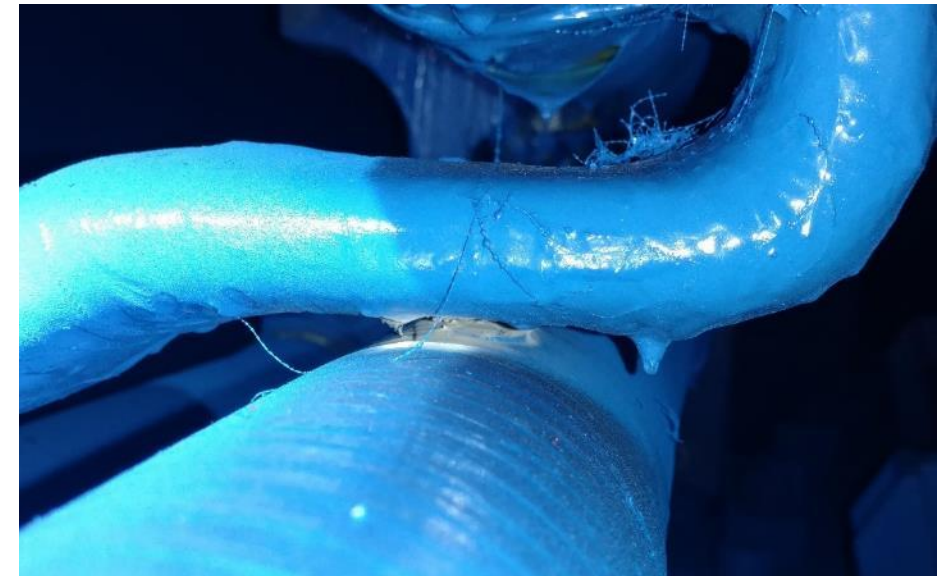
Review of physical location of the couplers along with the winding diagram indicated the likely location of the problem.

Physical inspection and blackout test confirmed the location of the inter-phase corona activity

- Voltage at which the activity was observed was higher than original blackout test for the involved phase(s) achieved. One possible reason it wasn't seen – though access and visibility is also a challenge!

The second blackout test, conducted with rotor in, provided greater access to end-winding to see the issue.

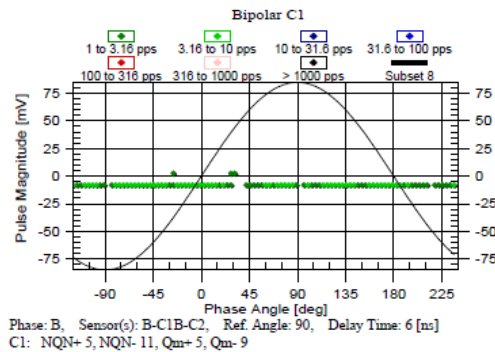
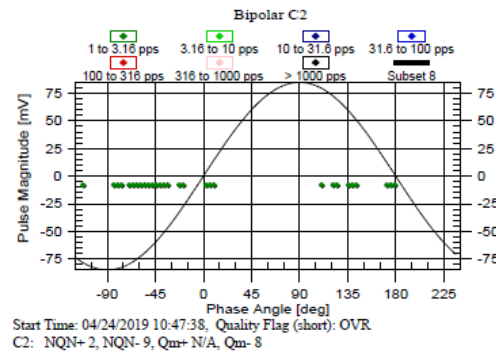
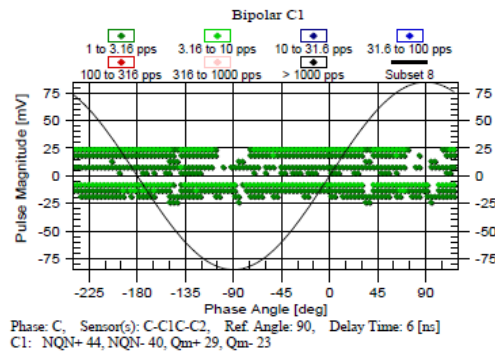
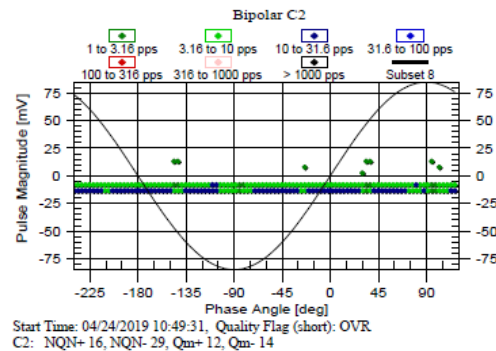
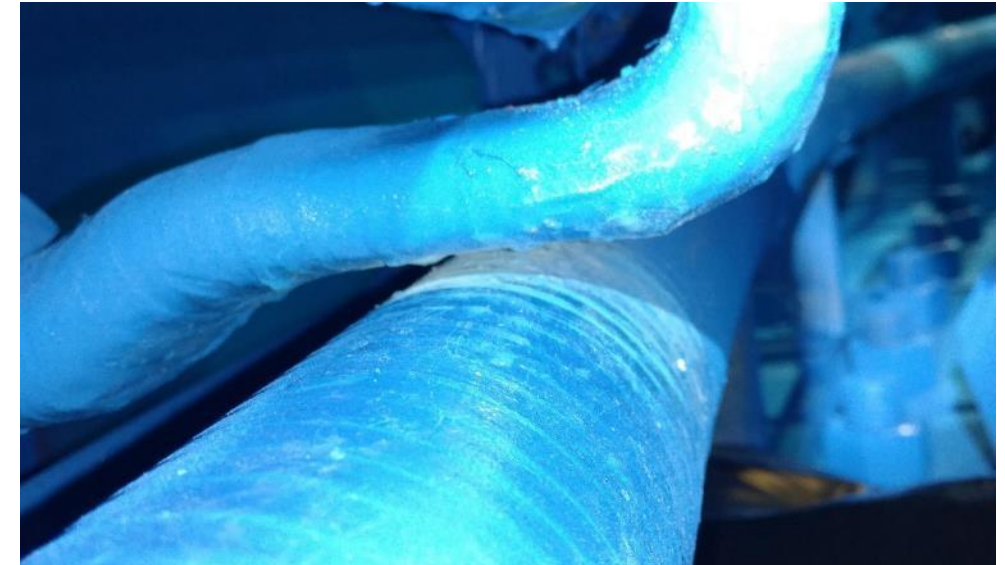
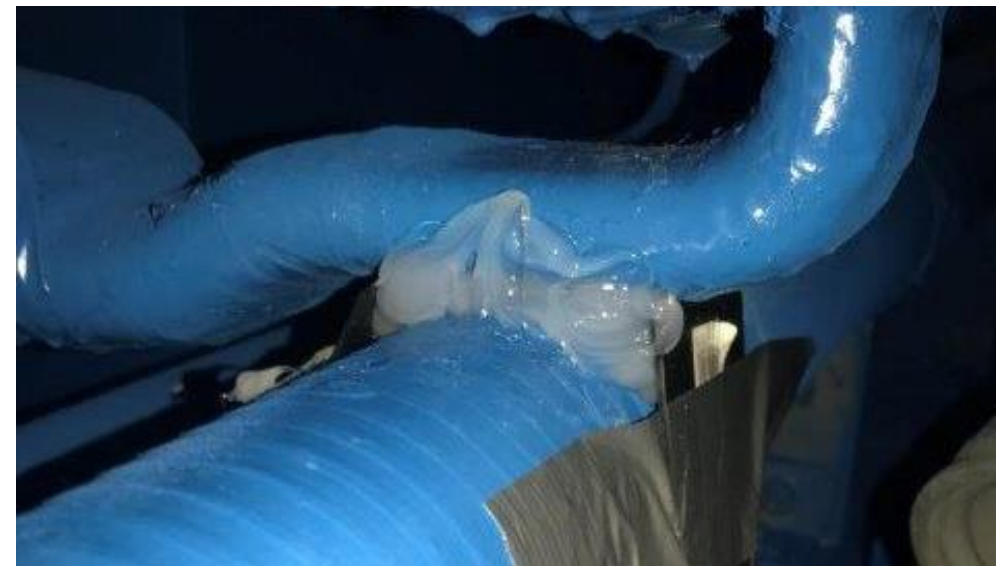
PDA results taken afterwards show no remaining activity (low level broadband clusters only)

Using garnet paper, sanded varnish drips and loose material to clean the area. Filled the narrow gap with 100% silicone, injected to completely fill the gap.

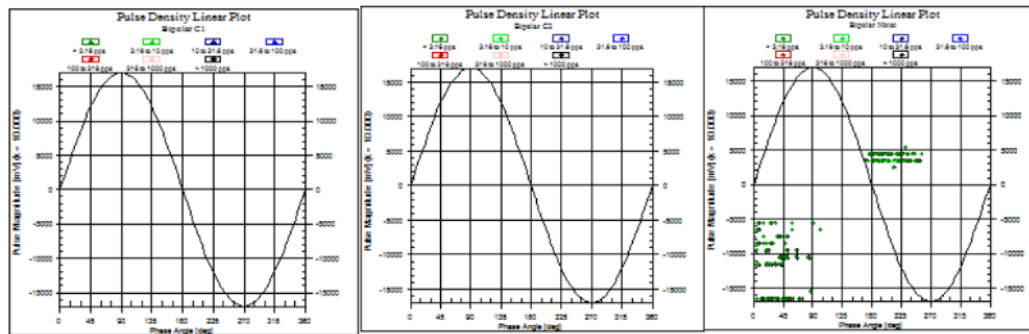
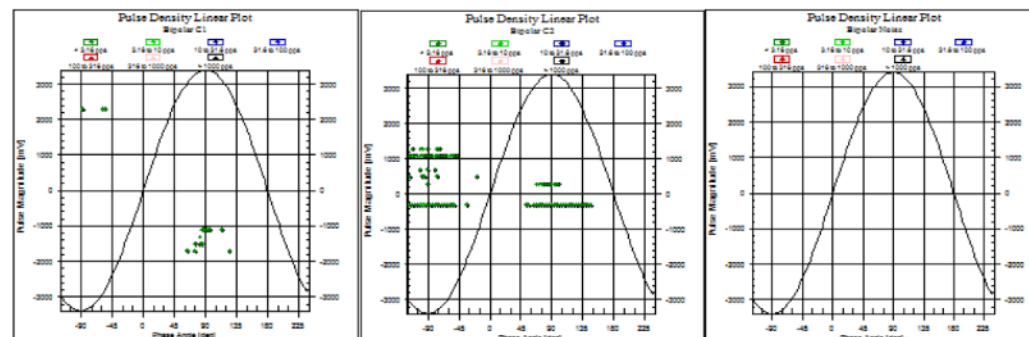
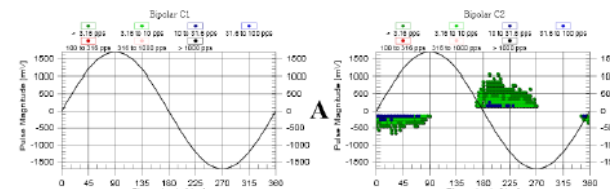
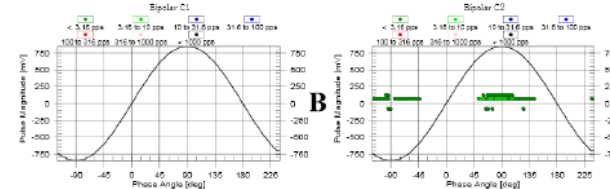
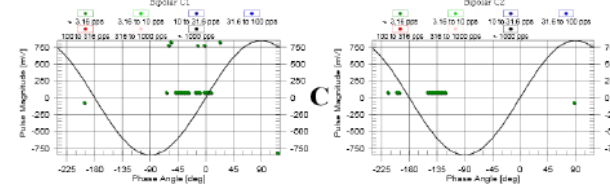
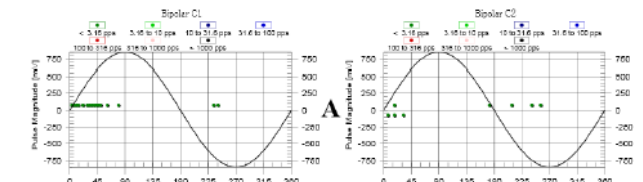
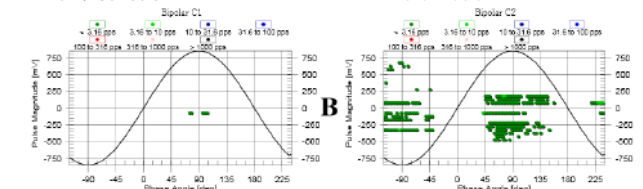
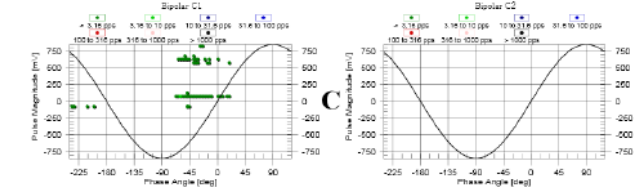
Again, initial PDA data was recorded following commissioning after a rewind was performed. The report indicated potentially numerous issues which were considerably less straightforward to interpret than the first Case Study example. Significant noise (gap discharge) was present, likely cross-coupling, some evidence of slot-exit PD, etc.

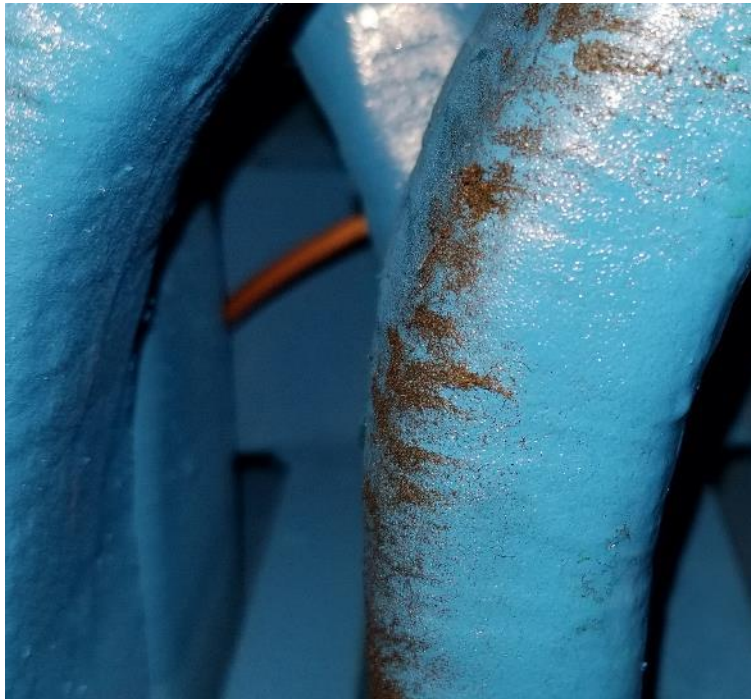
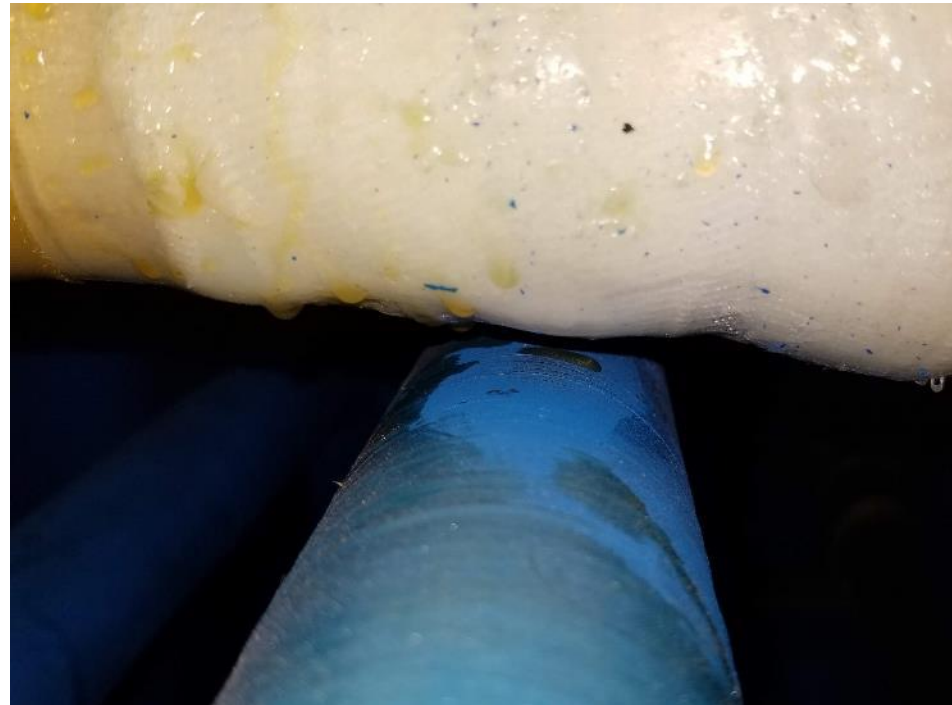
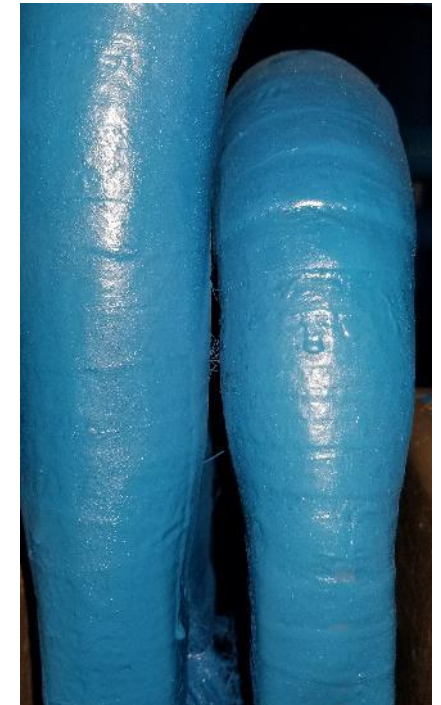
General findings during inspection and blackout testing were low clearances between some circuit connections, as well as air gap sensor leads which were loose and relatively far from the core end.

Resolving some of these items through securing leads and filling gaps removed the noted corona locations during repeated blackout testing.

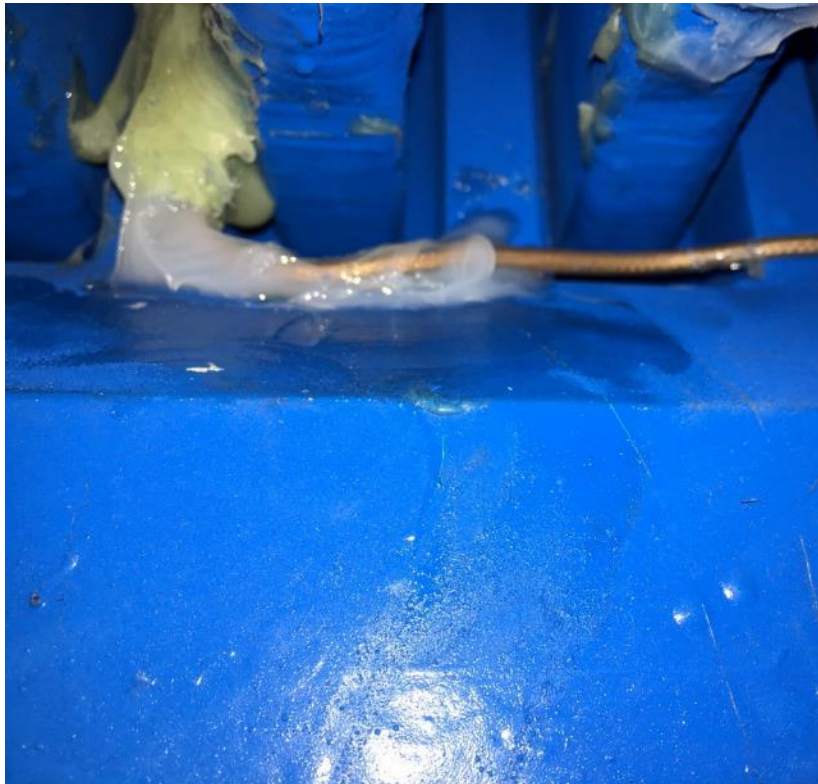
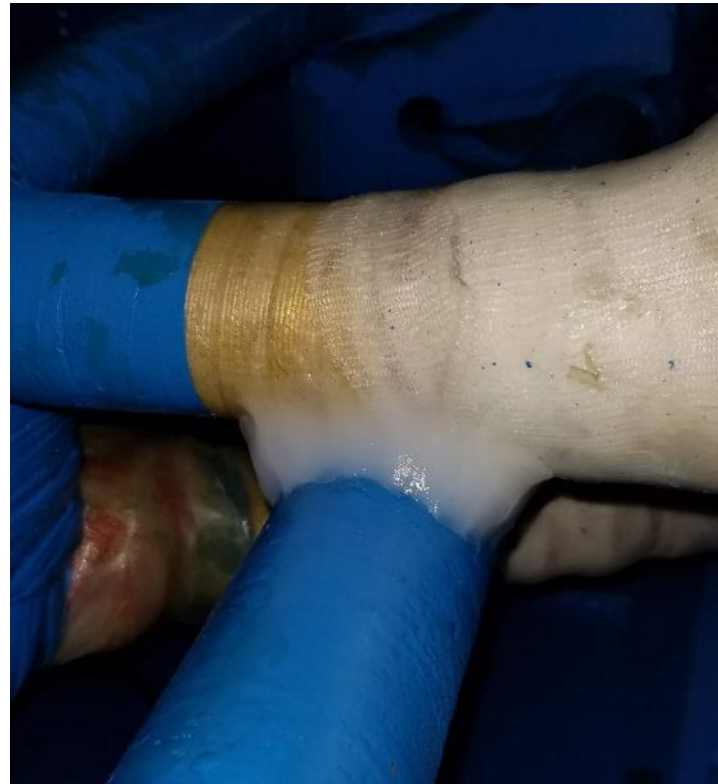
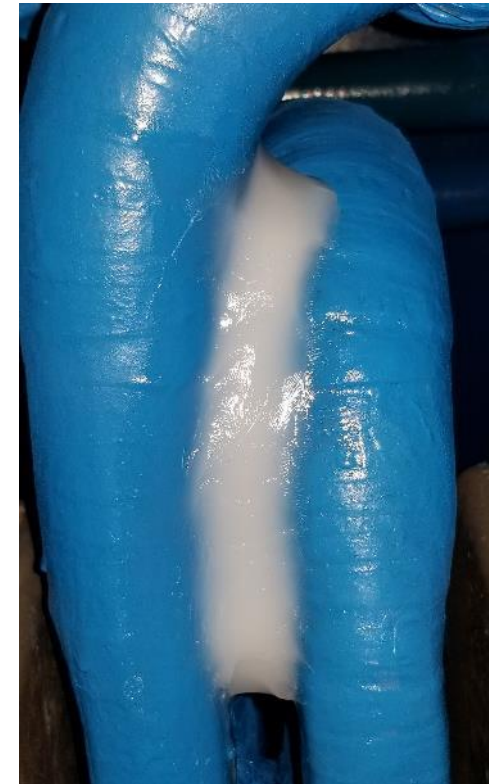
General findings during inspection and blackout testing were low clearances between some circuit connections, as well as air gap sensor leads which were loose and relatively far from the core end.

Resolving some of these items through securing leads and filling gaps removed the noted corona locations during repeated blackout testing.

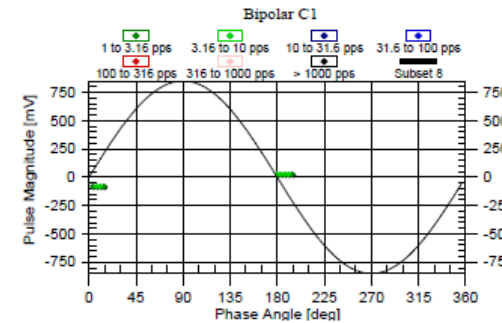
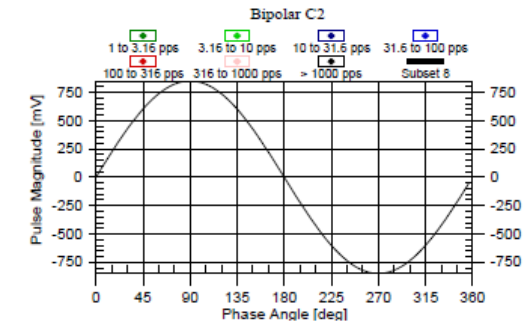
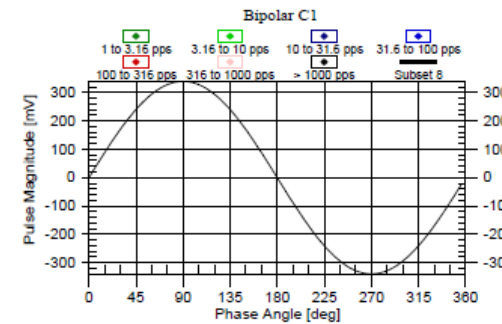
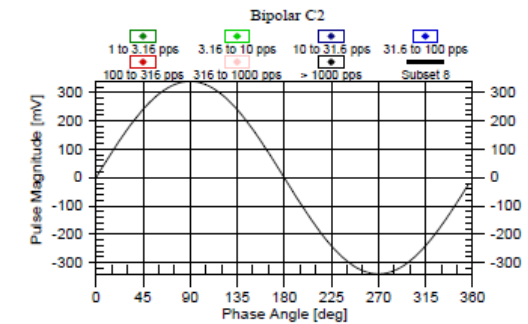
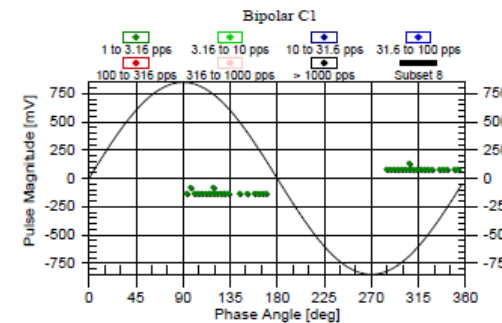
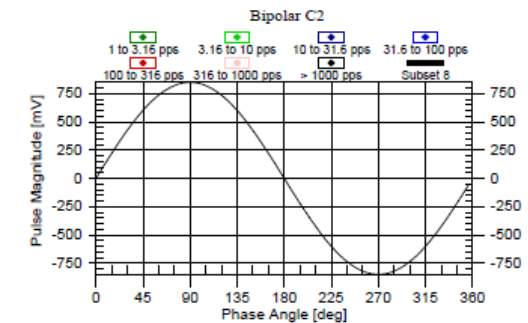
PDA Analysis performed afterwards showed greatly improved results, with previous issues resolved.
