BE KIND REWIND

Sometimes you really can't fix it!

IRMC June 28, 2023 Houston, TX

Synopsis: We attempted a repair and ended up rewinding.

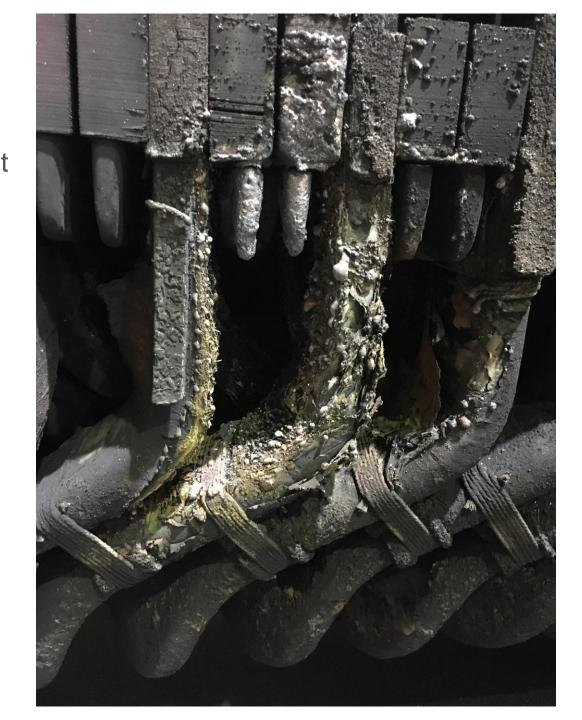
- Late Summer 2016
- Generator differential trip on start-up of Unit
- Fault between A and B phases
- 64G relay did not trip due to a loose wire
- Visual inspection found failure near slots 1 and 2

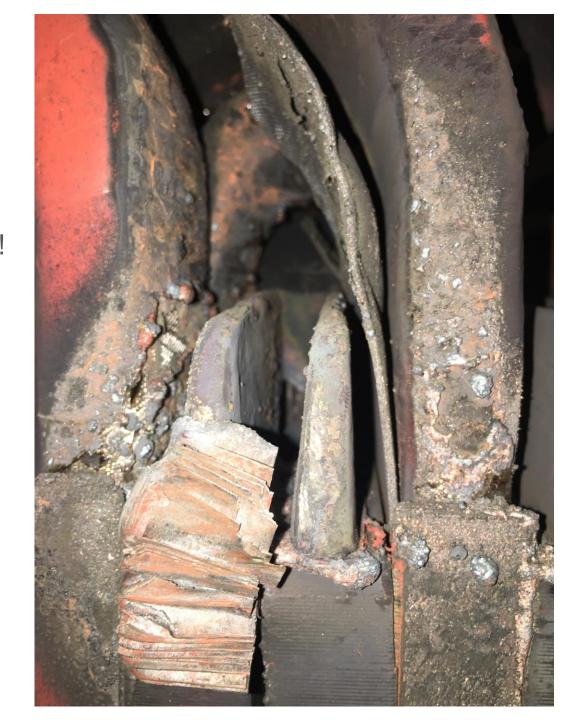
- Plant staff attempted to isolate failed coils
- Could not clear both phases
- Removed the rotor
- Found second failure location near slot 165!
- No money for a rewind
- Developed a repair plan:
 - 1 coil bypass
 - 2 full coil replacements
 - 5 half coil splices
 - Rewedge unit
- Repair would leave few spares

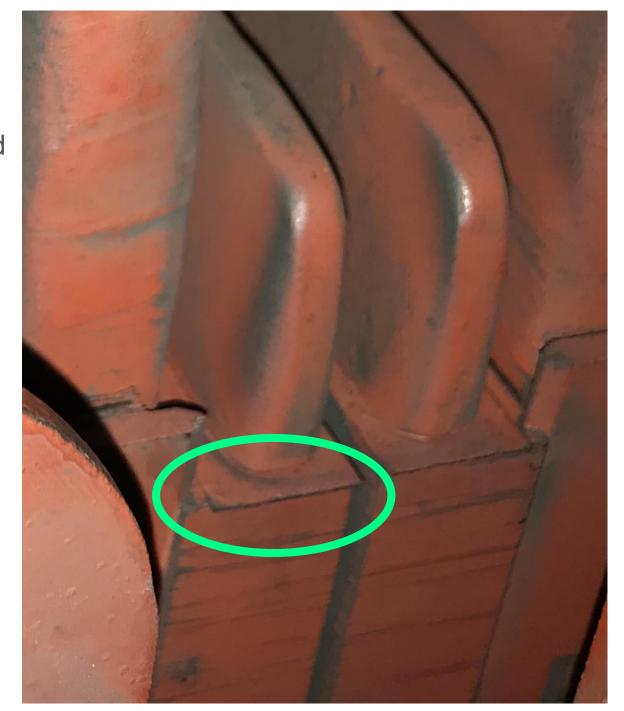
- Contractor's inspection revealed widespread issue with the top core lamination
- "Heavy" lamination had migrated toward the bottom coils
- Affecting 30-50% of slots
- Likely cause of the slot 165 failure
- Unit 1 had the same issue
- Could not proceed with repair
- Contractor was very helpful!
