**CORONA (PARTIAL DISCHARGE)
REHABILITATION CASE STUDY
HIGH-VOLTAGE STATOR WINDINGS**

**Presented to : IRIS Rotating Machine Conference
Houston, Tx . June,28, 2023**

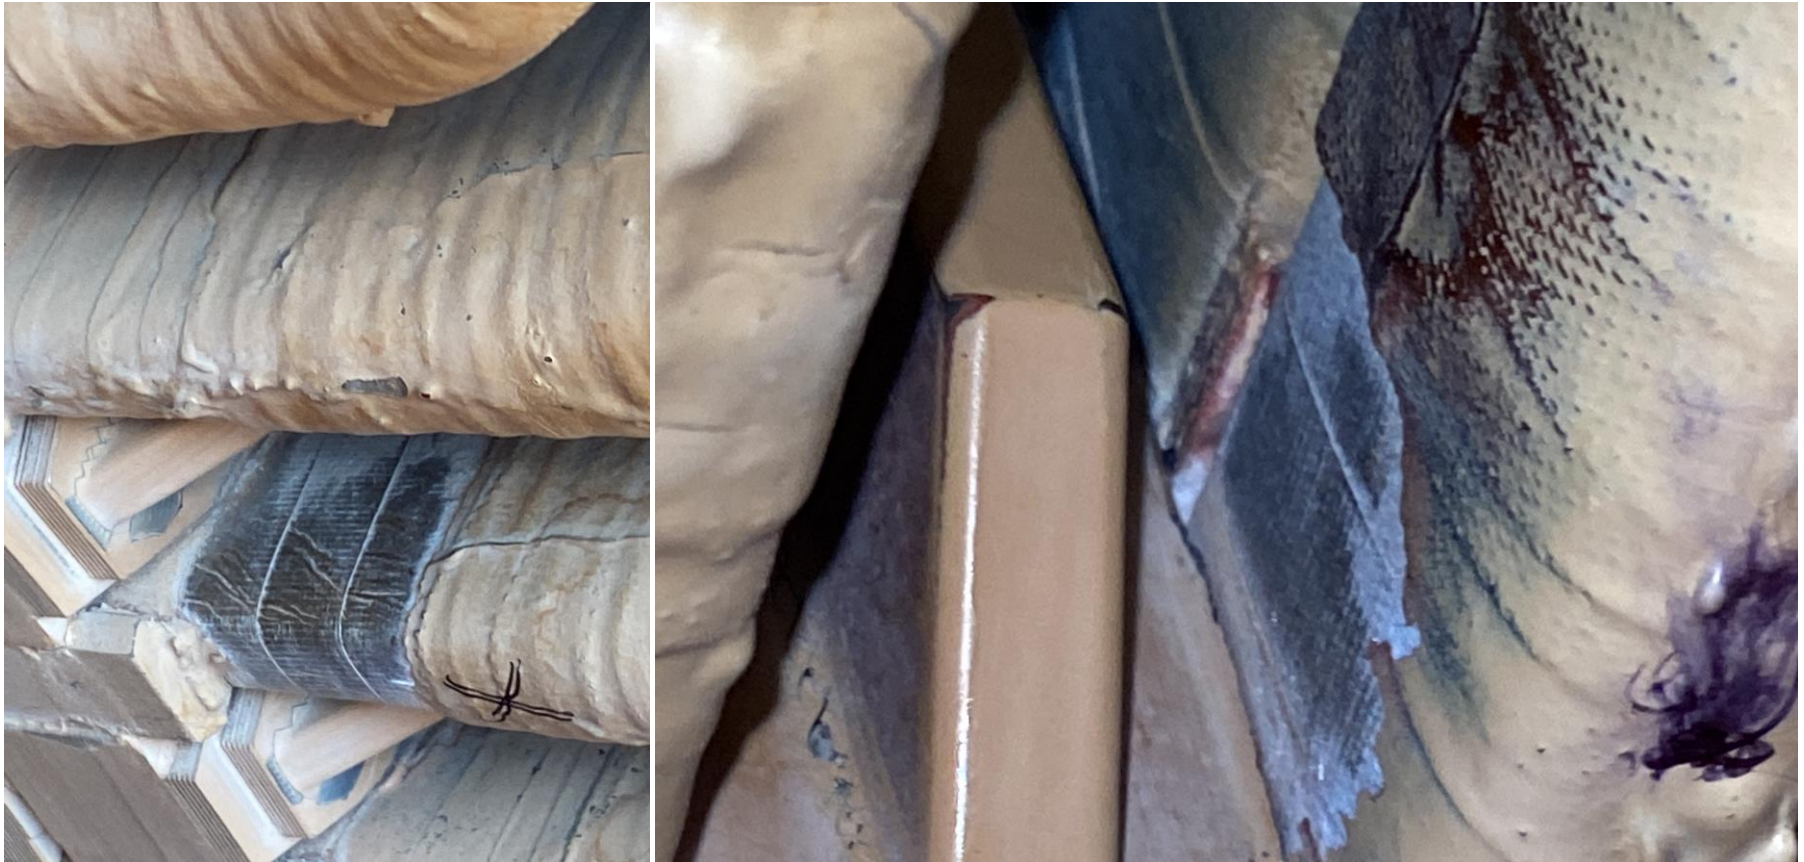
30000 HP, 13800 V – FIELD EVALUATION

- Elevated PD trending results with PD detectors
- Visual inspection and UV camera test revealed several coils with advanced Partial Discharge activity

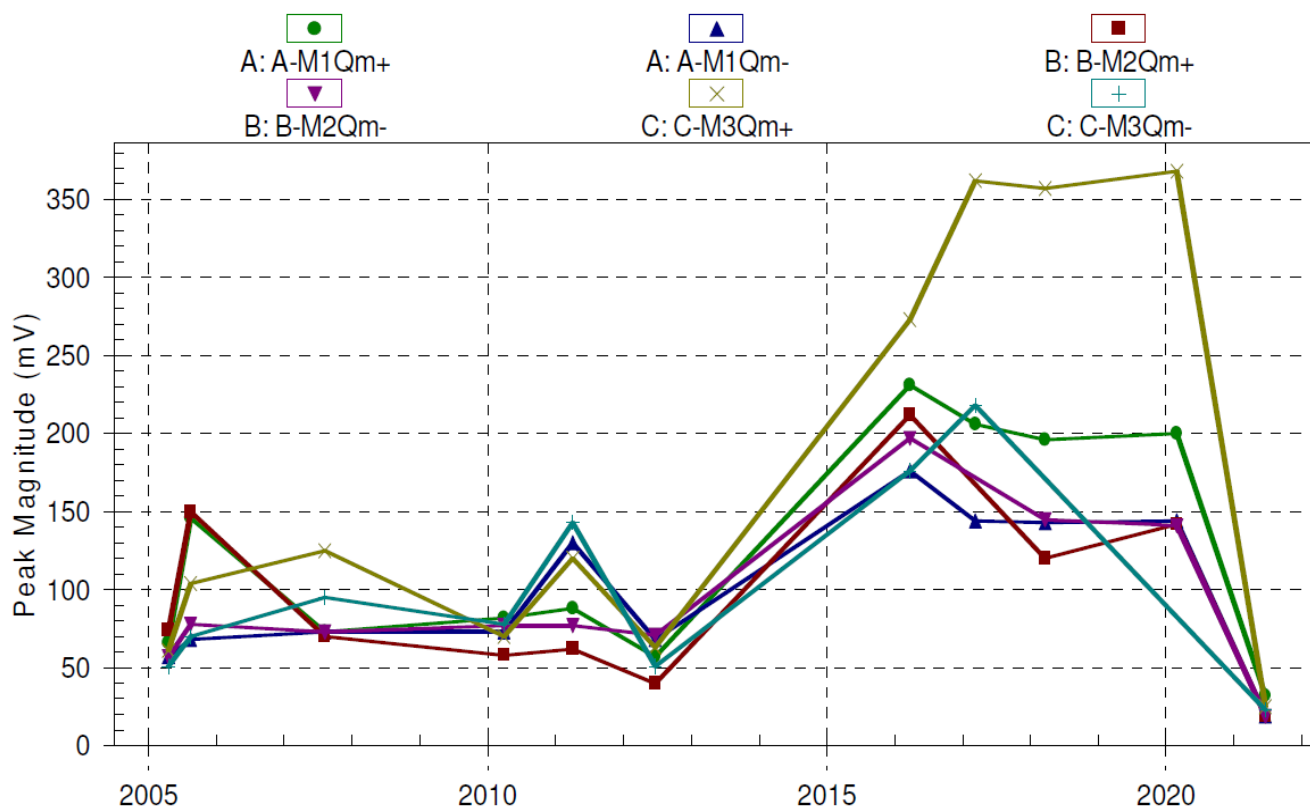
PARTIAL DISCHARGE RESULTS (OFFLINE) AFTER RE-ESTABLISHING CORONA SUPPRESSION SYSTEM

The Partial Discharge is stable (no more than 25% difference in Peak Magnitudes (+/-Qm), so there is no evidence of a change in winding condition. The Qm values recorded between 2016 and 2020 were an artefact of testing at lower sensitivity ranges.

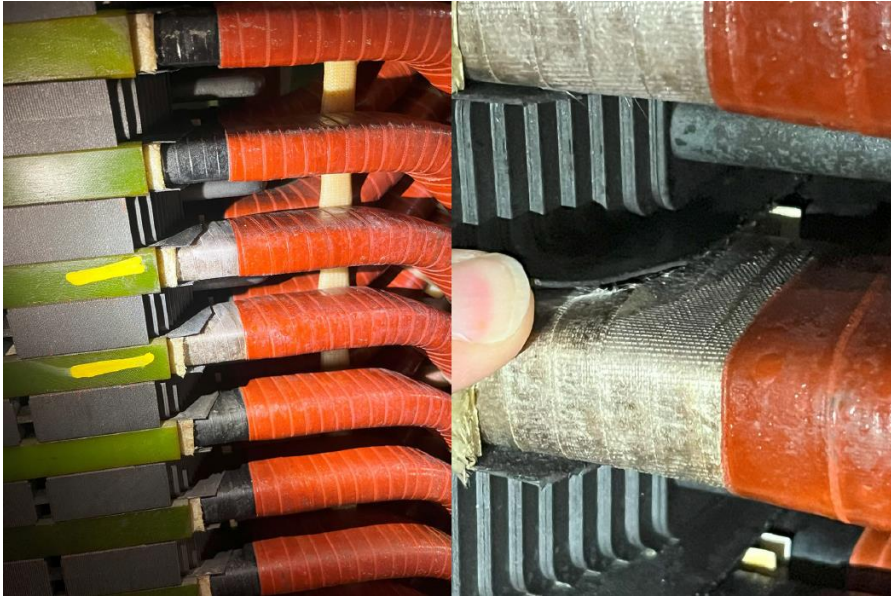
Before

22.5MVA , 4P, 12470V SYNC GENERATOR (PARTIAL DISCHARGE)

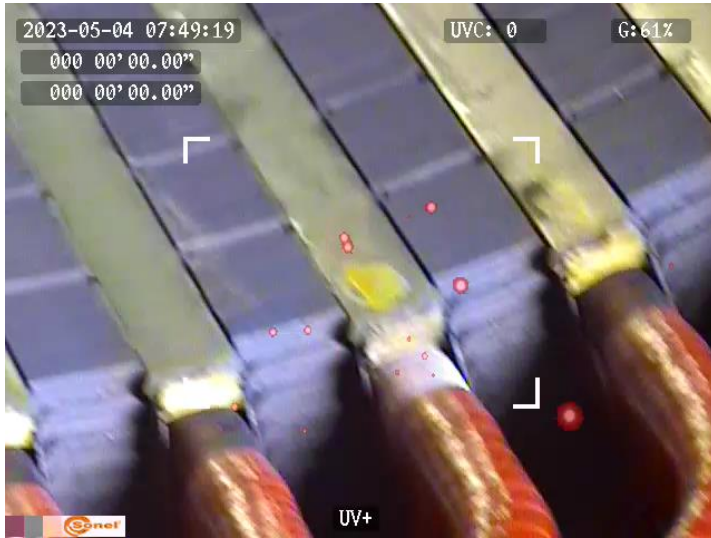
Before

22.5MVA , 4P, 12470V SYNC GENERATOR (UV CAMERA TEST)

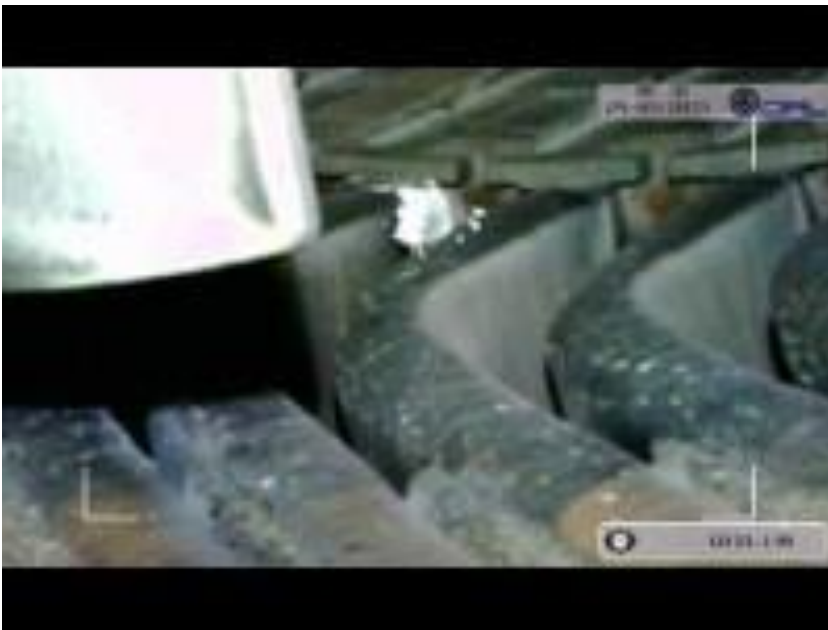
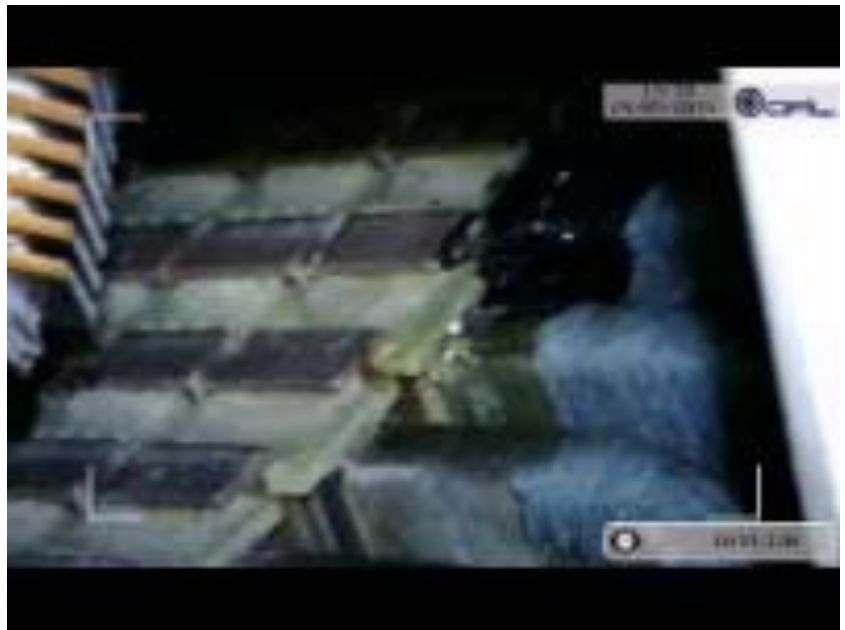
REDUCE WINDING PD DURING OUTAGES

Re-establishing the corona suppression system reduces partial discharge if found outside the slot.
