Osmo Koponen
Leading Specialist
Generator Engineering
TGS Finland Oy
osmo.koponen@fortum.com

24.4.2022

DETECTING STATOR WINDING BAR VIBRATION WITH ON-LINE PARTIAL DISCHARGE MEASUREMENTS – TWO CASE STUDIES

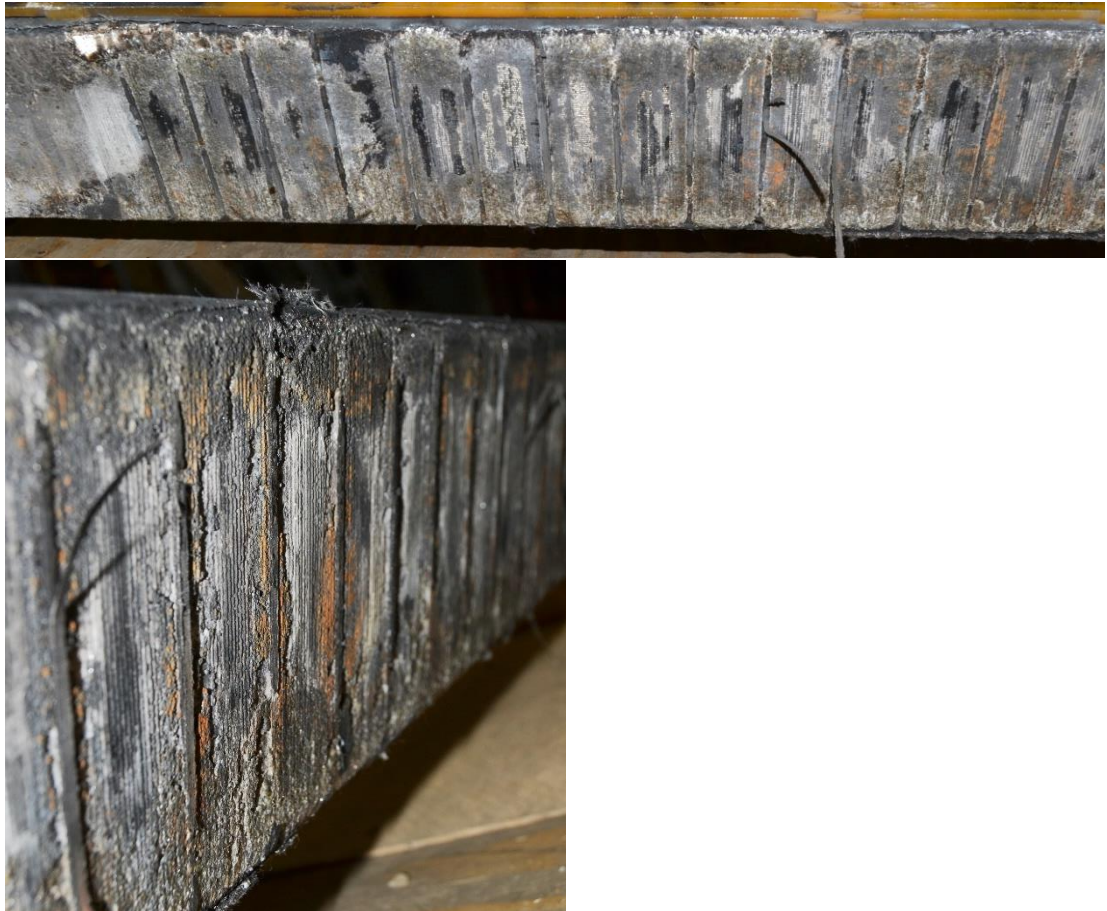
The first obvious negative consequence is the abrasion and wear of the main insulation of the vibrating bar, which can be clearly seen both in Picture 1 of Case 1 and Picture 5 of Case 2. In both cases the steel lamination of the stator core has left a distinctive pattern on the main insulation of the failed bar. In Case 2 the main damage was on the bottom of the top bar, which has been pounding on the filler strip between the bars in the slot and was finally punctured.

The generator experienced a stator winding failure in 2014, which was confirmed to be caused by puncture of the main insulation of a vibrated stator winding top bar. The generator was repaired by replacing the failed top bar and returned in operation.

Picture 1. Failed stator winding bar of Case 1. The crater-like appearance is clear sign of sparking, caused by slot discharges or more likely vibration sparking.

The failed bar location was 40 % from the line-end with some 5,5 kV voltage stress → possibly both traditional PD and some vibration sparking. The surface of the failed bar looked eroded by both mechanical wear and discharges.

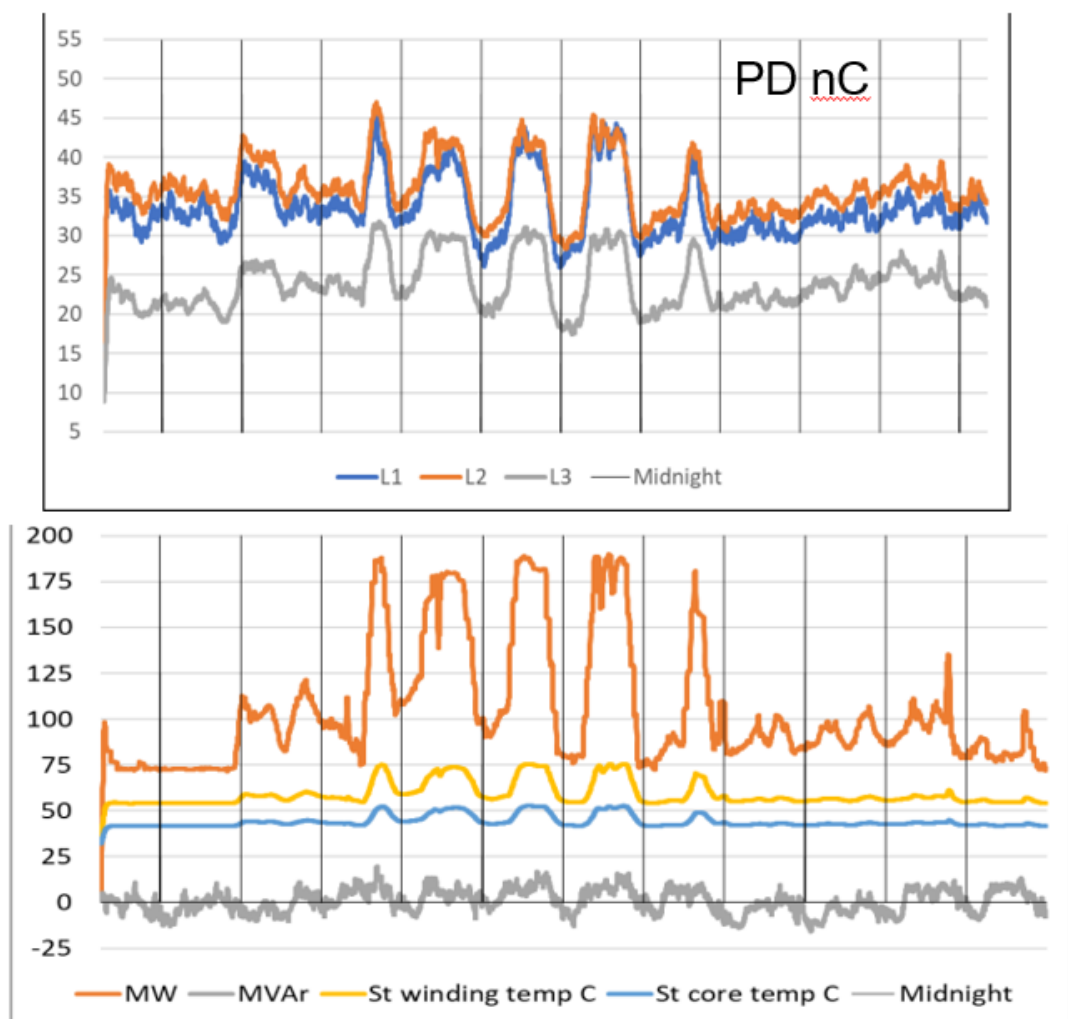
The generator of Case 1 shows clear and strong positive correlation between on-line partial discharge magnitude and the power or stator current, as shown in Picture 2.

Picture 2. Results of continuous on-line PD monitoring 2021 showing clear correlation between on-line partial discharge magnitude and the power level of the generator. The time between two vertical lines is 24 h. Measured with Omicron MPD600 system (frequency range 100-400 kHz). The signal in winding phase L3 is mainly cross-coupling.

However, the most common behavior recorded with continuous on-line PD monitoring system is the type shown in Picture 2, clear positive correlation between PD magnitude and stator current.

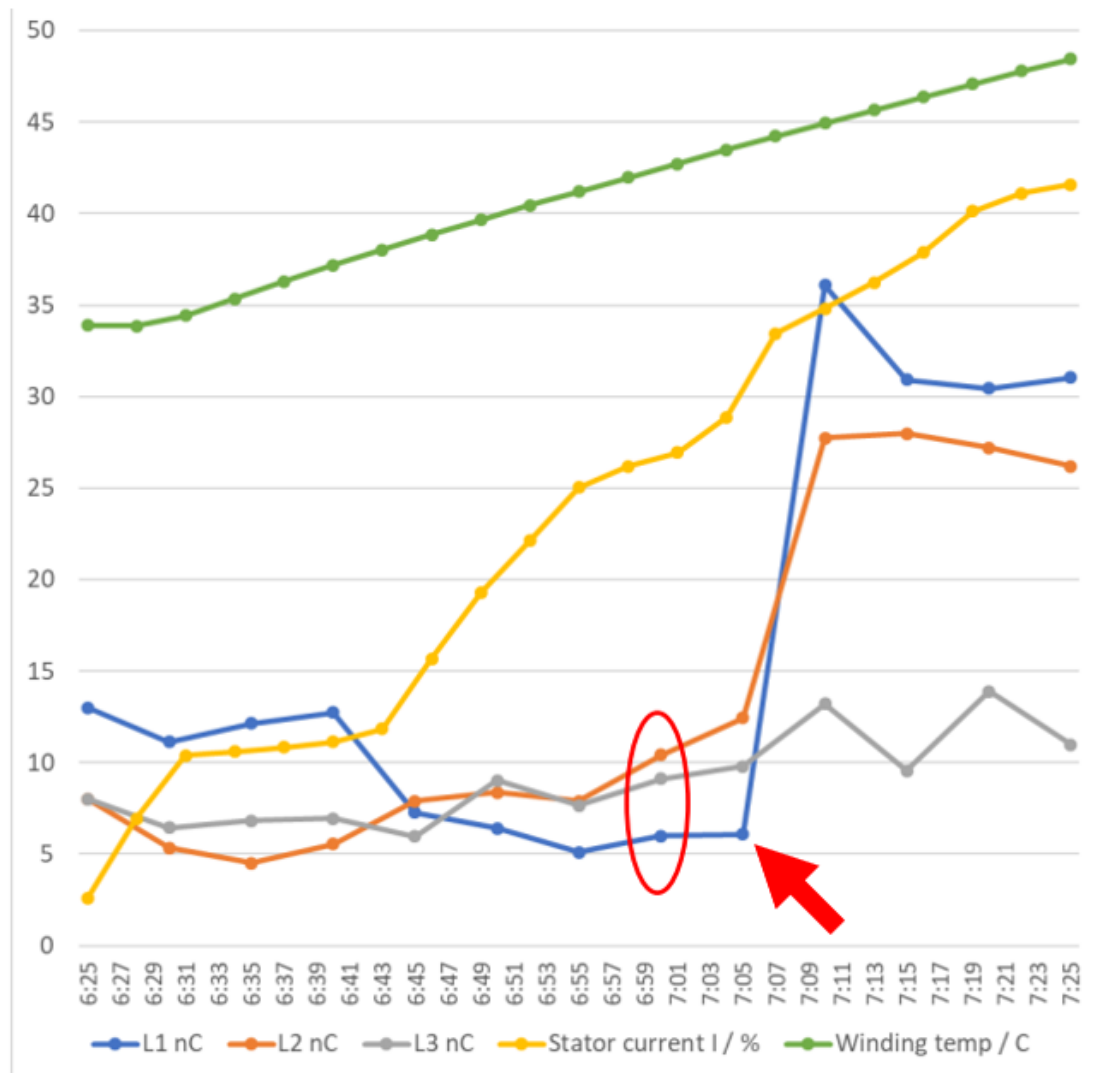
On-line PD measurement was performed also during start-up of the generator. The result in picture 3 shows a clear activation threshold of strong discharges, likely caused by bar vibration, with increased stator current. This can be explained by the fact that the forces on the winding bars causing vibration are proportional to the square of the current.

Picture 3. Results of continuous on-line PD monitoring 2021 showing the activation threshold (red arrow) of strong on-line partial discharges during start-up of the generator with increasing stator current. Measured with Omicron MPD600 system (frequency range 100-400 kHz). The signal in winding phase L3 is mainly cross-coupling. Voltage is all the time steady rated voltage and the time stamp h:min is shown on the horizontal axis.

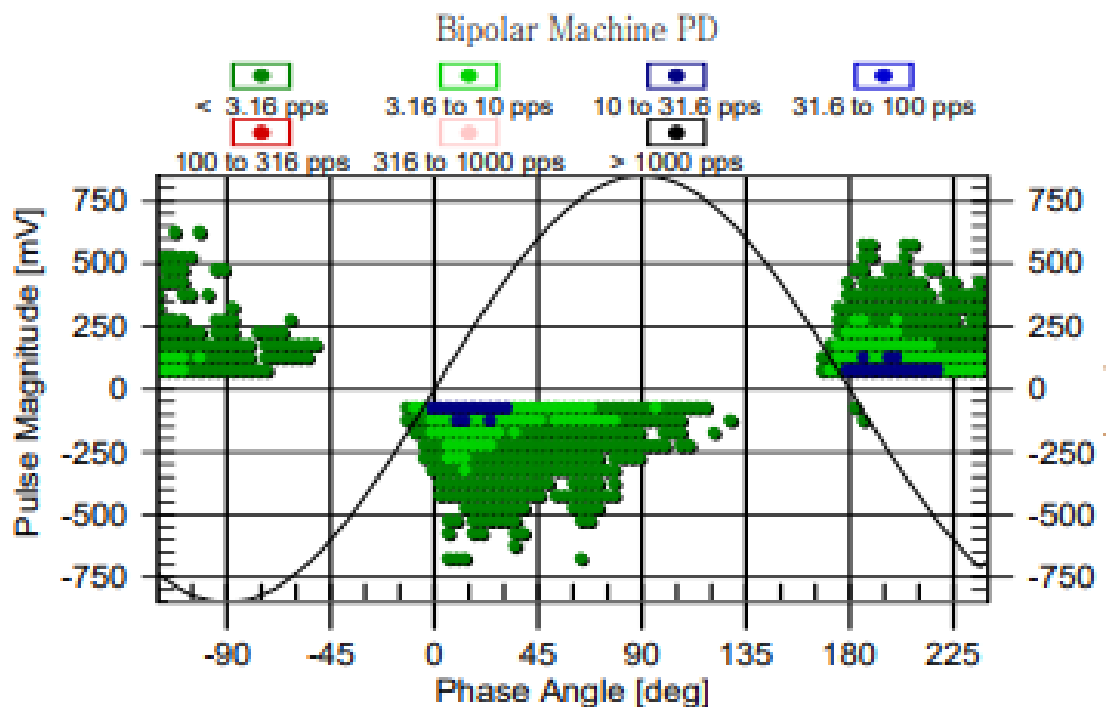
Picture 4 shows an on-line PD measurement pattern measured with Iris TGA-B system. This is measured in 2021. Unfortunately no on-line PD measurements were performed before the failure. After the failure the on-line PD magnitude has been high in all measurements, with some variation.

The result is high even at less than half the rated output power. Typical or expected pulse magnitude in machine with normal condition would be less than half of the values shown in picture 4. In Iris comparison tables $Q_m 95\% = 619$ [10].

Picture 4. Result of a single on-line PD measurement 2021 of phase L2 at power level 84 MW + 13 MVAR showing high pulse magnitude. Measured with Iris TGA-B system (frequency range 40-350 MHz).

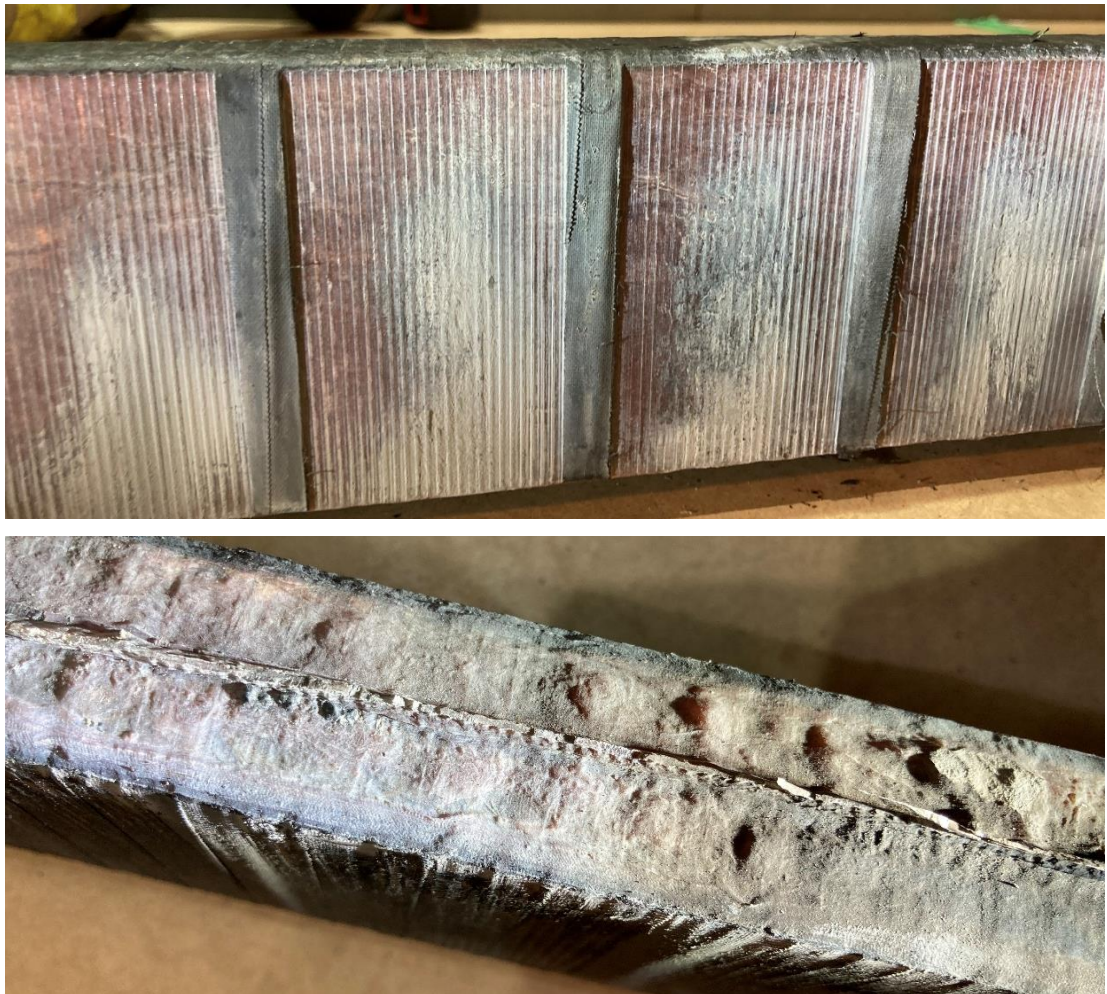
The generator of Case 2 is a 85 MVA air cooled turbo generator with rated voltage 10,5 kV manufactured in 1991. The generator experienced a stator winding failure in 2021, which was confirmed to be caused by puncture of the main insulation of a vibrated stator winding bar. It was repaired by replacing the failed top bar and returned in operation.

Picture 5. Failed bar of Case 2. Bottom of the top bar was punctured (lower picture). The line in the middle of the bottom is caused by the structure of the filler strip between top and bottom bar and is not a feature of the insulation system. No clear signs of sparking (slot discharges or vibration sparking), the erosion appears to be mechanical.

The failed bar location was 57 % from the line-end with only some 3 kV voltage stress → likely no traditional PD but possibly some vibration sparking. The surface of the failed bar looked eroded mainly by mechanical wear; no crater-like appearance typical for heavy discharges.

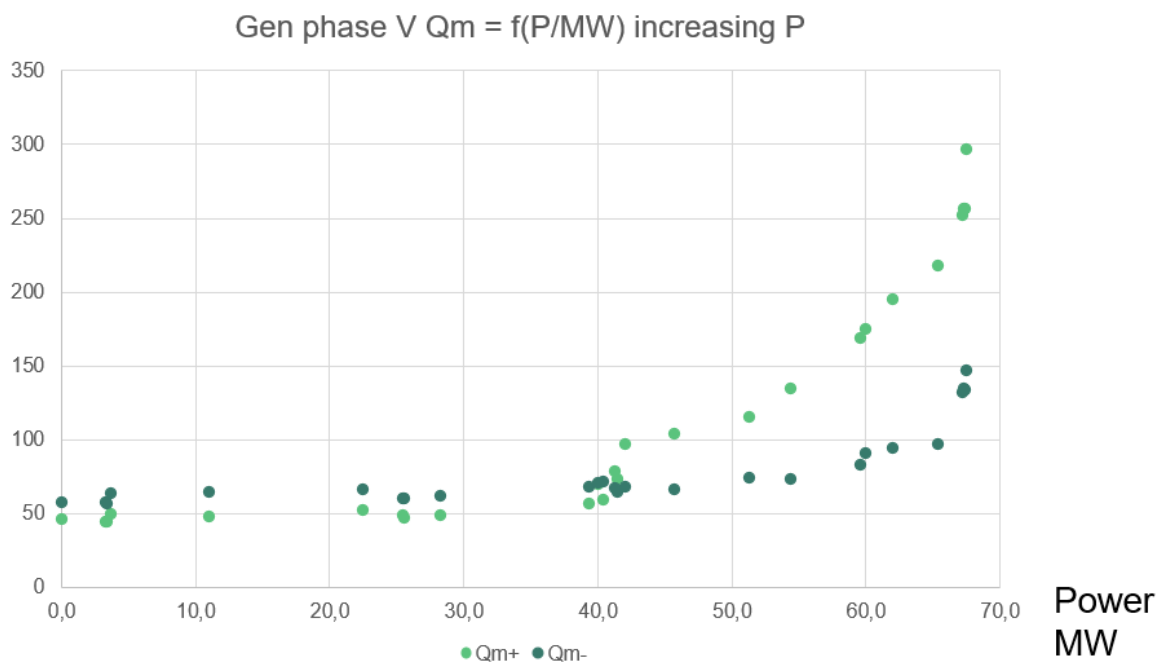
On-line partial discharge measurement was performed also during start-up of the generator. The result is shown in picture 6 and it shows a clear activation threshold of strong discharges, likely caused by bar vibration, with increased stator current. This can be explained by the fact that the forces on the winding bars causing vibration are proportional to the square of current.

Picture 6. Results on-line PD measurements in 2021 after the repair showing the activation threshold of strong on-line partial discharges during normal start-up of the generator with increasing stator current. Measured with Iris TGA-B system (frequency range 40-350 MHz). Voltage is all the time steady rated voltage. Vertical axis shows the absolute value of parameter Qm.

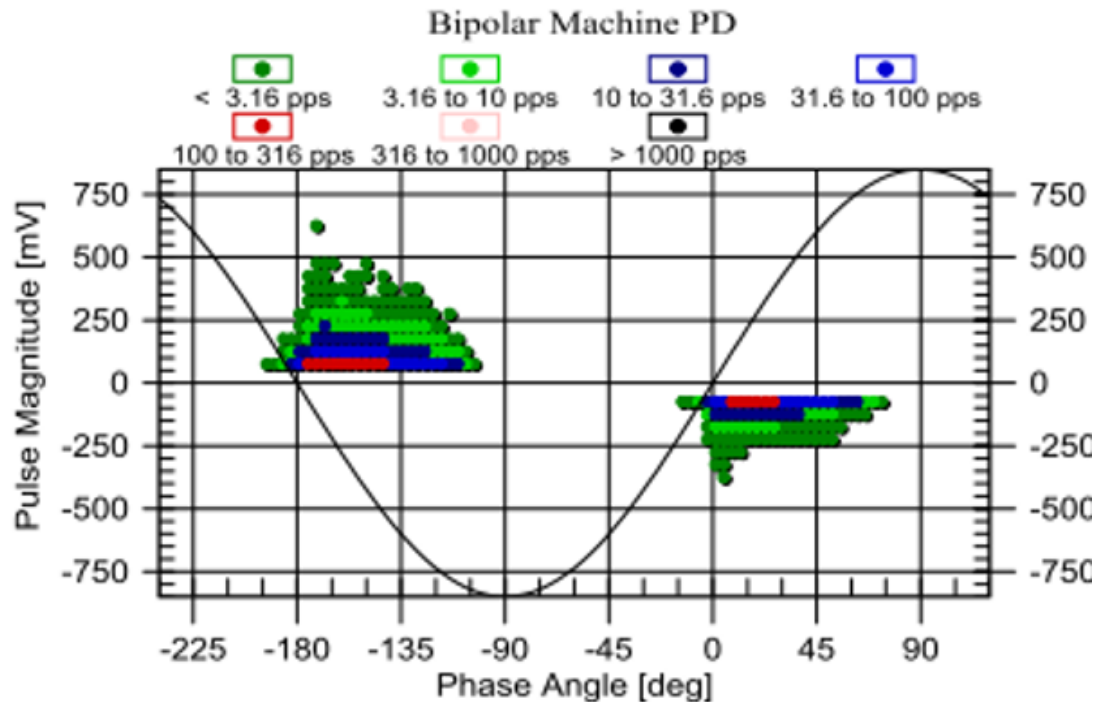
Picture 7 shows an on-line PD measurement pattern measured with Iris TGA-B system. This is measured in 2021 after the repair at appr. 90 % power level. The result is high; typical or expected pulse magnitude of a machine in normal condition would be less than half of the values shown in picture 7. In Iris comparison tables $Q_m 75\% = 196$ and $Q_m 90\% = 415$ [10].

The magnitude was clearly lower at least a year before the failure.

Picture 7. Result of a single on-line PD measurement of phase V at 90 % power level showing high pulse magnitude. Measured with Iris TGA-B system (frequency range 40-350 MHz).
