Detecting generator stator winding bar vibration with on-line PD measurements

Two case studies

TGS FINLAND OY

Osmo Koponen, 16.6.2022

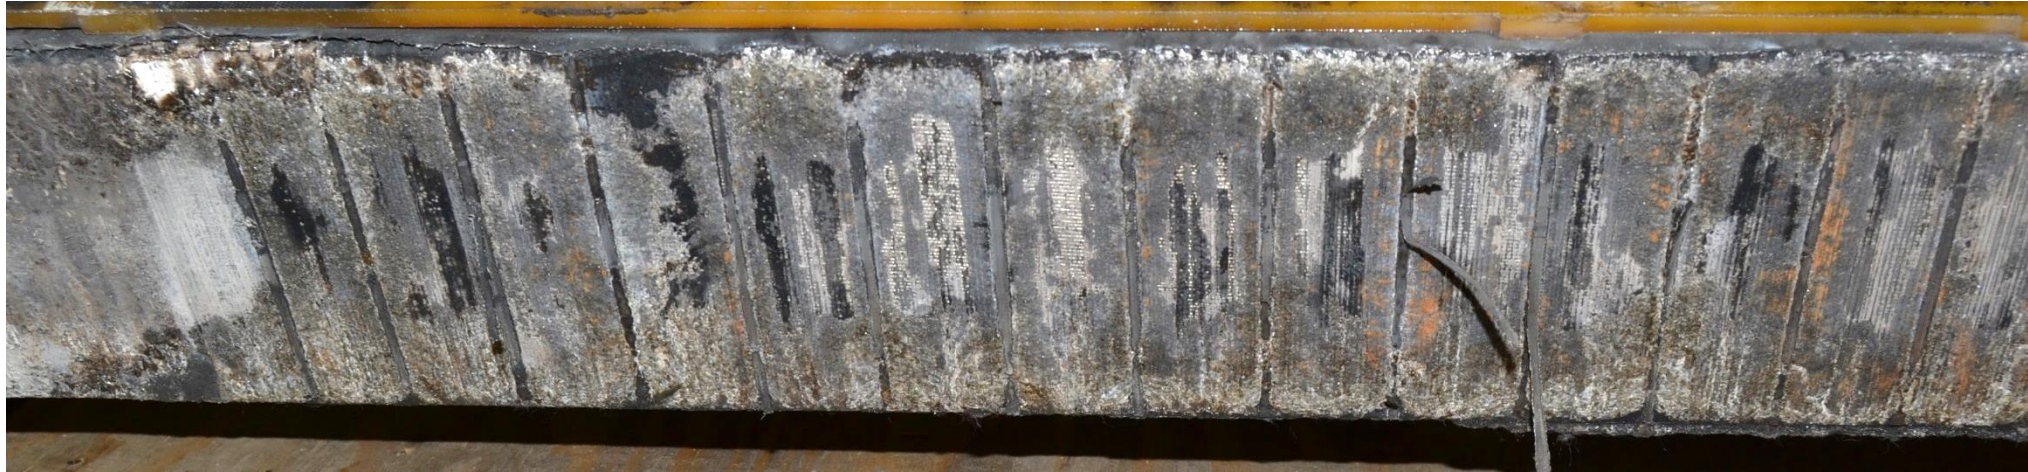
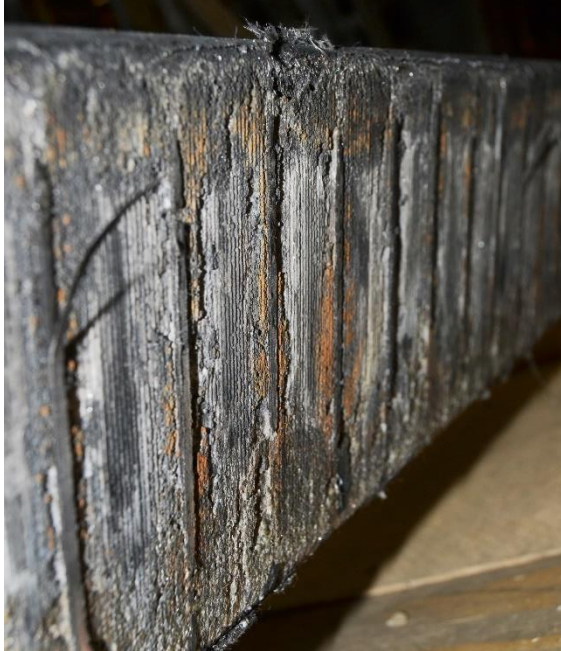
Damaged and failed bar Case 1

- Has already failed once due to a vibrating top bar but was repaired
- Demonstrates very power (or current) dependent high on-line PD level

- Case 1 failed the first time some 5 years after commissioning. Therefore it is obvious that poor design or poor manufacturing quality was a significant factor.
- In Case 1 it is likely that the vibration started soon after commissioning and aging did not play any significant role.
- The failed bar location was 40 % from the line-end with some 5,5 kV voltage stress → possibly both traditional PD and some vibration sparking. The surface of the failed bar looked eroded by both mechanical wear and discharges.
- The fit in the slot seemed to be quite loose, which may have been a contributing factor preventing proper gluing effect of the stator bars in GVPI process.
- According to the information given by the manufacturer there is also a separation layer wrapped around the bars, therefore prevention of proper gluing effect may have been also intentional.

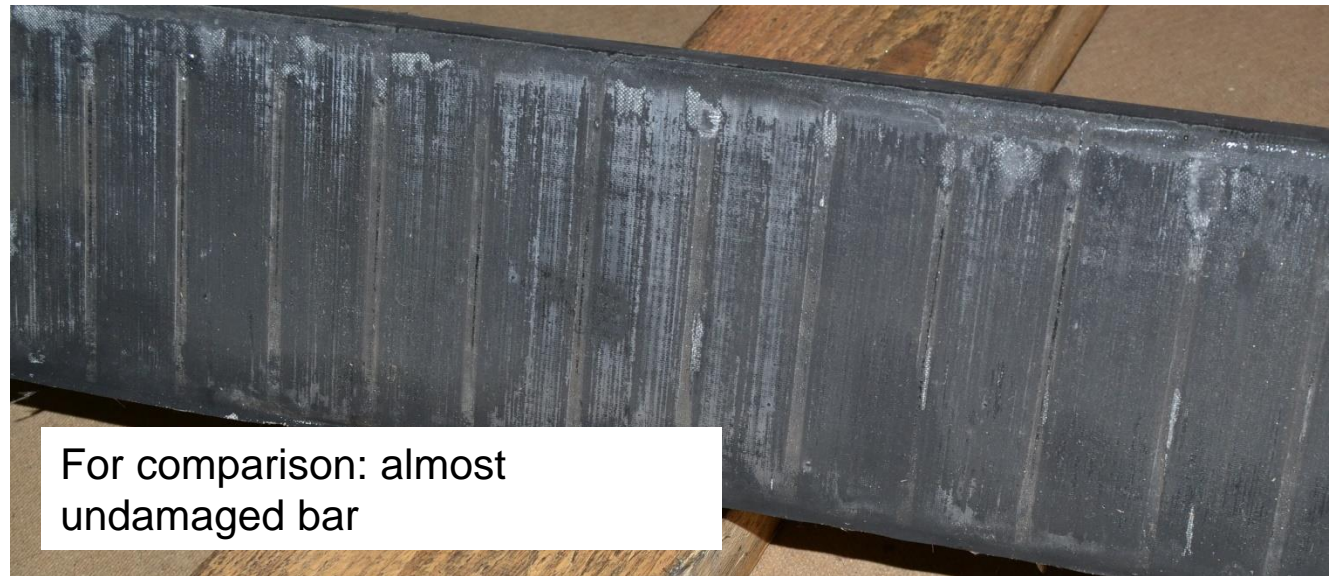
For comparison: almost undamaged bar

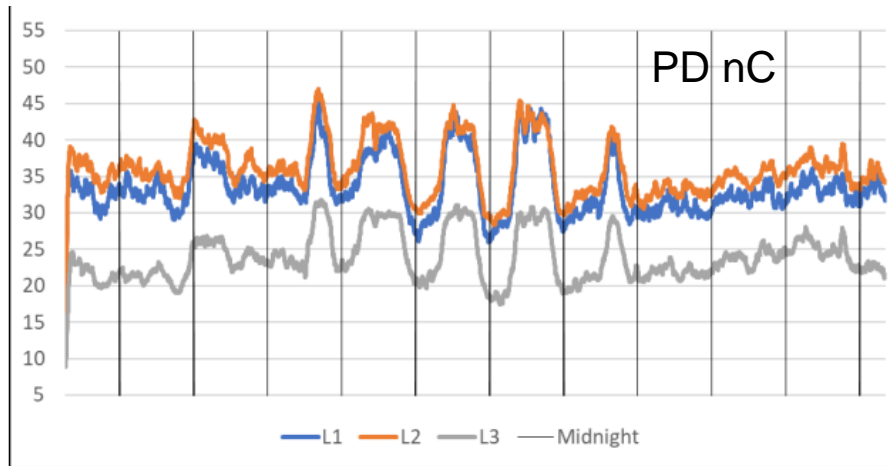
Measured with
Omicron MPD600
system

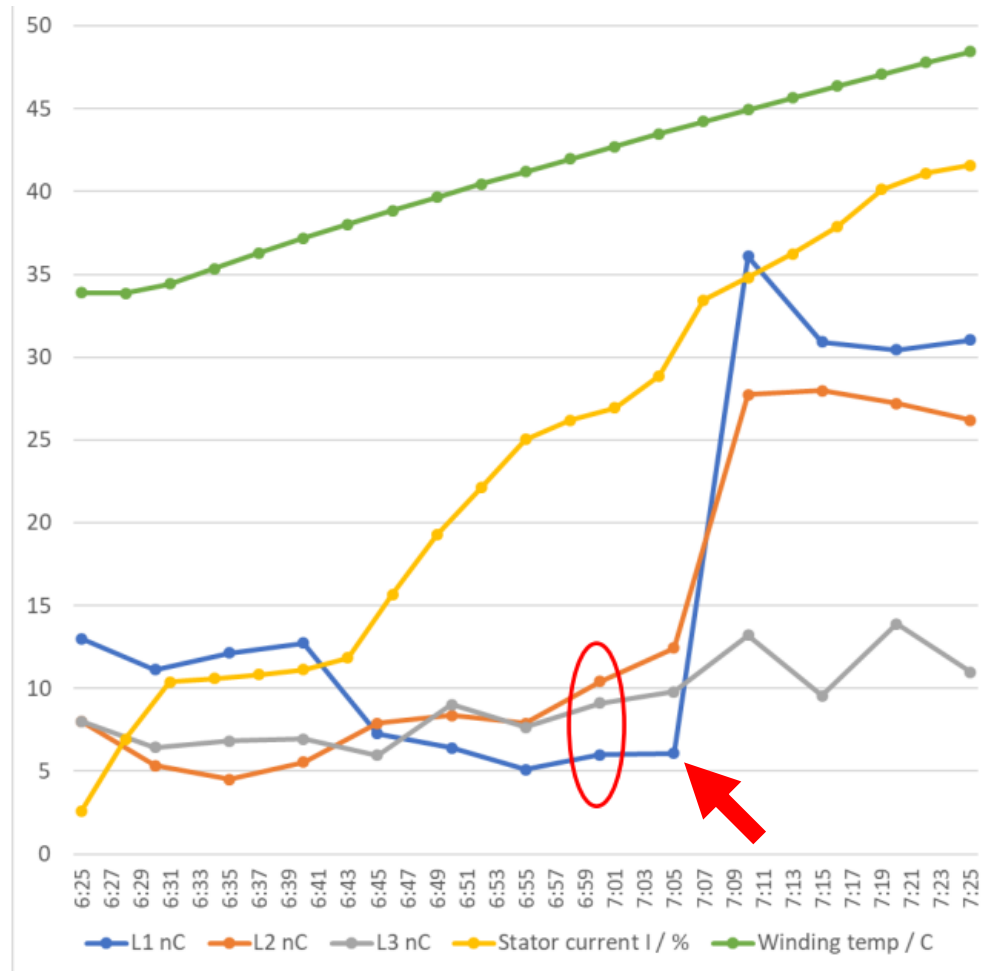
- Demonstrates a clear activation threshold in on-line PD when power increased in start-up

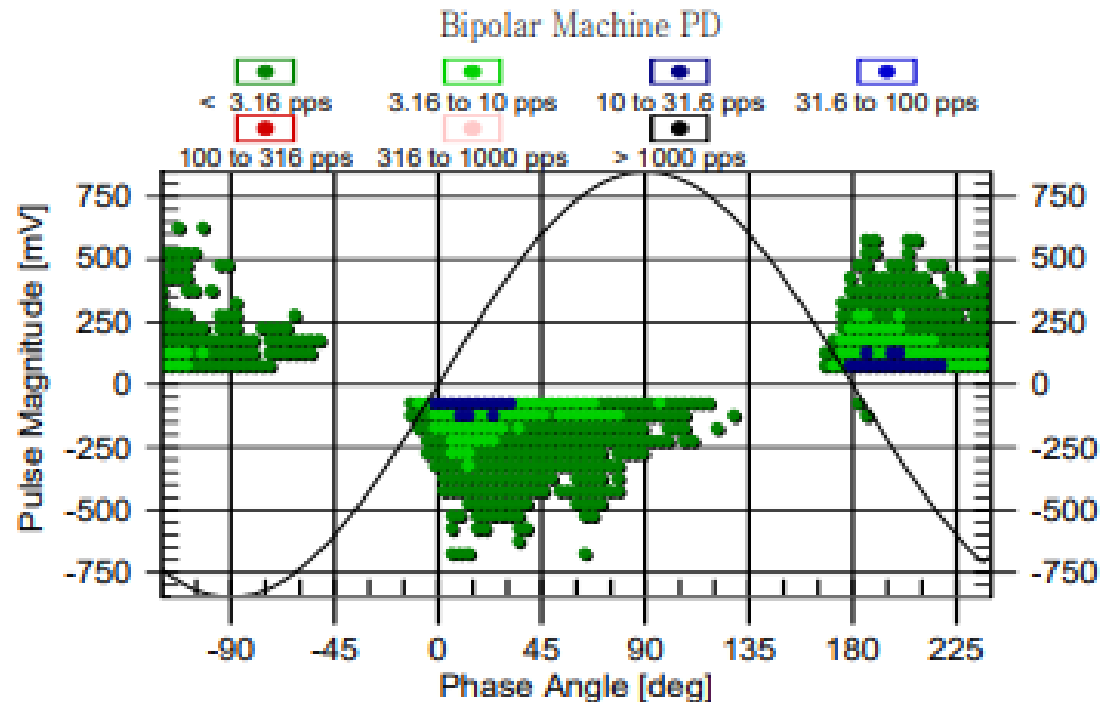
- Demonstrates now high on-line PD level (here 84 MW + 13 MVAR)
- On-line PD was not measured before the first failure

Phase: B, Sensor(s): B-M2B-S2 Delay Time: 16
Mach.: NQN+1309/-1256, Qm+662/-600 K-scale: 1.00

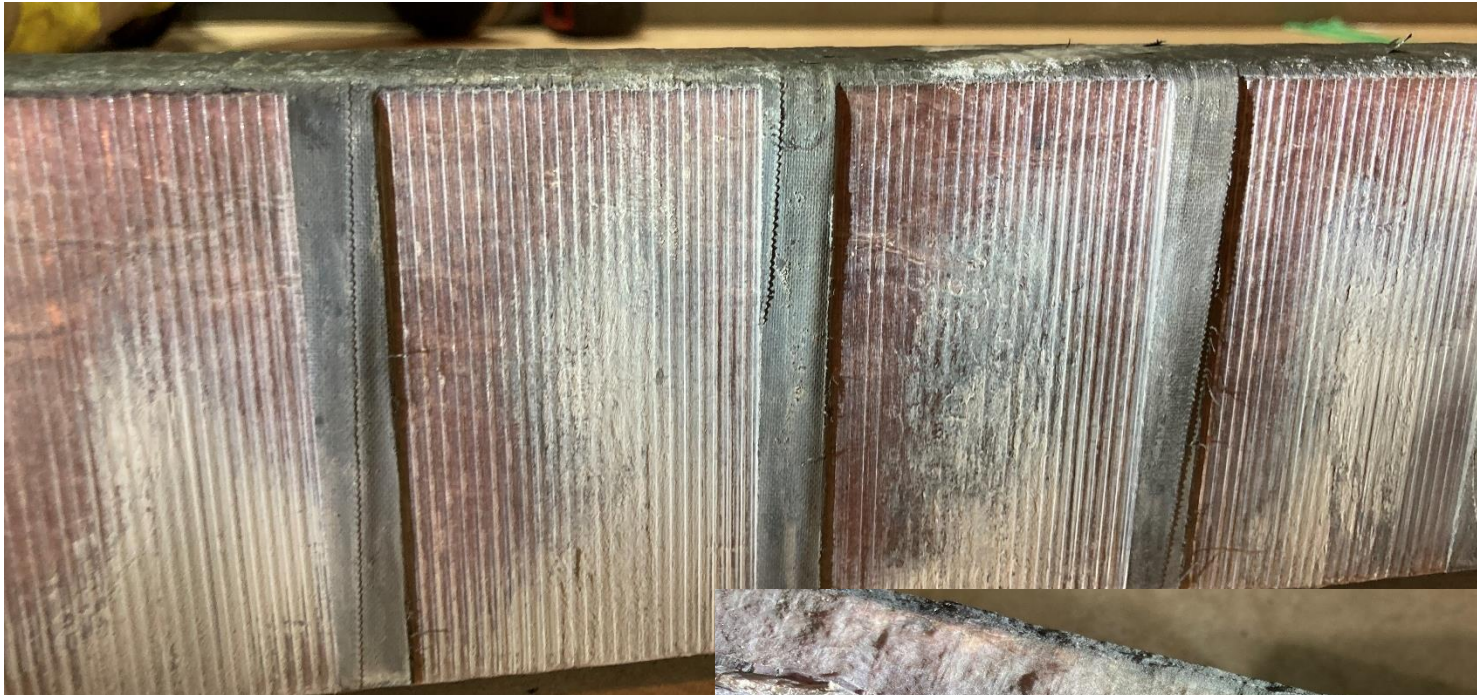
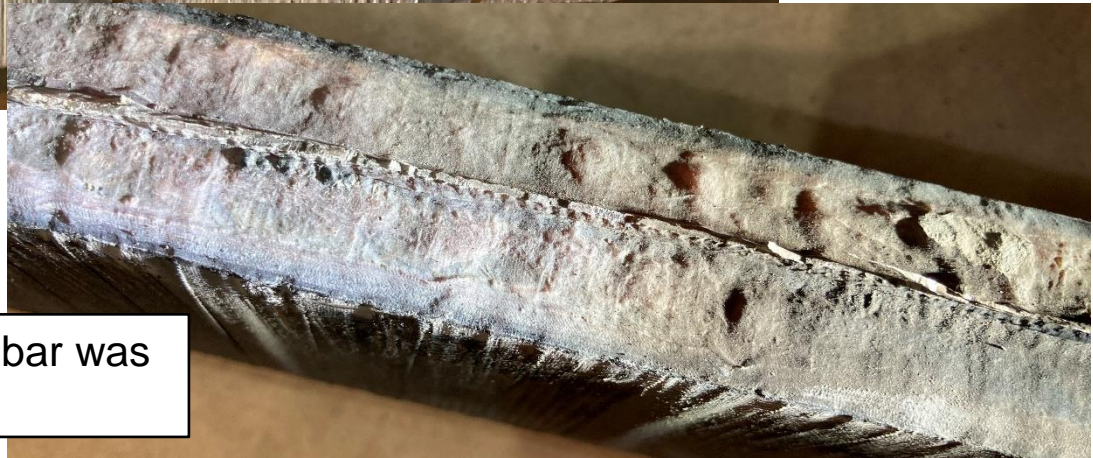
Damaged and failed bar Case 2

Bottom of the top bar was
punctured

- The failed bar location was 57 % from the line-end with only some 3 kV voltage stress → likely no traditional PD but possibly some vibration sparking. The surface of the failed bar looked eroded mainly by mechanical wear; no crater-like appearance typical for heavy discharges.

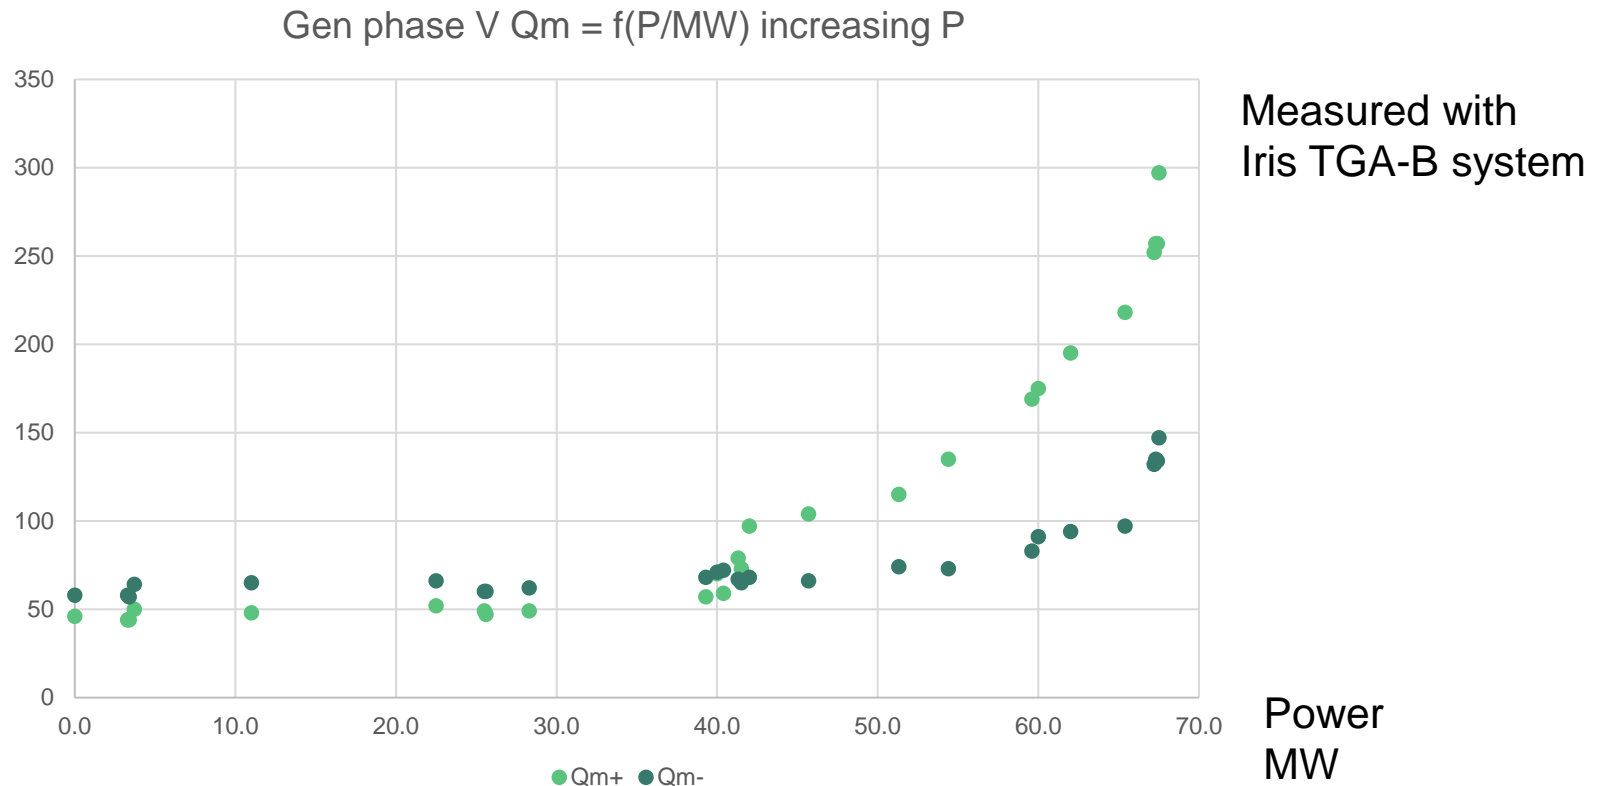
- Has already failed once due to a vibrating top bar but was repaired
- Demonstrates clear activation threshold in on-line PD when power increased in start-up

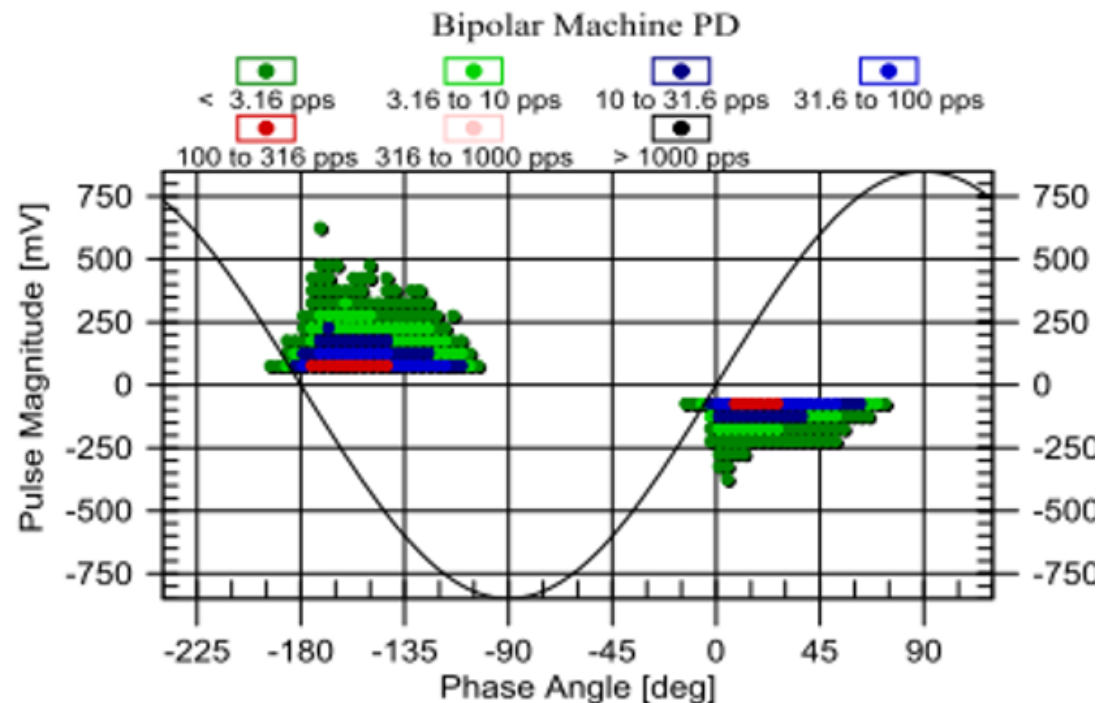
- Demonstrates now after the first failure high on-line PD level (here appr. 90 % power) and also clear dependence on output power (or current).
- Did not show significantly high on-line PD level before the first failure.

Phase: B, Sensor(s): V-M2V-S2 Delay Time: 12
Mach.: NQN+870/-502, Qm+385/-238 K-scale: 1.00
