# Hydro Generator Rotor Earth Fault

## Installation of Carbon Dust Collection System

Peter Kelly, ESB Ireland

25<sup>th</sup> IRMC – Iris Rotating Machine Conference Houston, TX, June 26-29, 2003

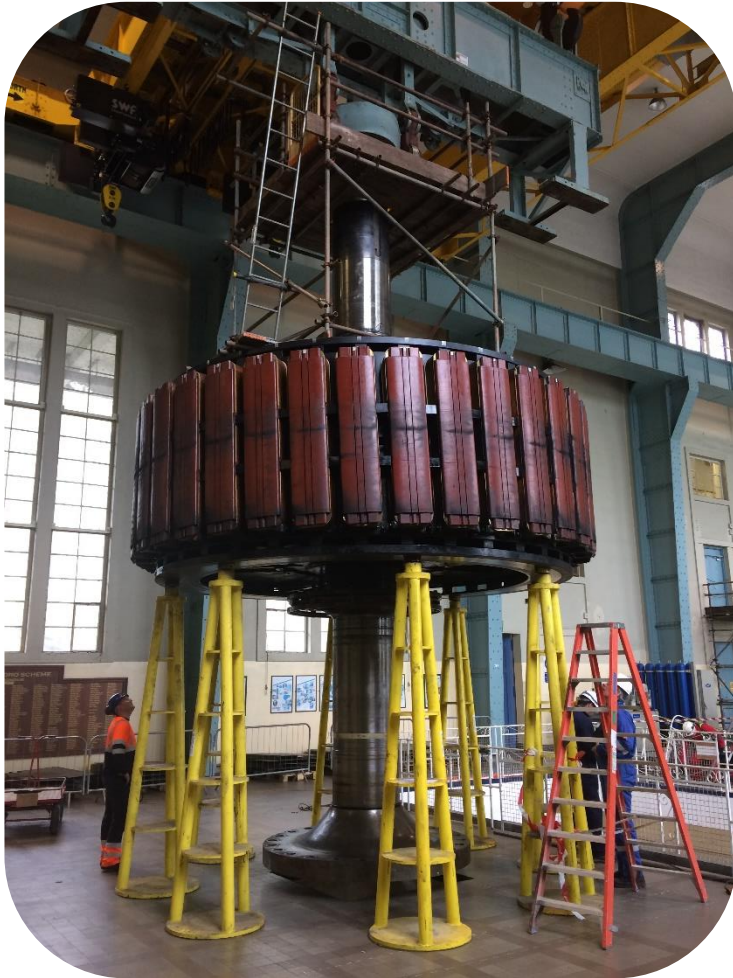
Extracted Rotor

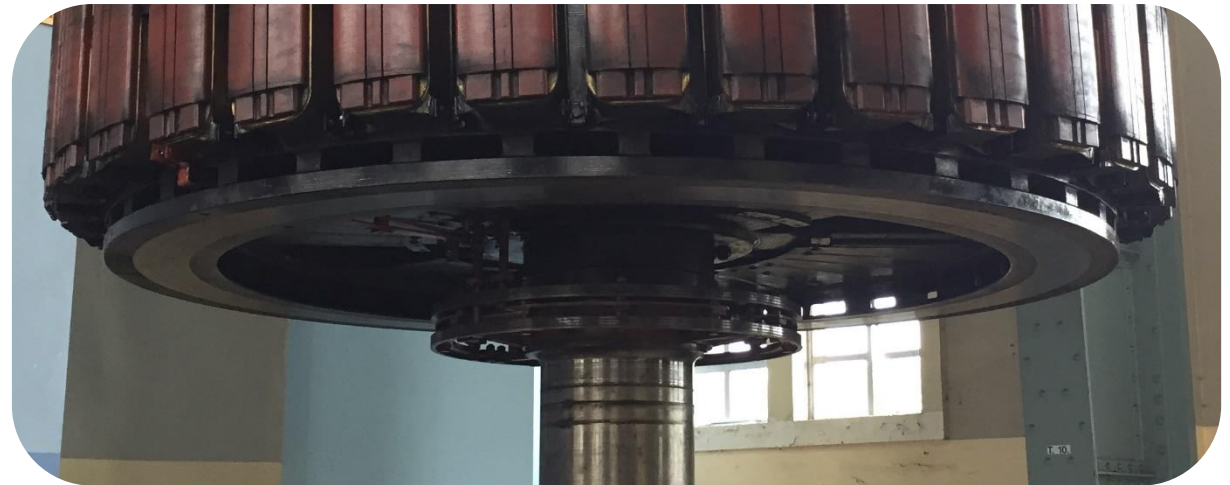
Slip rings located beneath generator rotor.  
Rotor cooling fans located at top and bottom.

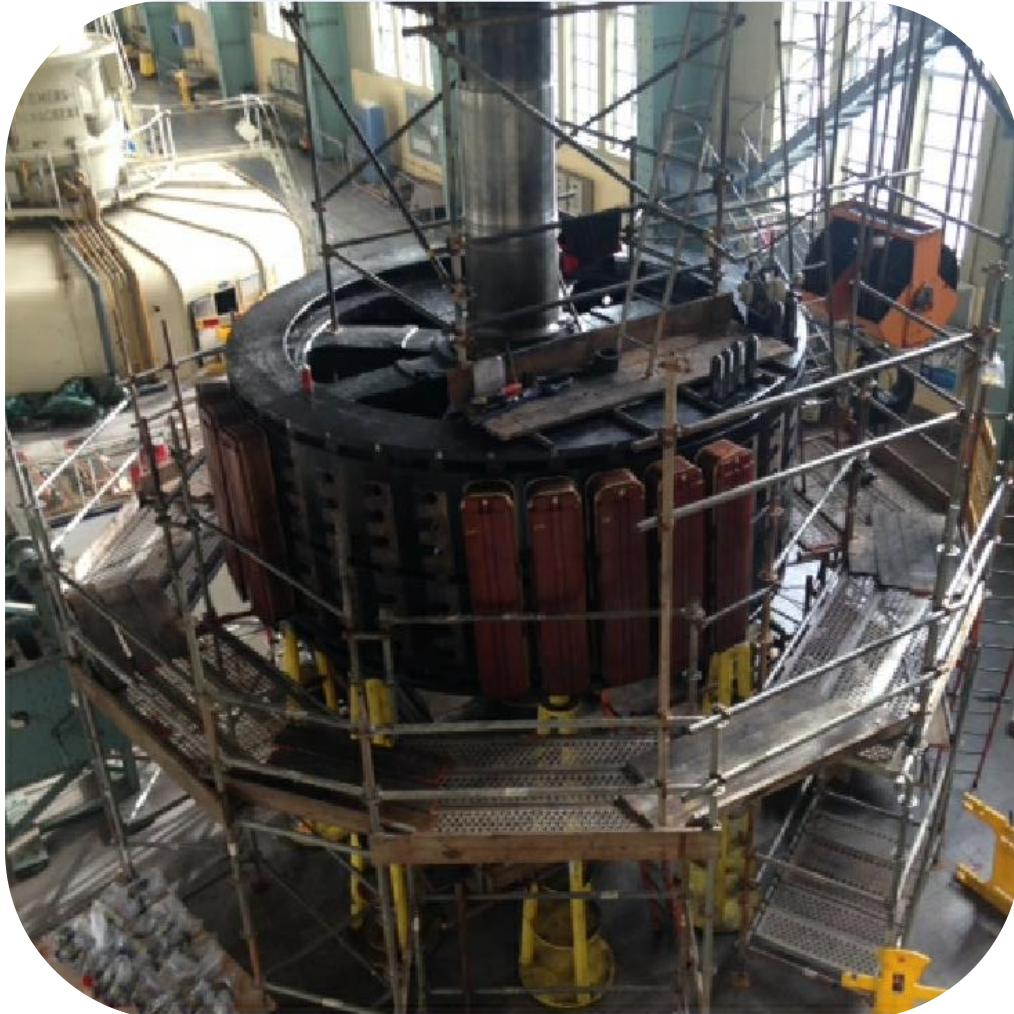
Rotor Poles Disassembly – 36 Poles

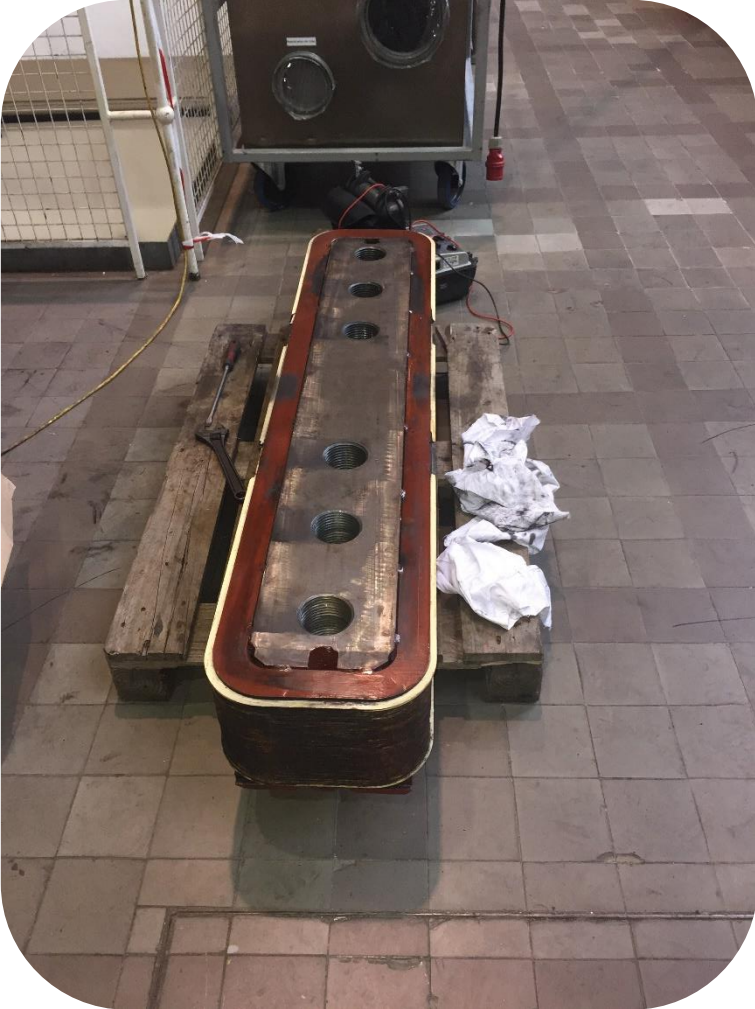
Rotor Pole

- Significant carbon dust and oil deposits on the poles
  - Pole windings
  - Pole shoe
  - Pole shims
  - Rotor rim
- Due to the carbon dust built up, tracking paths to ground
- Contamination found on the inner radius of the rotor pole windings
  - No filler, silicon, RTV etc. inserted to prevent debris between pole winding and shoe
  - This was found to be the root cause of the rotor earth faults
  - Once cleaned, IR values were measured in the MΩ range

Vacuum based system that extracts the airborne carbon dust out of the machine, thus preventing future short circuits caused by low insulation between rotor coils and ground.

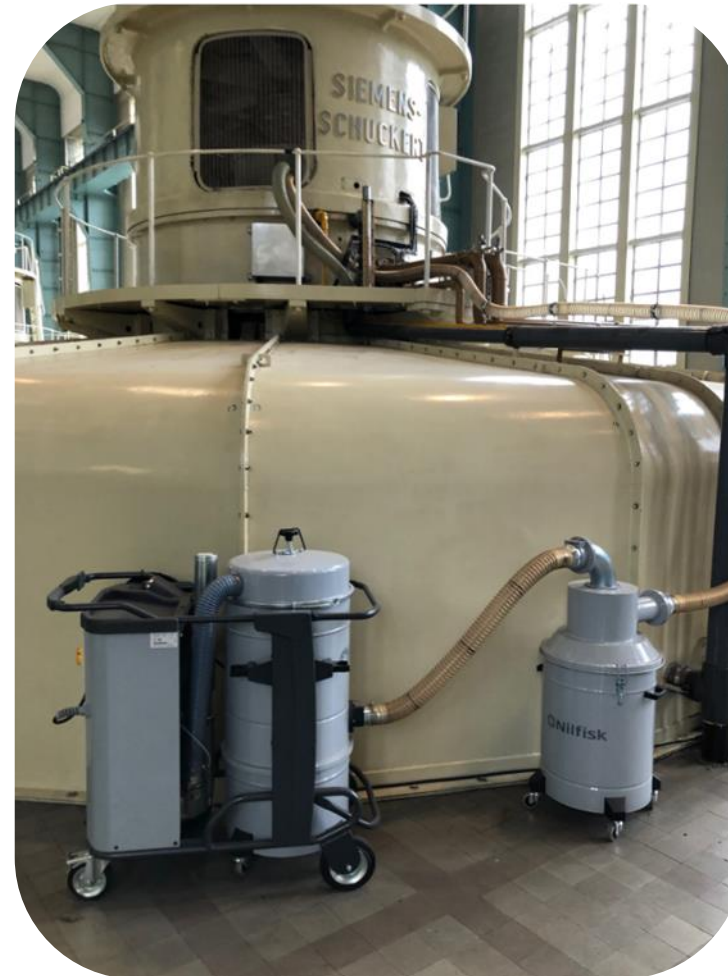
MERSEN DustCollector AA4

REF reading of  $>999M\Omega$  during operation.

Subsequent visual inspections and electrical testing noted that the machine is “clean” and the testing results indicate that the rotor winding is in a healthy state with no issues of contamination.

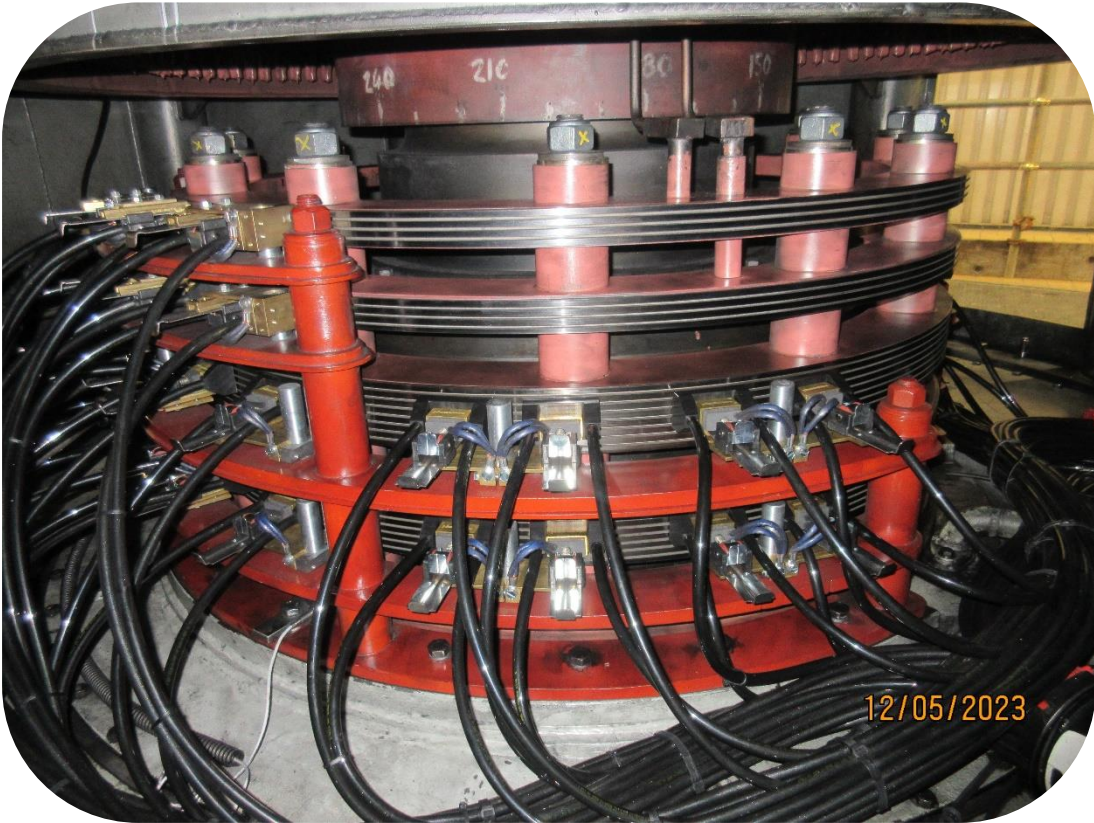
- Turlough Hill Unit 2 suffered from an issue relating to the oil mist separator and build up of carbon dust within the brushgear compartment.
- The Unit required cleaning every 3-4 months, as REF alarms were being received. This resulted in the unit coming offline for approximately 4 hours every 3-4 months.
- Following the installation of the MERSEN DustCollector this unit was inspected 6 months after installation and little to no carbon dust was evident in the brushgear compartment – therefore the unit shall run to each planned annual inspection without intermediate brushgear cleaning outages.
- This is a significant saving for ESB, and maintains the Turlough Hill Units available for dispatch for the Irish Transmission System Operator.

ESB Turlough Hill Installation
