Overhaul and repair management of a strategic generator in Western Australia

May 2022

Generator Overview

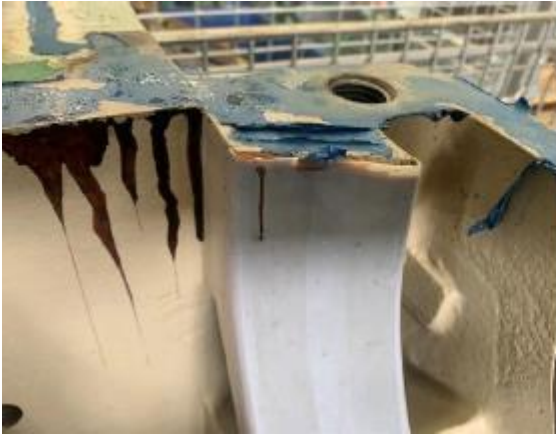
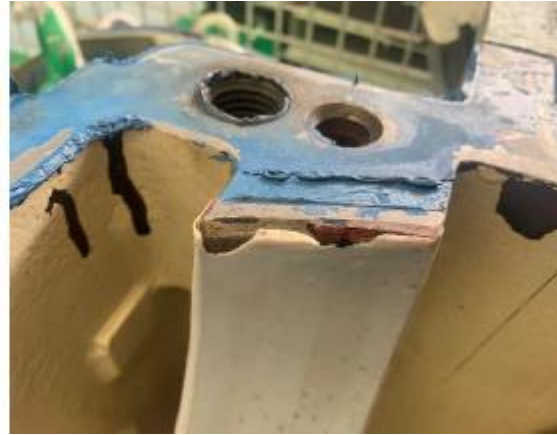
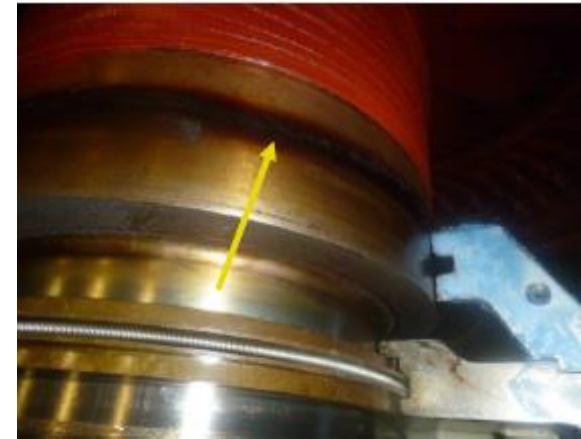
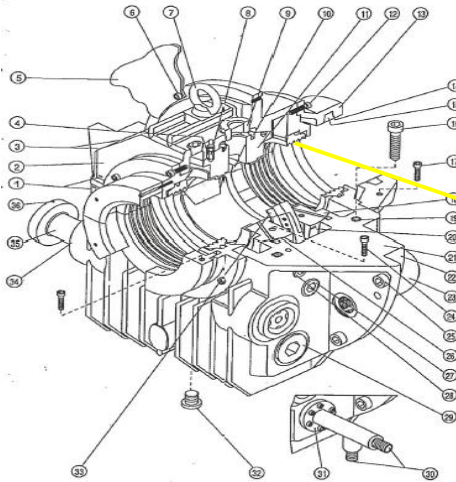
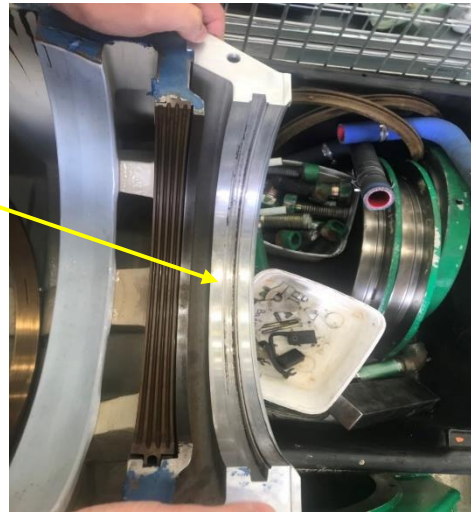
Repair Assessment - Bearing

Insulated liner on DE bearing was found damage.

Missing hemp packing to create a pressure differential to stop oil migration from bearing to the machine chamber

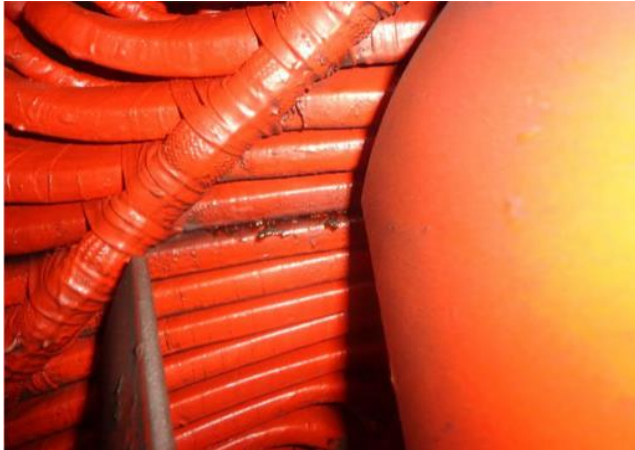
Moderate dirt contamination between two different phase coils on the stator endwinding, causing endwinding discharge.

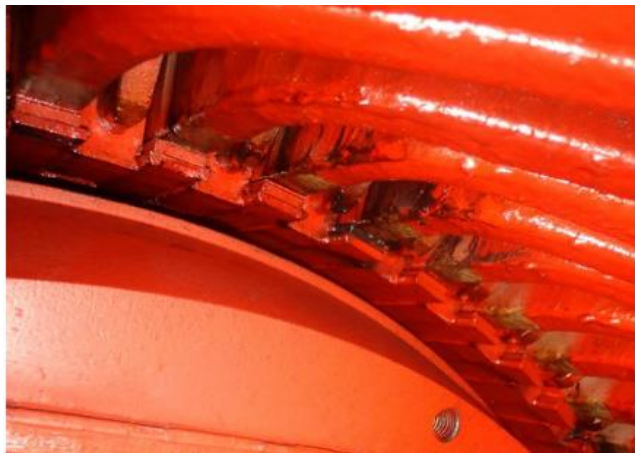
Grease build up near stress grading junction (creating arcing, resulting on discolouration).
Vaseline looks like black substance was also an indicator of loose wedges.

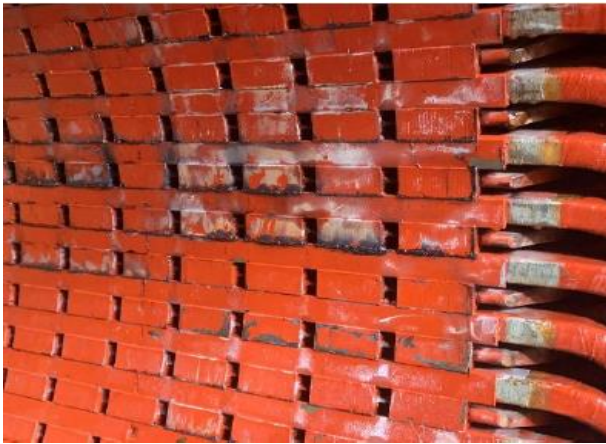
Dirt and grease contamination on the surface of stator wedges and inside the radial ventilation duct.
Greasing was identified at the slot exits where wedges were found loose, broken and missing.

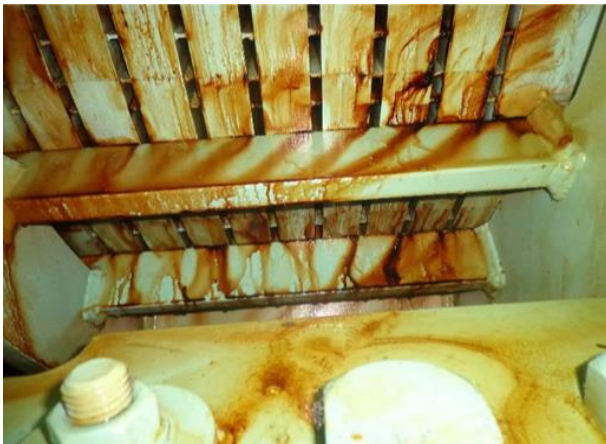
Oil stains dripping from the back iron core and on the keybars.
Oil pooling at the bottom of stator housing.

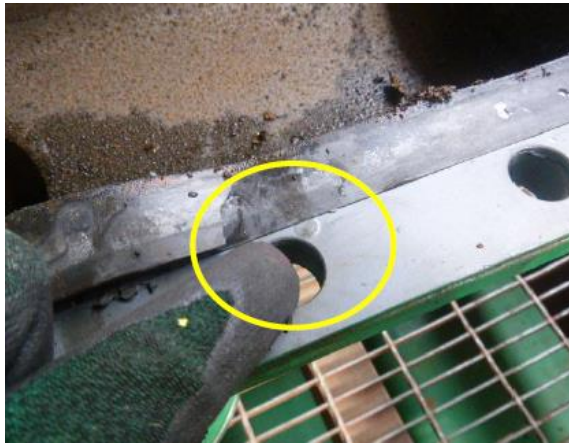
Compressed gasket causing leakage.
New gasket was installed during the
overhaul.

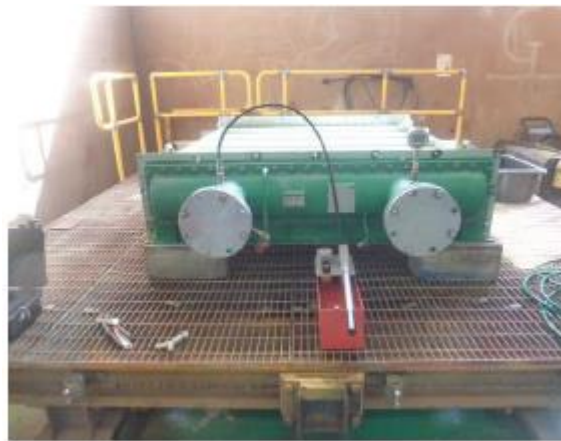
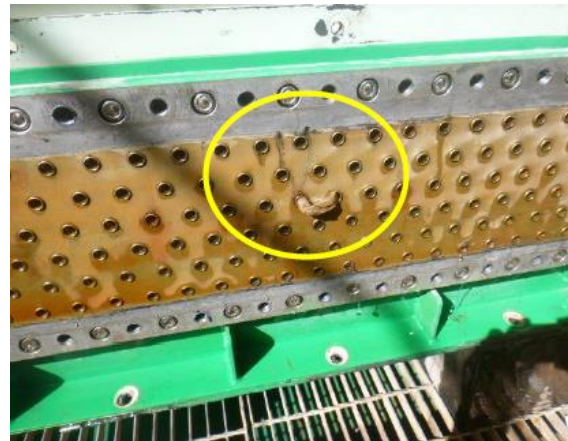
Tubes were partially blocked with plastic
bags and foreign materials.
All tubes were water pressure tested and
cleaned.

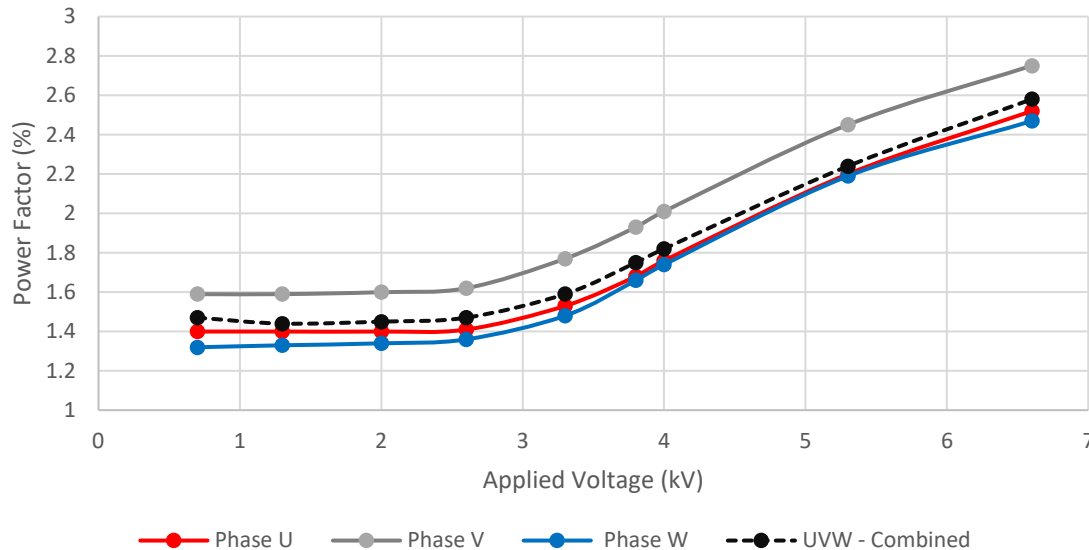
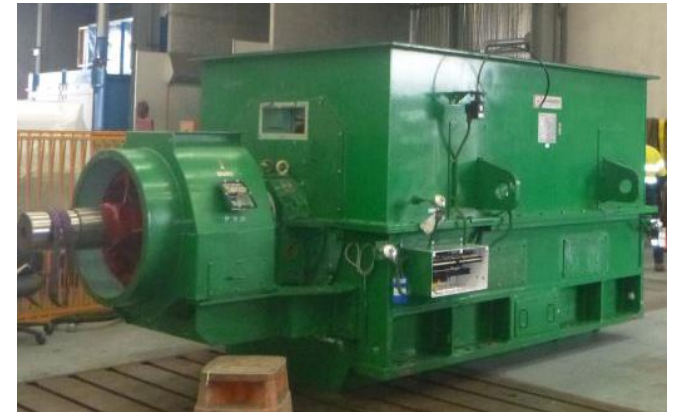
Power Factor Vs Applied Voltage

The test was conducted as stated in IEEE286 power factor and tip-up were improved.

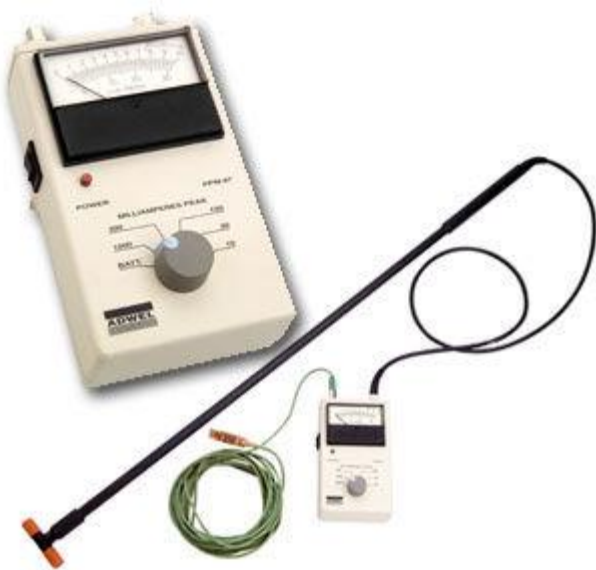
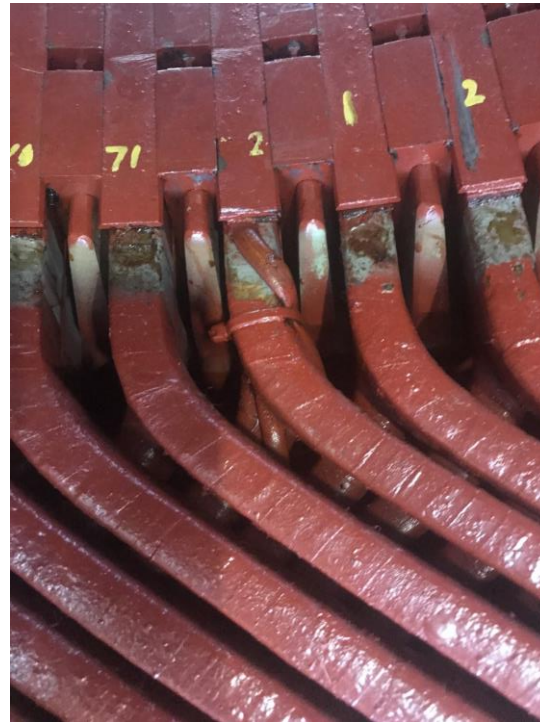
- Stator Corona Probe (TVA Probe) Test

Each slot was scanned with the PPM-97 Corona Probe. Most of the slots were qualified as having low readings at 5-10mA. The average reading was 11mA with 4 slots had areas measured up to 45mA. The maximum reading recorded was 90mA at slot 43.

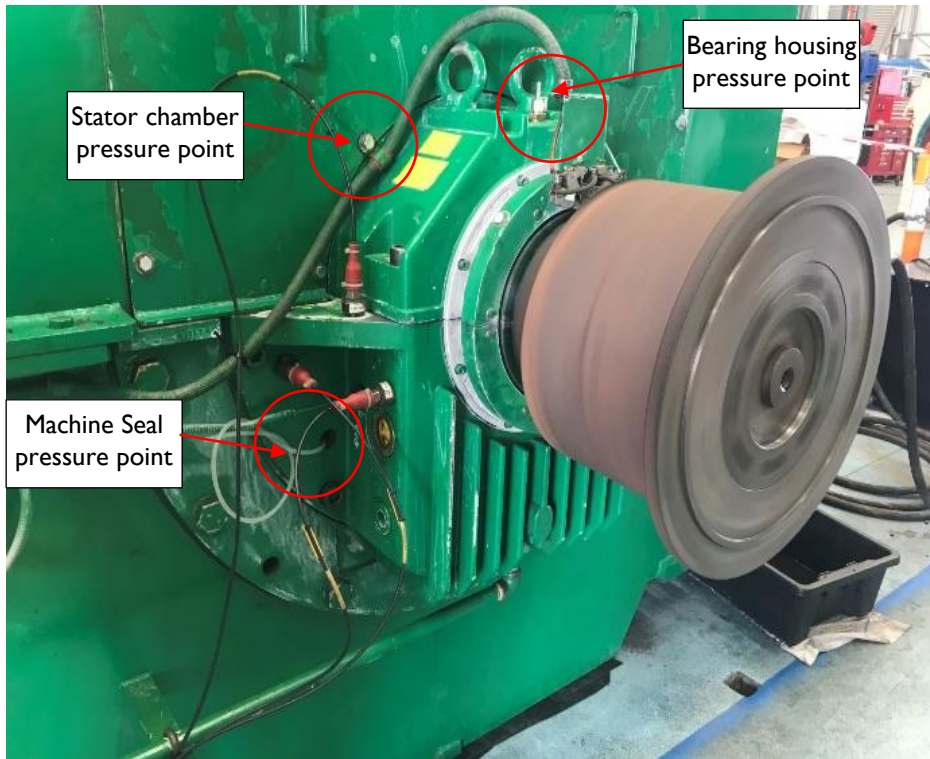
3 pressure point to record the differential pressure while machine was running to qualify the sealing.

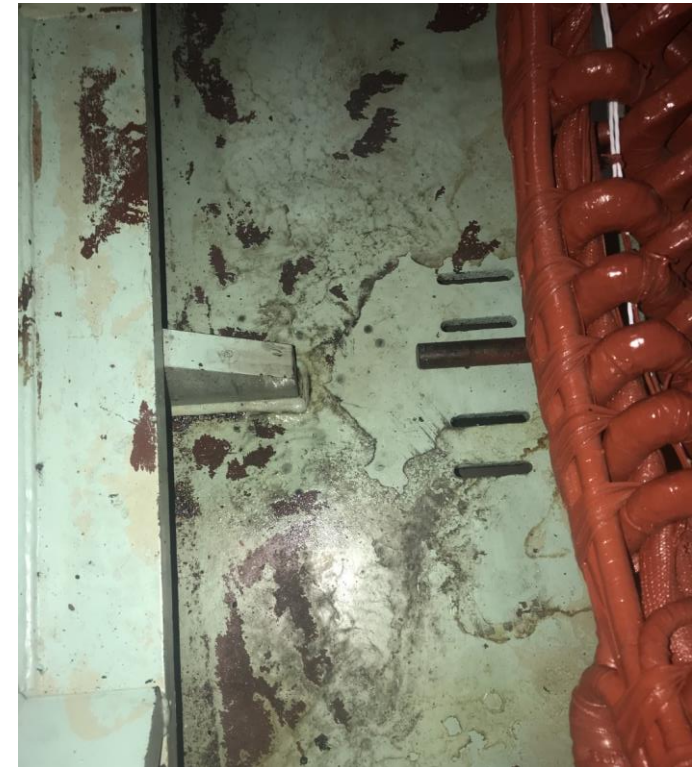
No oil leakage or migration identified inside the housing

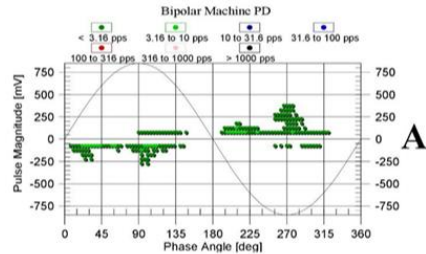
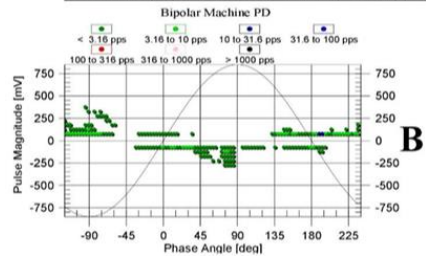
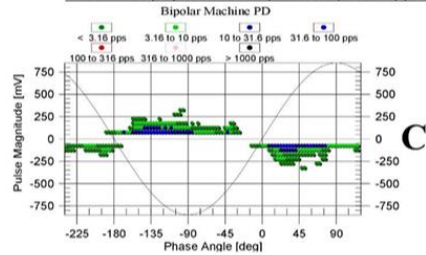
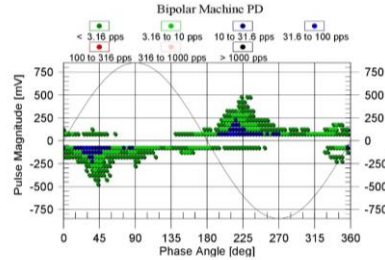
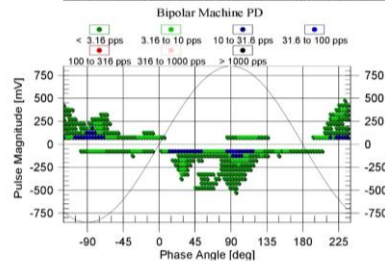
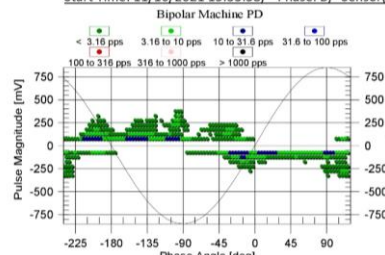
During the PD assessment, the partial discharge activity after the overhaul was improved and found relatively lower on the original line side of the stator windings.
