Overhaul and repair management of a strategic generator at a chemical works in Western Australia

Shinko 6970kW 7600kVA 6.6kV 831A 50HZ 4P 1500RPM 0.80PF Pilot excitation 60V 7.2A

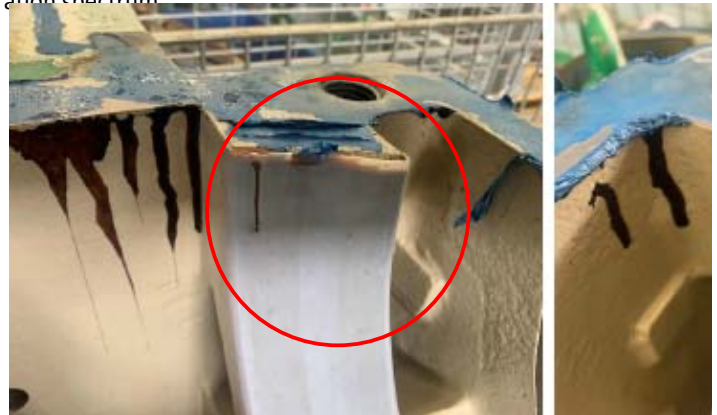
Oil staining on the bearing seal on both sides of the shaft was evident

SINFONIA (earlier known as SHINKO, OEM) was involved to provide the bearing machine seal installation instruction and drawing, to rectify the oil ingress into the bearing.

The assembly of the machine seal and shaft seal was completed per the OEM instructions. The instructions included aligning both halves of the labyrinth seal and including a hemp packing material on the inside groove of the machine seal and the torque values for the fasteners, pressure equalizing hoses were fitted across the labyrinth seal between the machine side seal chamber and bearing sump. New RENK centre flange-mounted bearings were fitted to replace the original bearings.

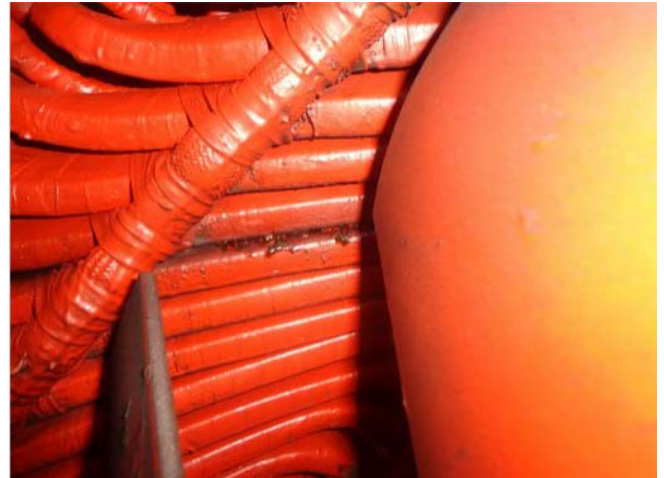
Item 15 from bearing diagram below shows the hemp packing used to provide sealing between the stator chamber and the bearing inner labyrinth seal which is identified as required by the OEM.

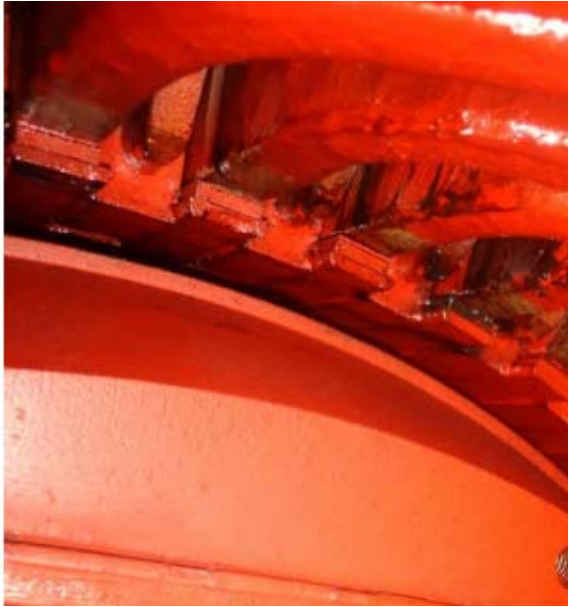
Grease was built-up on stress-grading area at the slot exit. Discolouration was noted at stress-grading junction on stator coils, few centimetres away from slot exits with, indications of corona discharge to stator tooth. The same discolouration was also found on the stator coils at the slot exits onto the core tooth supports at both ends of the stator core.

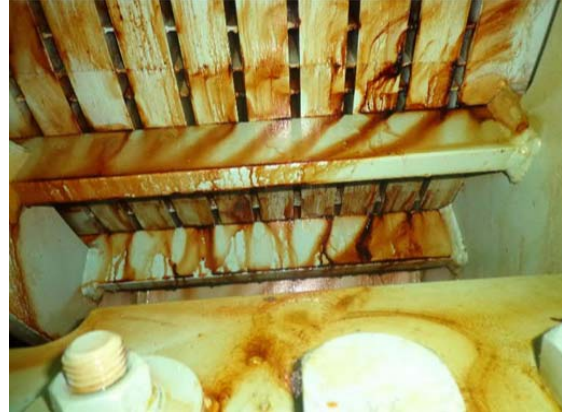
Oil Strains on the stator core and inside the slots were found dripping from the back iron and on the keybars. A pool of oil ingress was evident at the bottom surface of stator chamber.

Greasing was identified at the slot exits in the areas where loose stator wedges were identified.

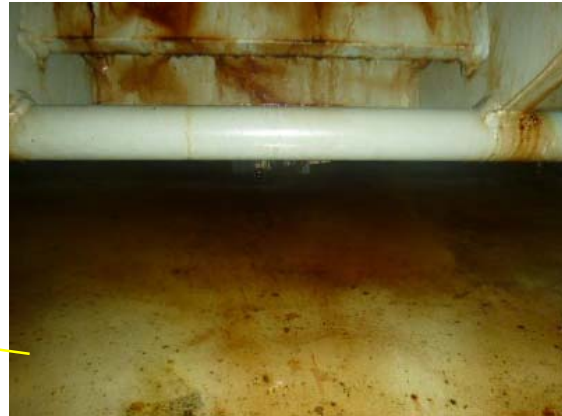
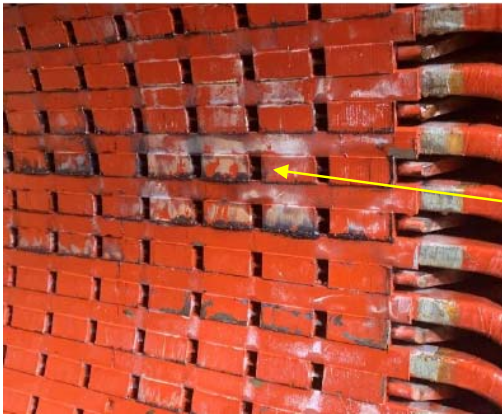
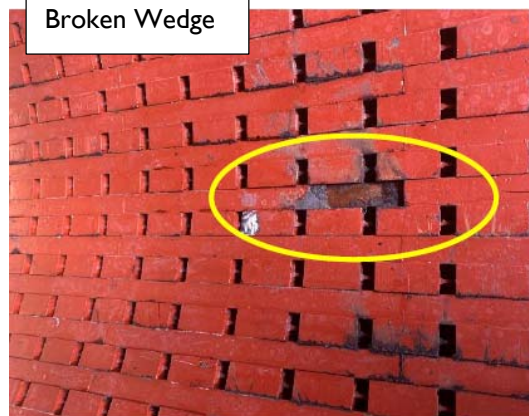
Dirt and grease contamination was found on the surface of stator wedges and within the stator core radial ventilation ducts. 3 slots were identified loosely wedged and some stator wedges were found to be missing.

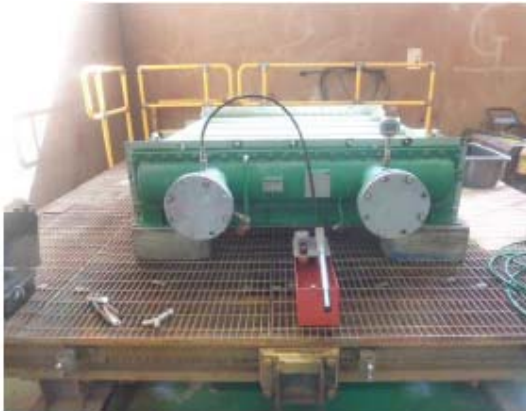
The heat exchanger was pressure tested and slight leakage was identified from the compressed gasket and drain valves. During the testing, some tubes were found partially blocked with plastic bags and foreign material.

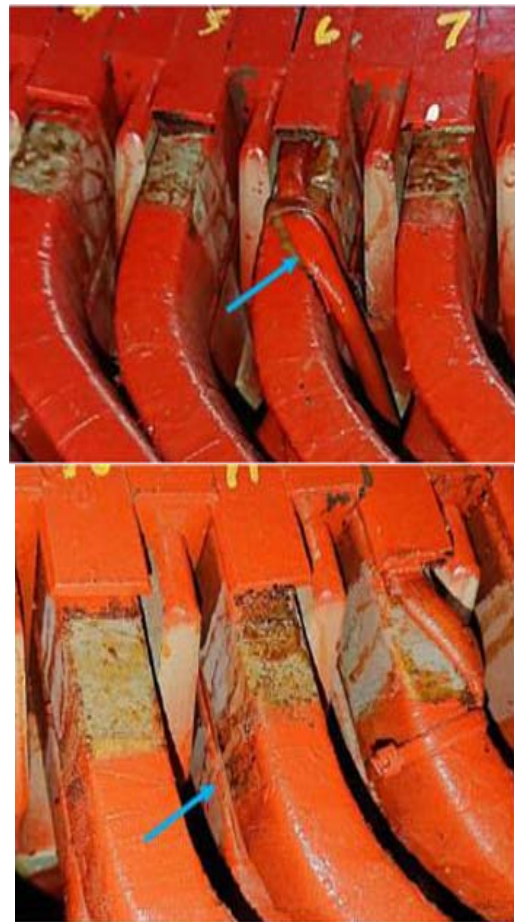
Non-classic PD activity, gap type discharge at the grading interface was identified during the offline PD testing.

An ultrasonic audibled discharge test was performed to validate the local surface PD activity around the endwinding region at 3.8kV. Headphones were used to locate the audible PD. Minor to moderate level of PD activity was confirmed at the slot exit at both connection end (CE) and non-connection end (NCE) of the stator winding. A moderate to high level of PD was recorded where the RTD cable were brought out of the slots across the stress grading region on the coils. Displaced centre packers between top and bottom coil sides were identified as compromising the stress grading on the non-connection end of the winding.

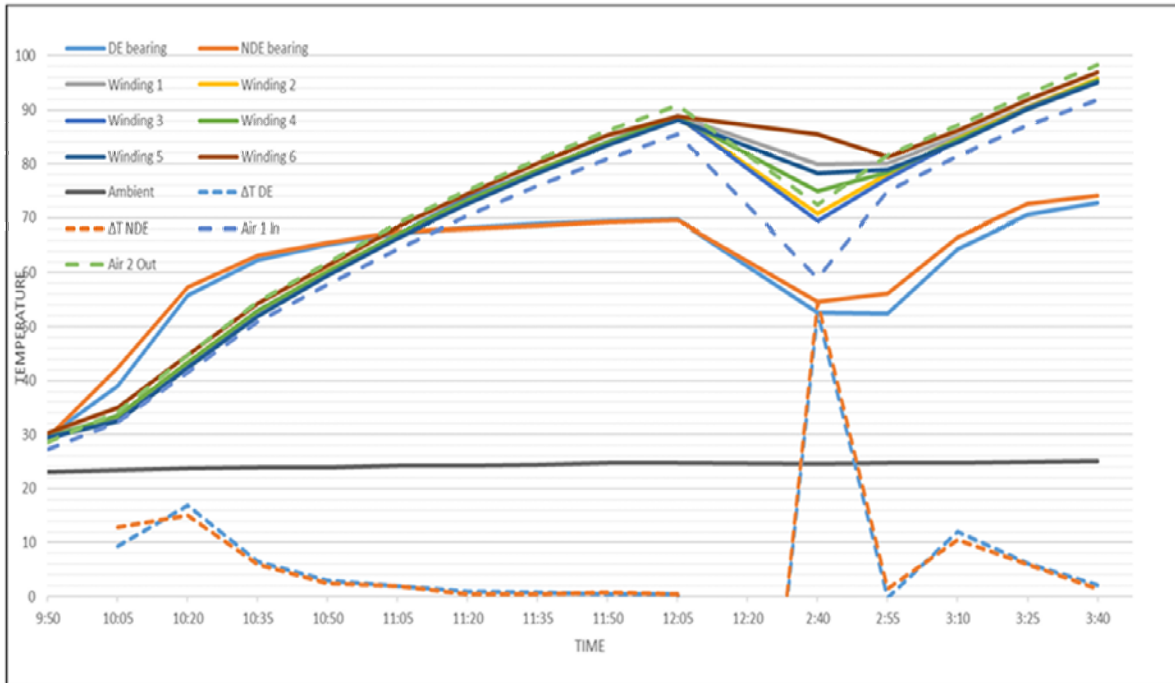
Run test results as a motor showing absorbed power, Volts, Amps, vibration, internal air bearing and winding temperatures

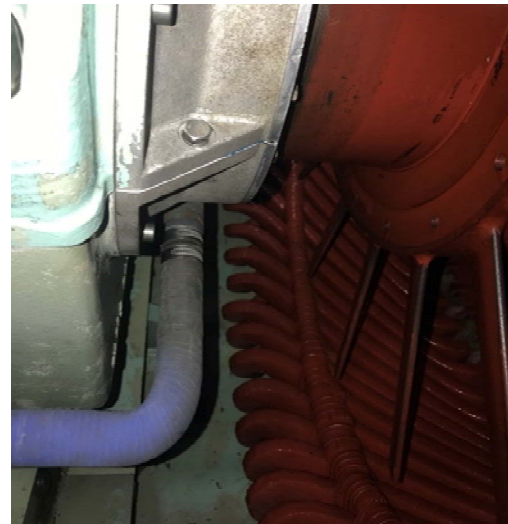
A fluke 922 Air Flow Meter was used to record the air pressure in the bearing housing, machine seal and stator chamber at both ends of the machine. The purpose of this test was to prove the effectiveness of the hemp sealing at the bearing housing to the stator winding chamber.
