IRMC 2023
The 25th Iris Rotating Machine
Conference

Partial Discharge Levels Before and After Partial Stator Winding Refurbishment in PSHPP Velebit

PSHPP Velebit

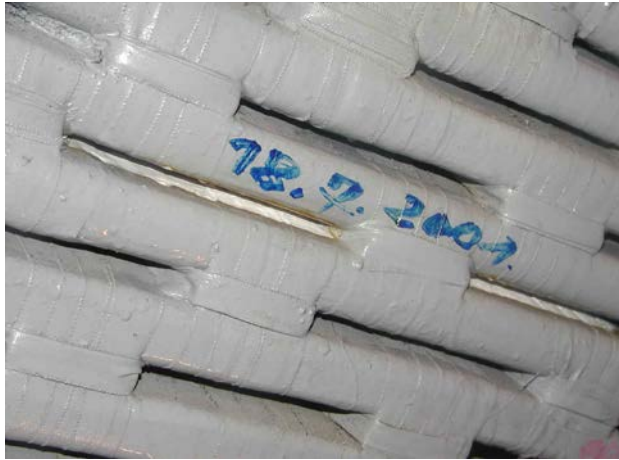
PD in end-winding (corona)

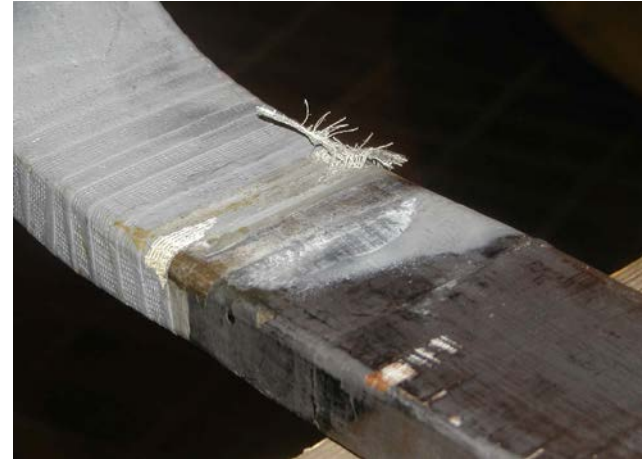
PD on semi-conducting and gradient coating connection (coating deterioration)

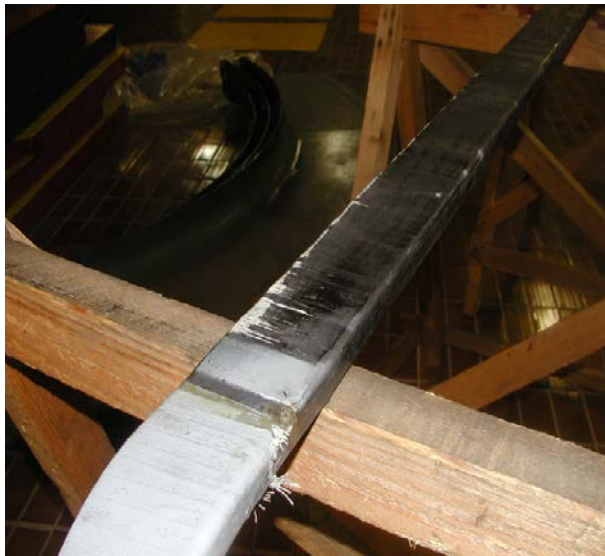
PD on interface semi-conducting and gradient coating (coating deterioration)

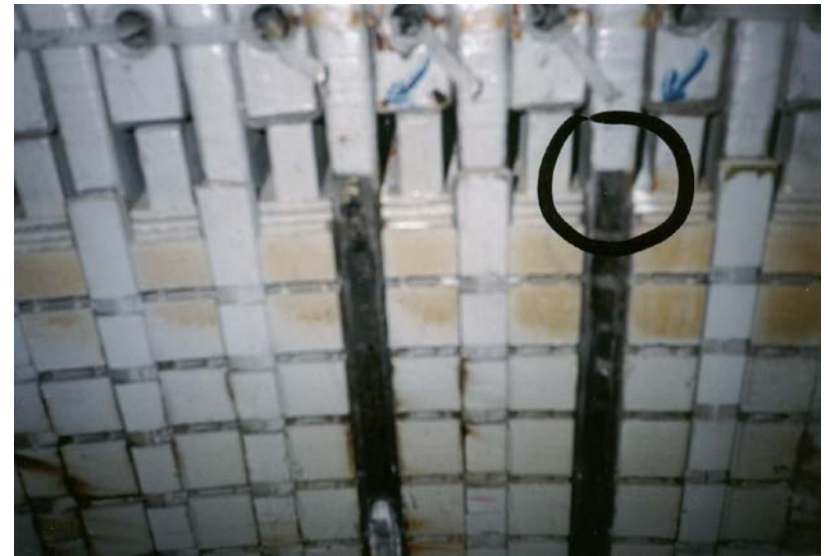
PD where bar exit's slot

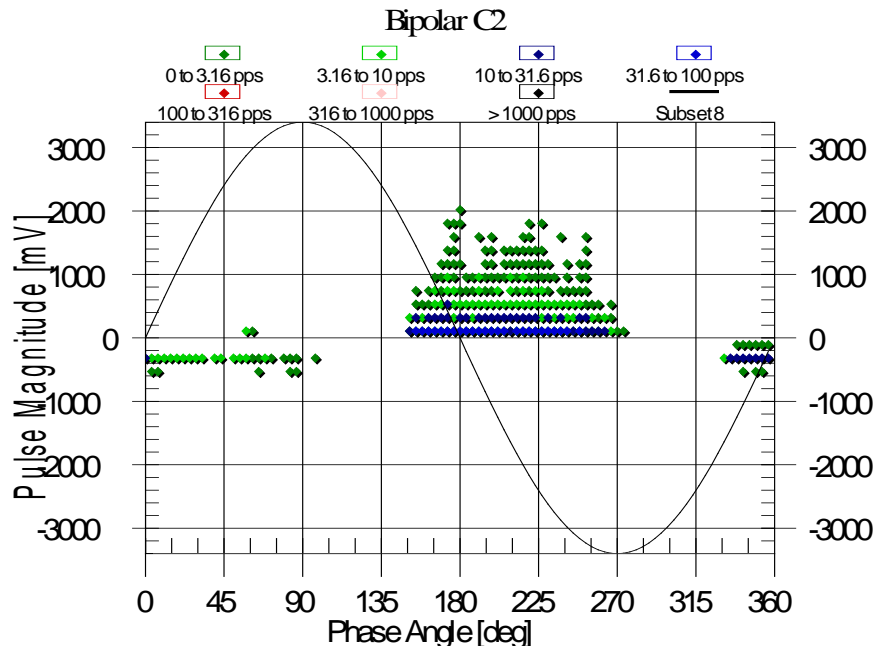
Phase U, coupler C2

(two highest results are shown)

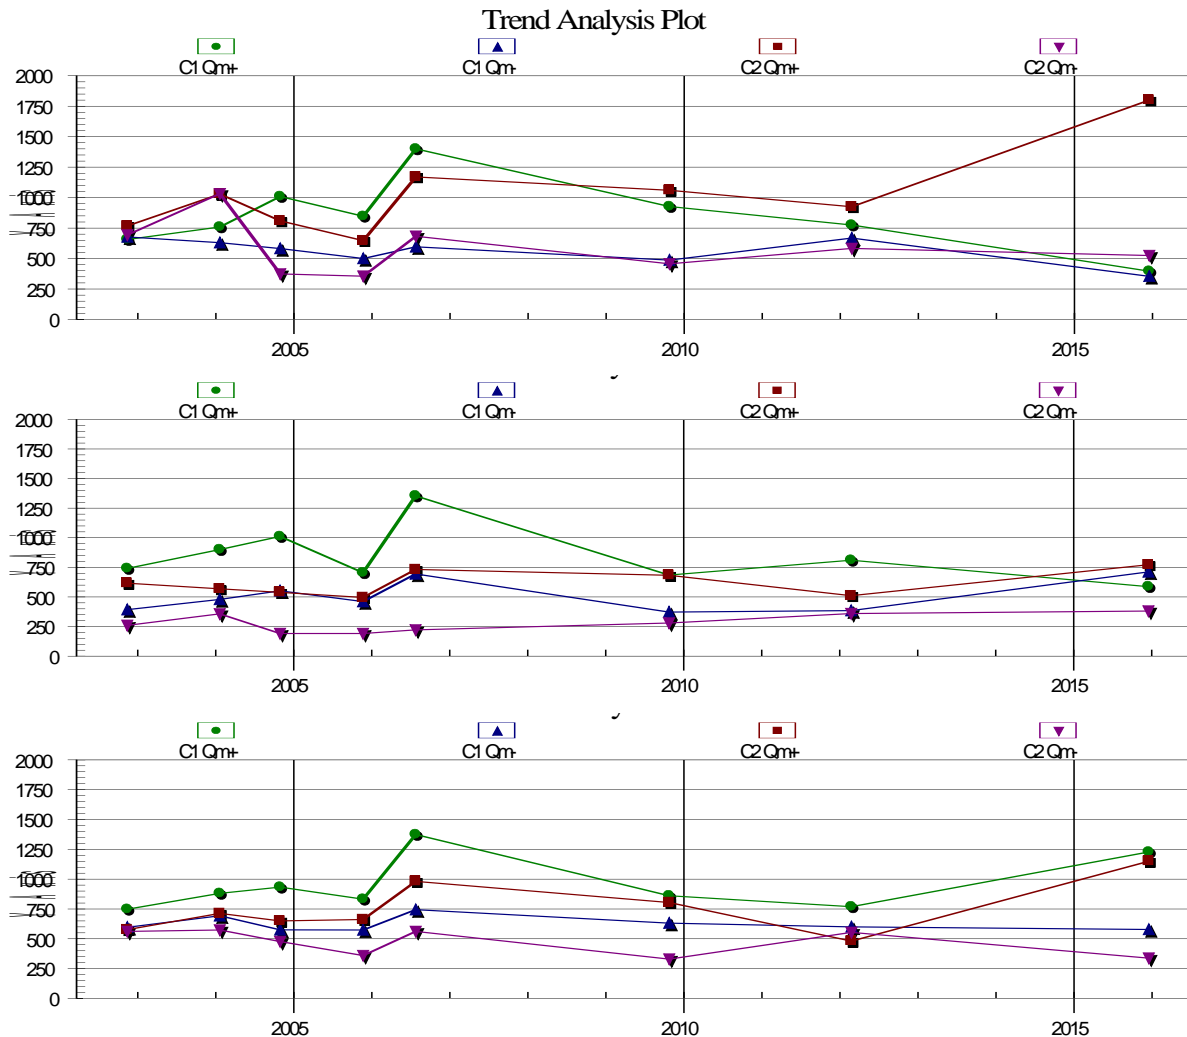
MG2 – Trend per phase up to 2015

Trend variable due to outage activities (cleaning, re-painting and recovery of corona damage)

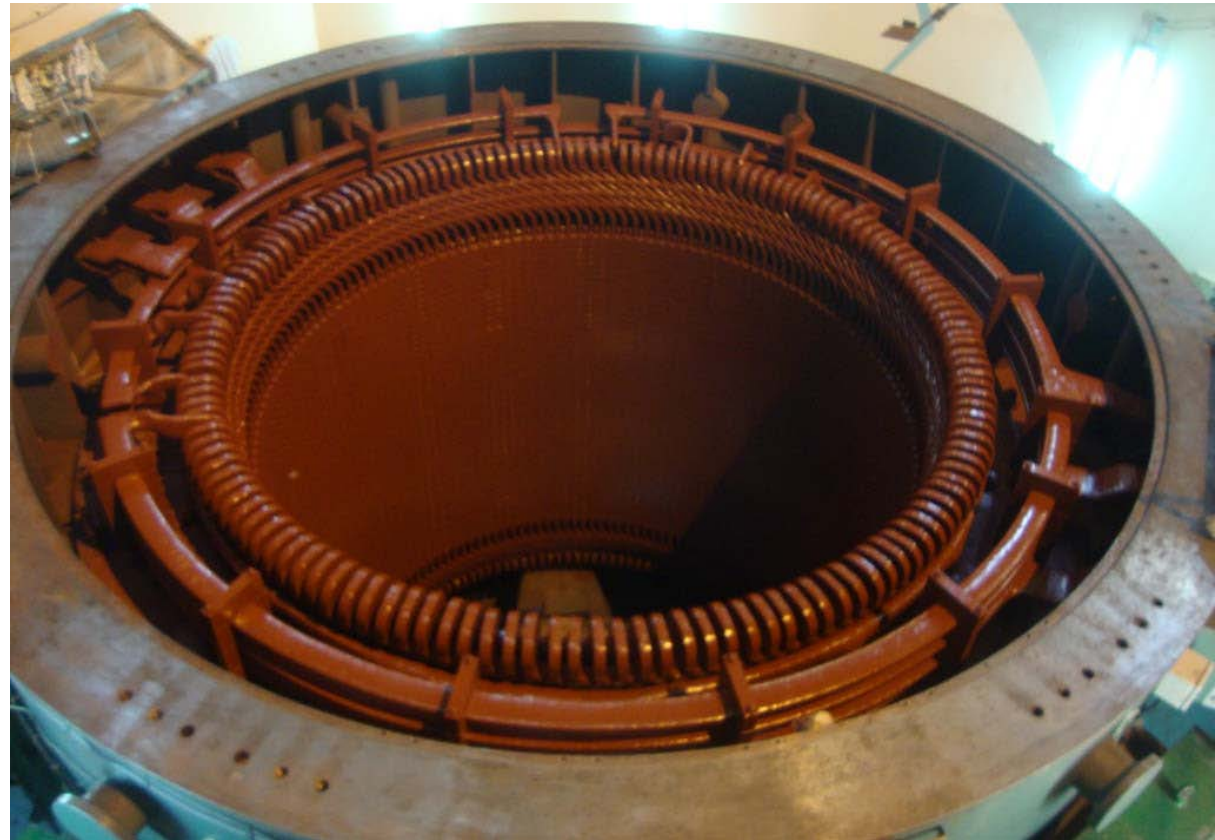
Refurbished bars
were installed and
connected to phases.

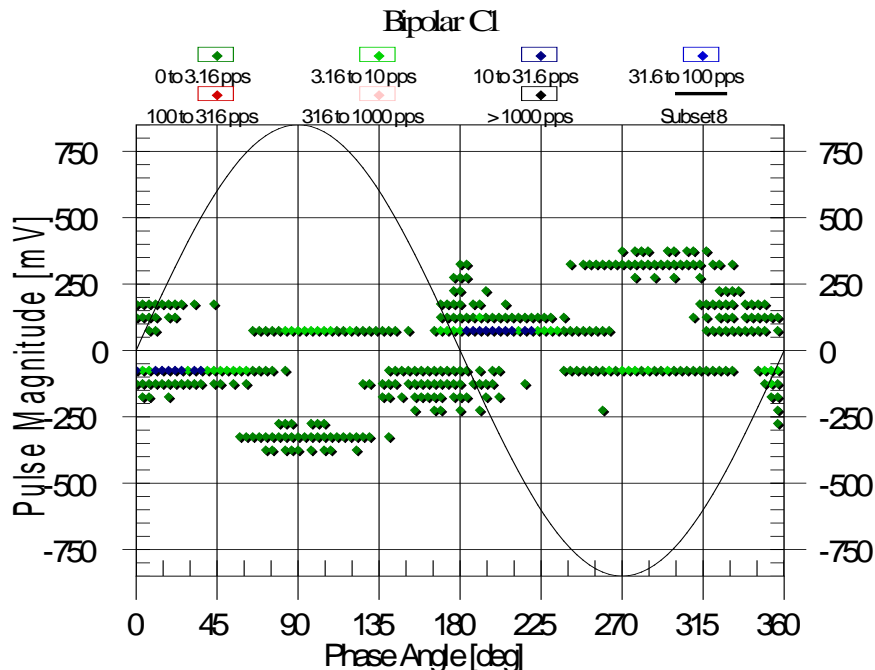
Phase U, coupler C1

- two highest results are shown
- notice change in measuring range (sensitivity): from 200-3200 mV to 50-850 mV

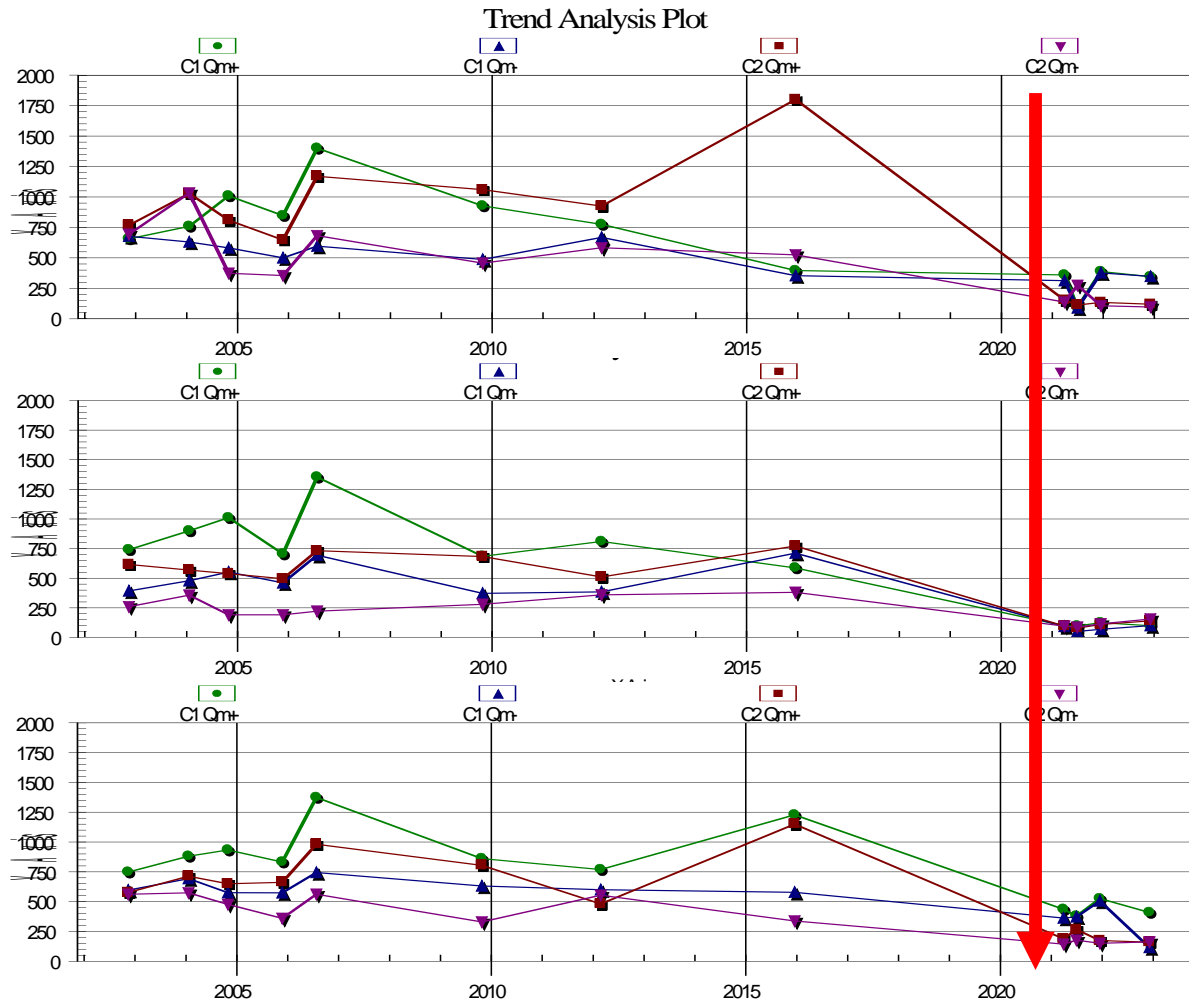
MG2 – Trend after Refurbishment

Refurbishment of MG2 stator winding has resulted in decreased PD levels.

After the refurbishment, the PD will be measured more often to determine the new trends.
