## **RESONANCE RELATED PROBLEM, DIAGNOSTICS AND SOLUTION PROPOSAL ON VERTICAL FRANCIS HYDROGENERATOR**

### **ABSTRACT**

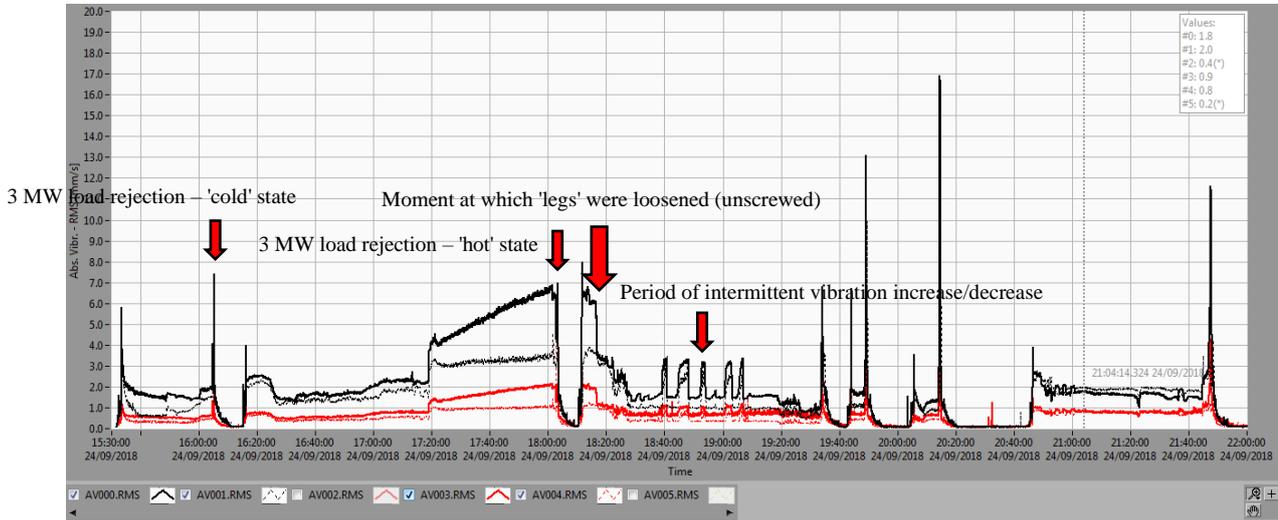
Fig. 3 RMS value of vibrational velocity in different measurement planes. Axial-radial plane (black), radial plane (red). Directions: X = full line, Y = dashed line.

An abrupt increase and decrease in vibrations on run-up and run-down is visible from the diagram. This resembles critical speed passage in turbine generating units. Additionally, around 17:19 h there is an abrupt increase in vibrations, mostly in axial-radial bearing X direction although no regime changes occurred at that moment. So, the question is why this increase occurred? Also visible is the vibration increase with temperature (the increase in vibrations from 17:19 h up until 3 MW load rejection in warm state).

For this reason, it was decided to loosen (unscrew) the additional stiffening elements ('legs') and this was done at 18:17 h (the moment is marked on Fig. 3). It can be noticed that the vibrations were immediately reduced and the largest change is in direction X of the axial-radial bearing. In the next period it can be seen that there exist intermittent increases and decreases in vibration levels (marked on Fig. 3) but the levels were not too high.

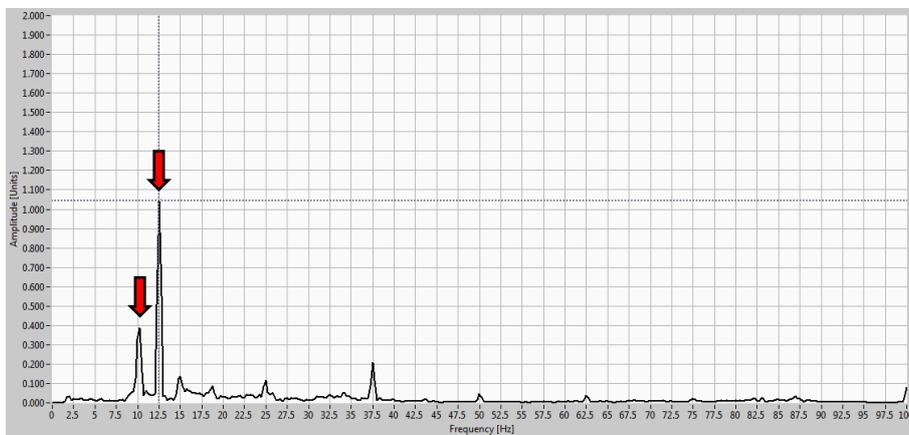
Fig. 4 Spectrum (amplitude RMS) of absolute bearing housing vibrations in axial-radial plane in direction X. The highest lines on 12.5 Hz and 10 Hz are marked. Spectral composition up to 100 Hz.

Two main lines are visible: the one on 12.5 Hz, which corresponds to the 1x harmonic of rotational frequency (750 rpm = 12.5 Hz) and is related to the rotor rotation and the line at 10 Hz whose existence is related to the vibrational response on system's natural frequency (this was additionally confirmed with a 'bump' test). Additionally, harmonics of rotational frequency are also visible (lines on 25 Hz and 37.5 Hz) but are smaller in amplitude.

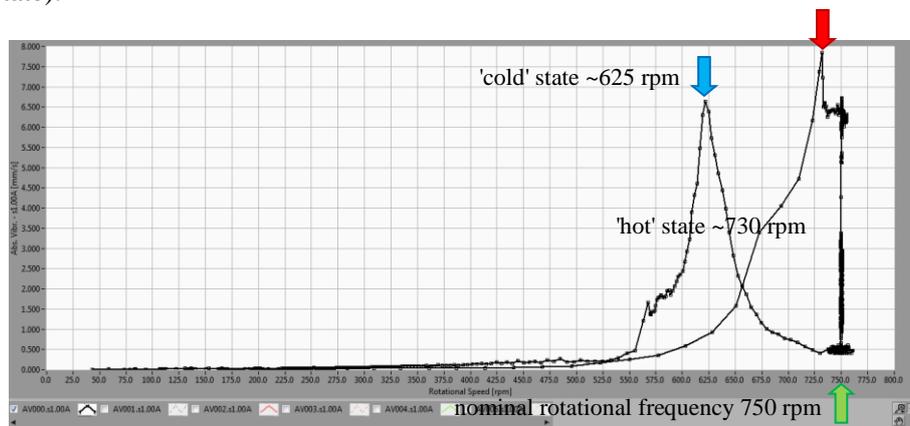
The increase in vibrational response with temperature can be explained through natural frequency increase as a result of additional stiffness increase related to temperature. During the measurements, the additional stiffening elements ('legs') were attached to the flange with appropriate screws and the warm-up increased the natural frequency towards the nominal rotational frequency. The vibrational responses with rotational speed increase (as a result of 3 MW load rejections) for the period around 16 h ('cold' state) and around 18 h ('hot' state) were compared. For this reason, Fig. 5 is given on which it can clearly be seen what the system natural frequencies are for both situations (~625 rpm for 'cold' and ~730 rpm for 'hot' state).

Fig. 5 Natural frequencies in 'cold' (blue arrow) and 'hot' (red arrow) during the 3 MW load rejection tests which resulted in rotational speed increase followed with a run-down.

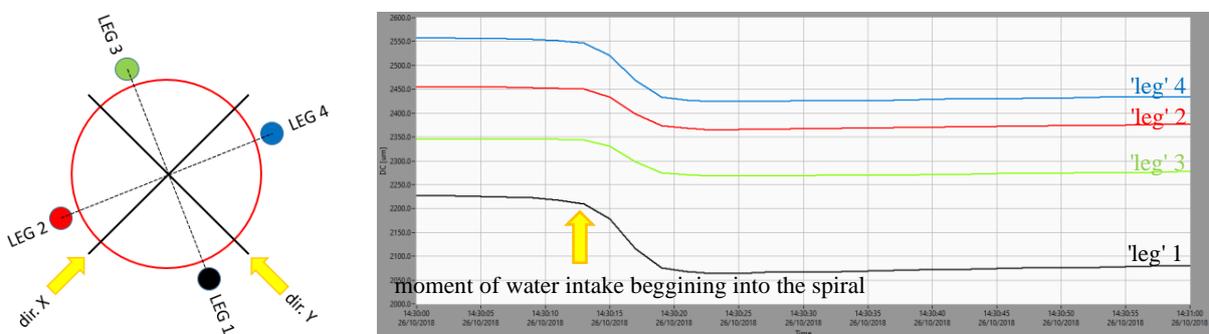
*Fig. 7 Sensor configuration in axial direction (Z). LEFT: Top view with radial sensor measurements X i Y and stiffening elements . RIGHT: Shaft static centerline position (DC) in axial direction (Flange to sensor)*

Fig. 7 trends clearly show how the spiral changes its volume (increases) due to water hydrostatic pressure (~15 bar) and, since the generator pedestal is mounted on it, as a result it also lifts. This results in reduction of distance between pedestal and sensor on additional stiffening elements. It is also visible that this increase is asymmetrical – that is it is not the same for all stiffening elements. For example, on 'leg' 1 it is the largest and is ~160  $\mu\text{m}$  while on 'leg' 3 it is the smallest and is ~80  $\mu\text{m}$ .

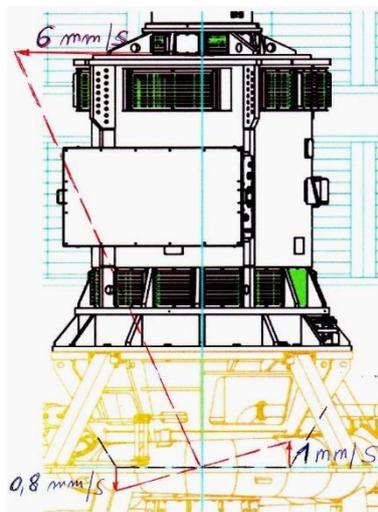
Fig. 8 shows the visualization of the vibration deflection shape according to vibration vectors obtained from the sensors on the flange, next to the spiral case, with the expected vibrational vector on the measurement position near the position on top of the generator. It should be additionally pointed out that these are 10 Hz vibrations and not vibrations on nominal rotational frequency of 12.5 Hz.

Fig. 8 Visualization of the unit deflection shape according to the measurements. Vibrations on 10 Hz (natural frequency).

From [Fig. 8](#) and the geometry one can see that ~6 mm/s is expected for a perfectly rigid pedestal. Since ~7 mm/s was measured, which is a very similar number, it was concluded that the generator pedestal's stiffness is adequate and that for the existing vibrational state the structure stiffness distribution below the spiral flange is responsible. The generator is founded on this flange through the bearing pedestal. Therefore, the overhaul procedures should be defined in changing the properties of this structure. It is a part of the spiral case with concrete filament from the spiral case to the draft tube. This part of the structure is not available for visual inspection but it exactly here that the repair works must be done in order to increase stiffness, that is, structure resistance to axial vibrations.

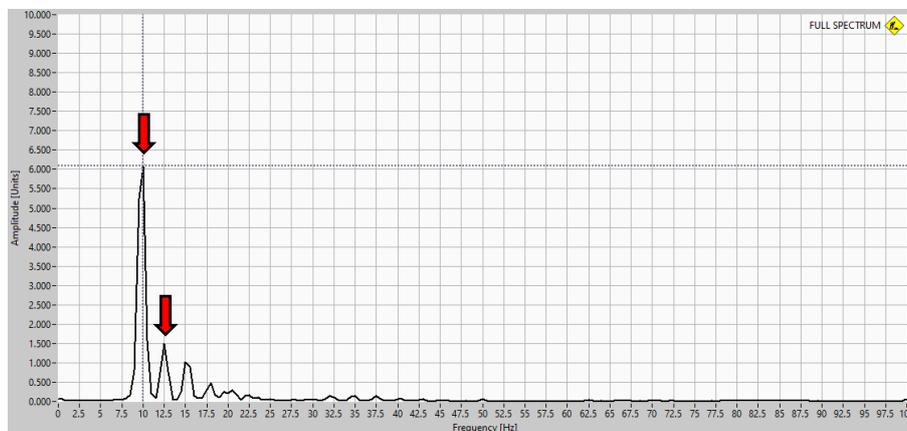
*Fig. 9 Spectra (amplitude RMS) of absolute generator bearing housing vibrations in axial-radial plane in direction Y. Two largest lines on 10 Hz and 12.5 Hz are marked. Spectra is shown up to 100 Hz.*

It can be clearly seen that the dominant vibrational response is at natural frequency of 10 Hz so the problem needs to be solved in such a way as to increase this frequency above nominal operating frequency of 12.5 Hz. This will be done by actions in the construction foundation region.

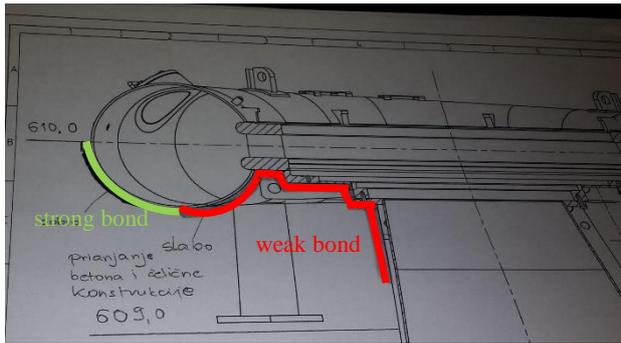
During the repair works, a relatively large zone was found in which the concrete and steel construction contact is poor. This is marked on [Fig. 10](#) (left part of the figure).

Fig. 10 LEFT: Overview of as-found state during repair works. RIGHT: Additional steel rods (concrete reinforcement) added during repairs.

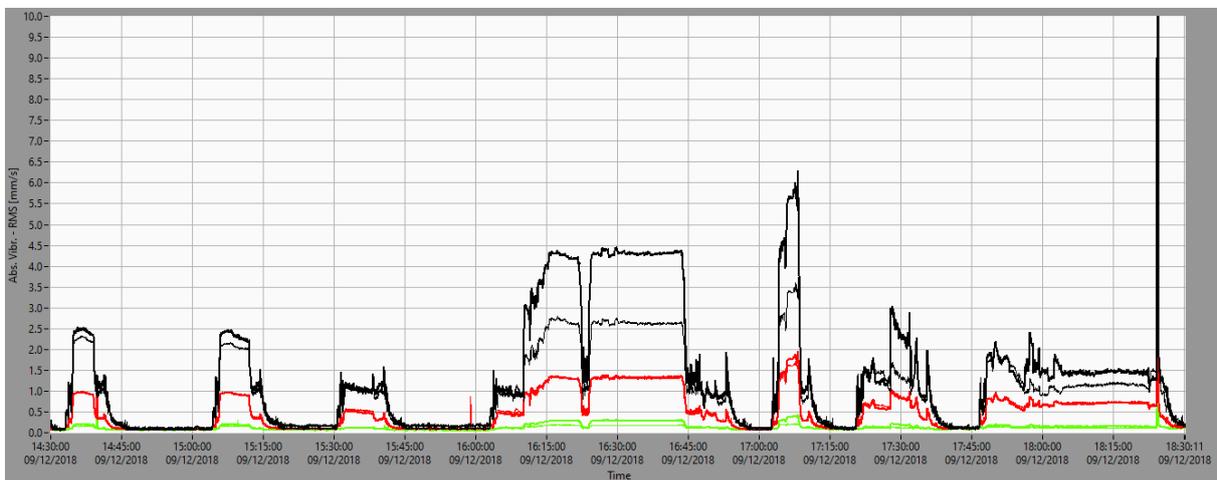
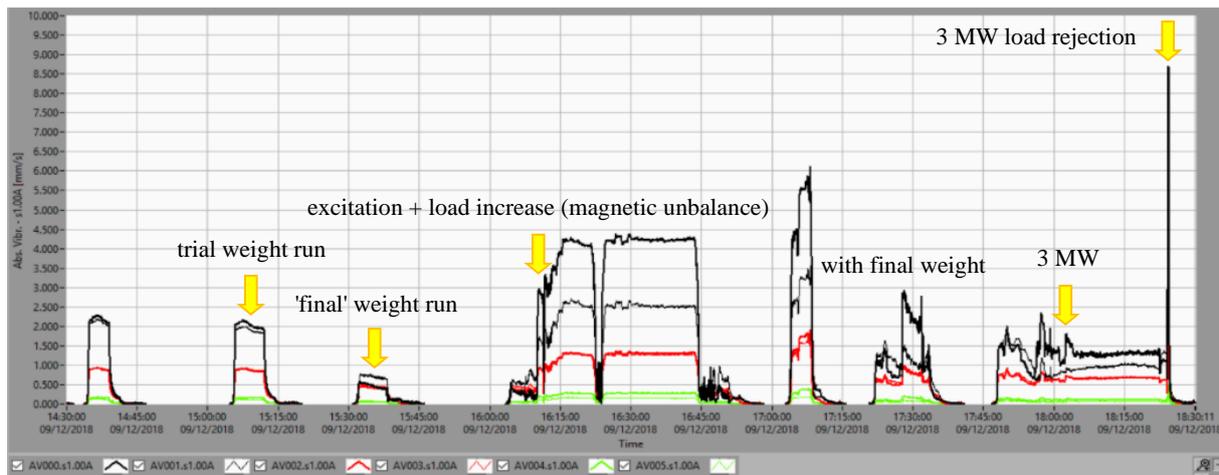
On Fig. 11 Fig. 11 results of the RMS values of vibrational velocity (upper diagram) and 1x harmonic of rotational frequency of vibrational velocity (lower diagram) are shown. Since the RMS value is almost identical to the 1x harmonic, it is clear that the 1x harmonic is dominant. This was confirmed by spectral analysis and it was additionally established that the response at 10 Hz is no longer present. This is a proof that the natural frequency is above the nominal rotational frequency.

Fig. 11 UPPER DIAGRAM: Trends of vibrational velocity RMS values [mm/s] LOWER DIAGRAM: Trends of 1x harmonic of vibrational velocity (amplitude RMS) for: axial-radial bearing plane (black, X and Y directions), radial bearing plane (red, X and Y directions), flange connection of generator pedestal to the spiral (green, Z direction on two positions).

At first, the unit was balanced in mechanical rotation. By comparison of the vibration phase relations in the axial-radial and radial planes it was established that the vibrations are in phase. Therefore, it was sufficient to conduct the balancing in one plane only. From Fig. 11 Fig. 14 it can be seen how the balancing procedure was conducted during the first three unit runs (run-up and run-down). The first rotation was without balancing weight, the second with the trial weight in one plane and the third with the 'final' weight for mechanical rotation. It can be seen that the vibrations during the third run are now very low and within limits acceptable to the end-user (below 2.5 mm/s).

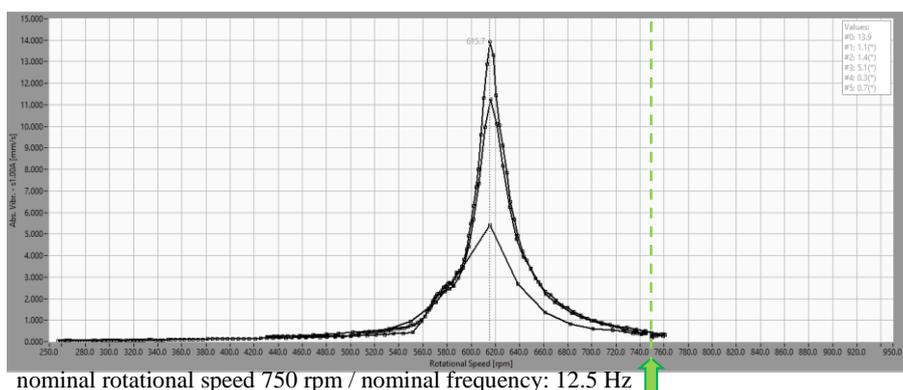
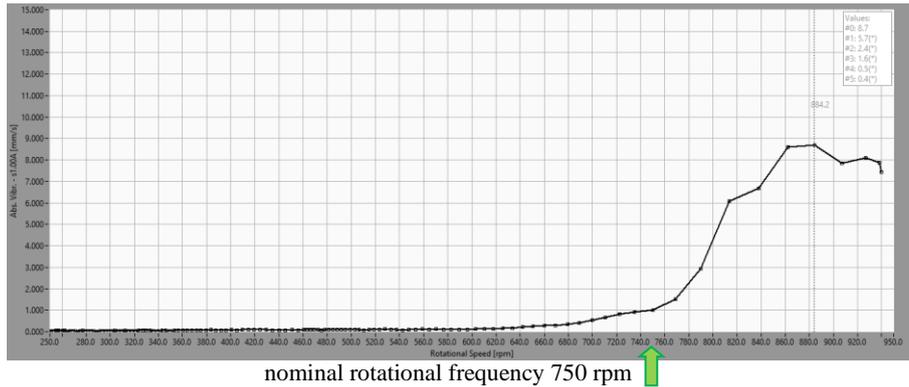
From Fig. 11 Fig. 14 it is visible how this was achieved during the 7th run and then, the decision was made to perform 3 MW load rejection in order to make possible the comparison of unit's vibrational behavior prior to and after the overhaul. The main question was at what value the unit's natural frequency was increased. For this reason, Fig. 12 Fig. 12 is given showing the natural frequency before and after the overhaul.

Fig. 12 UPPER DIAGRAM: 28.09.2018. – before the overhaul. Natural frequency ~10 Hz. LOWER DIAGRAM: 09.12.2018. load rejection from 3 MW – after the overhaul. Natural frequency ~14.75 Hz
