Study on cause analysis and detection method of inter-turn short circuit fault of large turbine generator rotor

ZHAN LIU

Xi'an Thermal Power Research Institute

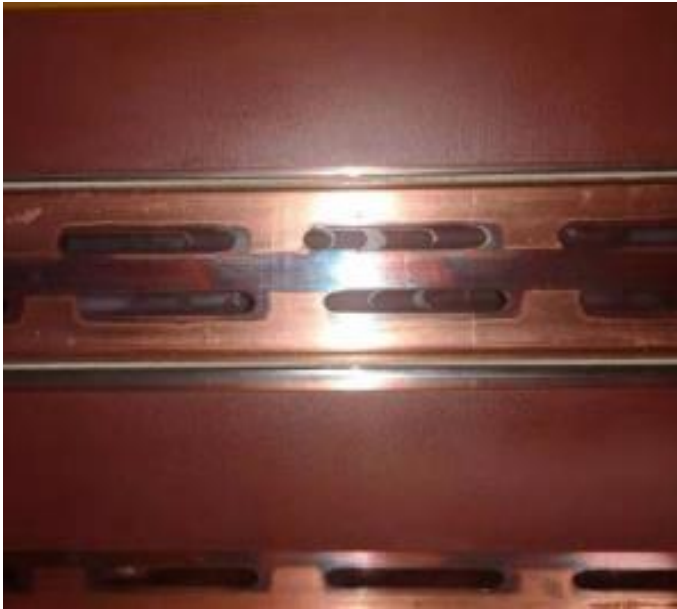
As to in-slot windings, the general inter-turn failure occurs mostly near the cooling duct or at the inter-turn insulation stitching region

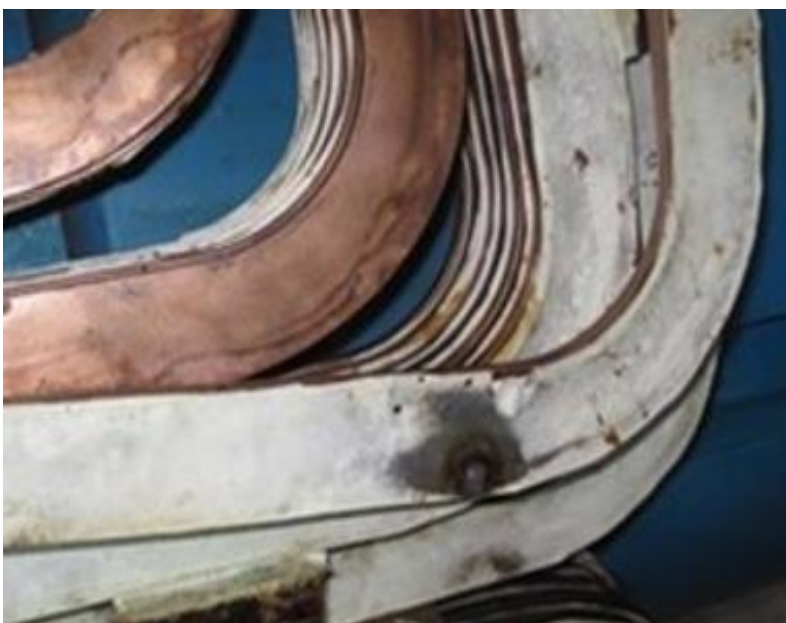
Failure spot around the corner

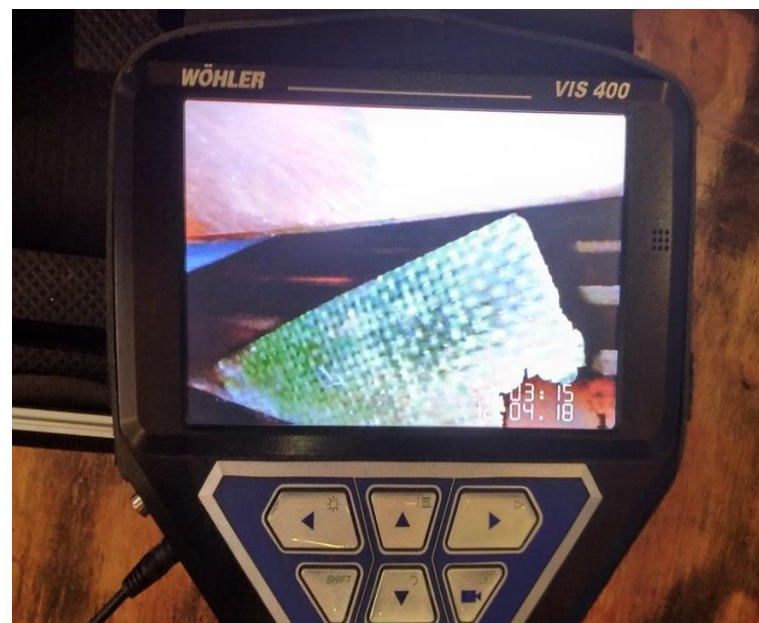
Displacement of the inter-turn insulation

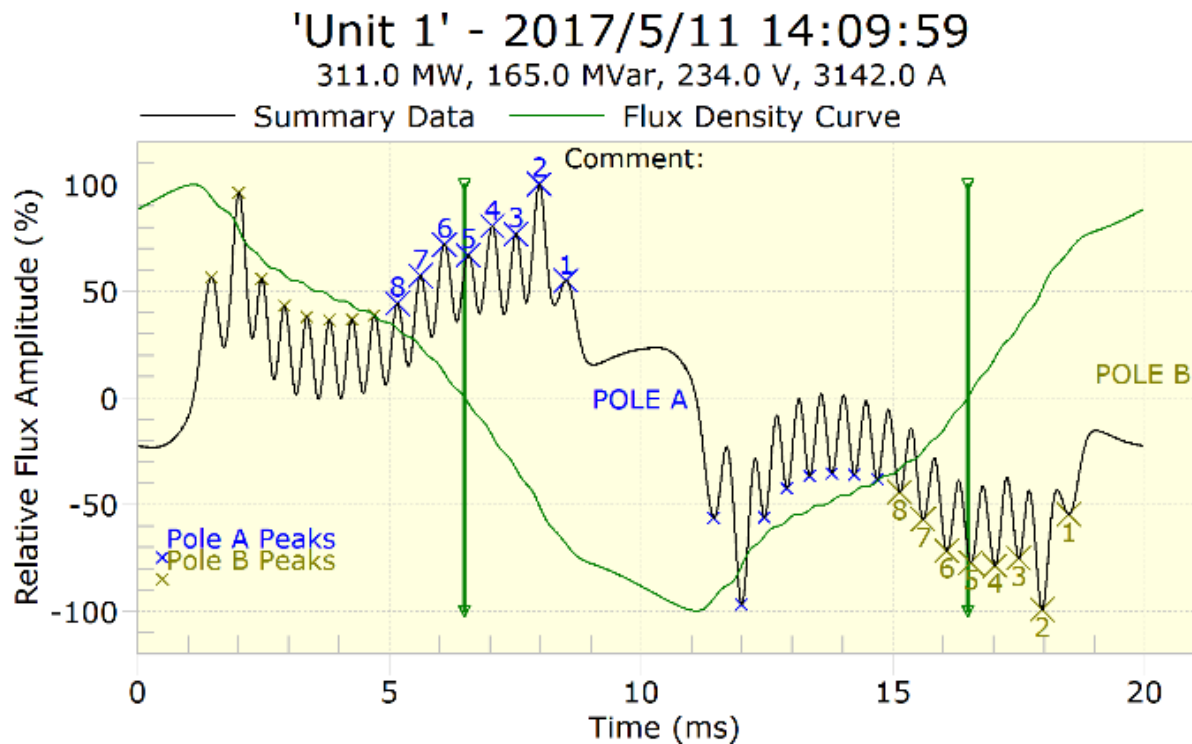
Detection coil waveform method

Table 1 Result of the rotor flux test

Coil	Pole-1	Pole-2	Feature value	limit
1	55.2	-54.9	0.47%	15%
2	99.9	-99	0.88%	8%
3	83.2	-81.2	2.41%	8%
4	86.7	-85.5	1.42%	8%
5	78.5	-79.5	1.18%	8%
6	67.1	-66	1.68%	8%
7	49.4	-49.1	0.49%	8%
8	33.9	-40.1	15.18%	8%

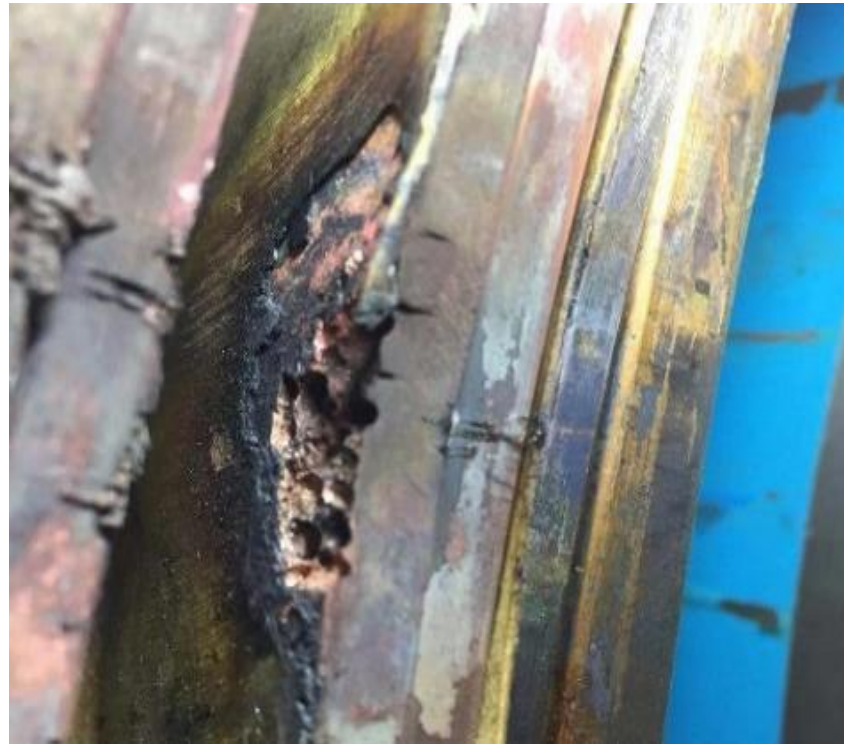
Failure spot

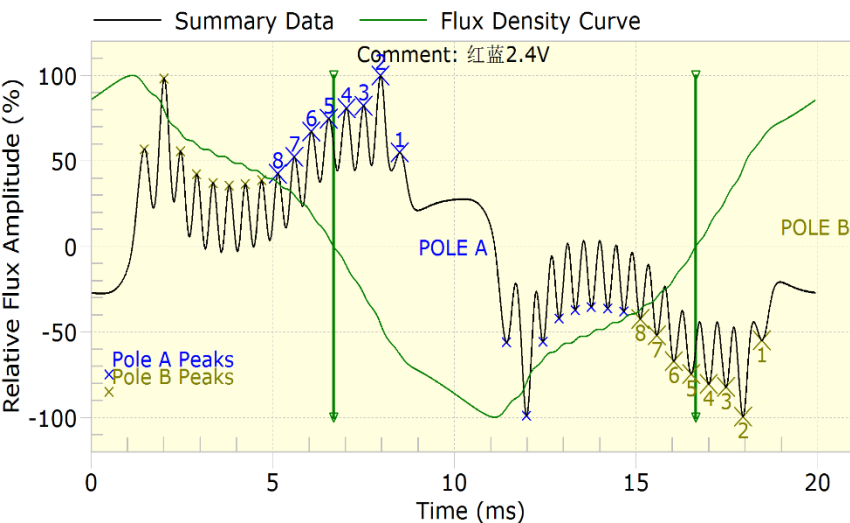
Test after repair

Table 2 - Result of the rotor flux test after repair

Coil	Pole-1	Pole-2	Feature-value	limit
1	54.9	-55	0.32%	15%
2	99.9	-99.5	0.44%	8%
3	82.2	-82.1	0.04%	8%
4	80.8	-80.6	0.33%	8%
5	74.5	-74.7	0.17%	8%
6	67.1	-67.0	0.13%	8%
7	52.2	-52.1	0.21%	8%
8	42.5	-42.4	0.19%	8%
