Osmo Koponen
Leading Specialist
Generators Diagnostic Engineering
TGS Finland Oy
osmo.koponen@fortum.com

20.4.2023

REPAIRING GENERATOR STATOR CORE SURFACE DAMAGE BY ELECTRO-ETCHING – A CASE STUDY

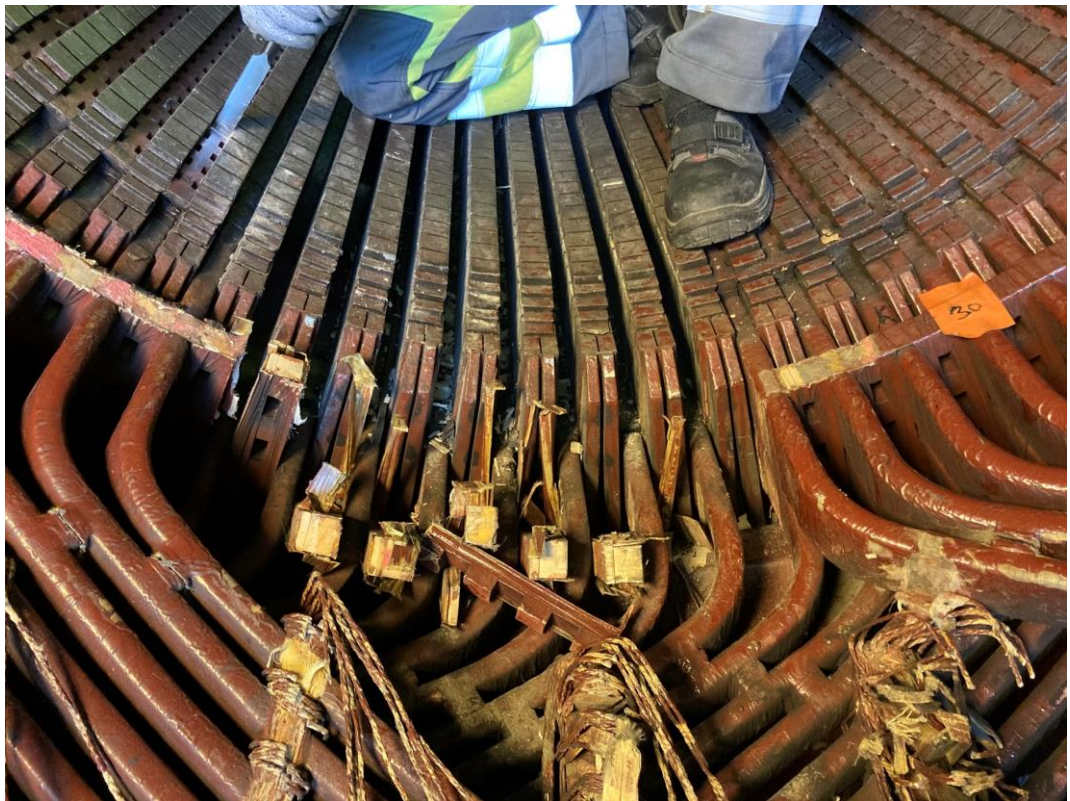
The generator is 120 MVA 3000 rpm 10,5 kV turbo generator. It suffered a catastrophic stator winding failure on winding end area. The resulting light arc, fire and contamination damaged the stator winding beyond reasonable repair, however the stator core stayed undamaged.

Picture 1. Damaged stator winding being removed for rewinding.

The stator was repaired by full rewinding.

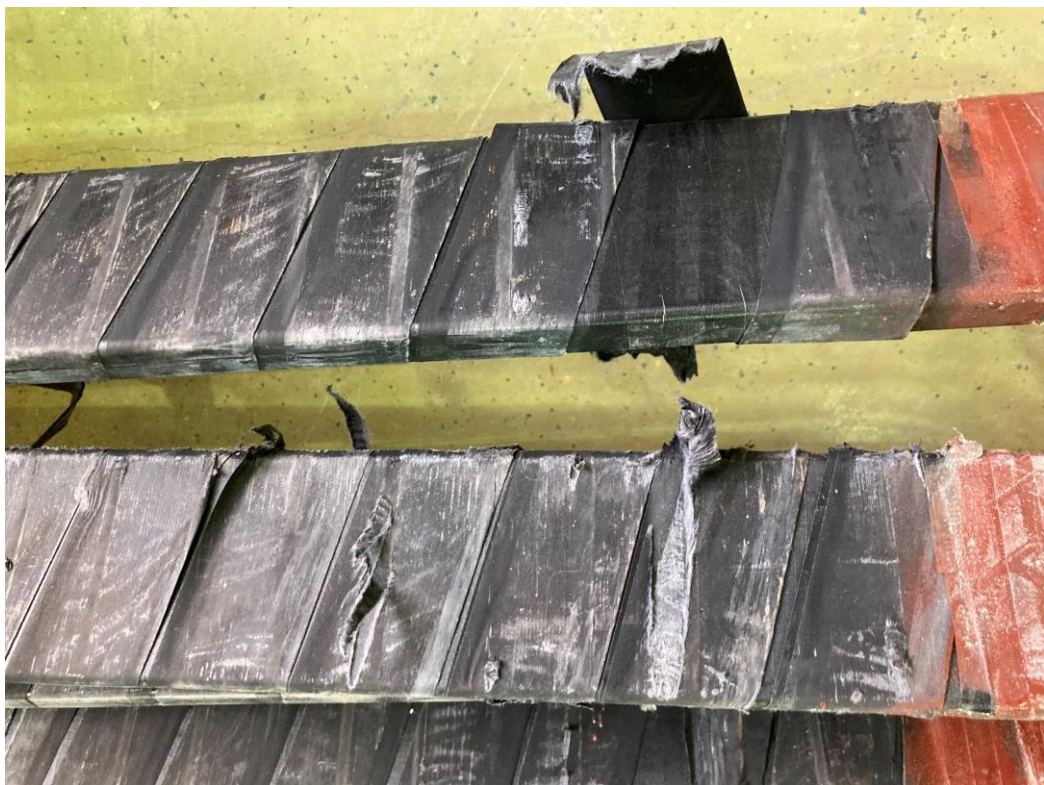
In original manufacturing the fit of the bars in the stator core slots was made tight by round packing (dry graphite tape wrapped around the bars), any ripple spring materials were not used.

Picture 2. Round packing type of fitting on the removed stator winding bars.

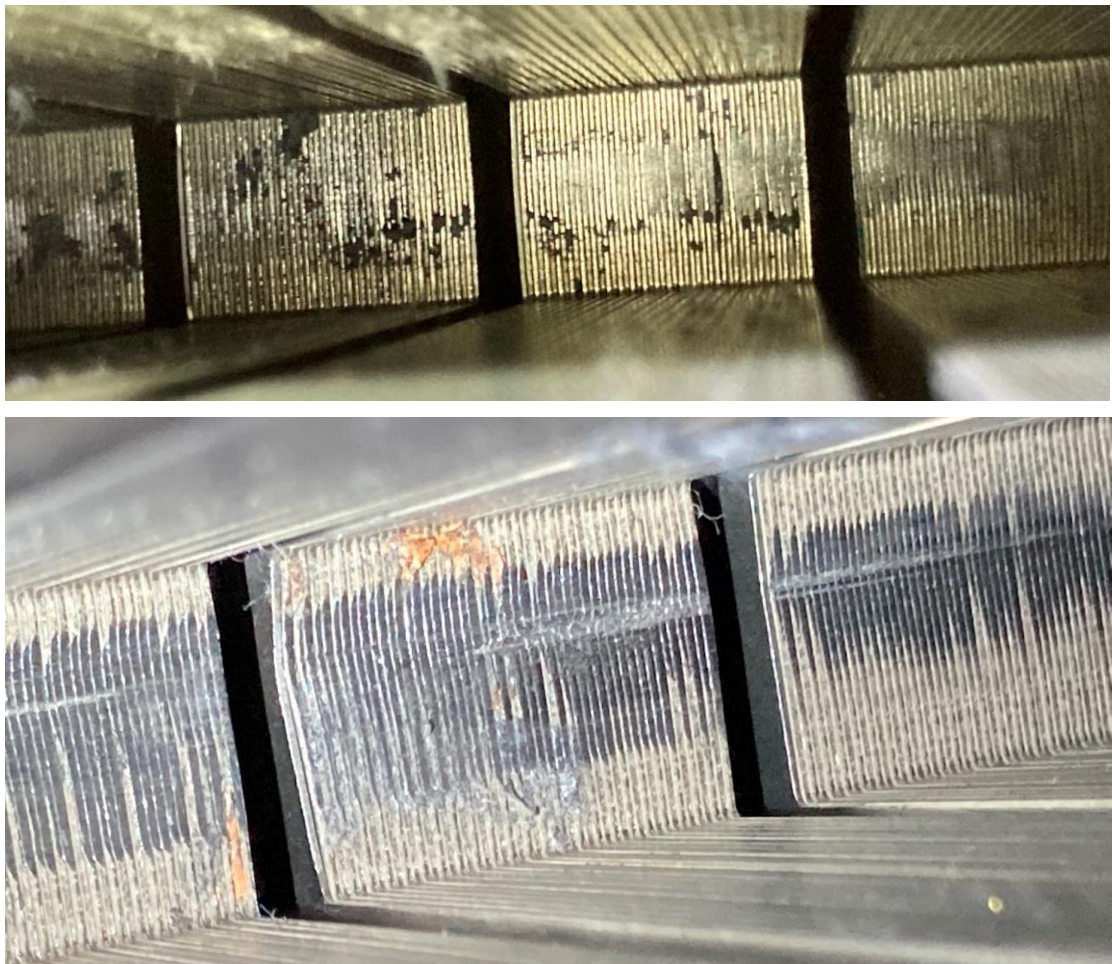
Some bars were stuck, likely because they were bent in the middle which expanded the bar width in the bending point. They were then forced out using a kind of large crow bar, which was supported against the bottom of the slot. The bottom of the slot was protected with a hard glass fiber laminate and the crow bar did not have any direct contact on the bottom of the slot.

However the pressure applied on the bottom of the slot was able to create metallic contacts between individual laminations. They were not exactly on the same level, and the pressure was able to spread the steel of the slightly protruding laminations in such way that it created a direct metallic contact with neighbor laminations.

It was easy to see the surface damage in visual inspection. The length of the damaged area in one stator core slot was some 40 cm, in addition there were some short 2 – 3 cm damaged areas on some slot ends.

Picture 3. The damage on stator core slot bottom. Metallic contacts between individual laminations are obvious.

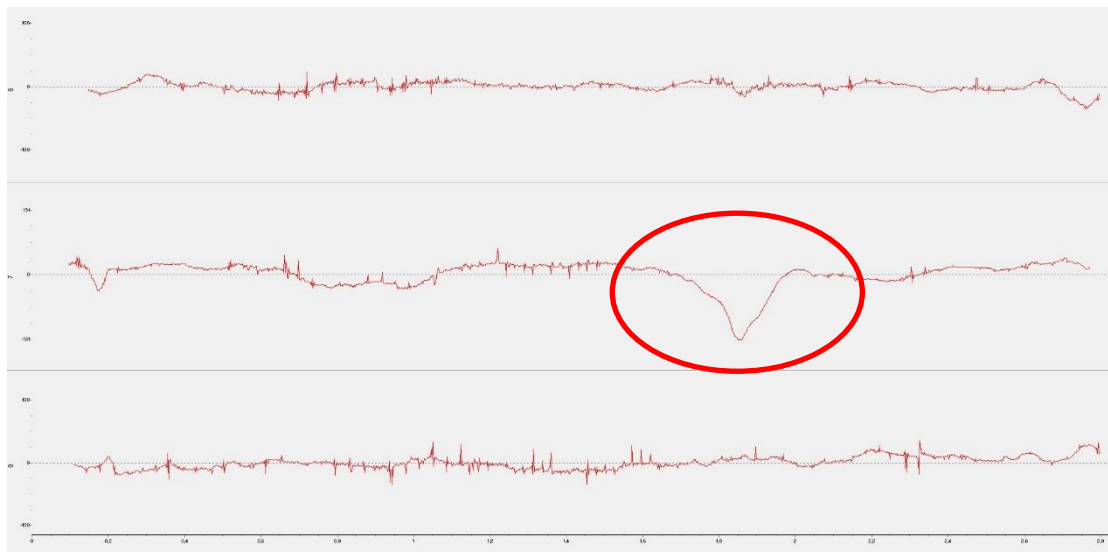
The damage on slot bottom was clearly detectable in the ELCID results. Measured $I_{quad} = 130$ mA at 4 % excitation indicates a possible local hot spot 5 – 10 °C above healthy core areas at normal operation.

Picture 4. ELCID I_{quad} curves of the damaged stator core slot (in the middle) and two neighbor slots. Deviation $I_{quad} = 130$ mA indicates a possible local hot spot 5 – 10 °C in normal operation.

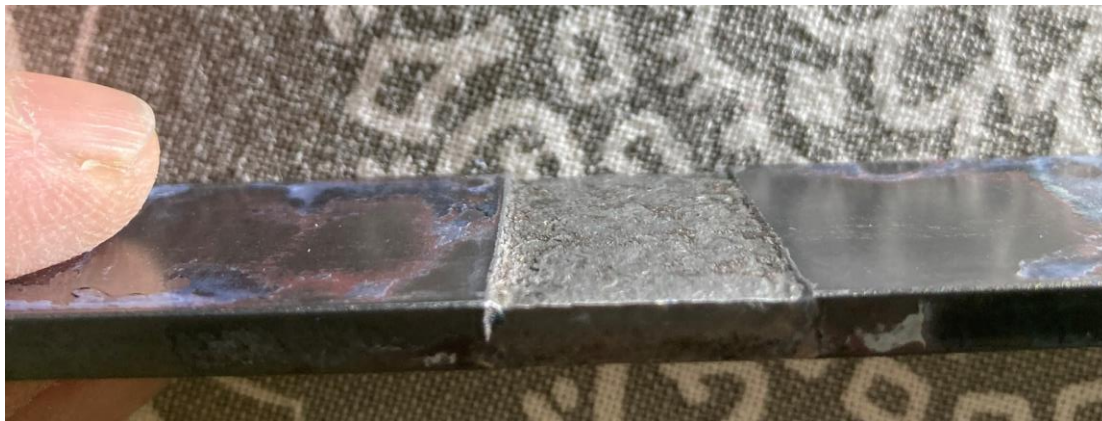
Picture 5 shows a test piece of structural steel where the electrolyte solution 30 % was applied absorbed on a cellulose pad, which was held in place with stainless steel electrode connected to the minus pole of the DC source. The cellulose pad was replaced whenever it became dry. The plus pole of the DC source was connected directly on the steel.

Picture 5. Test etching on a piece of structural steel. The area 30 mm x 18 mm in the middle was etched appr. 4 h with low 2 A DC current, which removed some 0,2 – 0,3 mm of the steel surface.

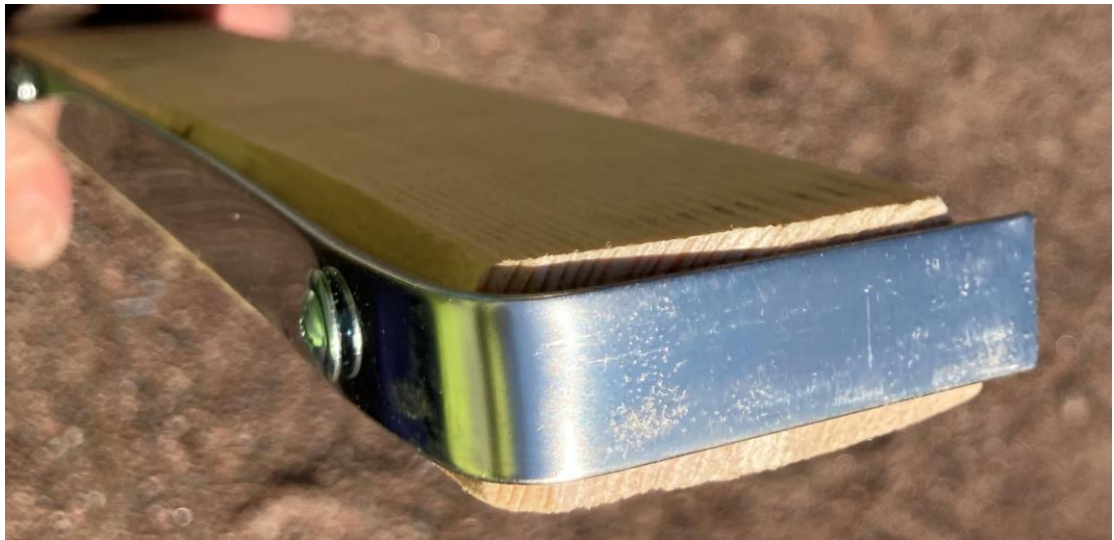
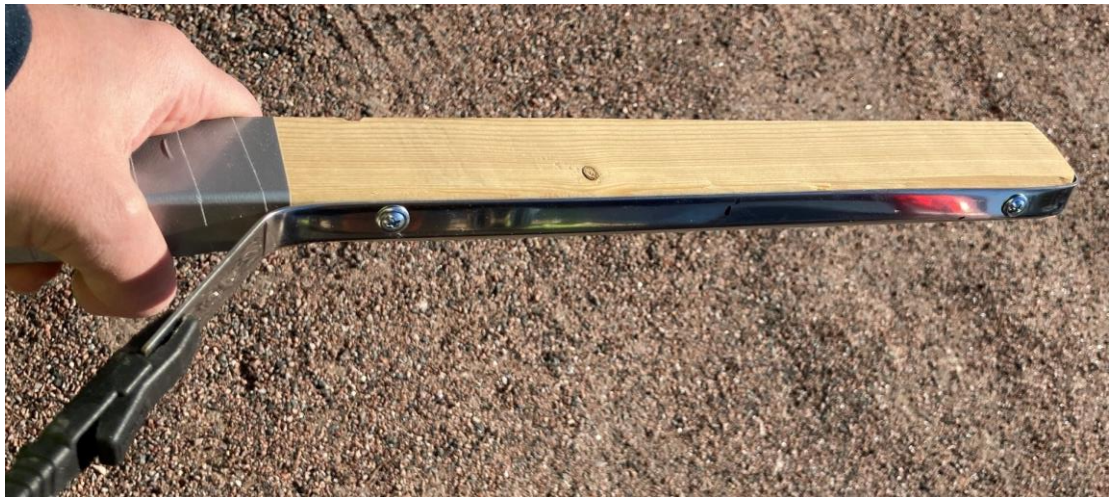
Picture 6. Wooden tool made to bring the stainless steel electrode with the electrolyte pad on the bottom of the slot. This is connected to the minus pole of the DC source. The stainless steel electrode is not corroded in the process.

A simple tool was made to handle to stainless steel cathode against the bottom of the slot, as shown in pictures 6.

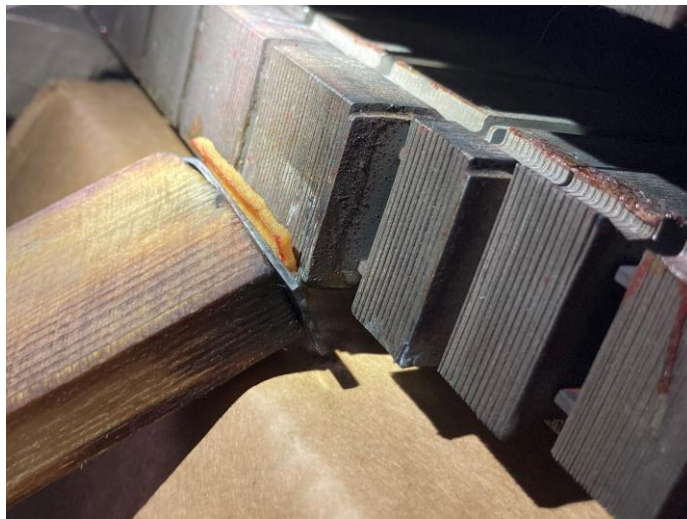
Picture 7. Pad wetted with electrolyte is held in place against steel core (here tooth top corner) with the tool holding the stainless steel electrode connected to DC minus. The stainless steel must not touch the core directly, because that will short circuit the DC supply. The area underneath is protected by covering it with cardboard.

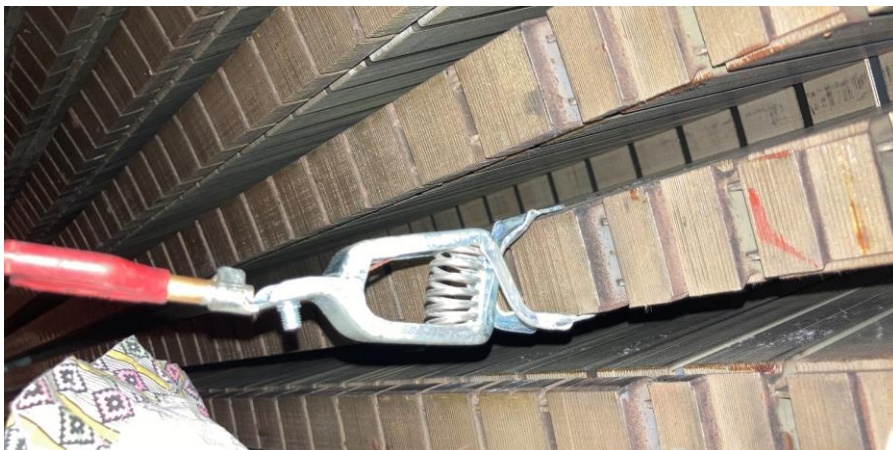
Picture 8. The core is connected to the DC plus.

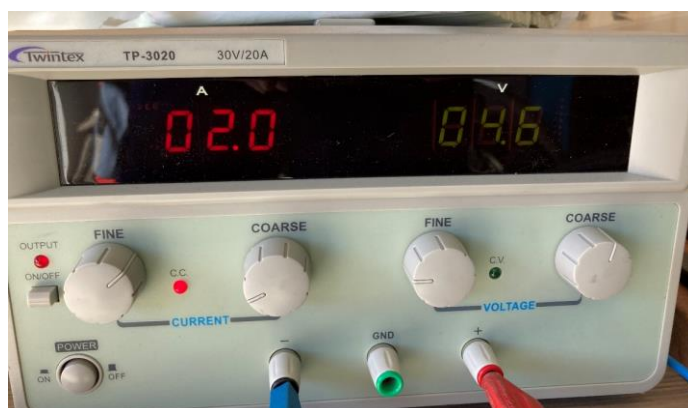
Picture 9. A standard inexpensive laboratory DC source was used for the electrolysis.

The DC source was an inexpensive (in the range of 250 USD) laboratory source. It is important that it is adjustable to find the correct settings.

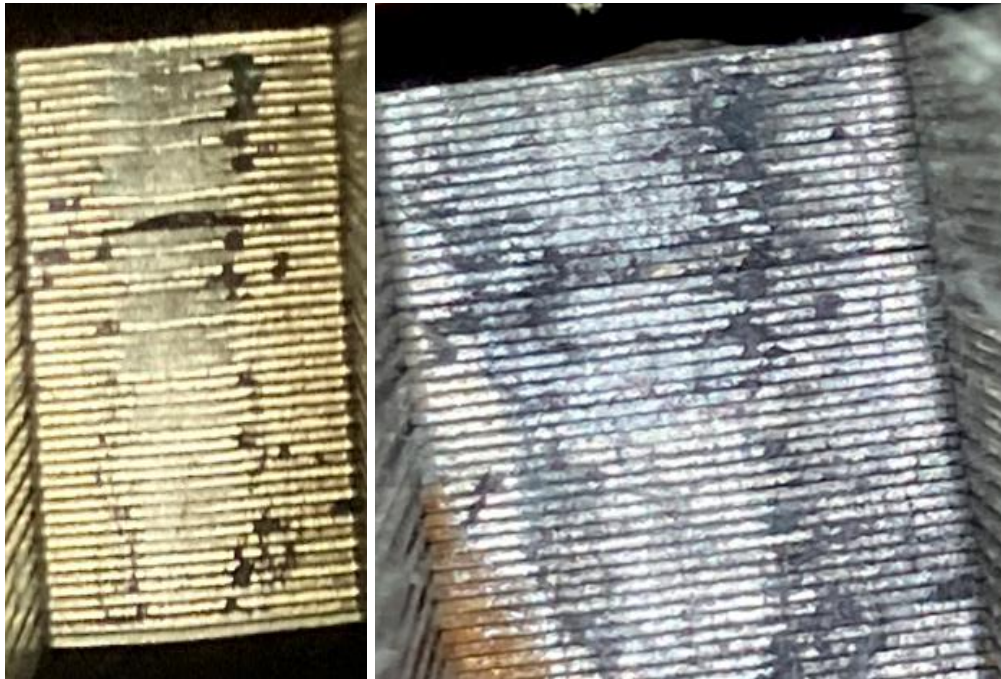
Picture 10 shows the situation before and after etching in one location.

Picture 10. Before etching (left) the spread steel is connecting laminations. After successful etching (right) the spread steel has been removed and the insulation between individual laminations is visible again. It is exactly the same spot in both pictures.

The etching was performed in one small area at a time, and it was stopped when visual inspection showed that the individual laminations can be seen again, as shown in picture 10.

The etched areas on the slot bottom were wiped clean and dry and then varnished to prevent rusting. It is important not to varnish any other areas to maintain good electrical contact of the bar slot corona protection electrode to the slot steel wall.

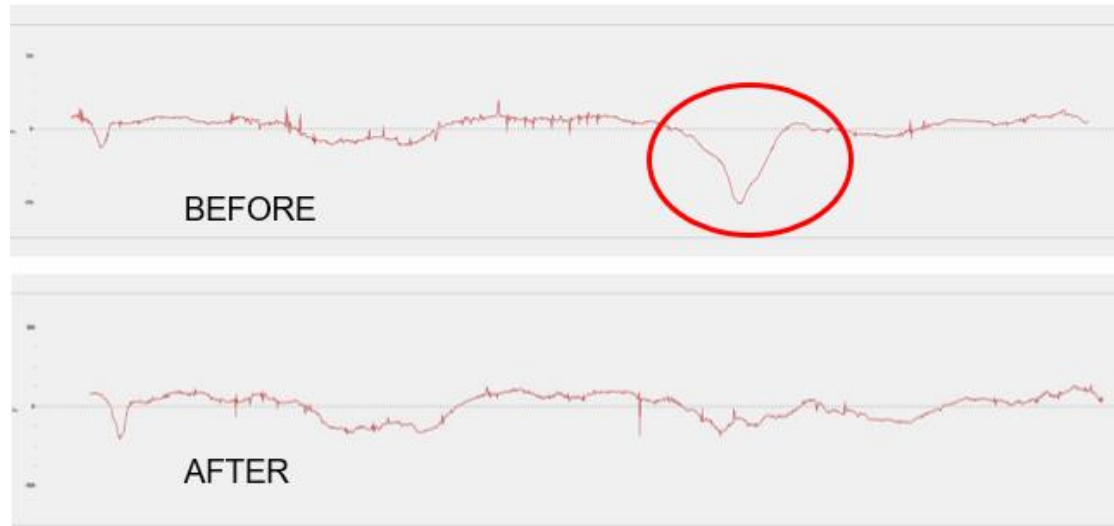
ELCID measurement was repeated after the etching. The results confirm that the work was successful and the core fault indication has disappeared.

Picture 11. ELCID measurement confirms the core fault indication $I_{\text{quad}} = 130 \text{ mA}$ has disappeared.
