# Creative Solutions For Significant Generator Failure Damage

**GE 9A4  
Shaft ID Damage  
& Repair**

# GE Water Cooled LP Shaft OD Damage & Repair

# GE 324 Main Lead Repairs

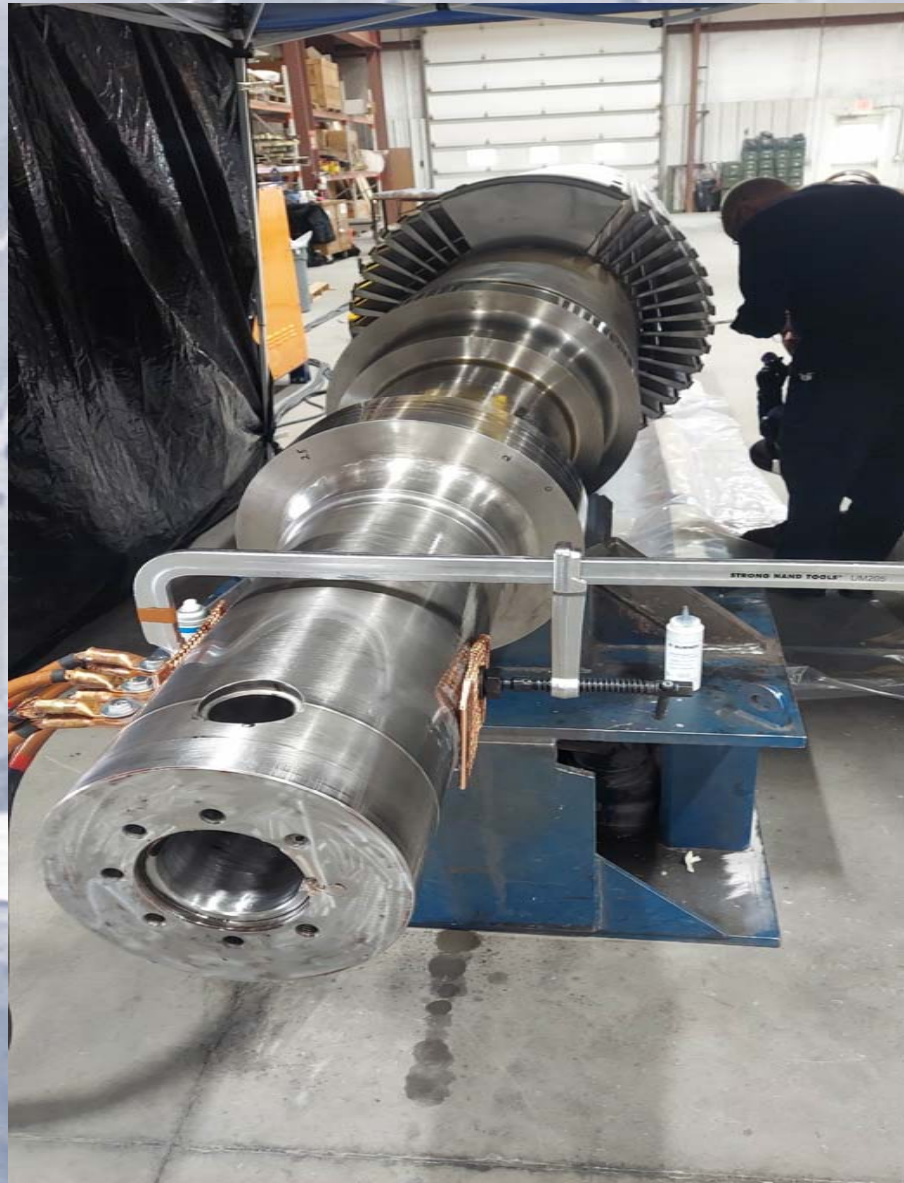
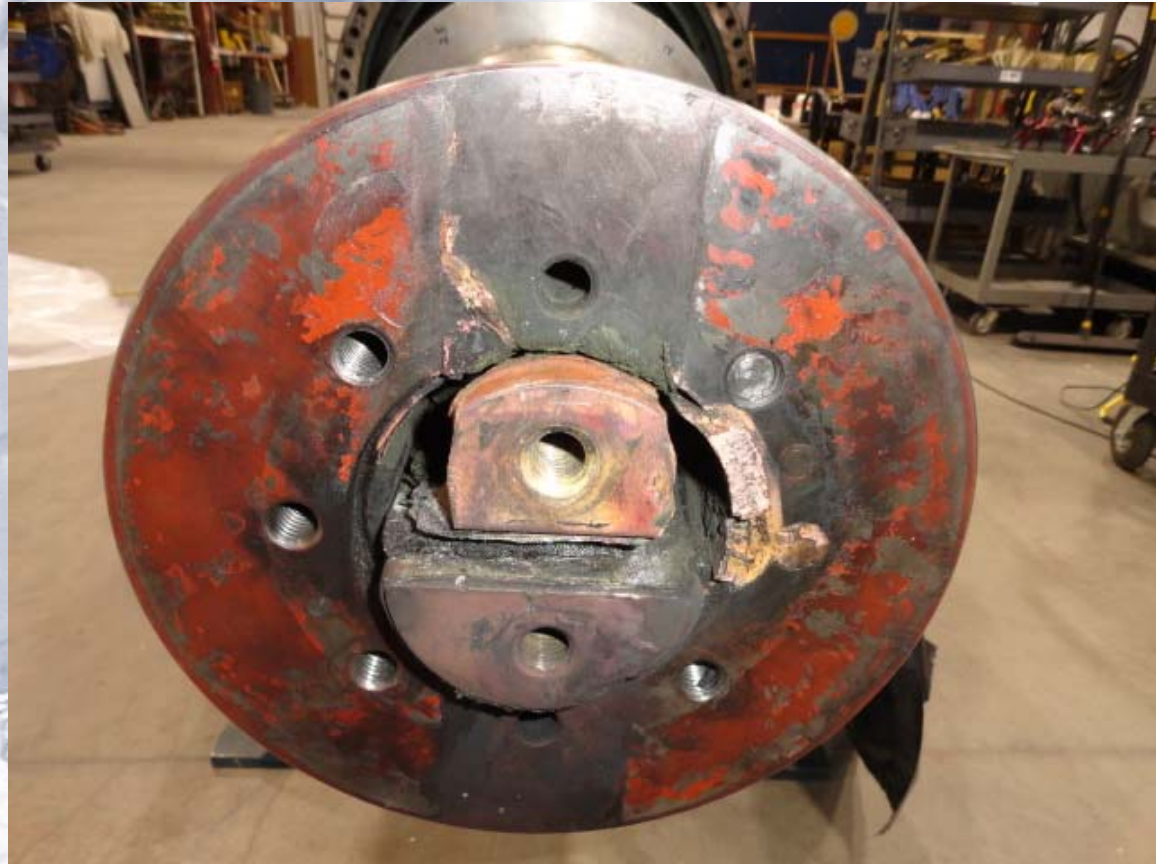
## Bore Copper Halves Shorted

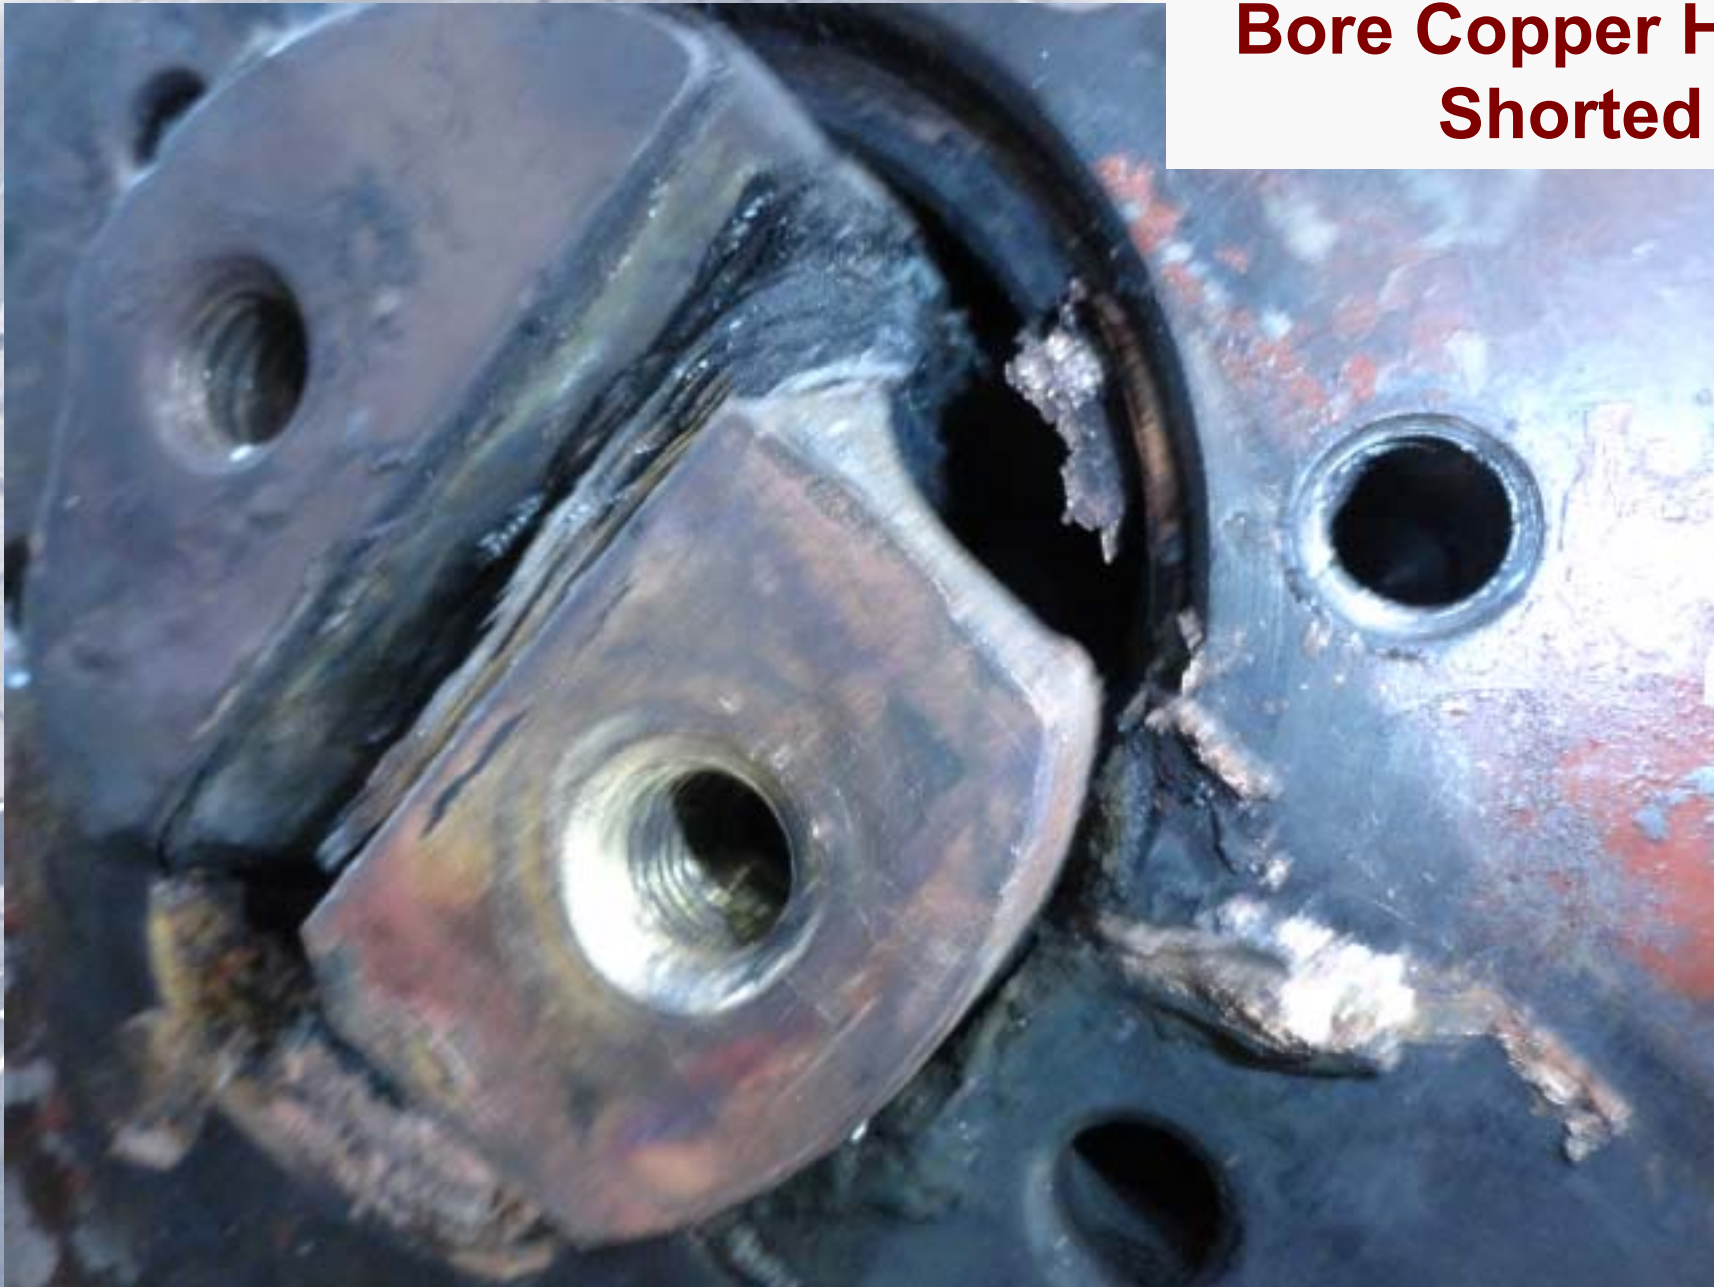
## **Bore Copper Halves Shorted**

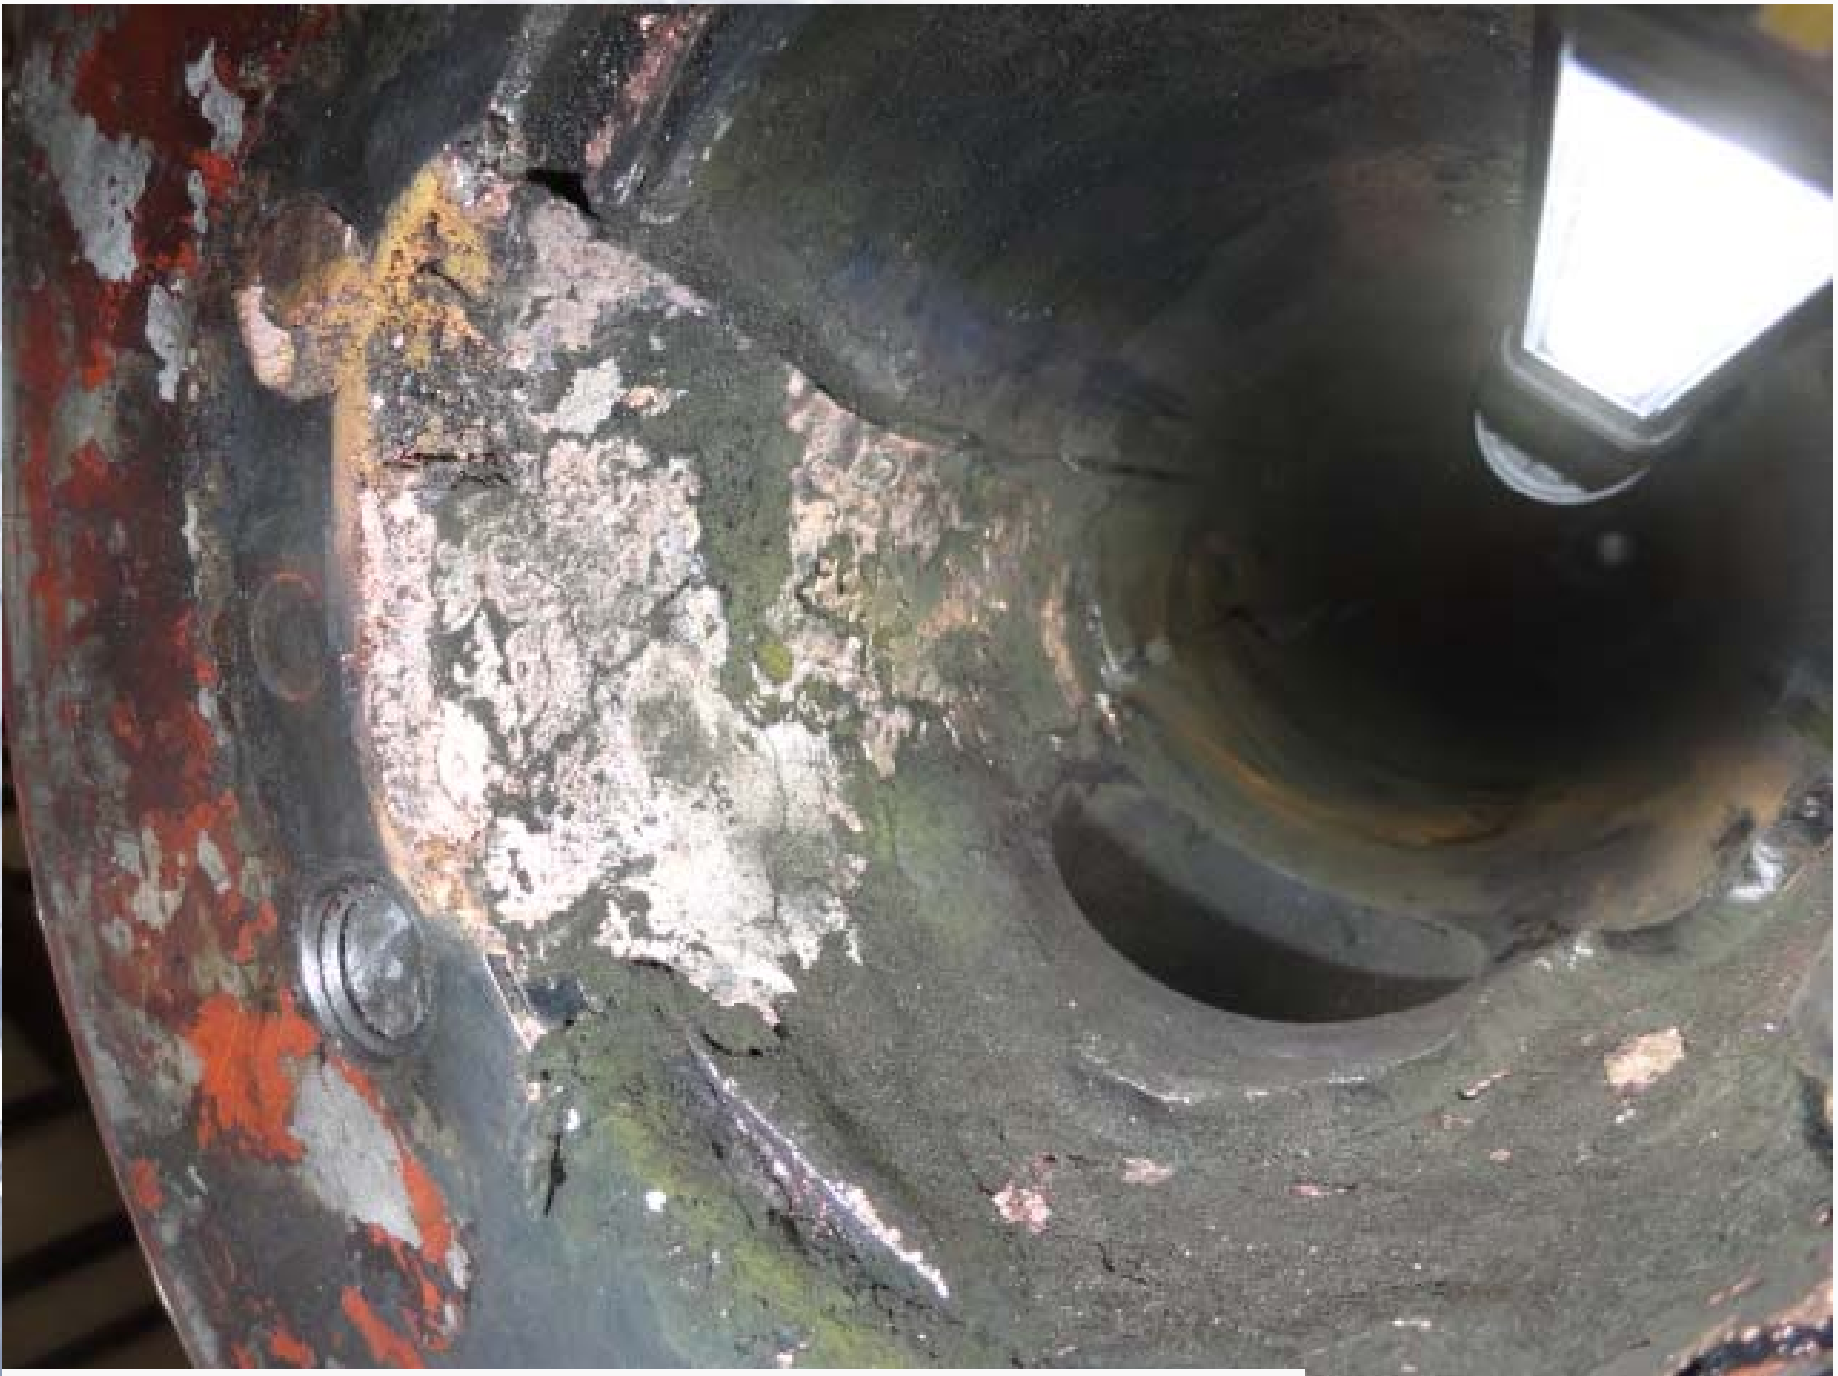
**Bore ID Damage Prior to Cleaning**

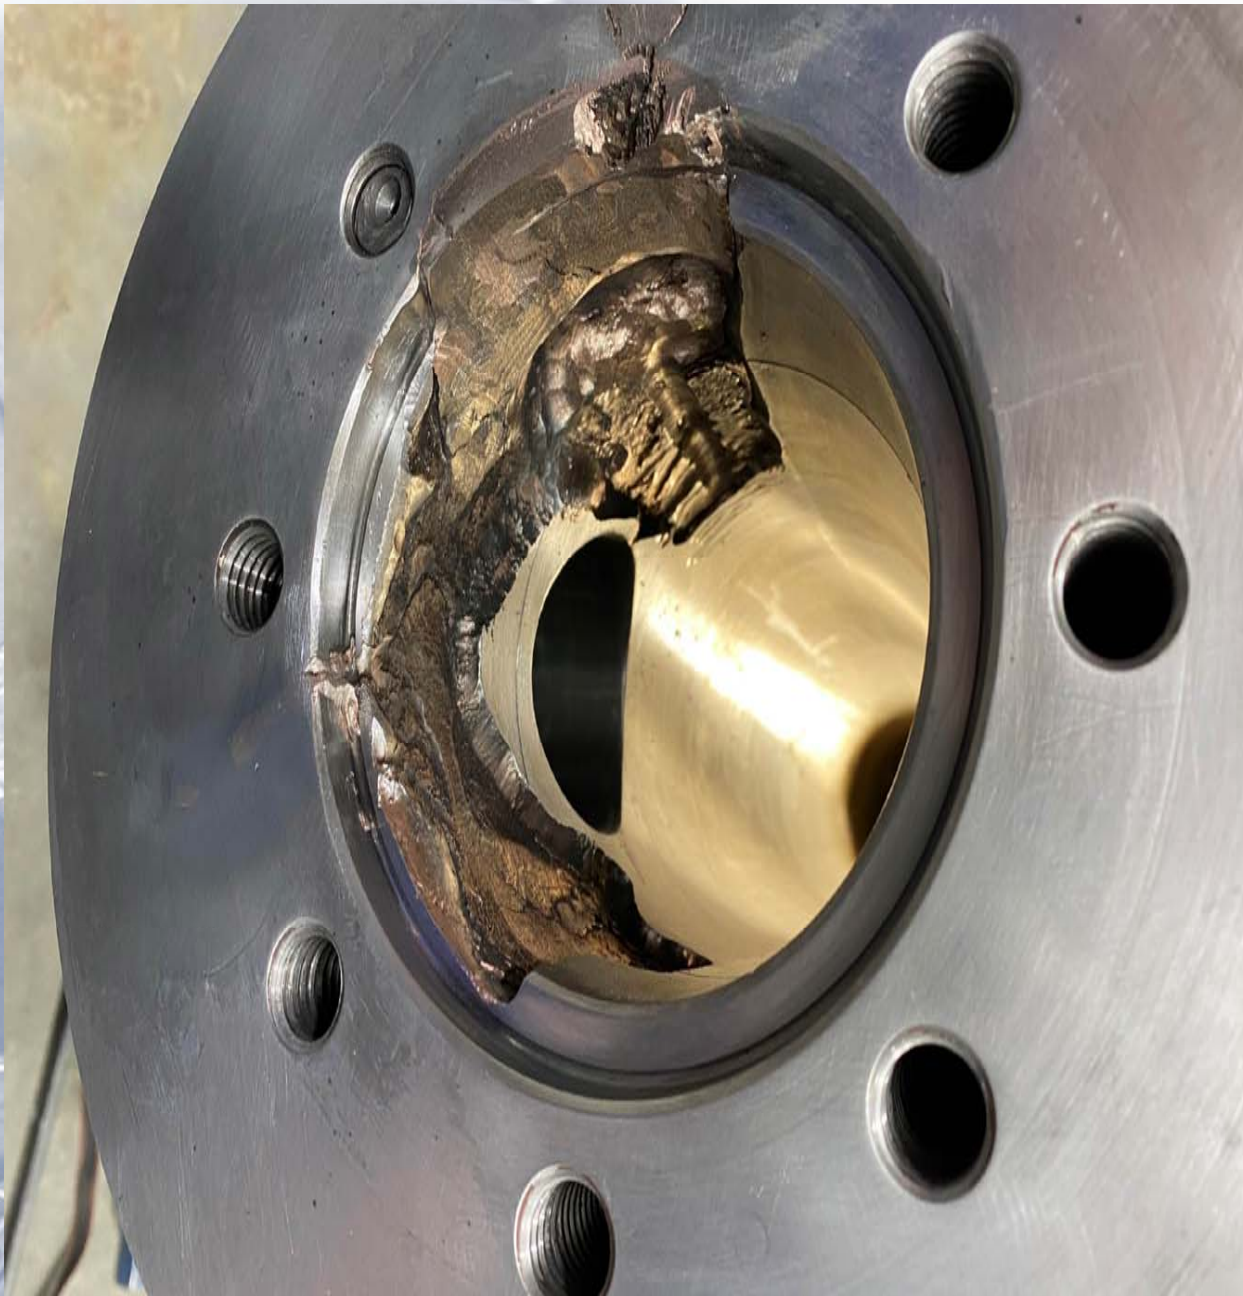
**Bore ID Damage After Cleaning**

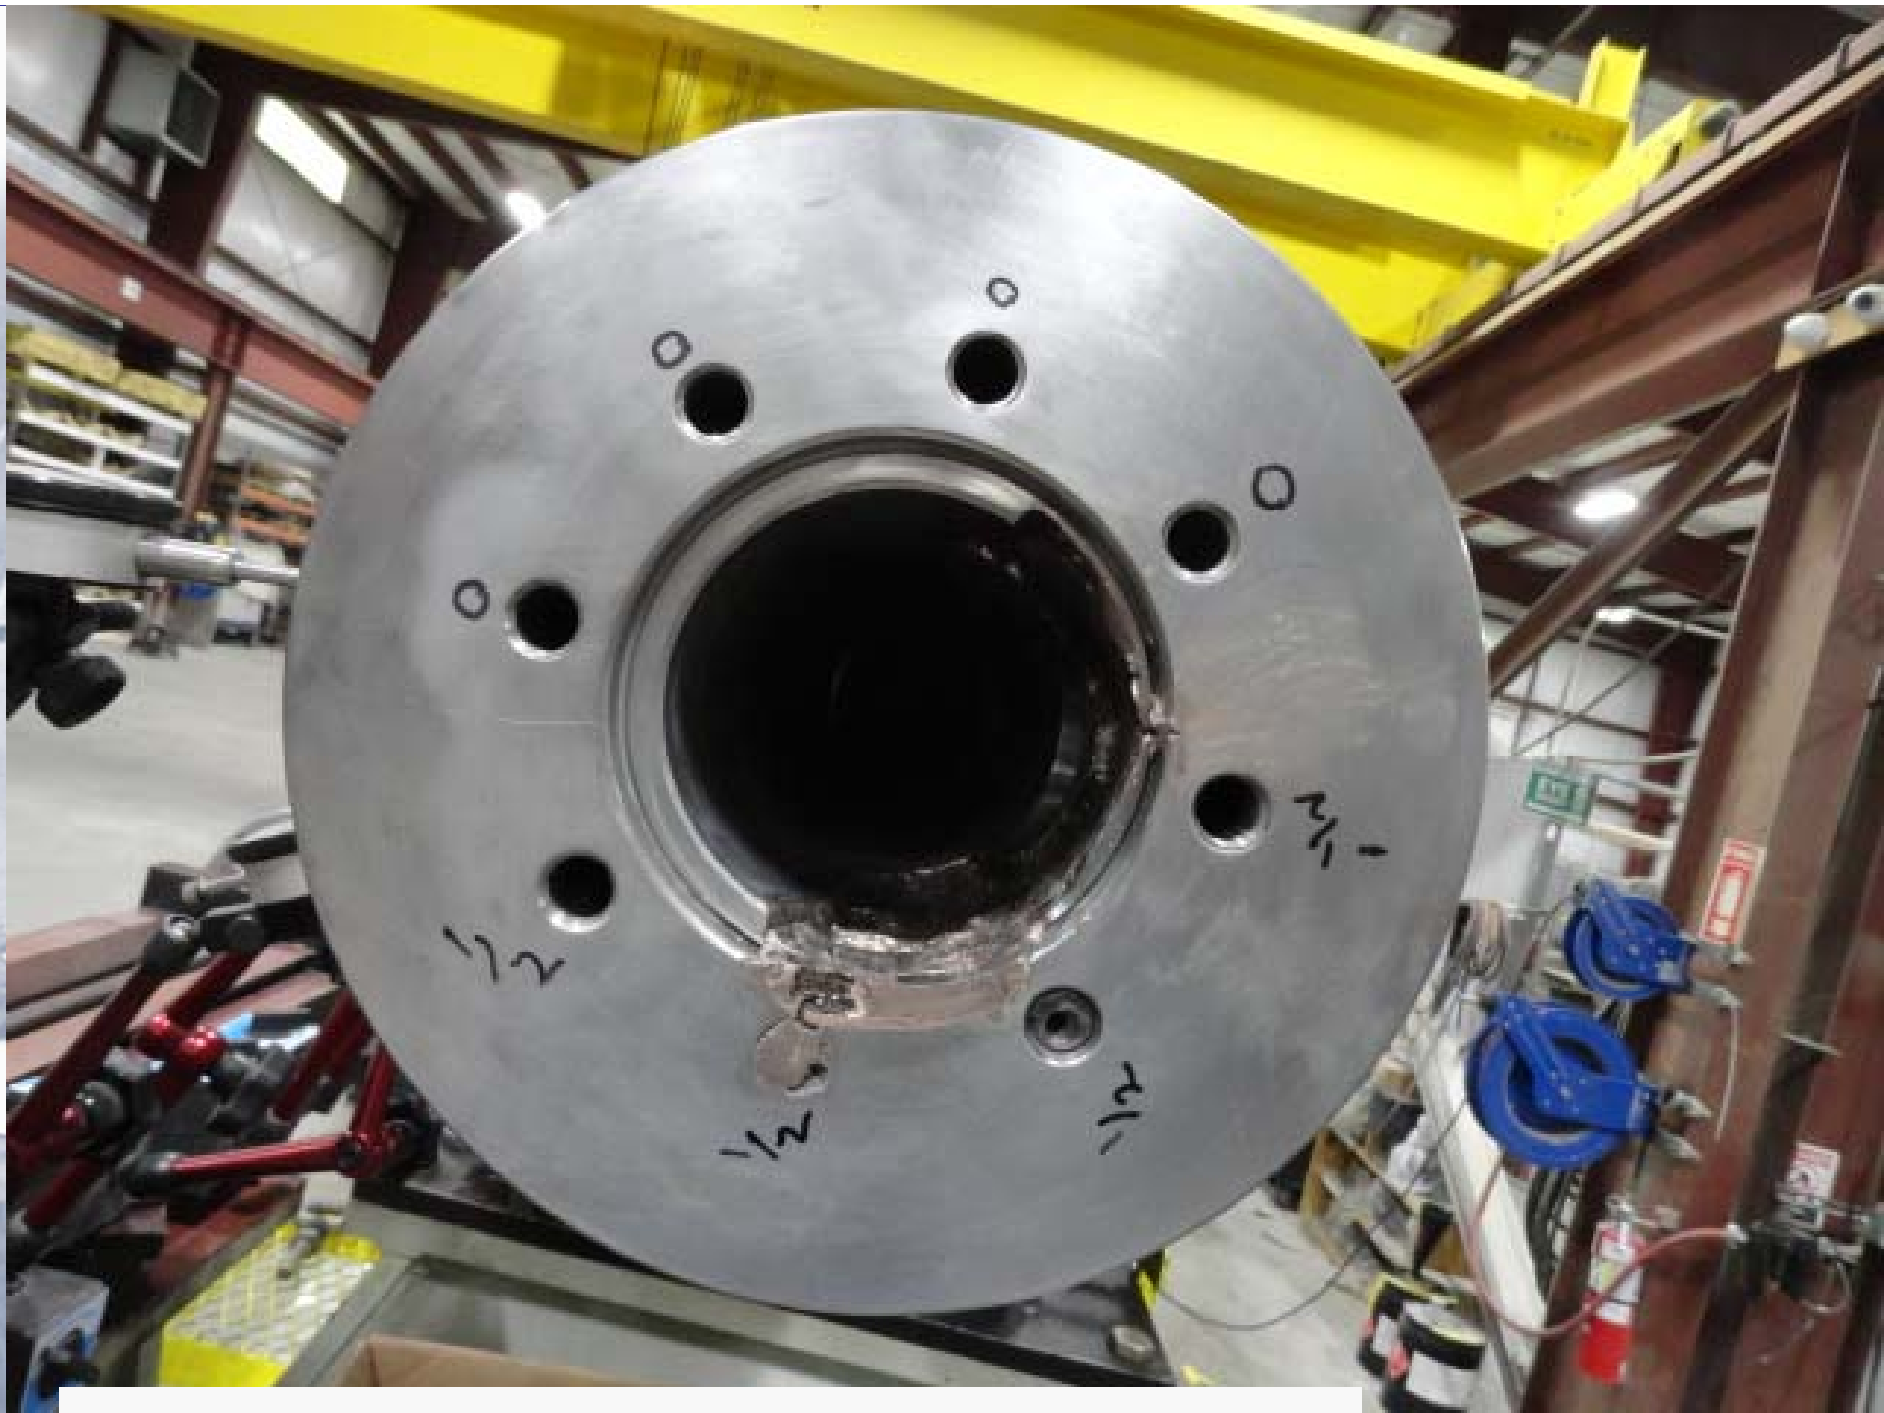
**Bore ID Damage After Cleaning**

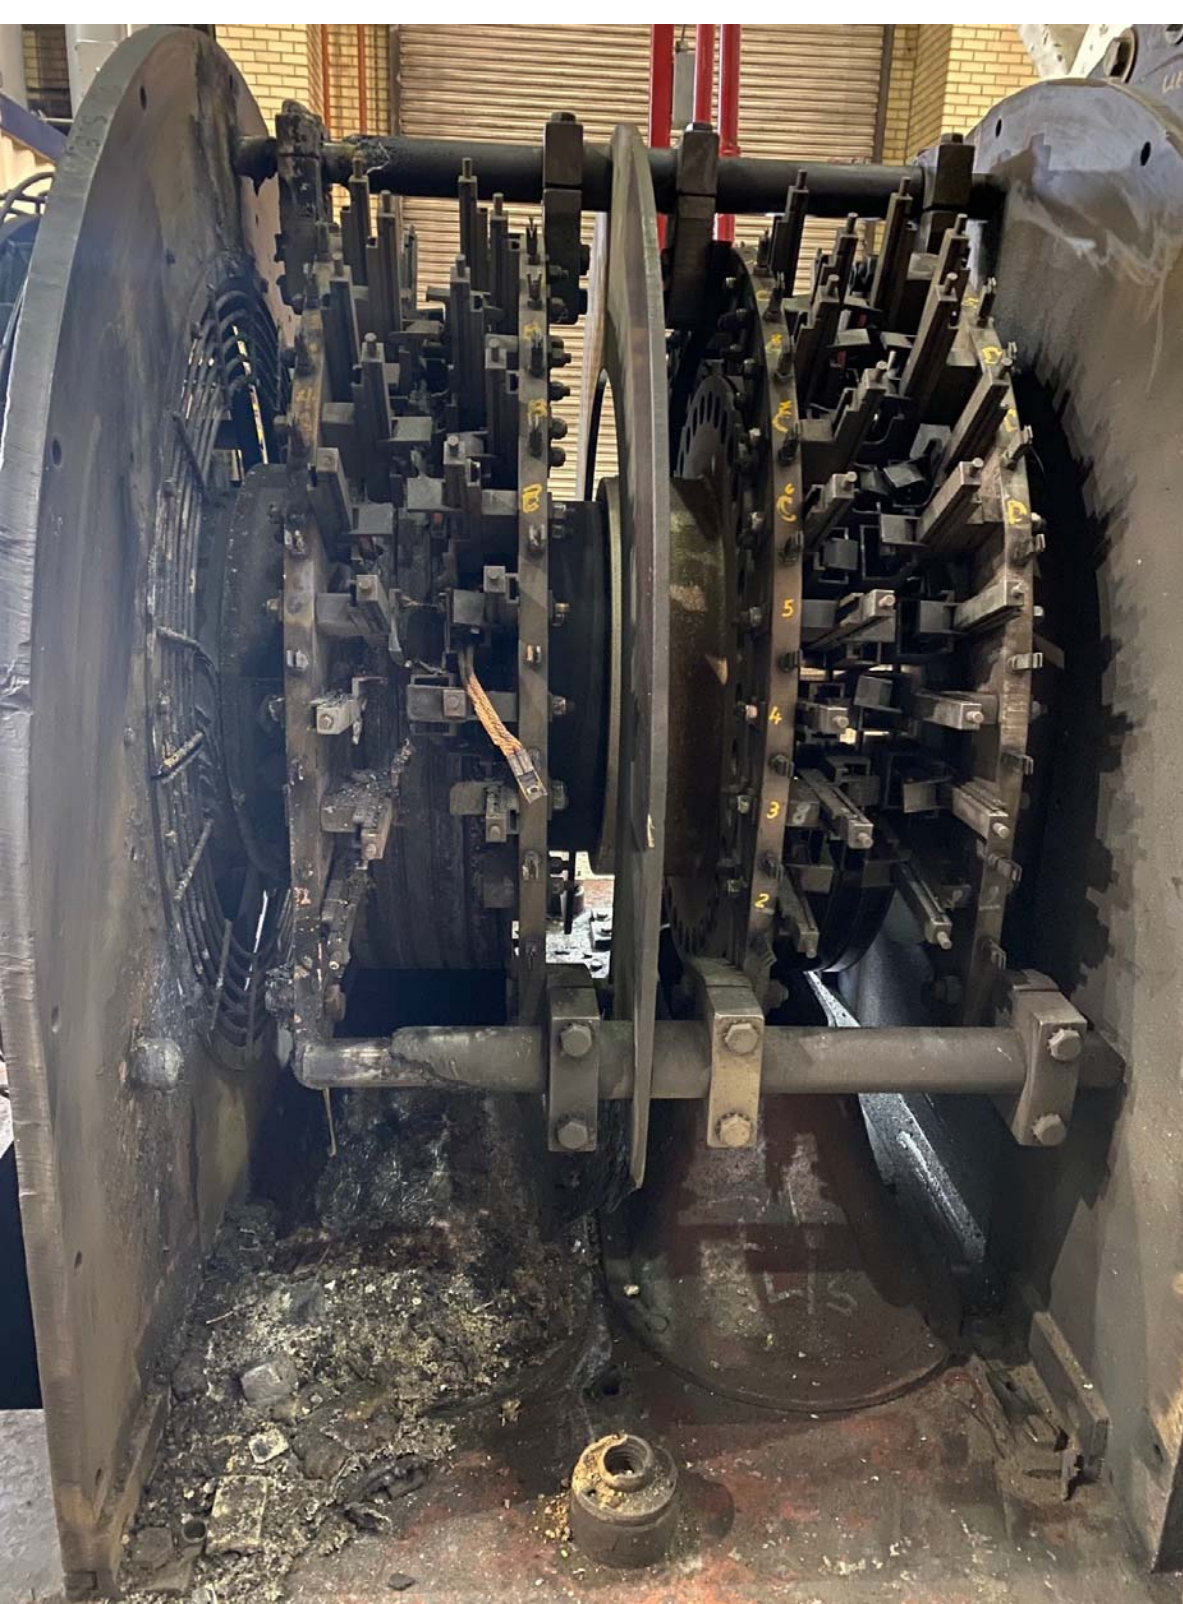
**Collector  
Ring  
Flashover  
OB Ring**

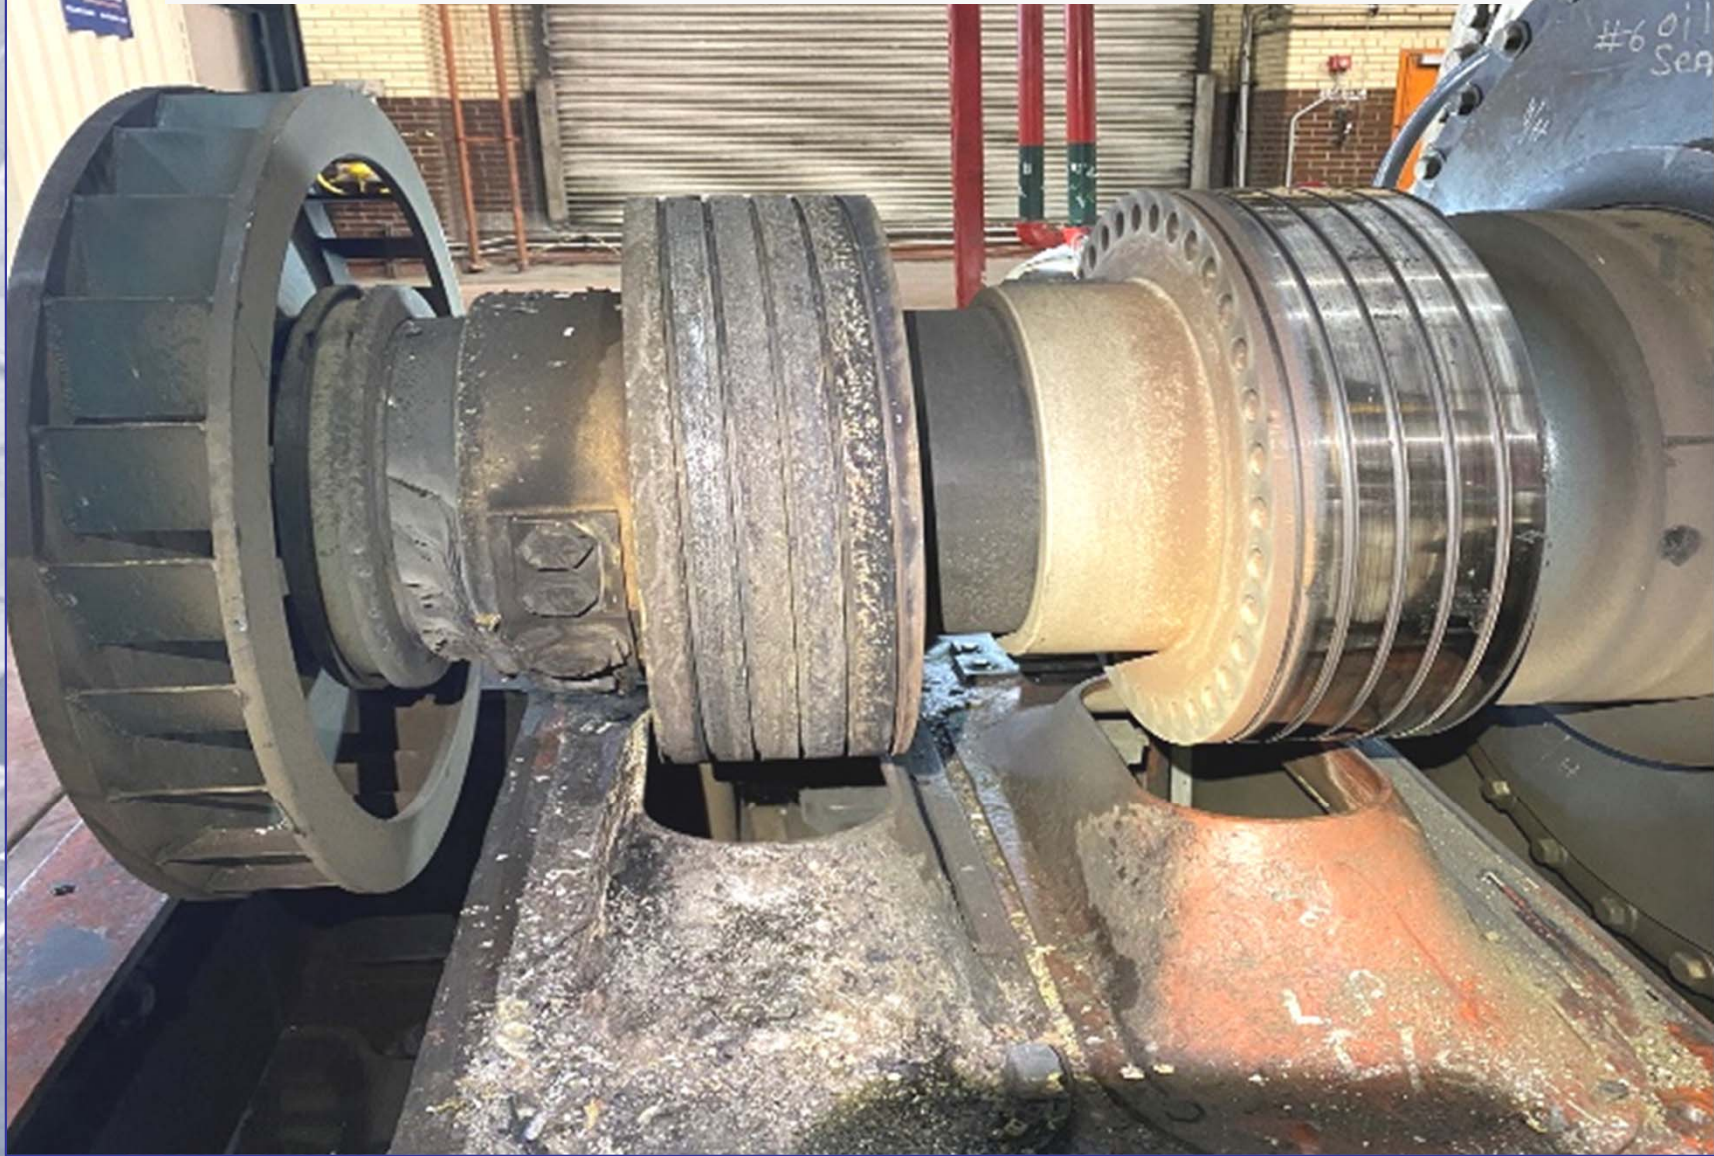
## OB Collector Ring & Shaft Damage

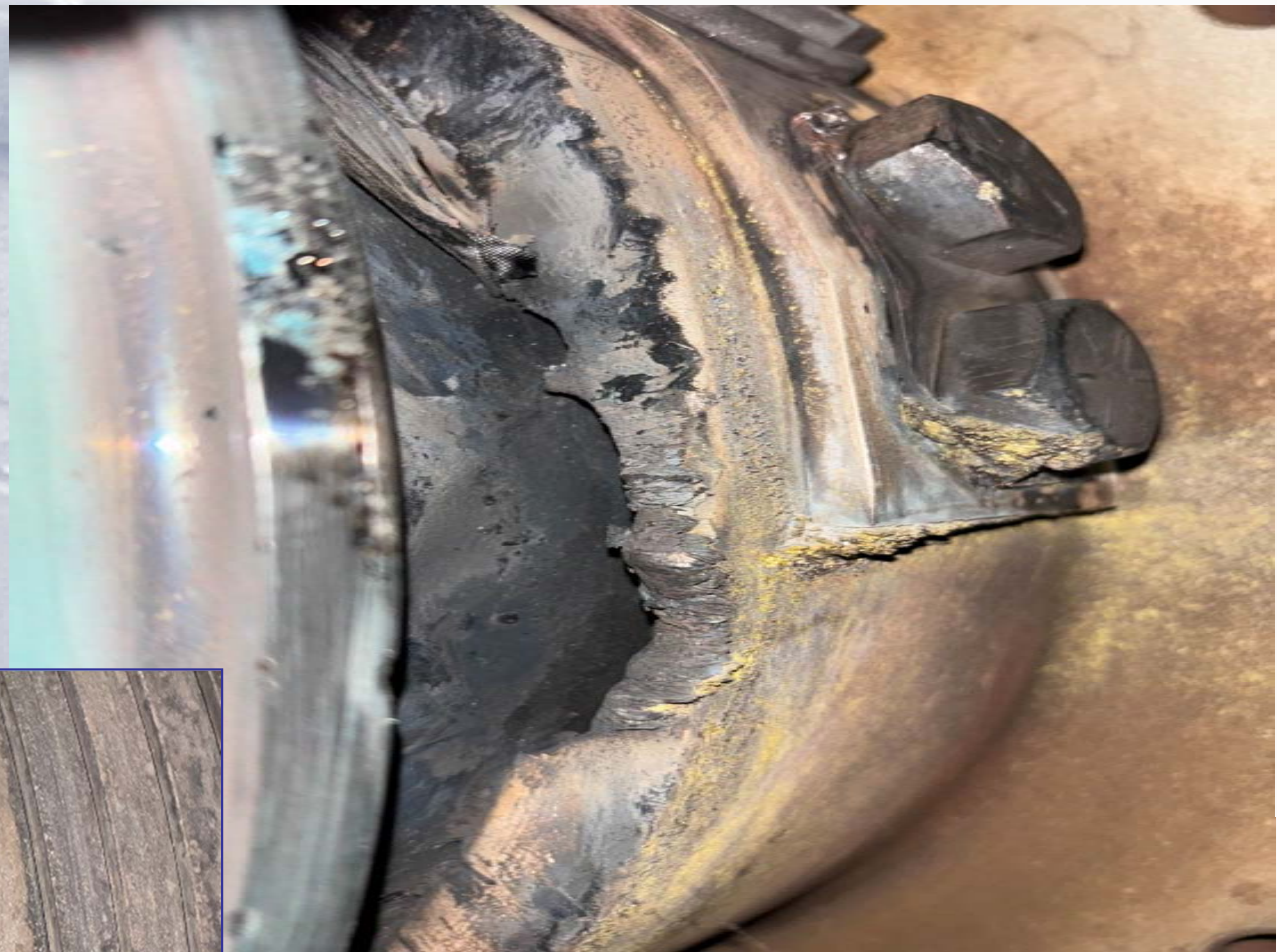
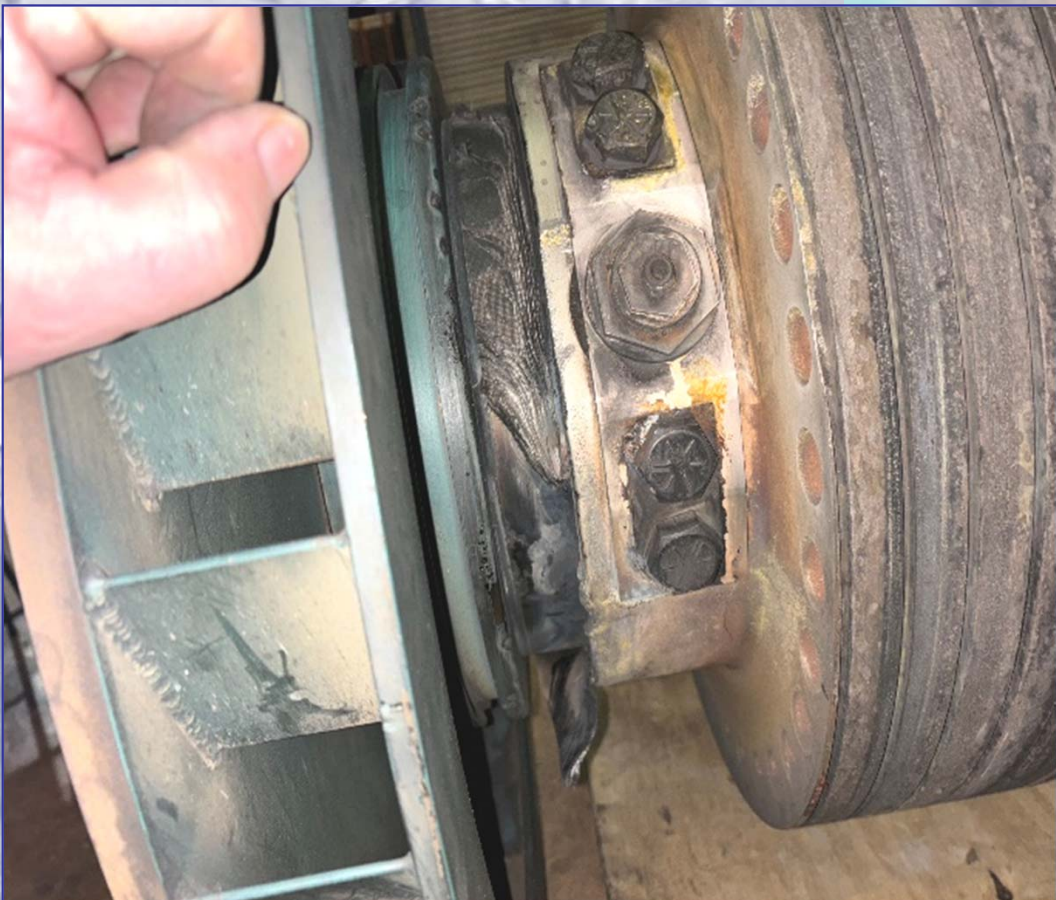
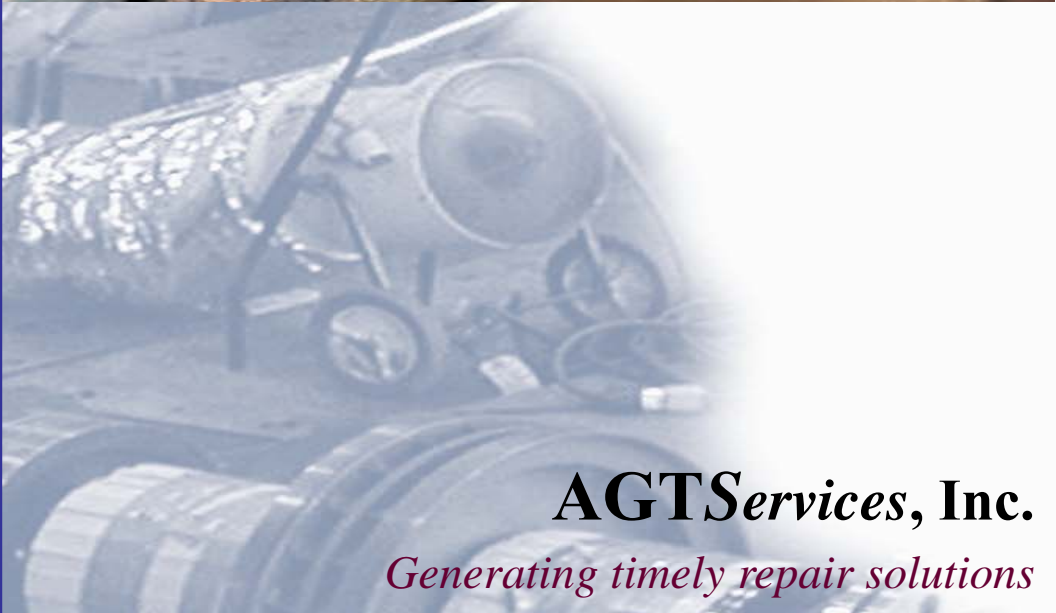
# OB Collector Ring & Shaft Damage

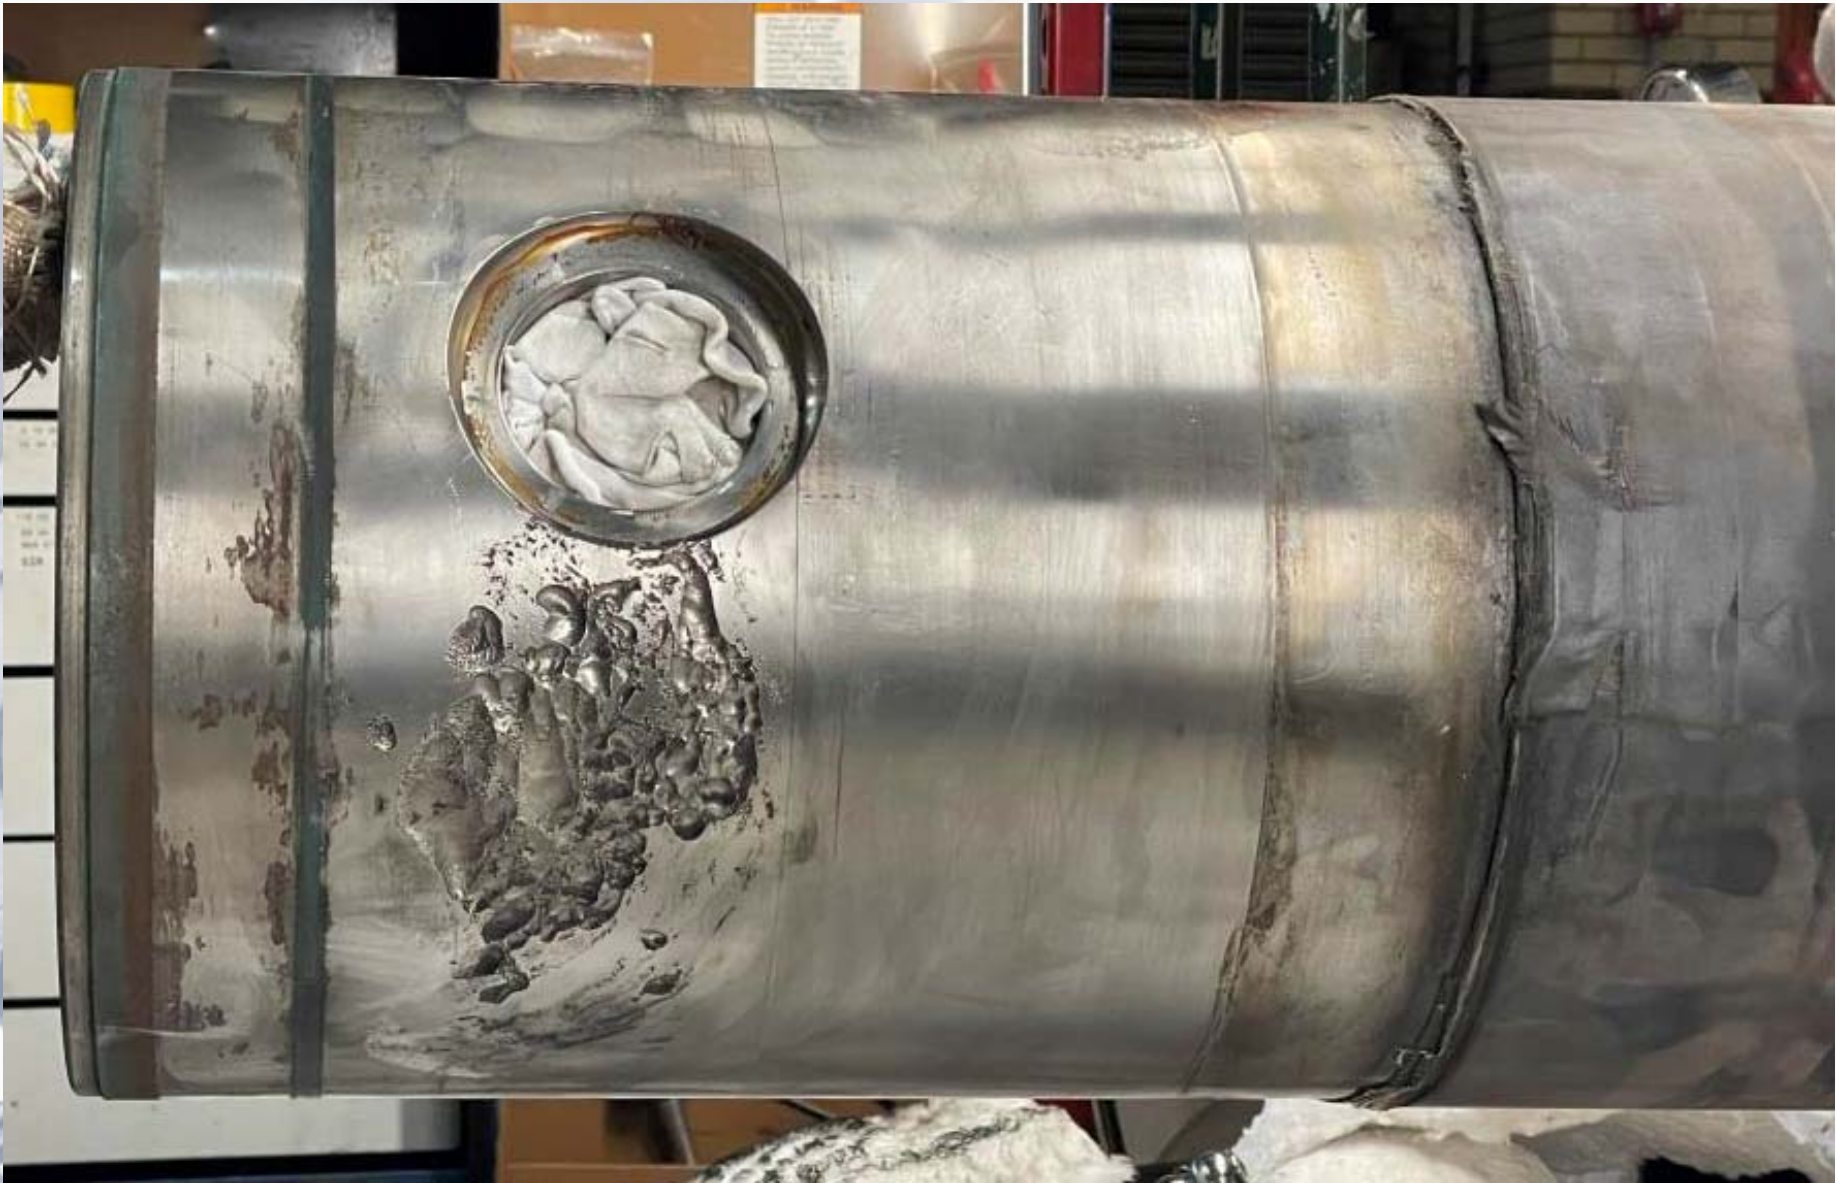
## Shaft Damage Due to Arcing

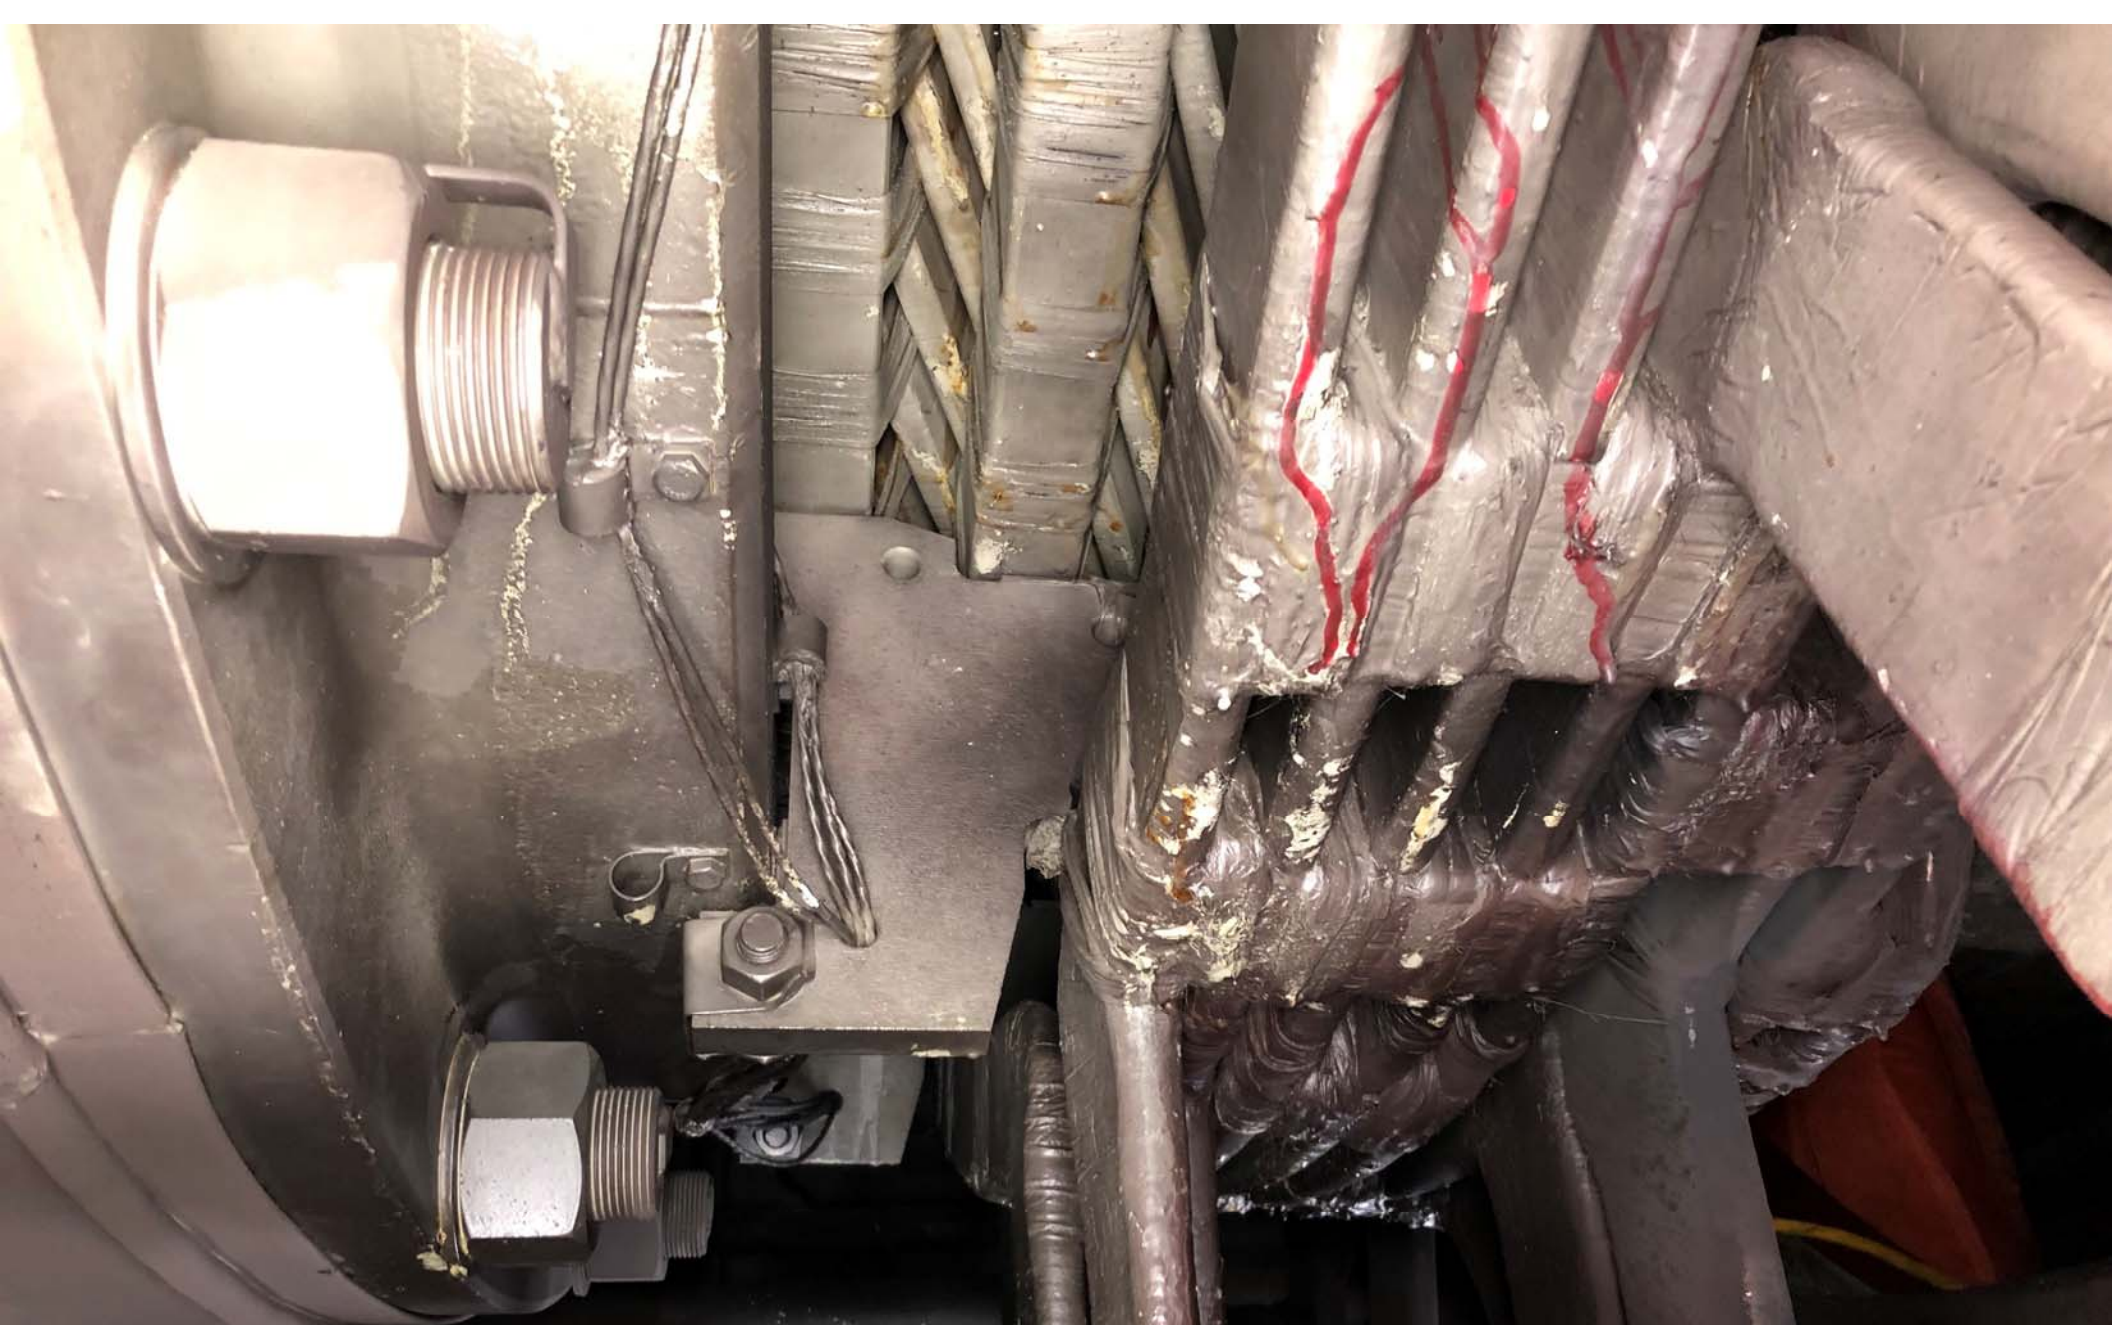
**Mechanical Abrasion  
Due to  
Loose Blocking  
& Loose Ties**
