# Creative Solutions For Significant Generator Failure Damage

**GE 9A4  
Shaft ID Damage  
& Repair**

# GE Water Cooled LP Shaft OD Damage & Repair

# GE 324 Main Lead Repairs

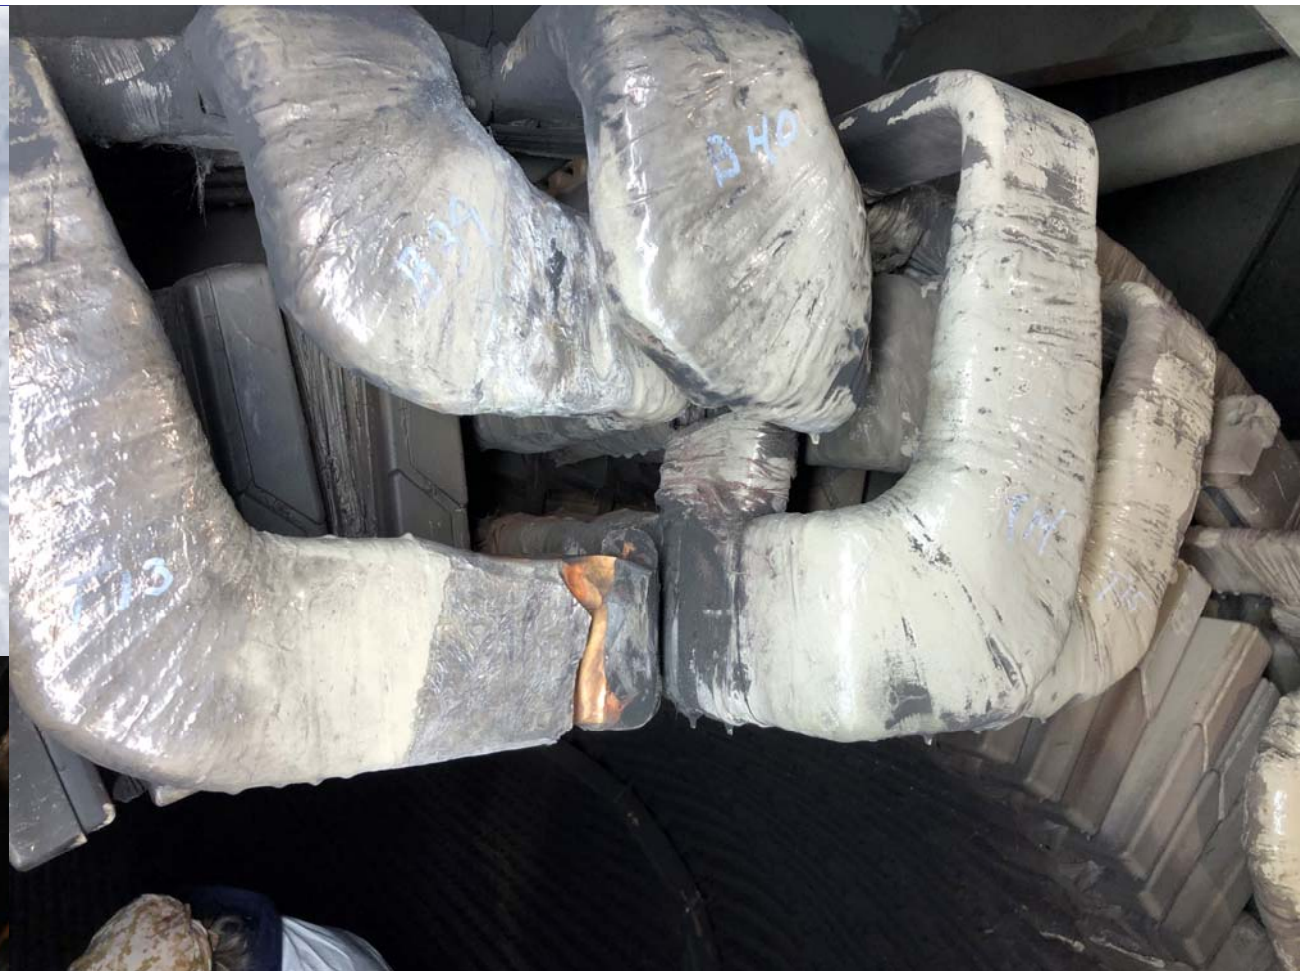
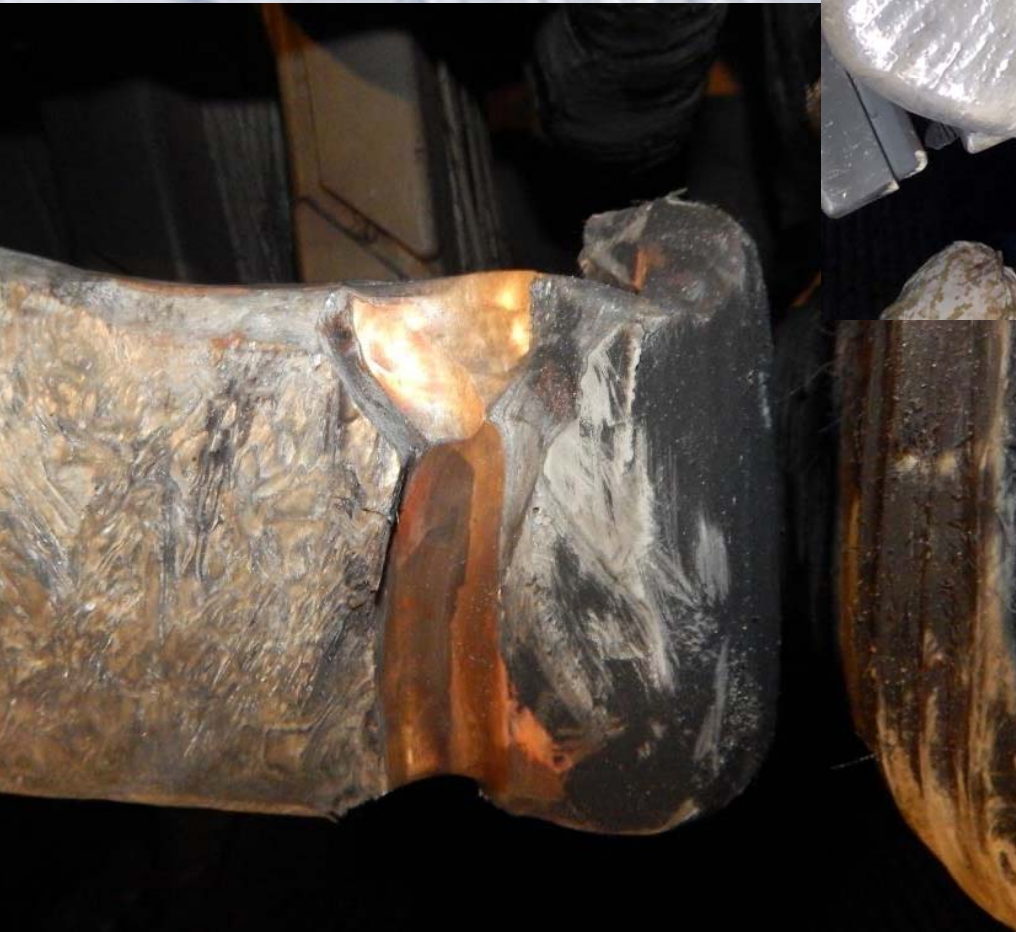
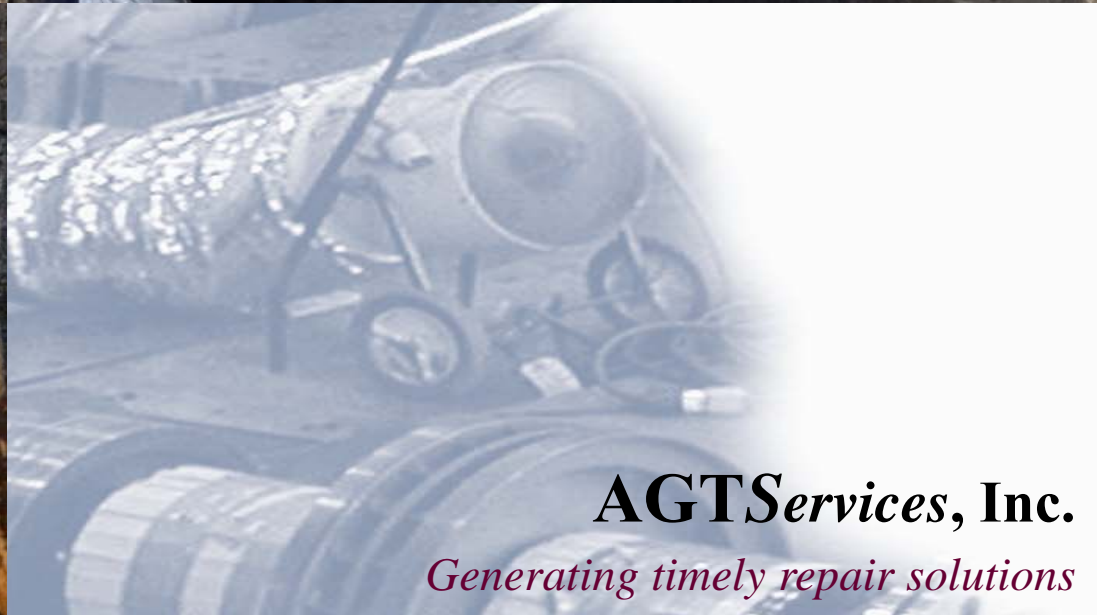
**Mechanical Abrasion  
Due to  
Loose Blocking  
& Loose Ties**

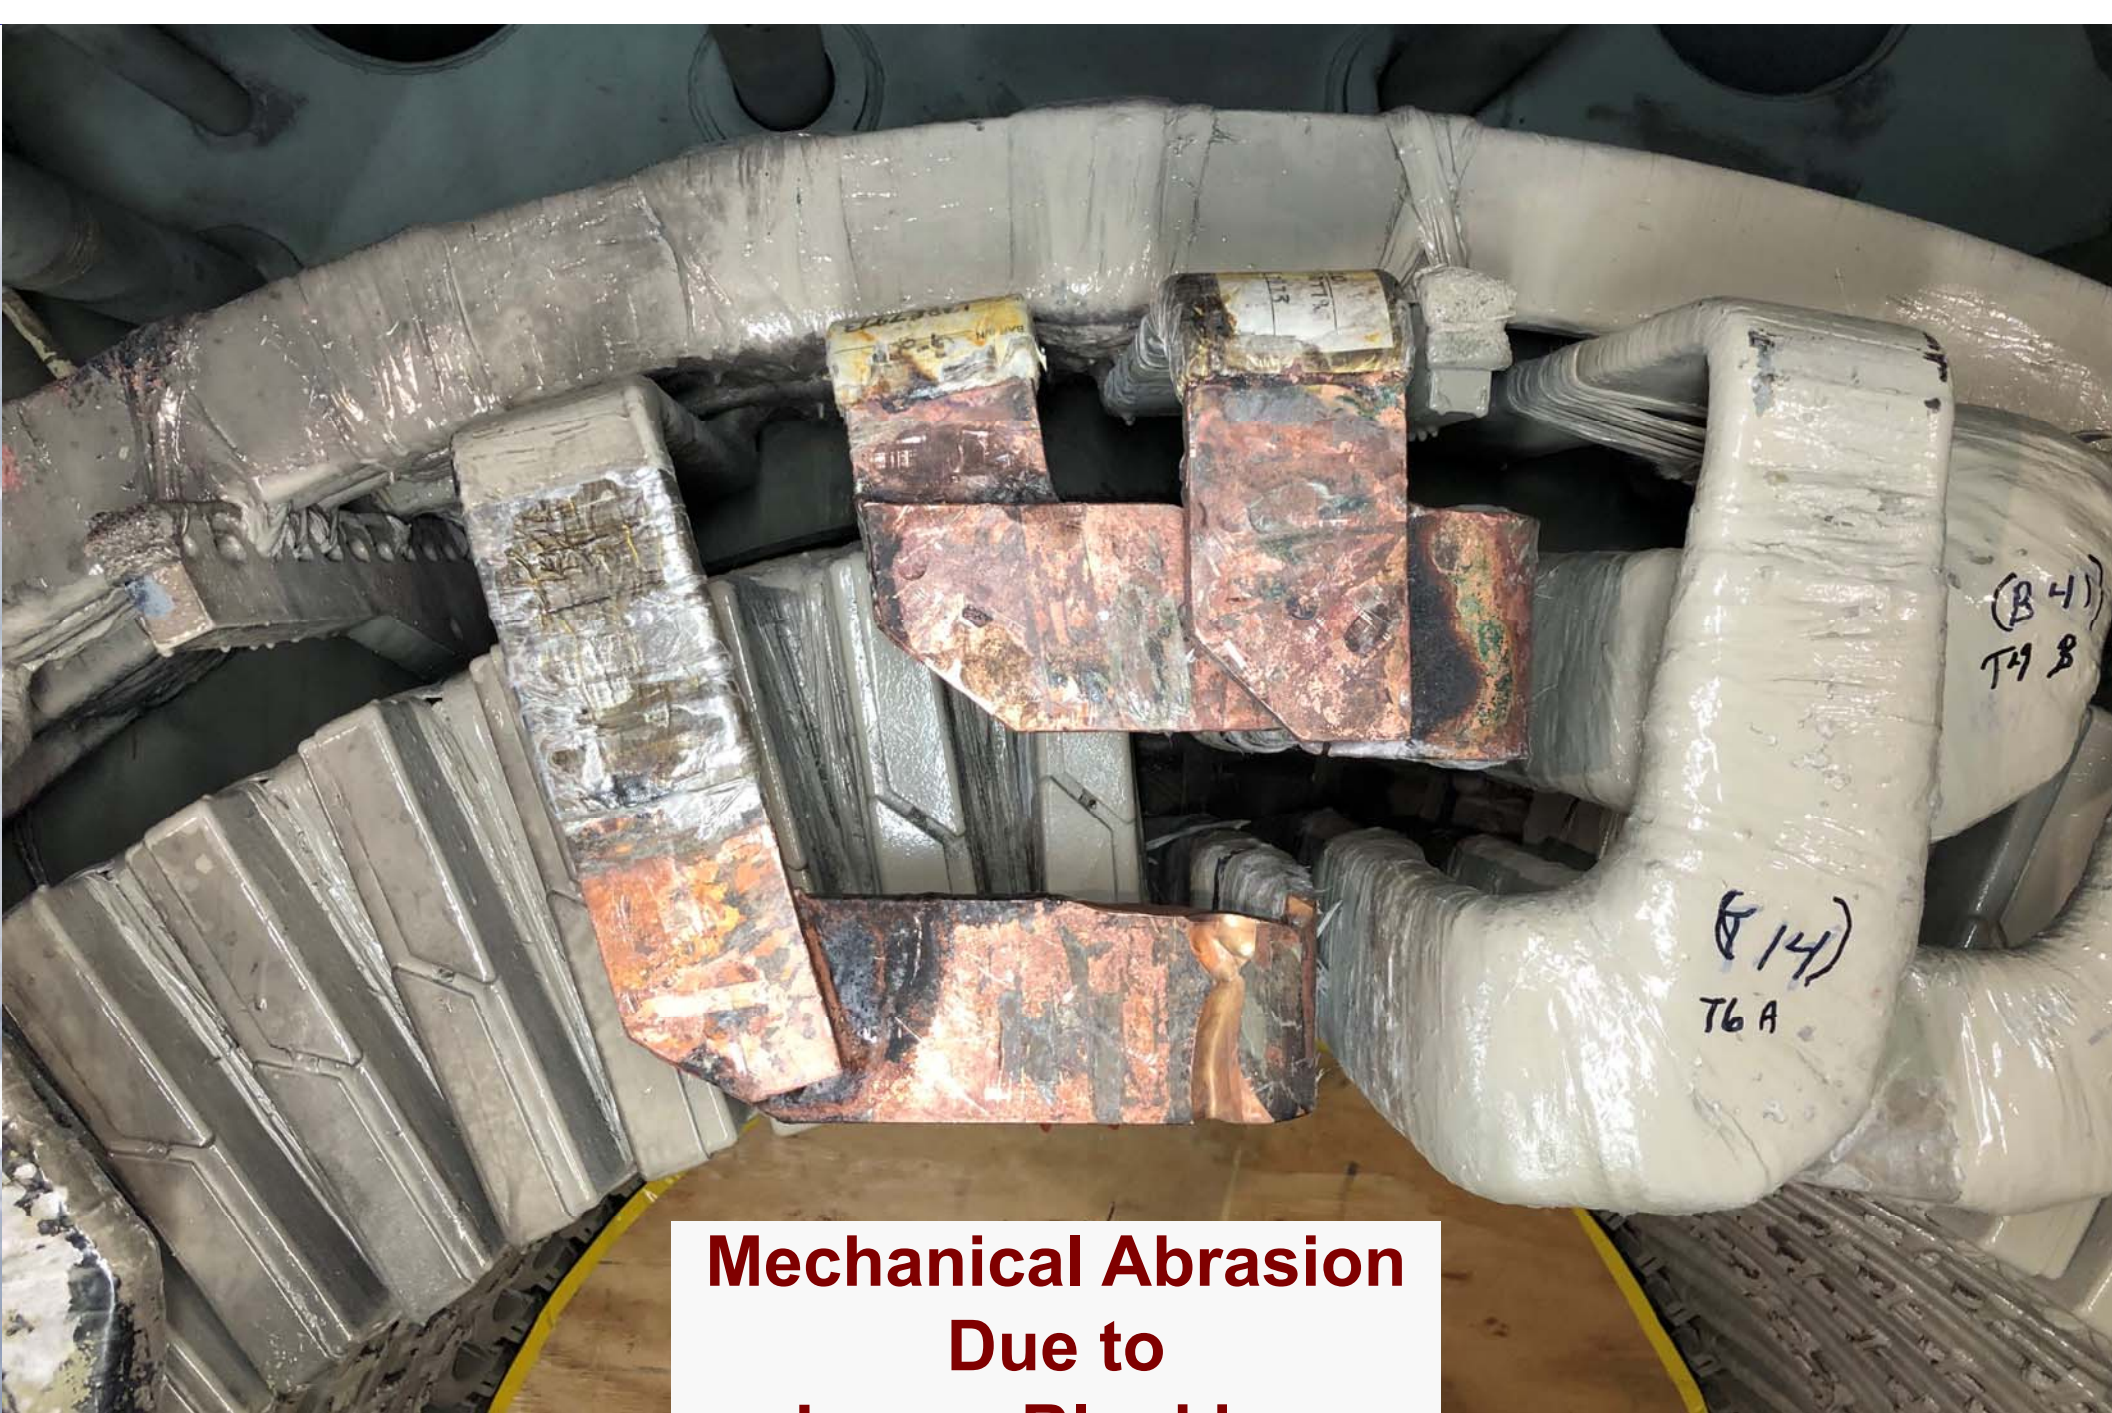
**Mechanical Abrasion  
Due to  
Loose Blocking  
& Loose Ties**

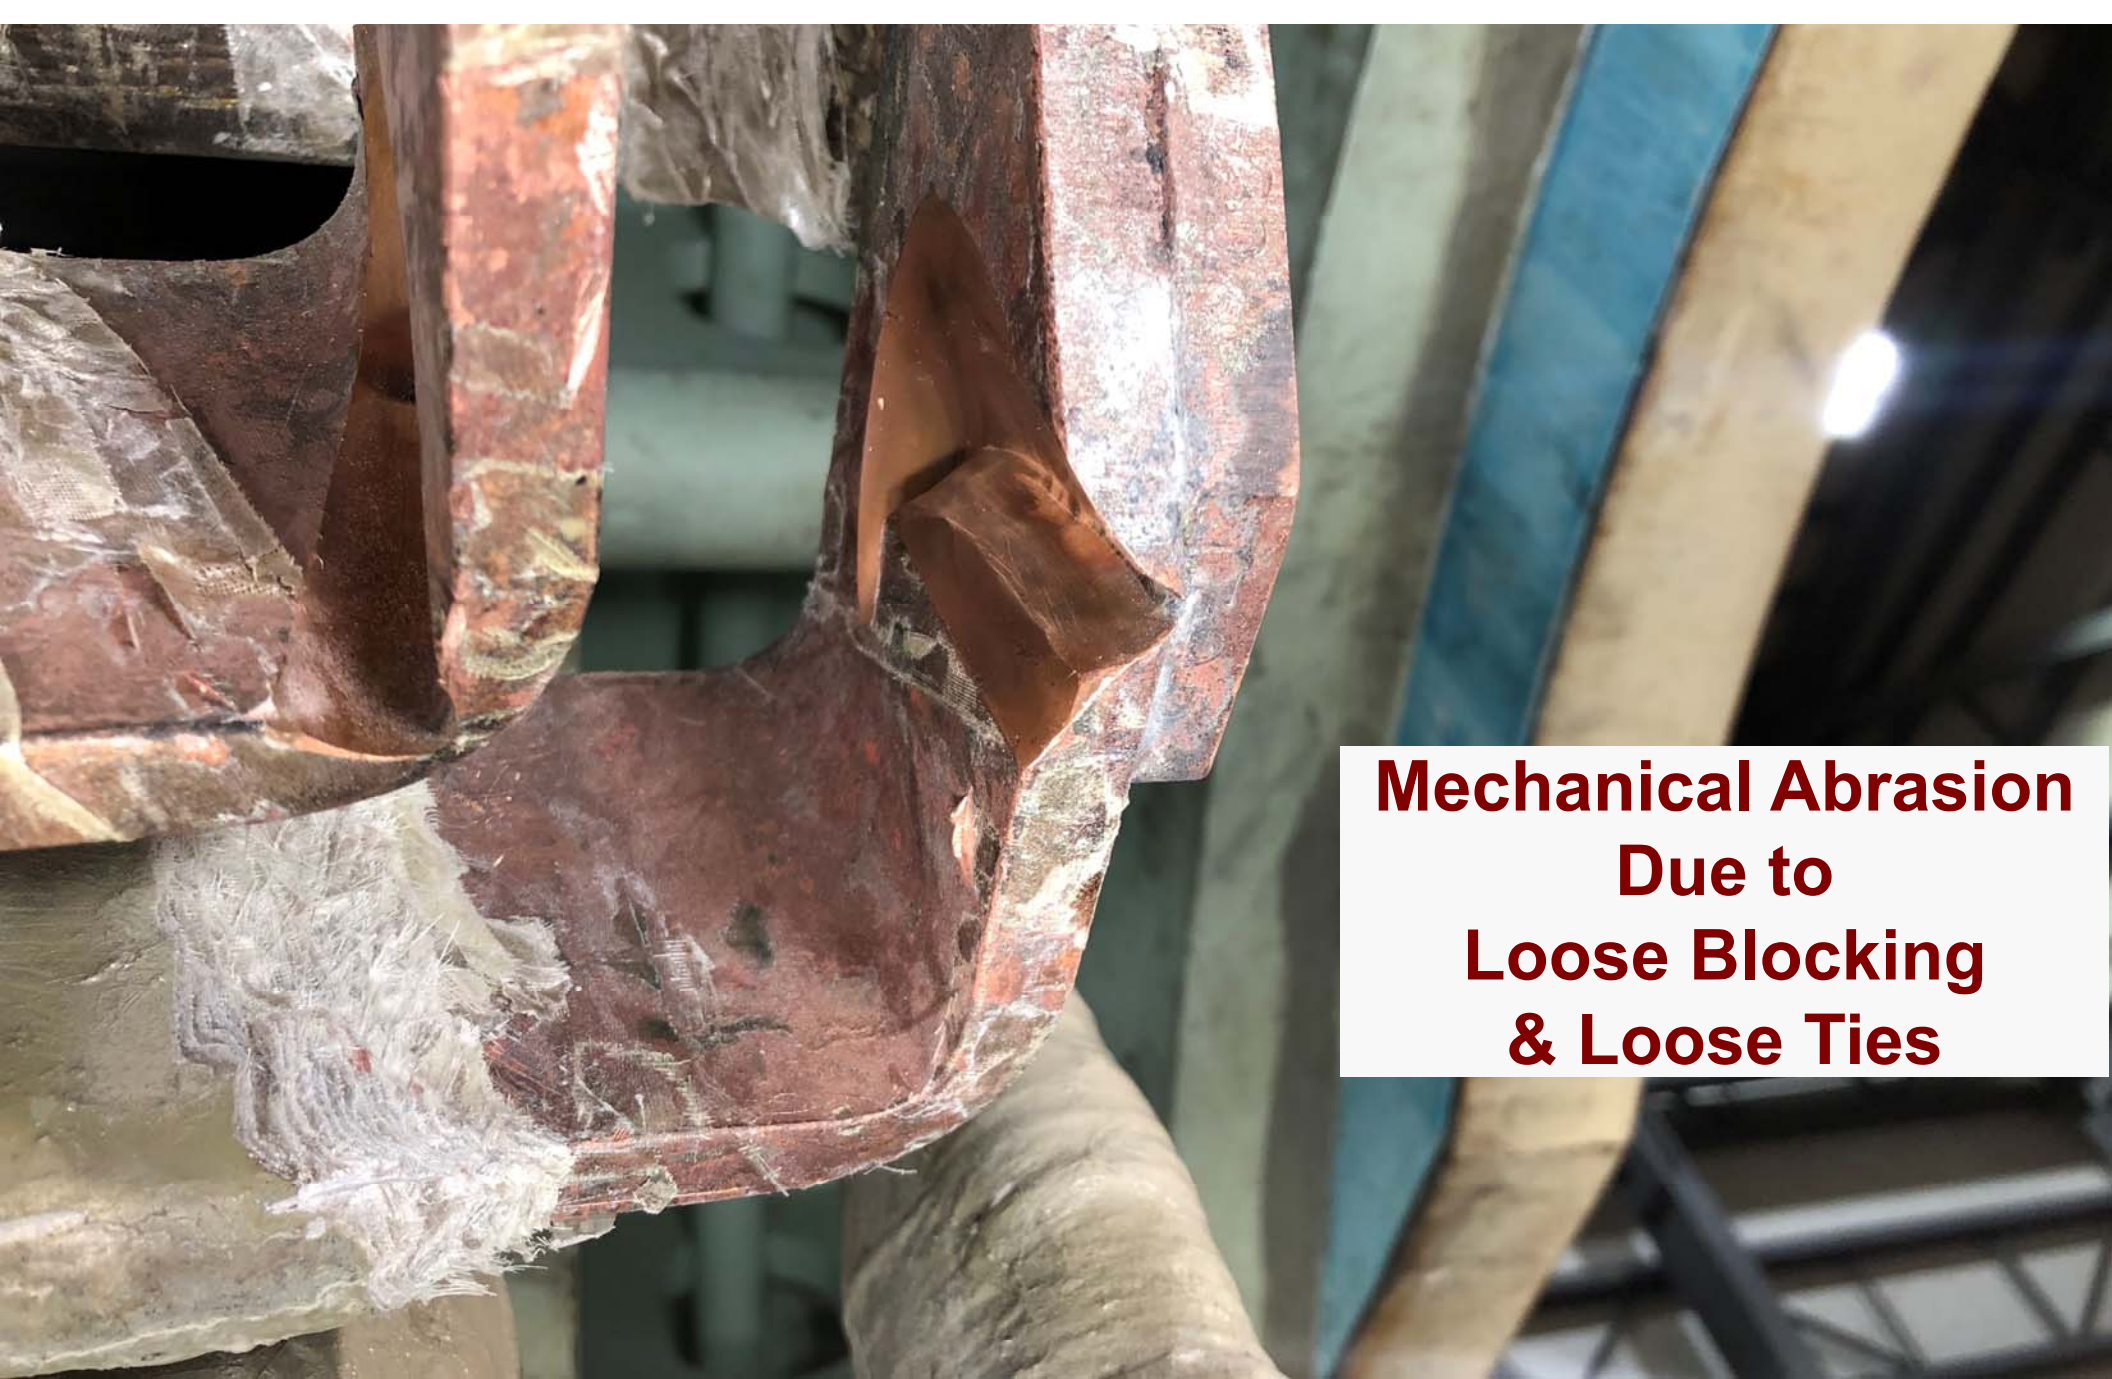
**Mechanical Abrasion  
Due to  
Loose Blocking  
& Loose Ties**

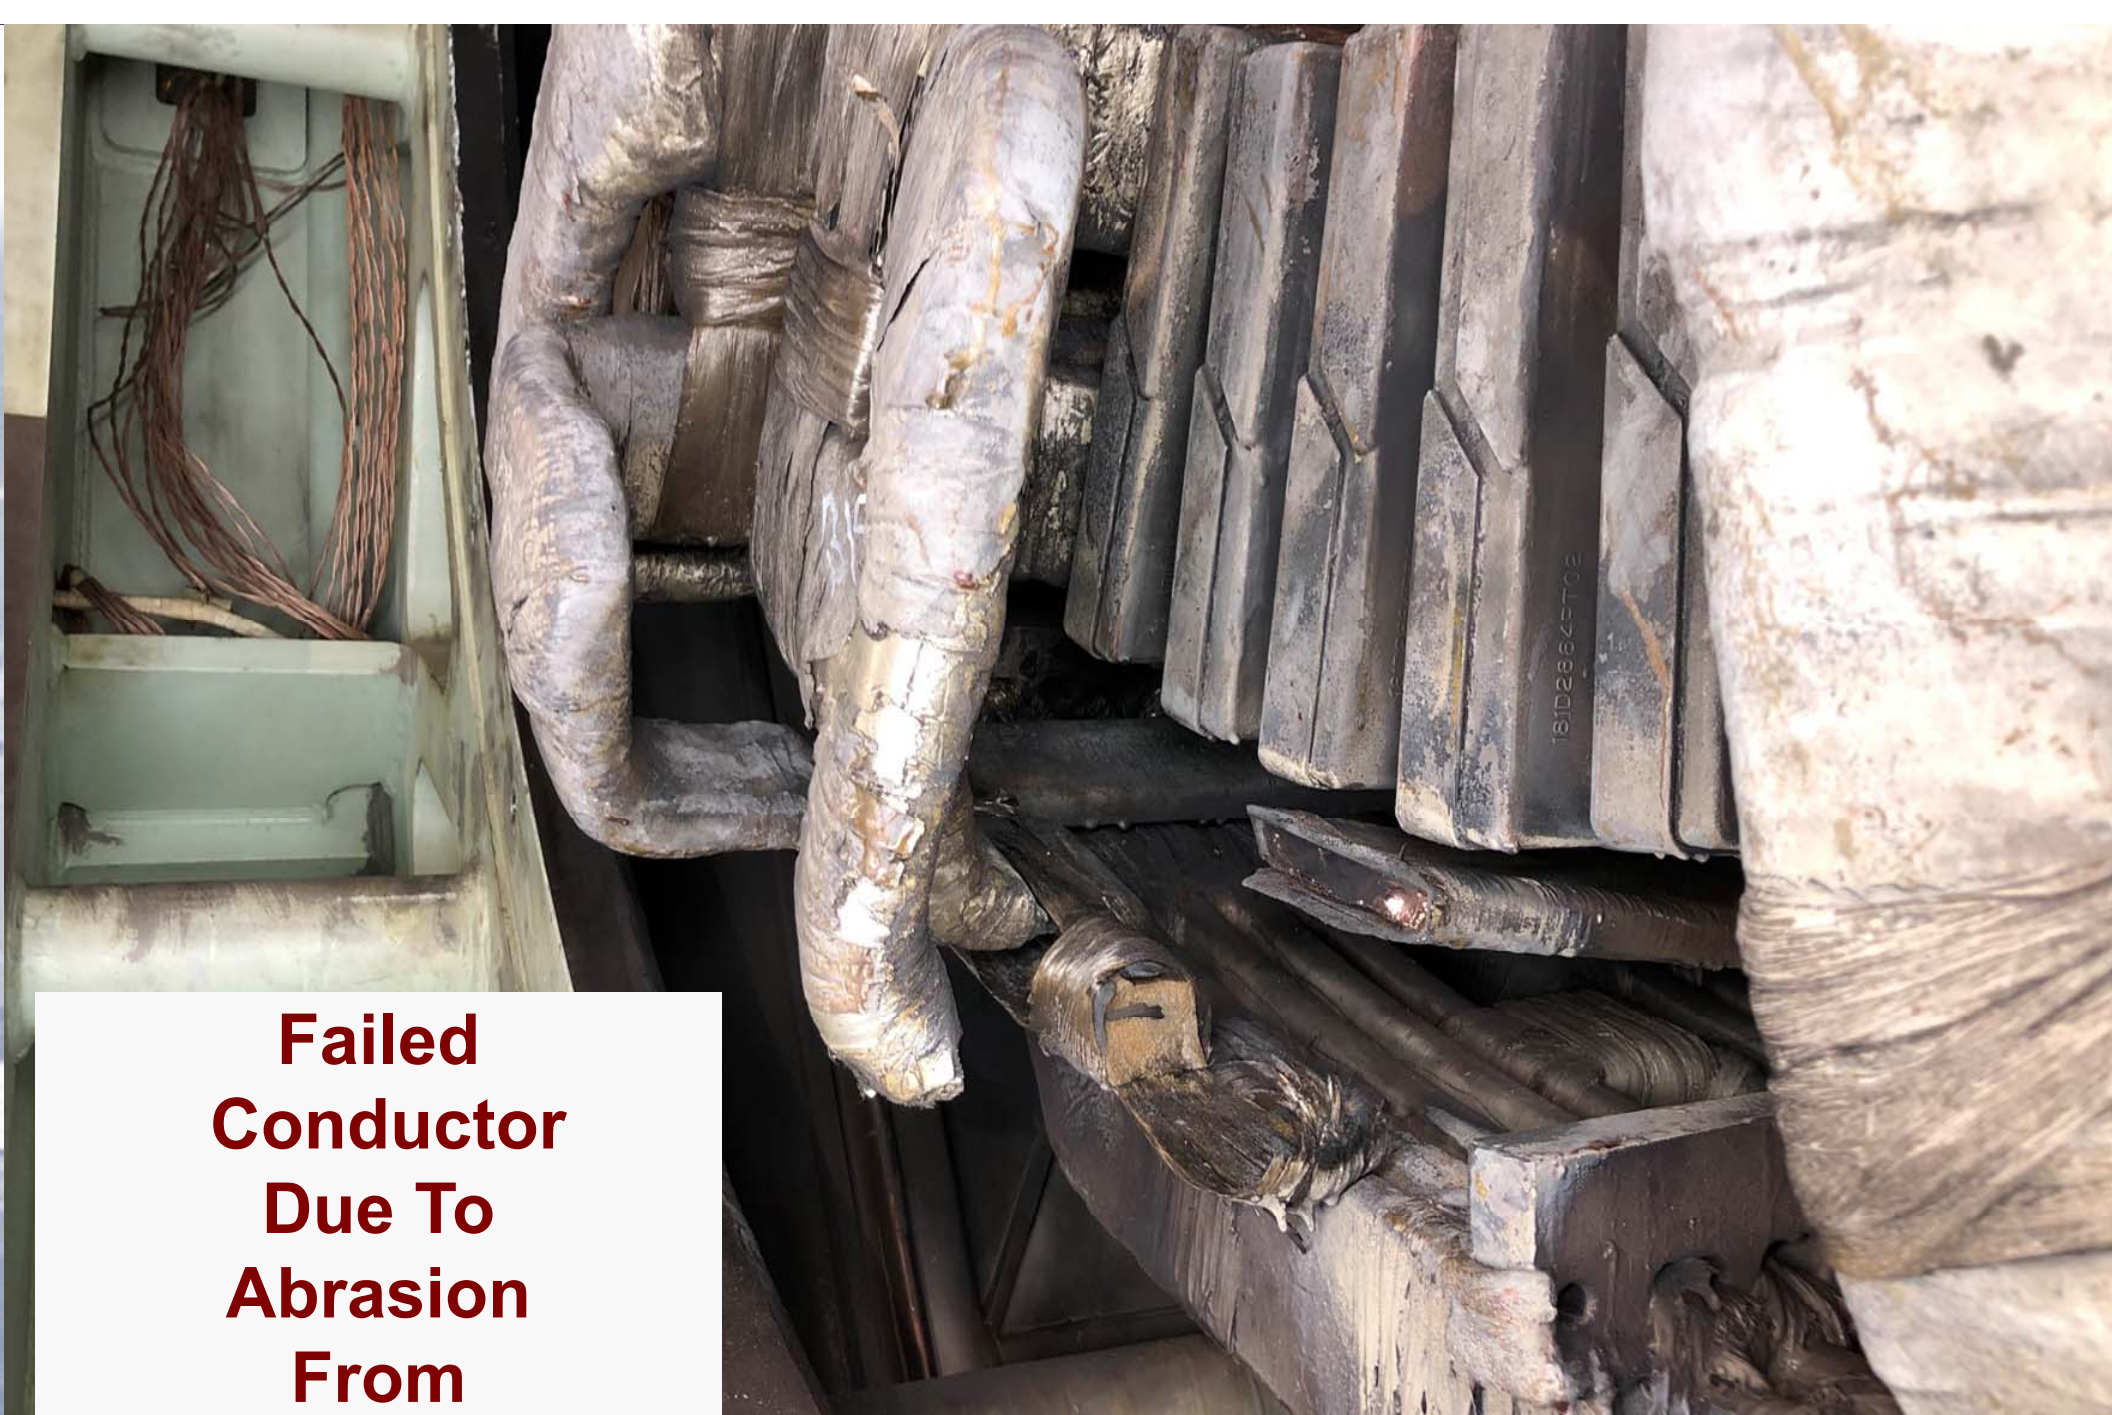
**Failed  
Conductor  
Due To  
Abrasion  
From  
Loose Blocks &  
Ties**

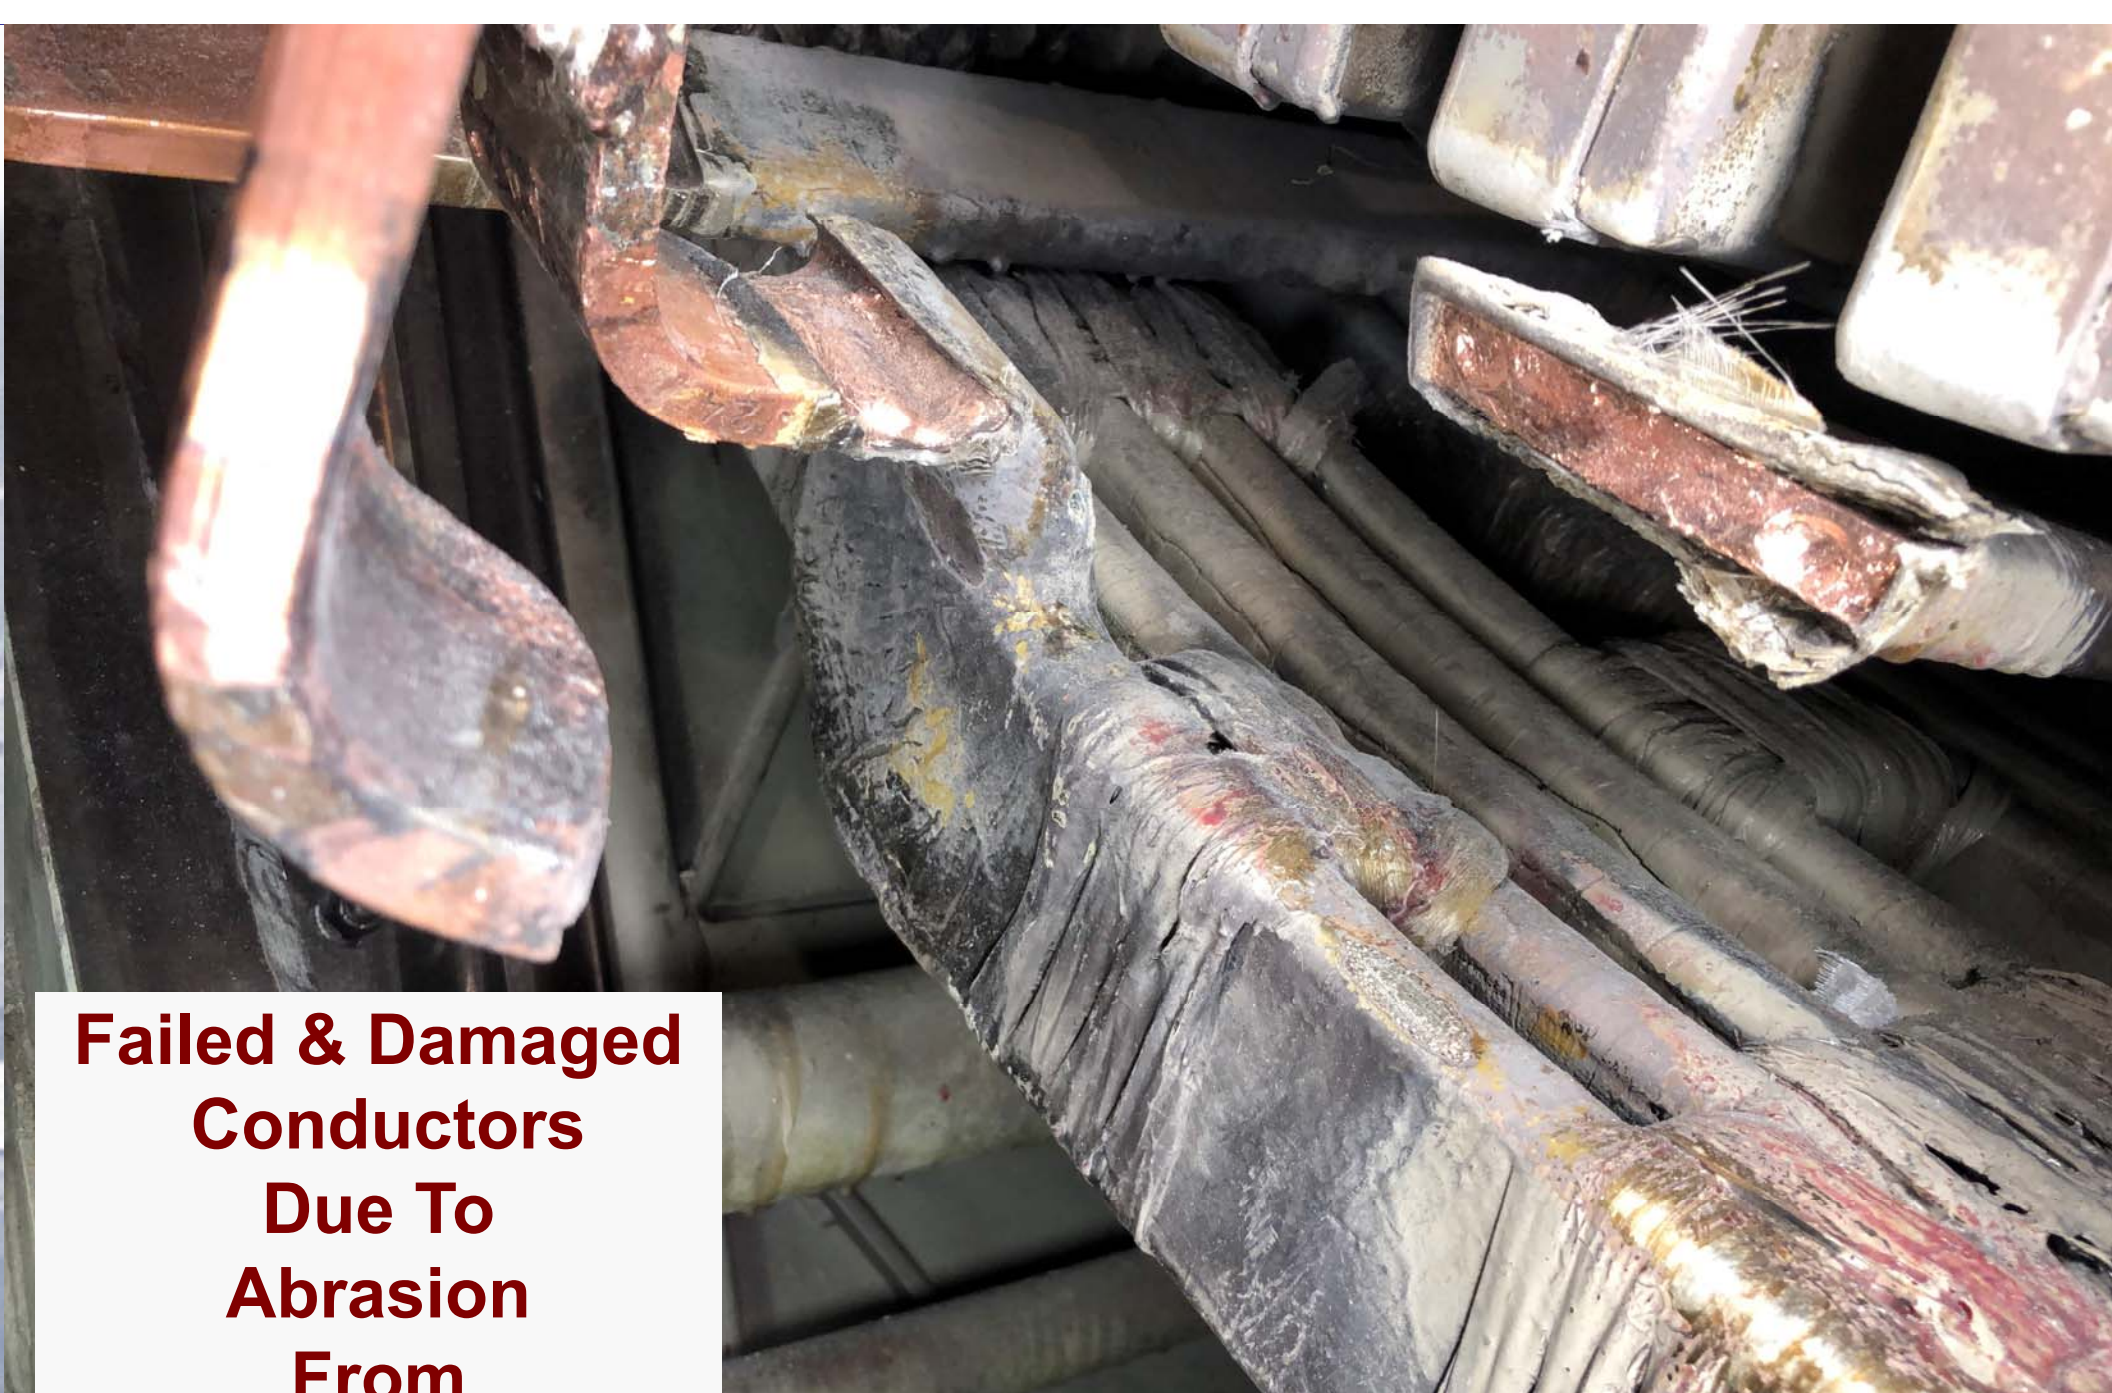
**Failed & Damaged  
Conductors  
Due To  
Abrasion  
From  
Loose Blocks &  
Ties**

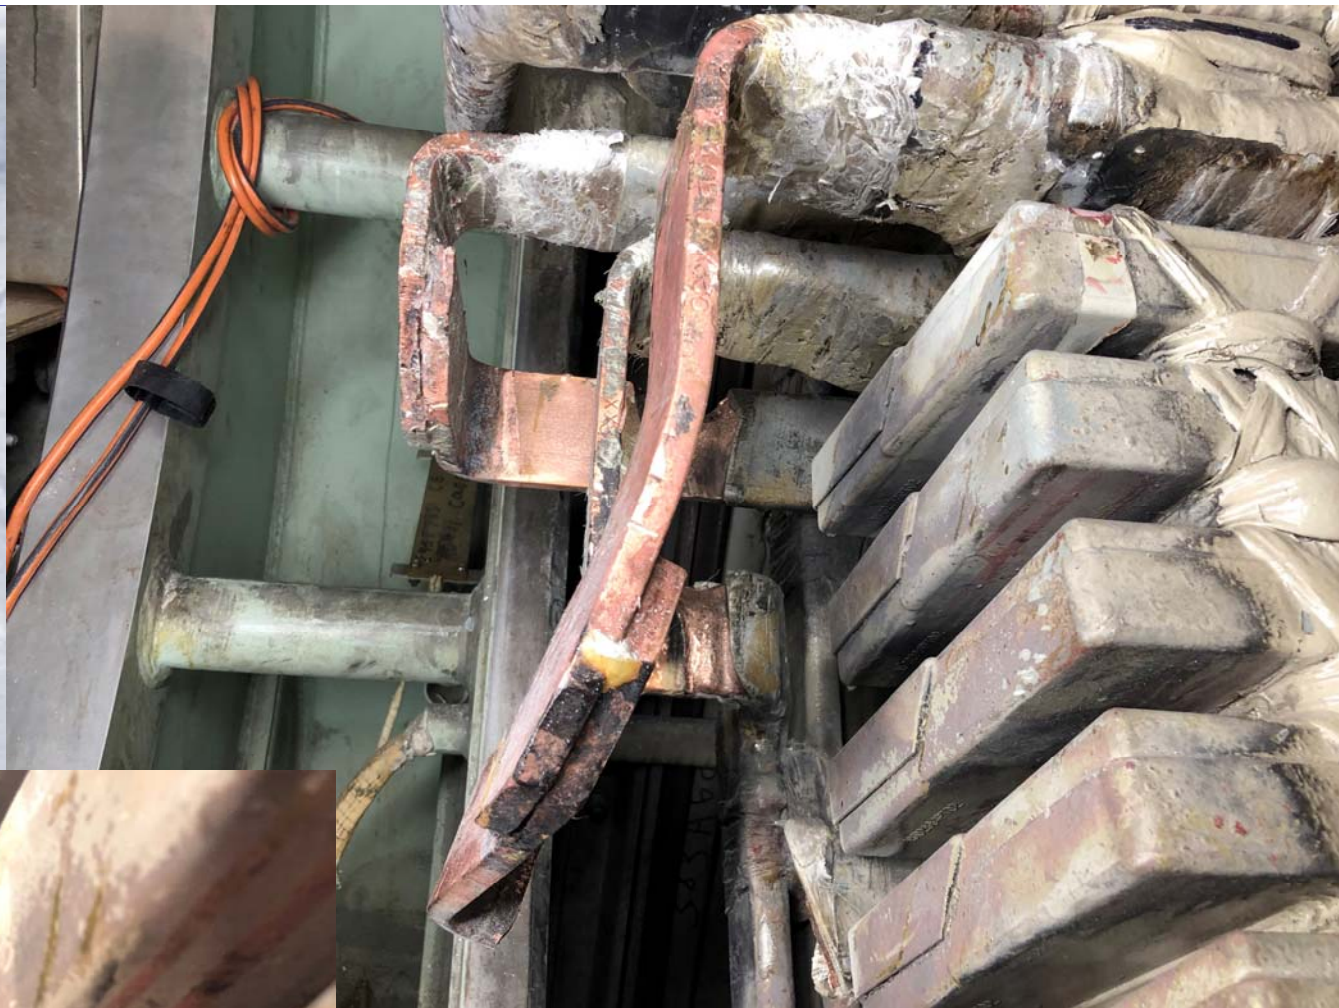
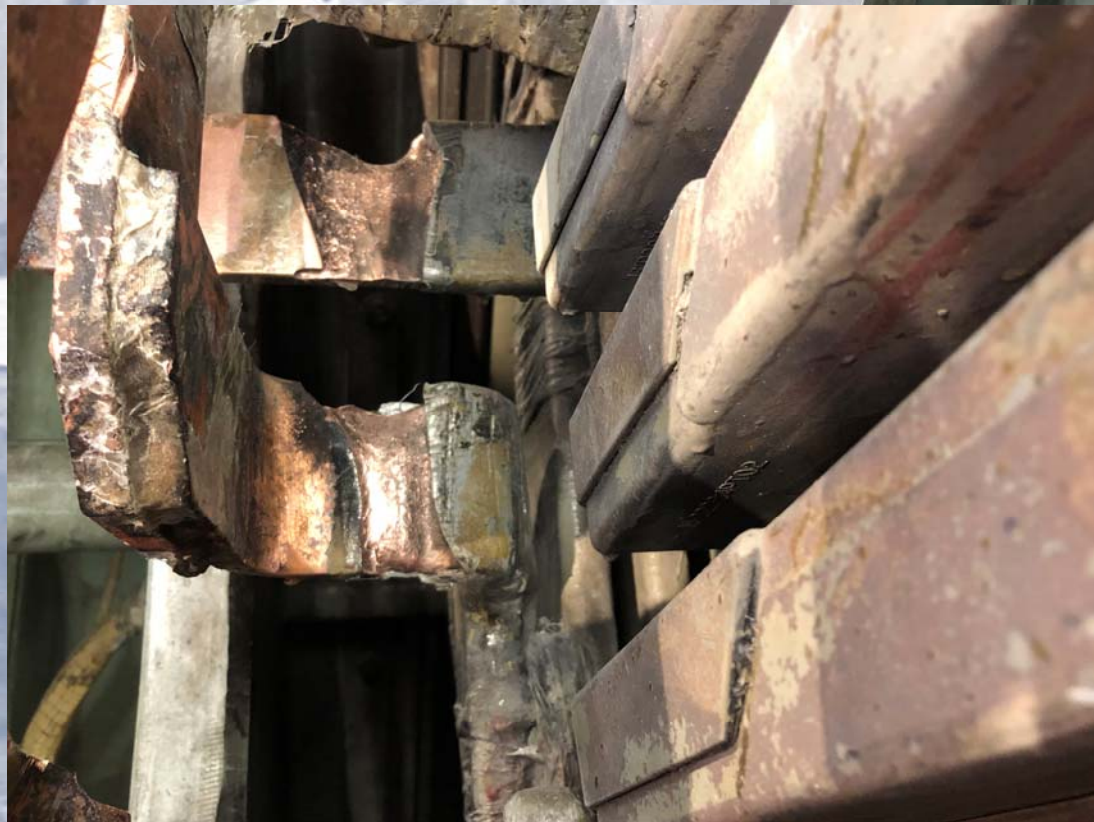
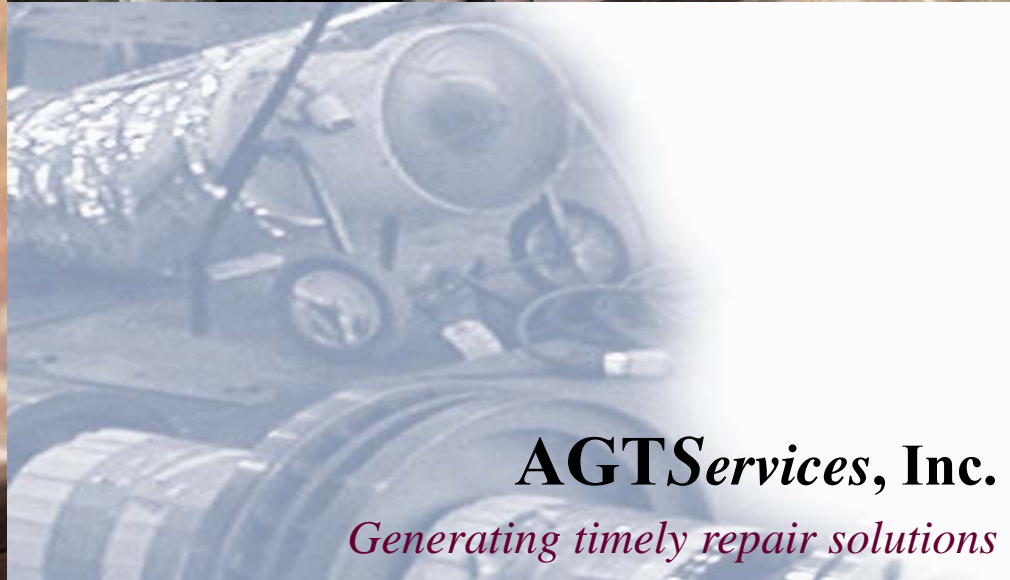
**Failed & Damaged  
Conductors  
Due To  
Abrasion  
From  
Loose Blocks &  
Ties**

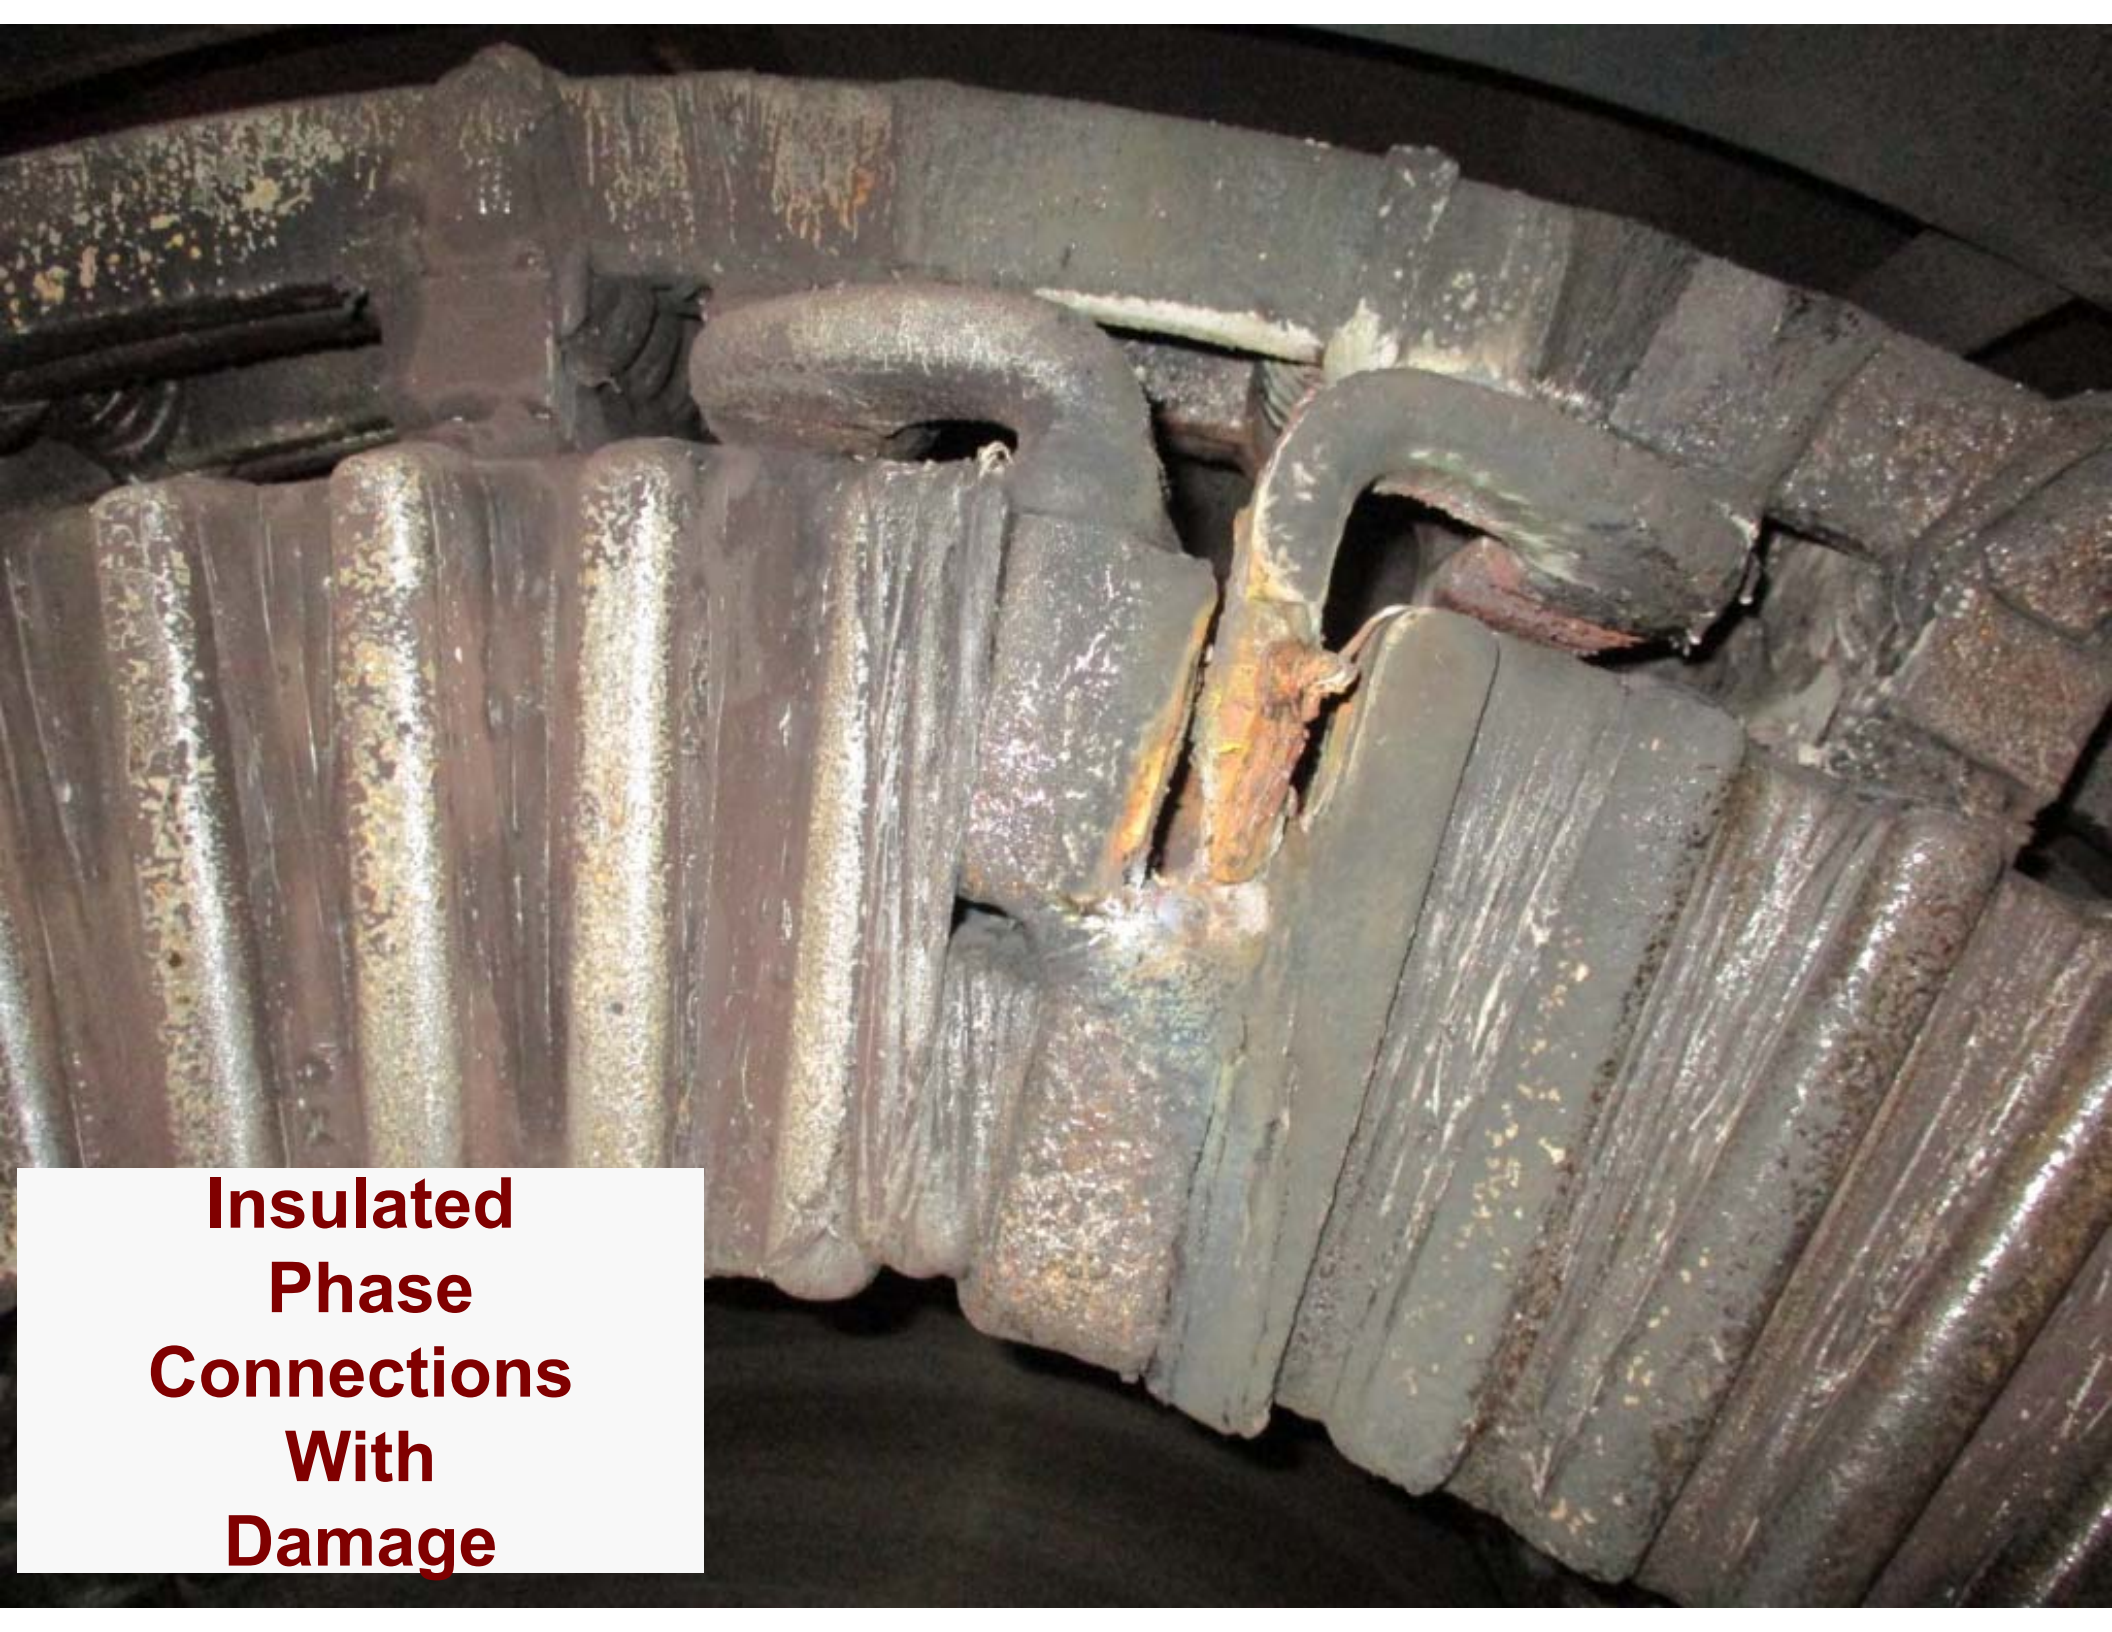
**Insulated  
Phase  
Connections  
With  
Damage**
