# Creative Solutions For Significant Generator Failure Damage

**GE 9A4  
Shaft ID Damage  
& Repair**

# GE Water Cooled LP Shaft OD Damage & Repair

# GE 324 Main Lead Repairs

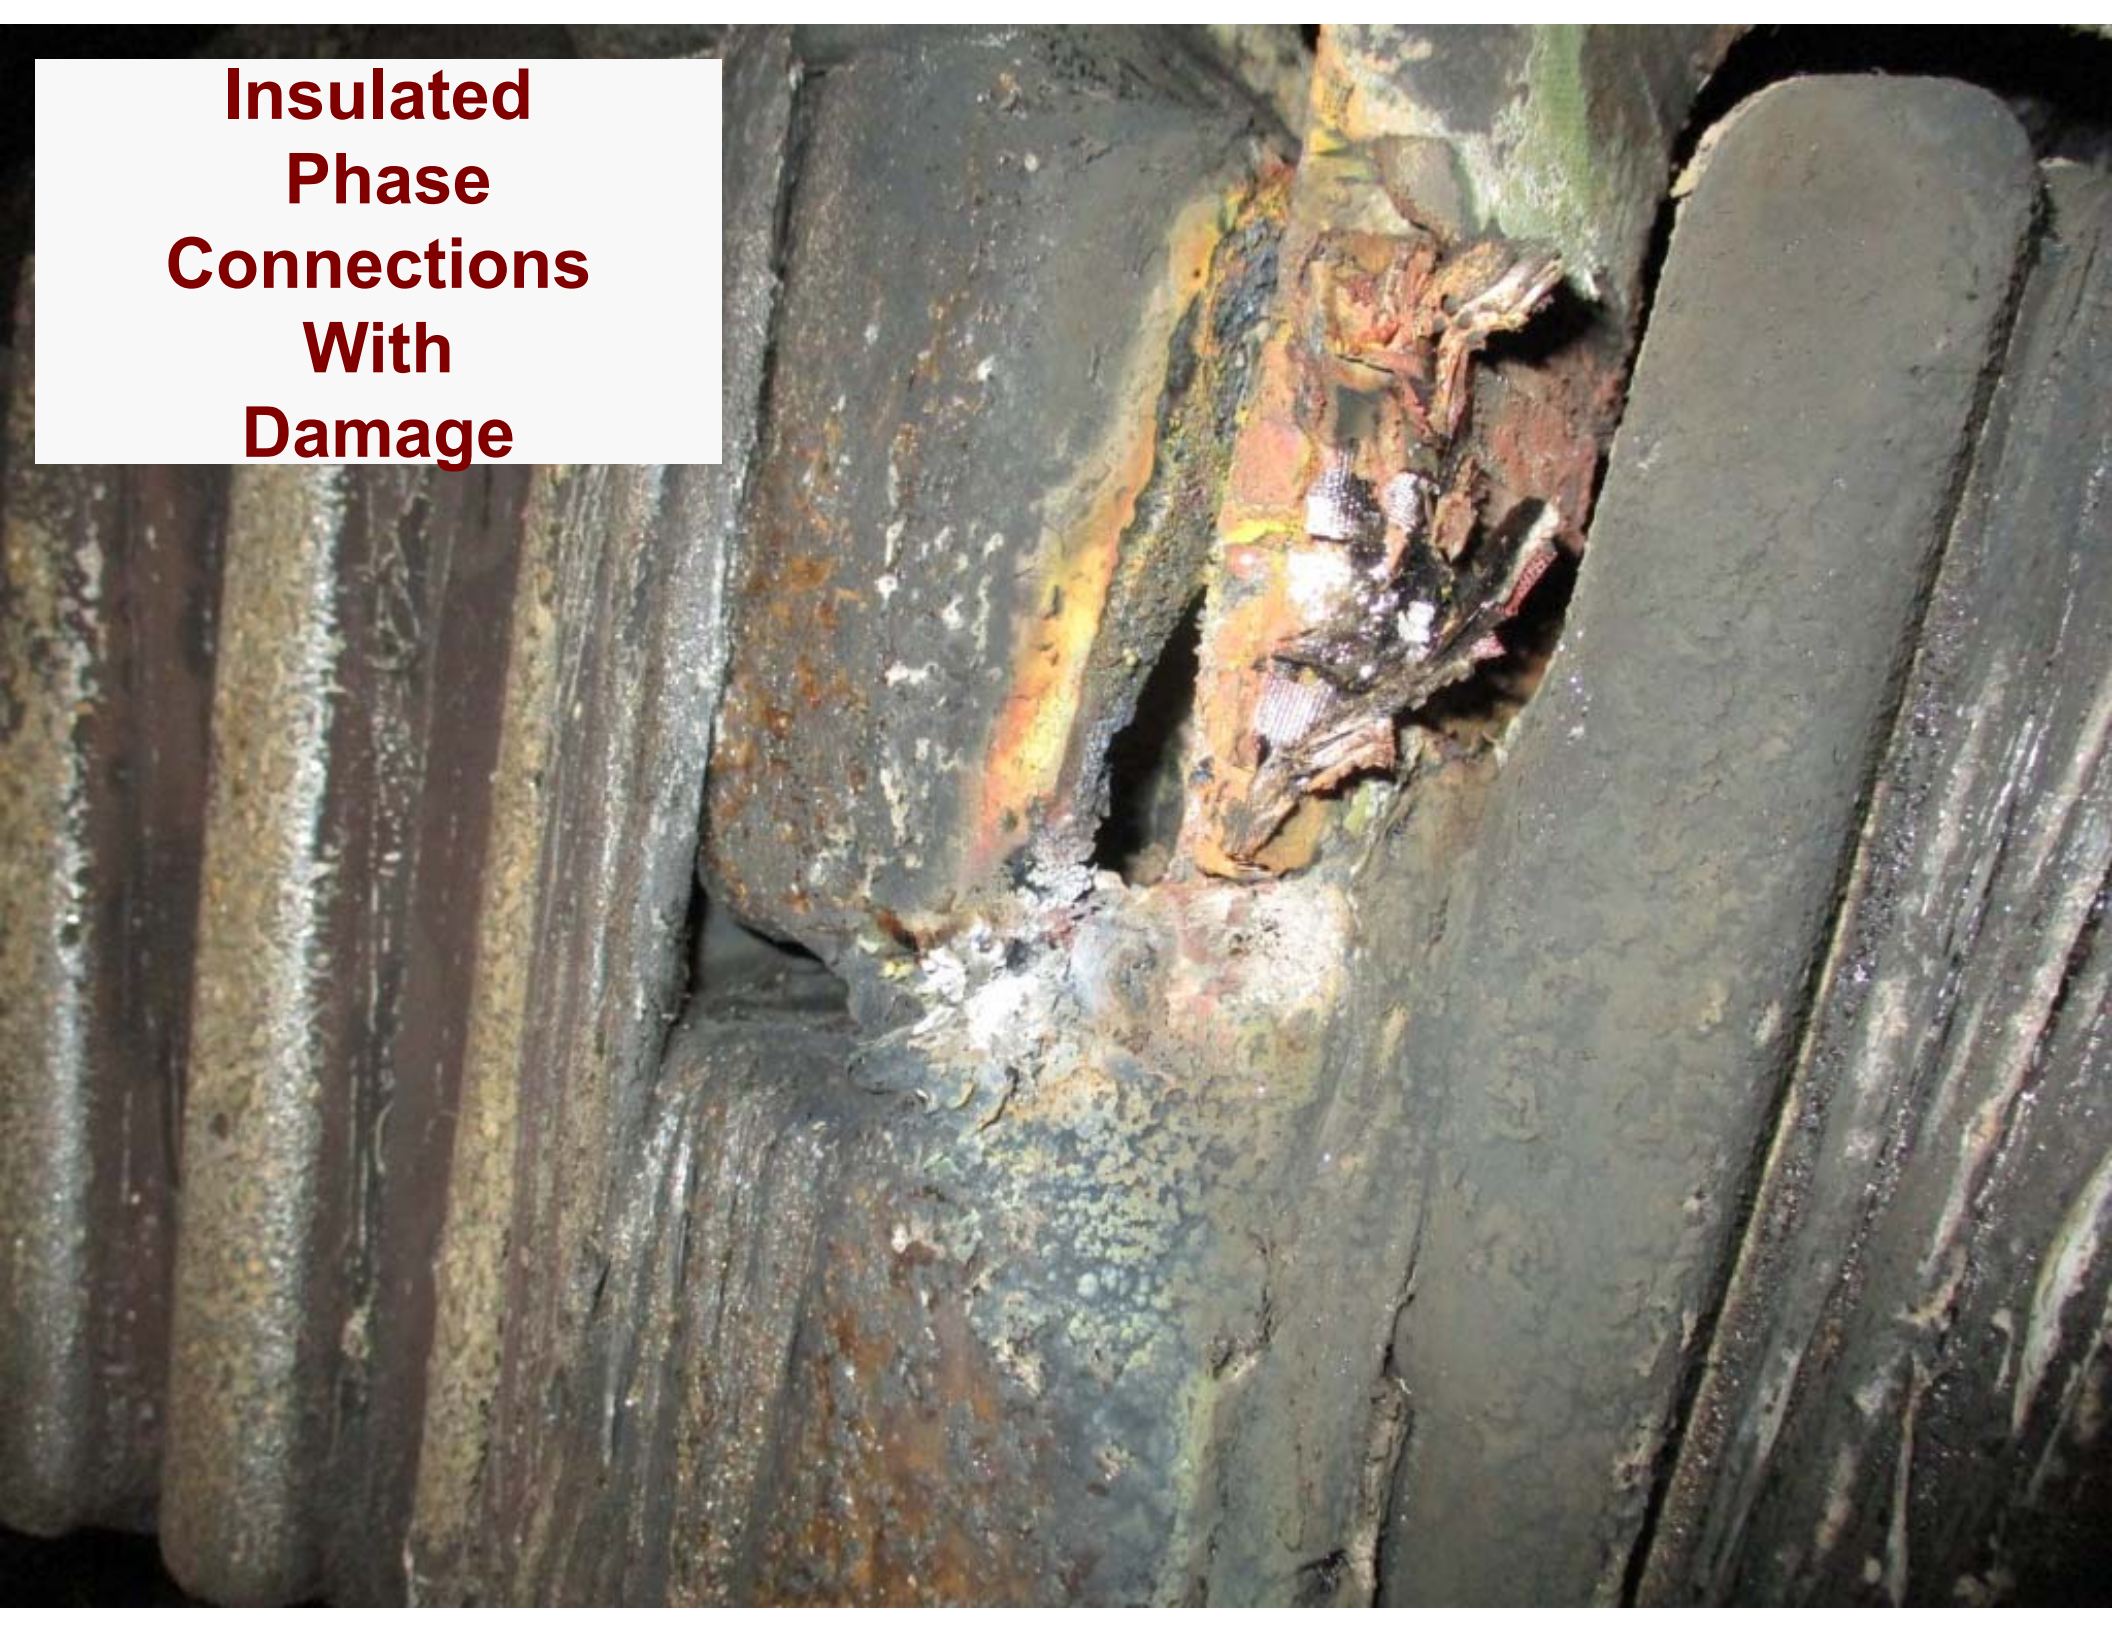
**Insulated  
Phase  
Connections  
With  
Damage**

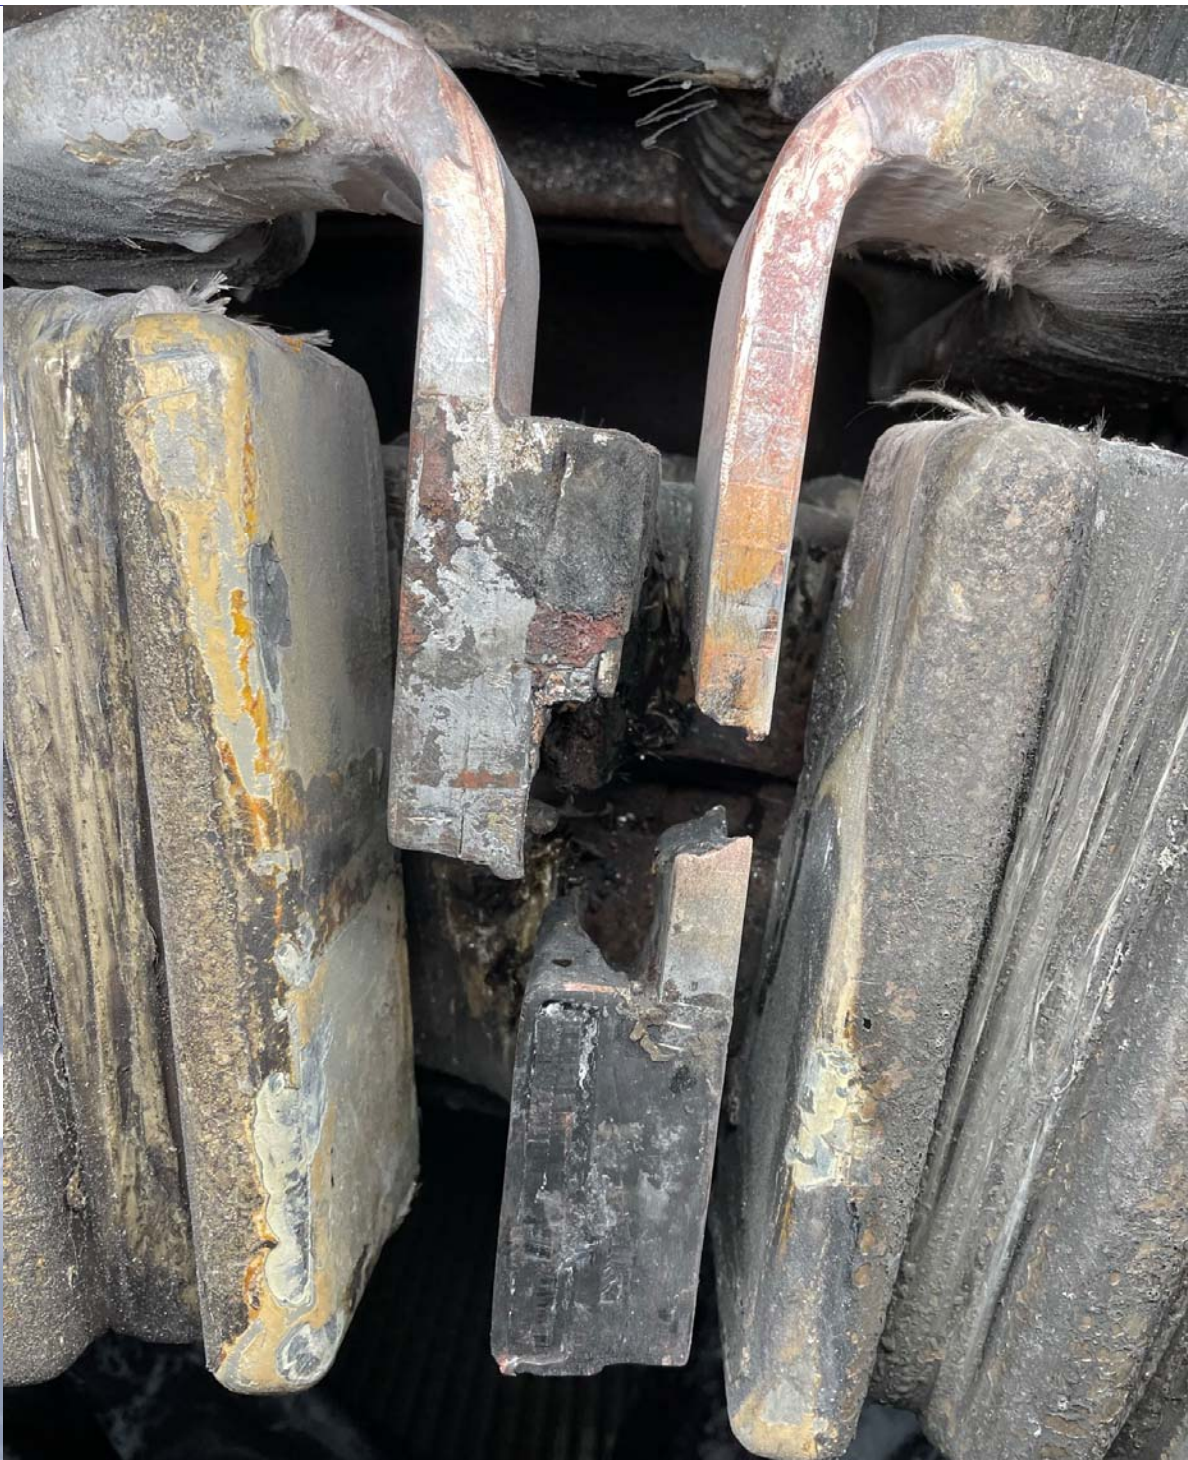
**Damaged Phase Connections**

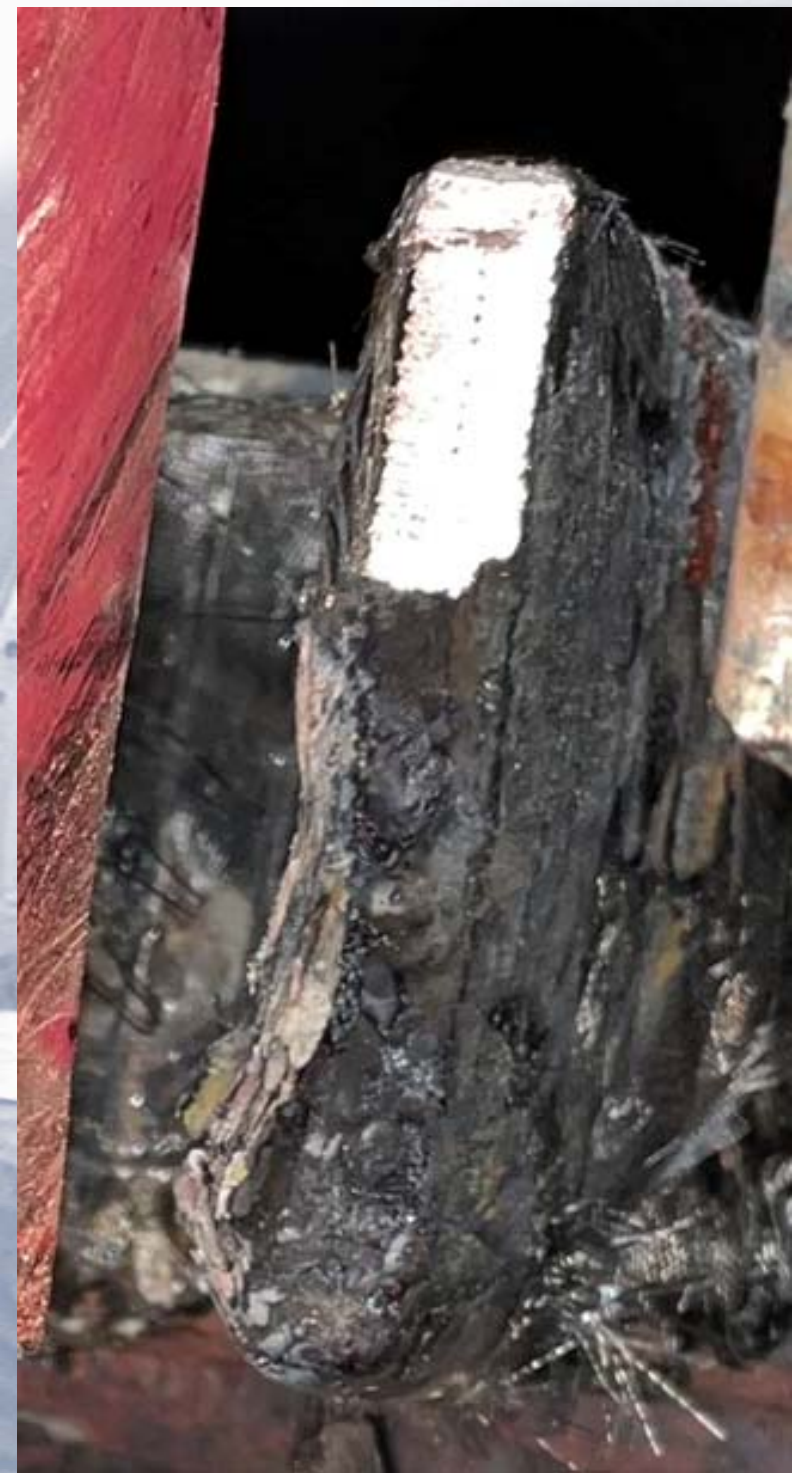
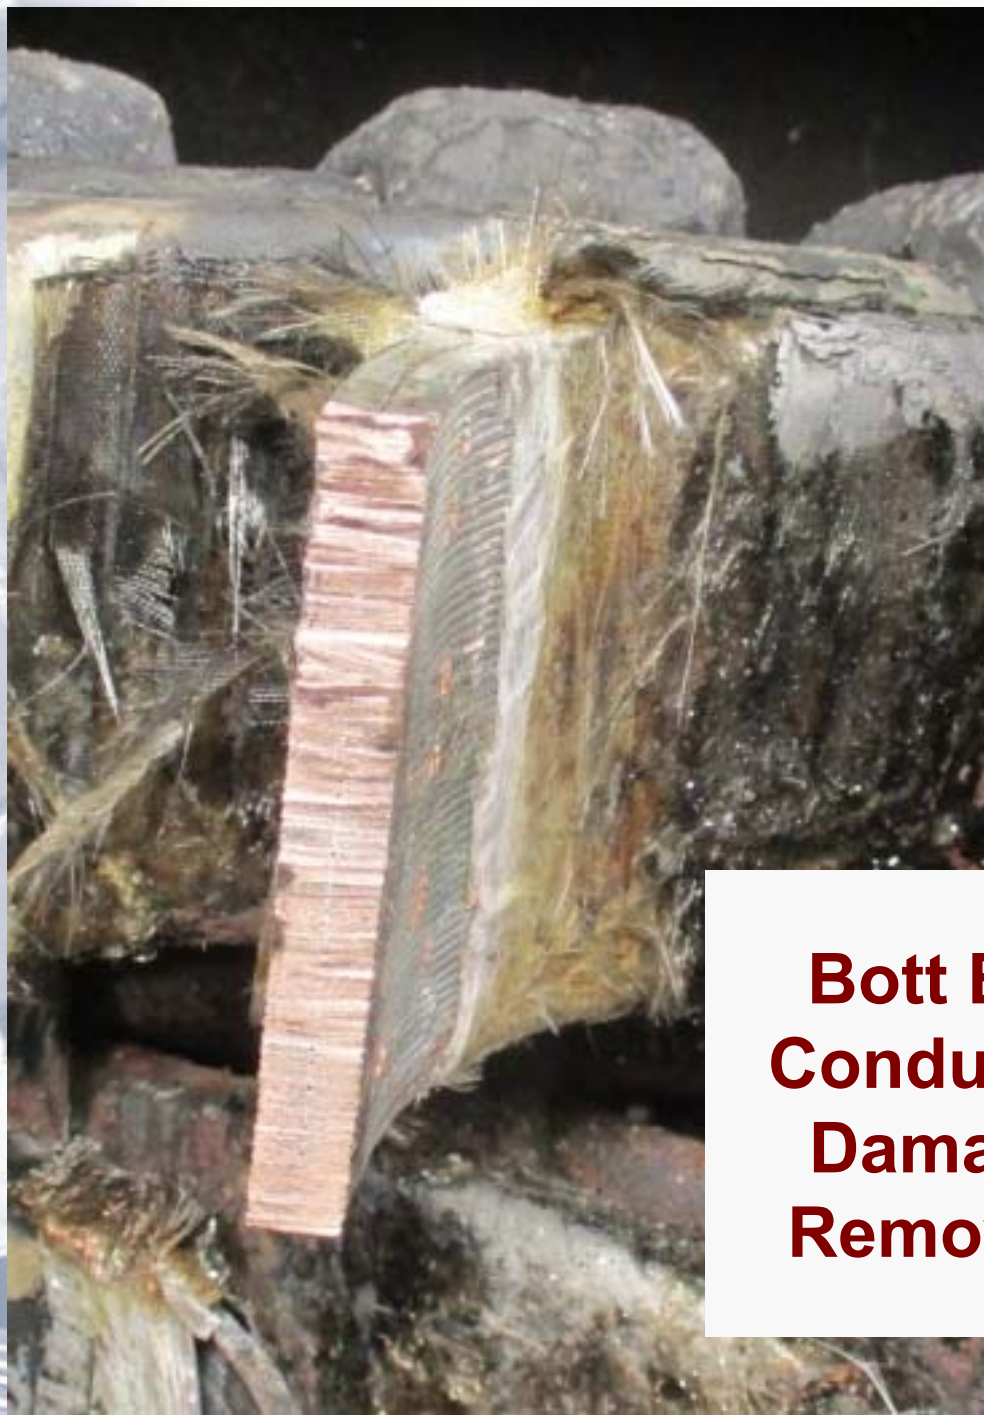
**Bott Bar  
Conductor  
Damage  
Removed**
