# IRMC 2024

*Predictive Monitoring of Partial Discharges in an Electrical Generator at a Gas Plant: Supporting Decision-Making for Interventions with Minimal Impact on Plant Availability*

# Case Study - Generator GE-513201D High Partial Discharge Levels Identification and Correction

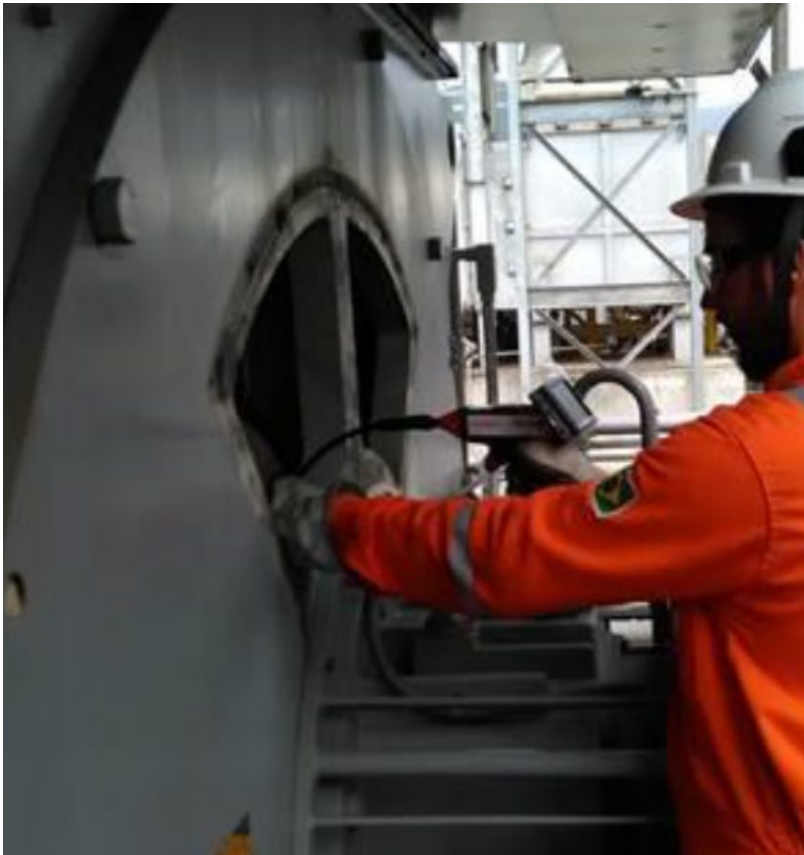
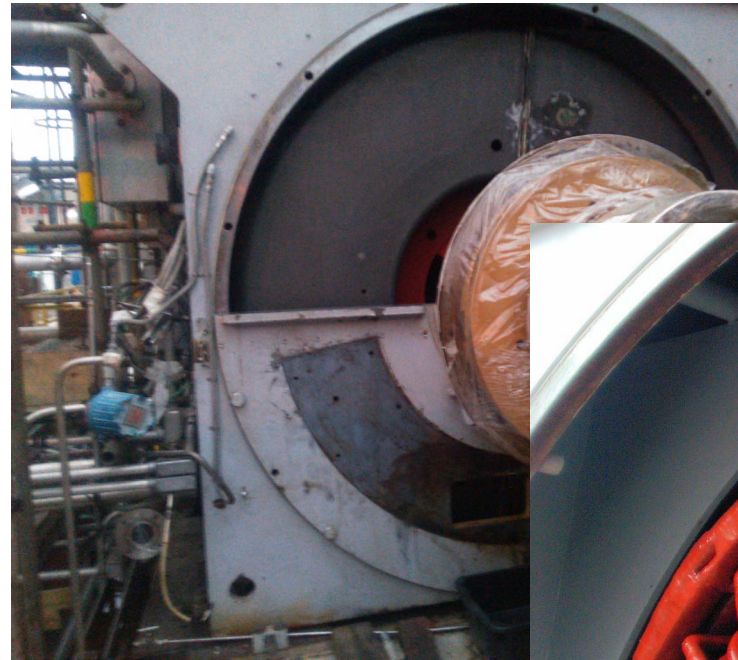
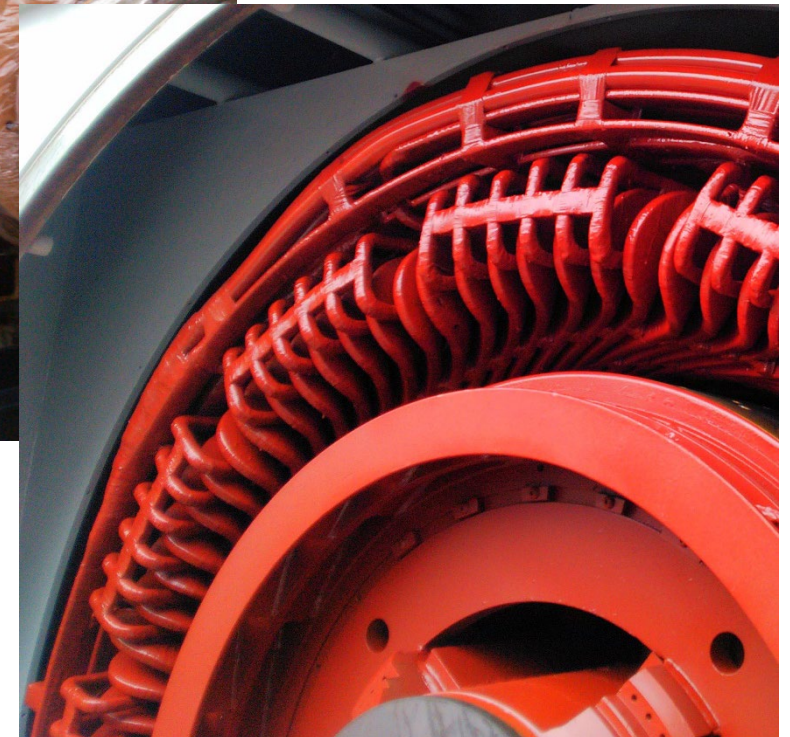
Endwinding (inner part) was not accessible for visual inspection or boroscopy, making it difficult to visualize the damage without machine disassembling

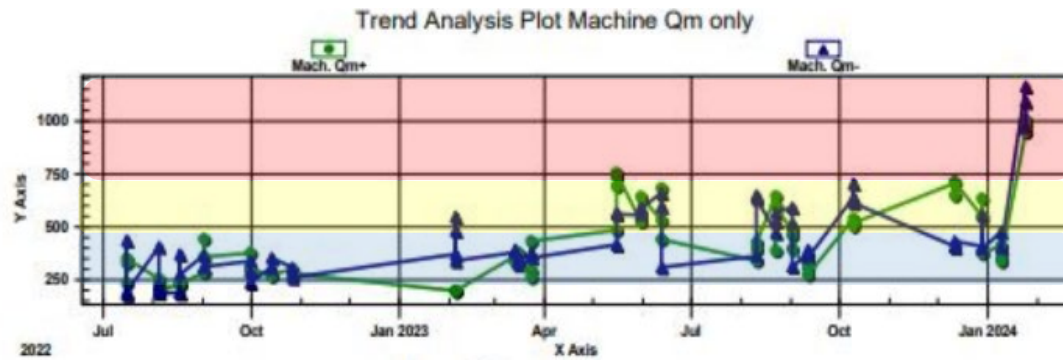
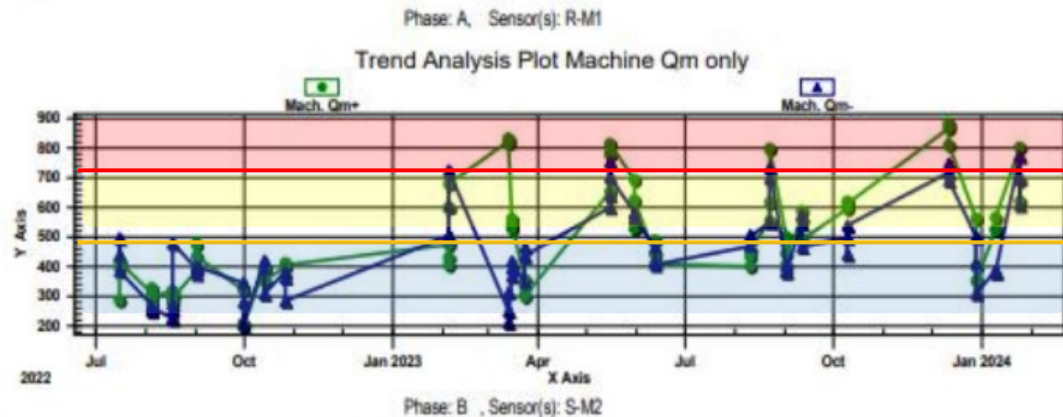
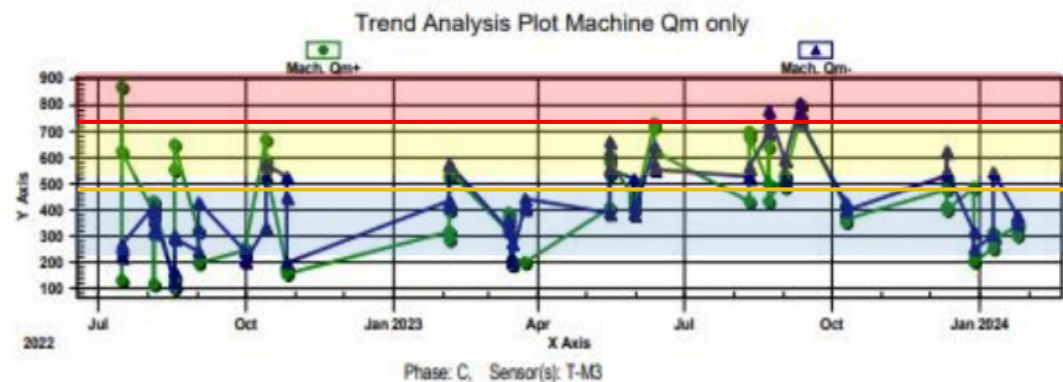
The Qm trend plot for generator GE-513201D showed values above the moderate and high references (Iris Database). A significant increase in Qm values was also observed over the 2.5-year monitoring period.

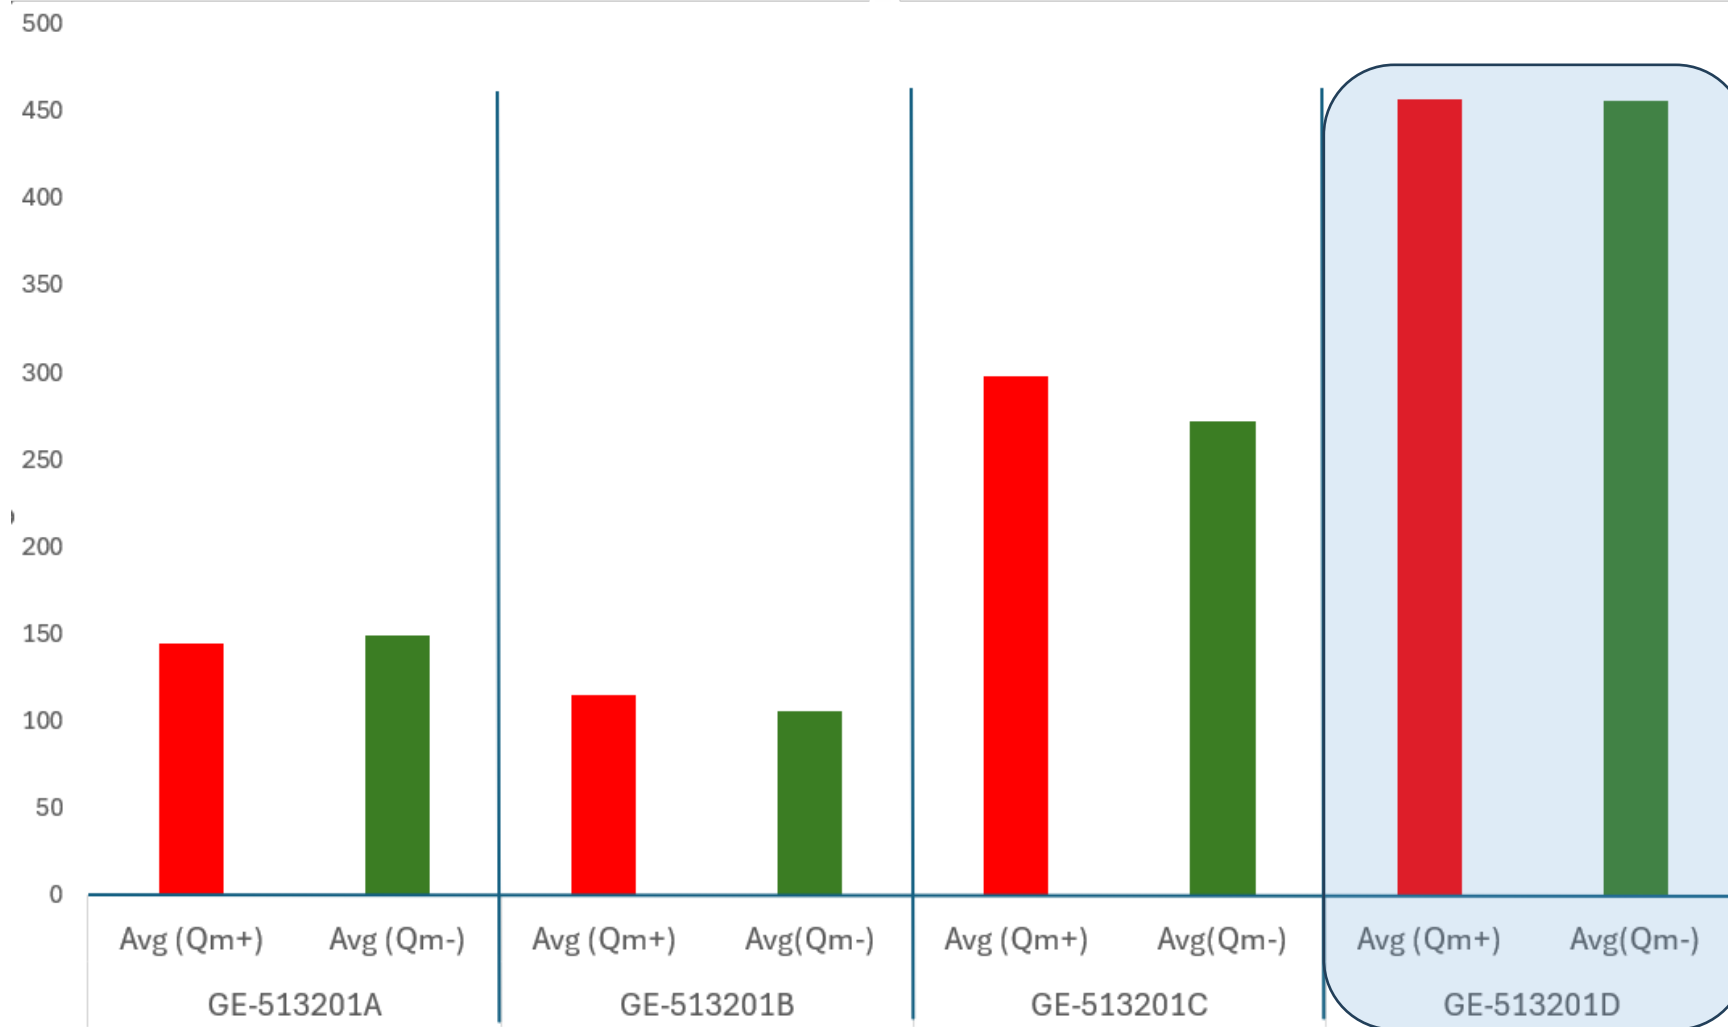
⚠ Generator C suffered water infiltration in 2021

*High Average Qm levels compared to the other generators (same model and age)*

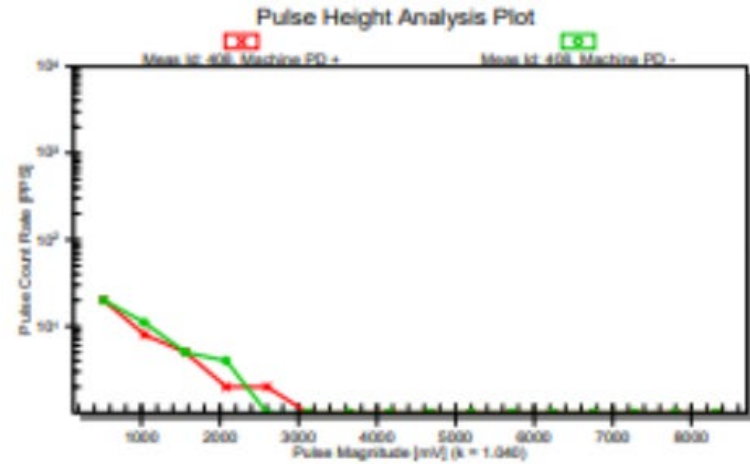
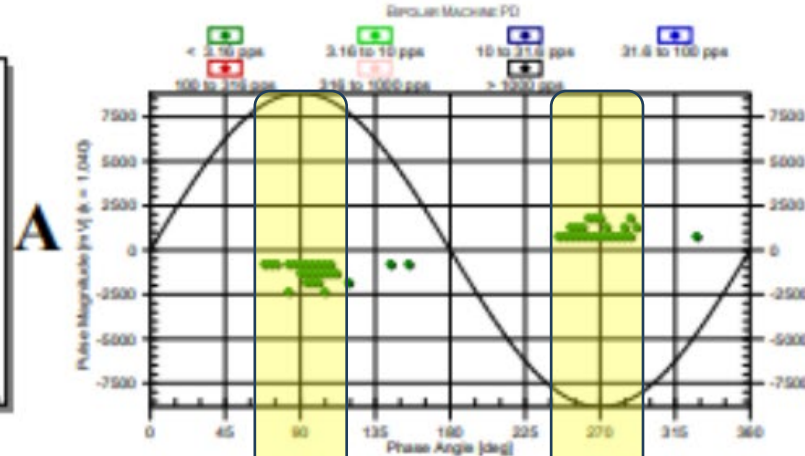
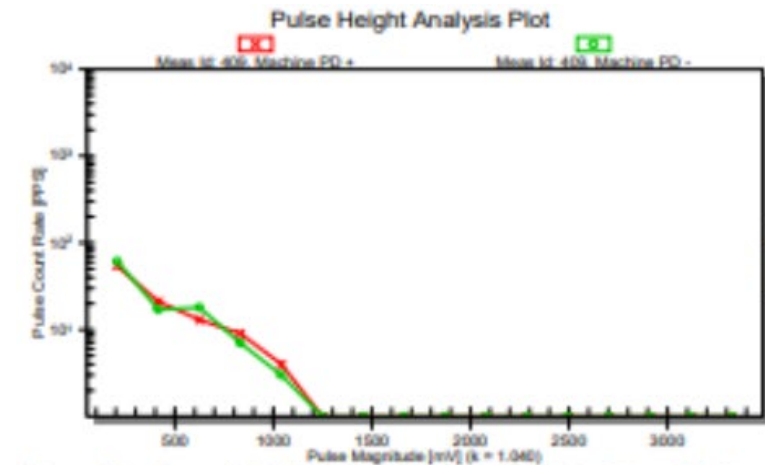
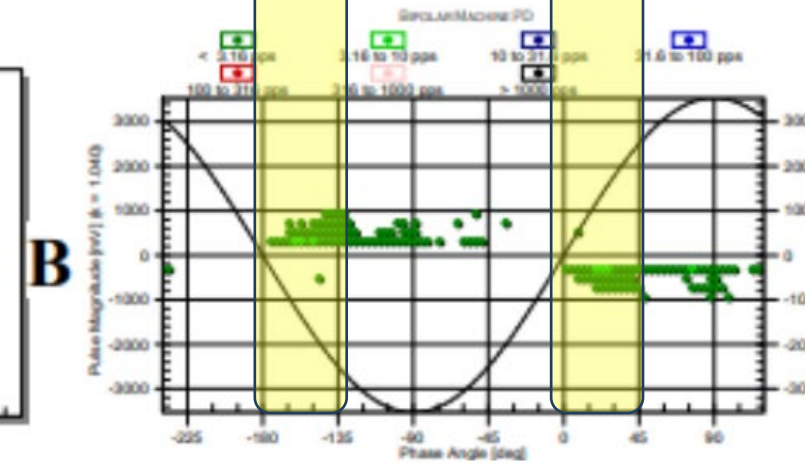
Opposite pulse Polarity in the two phases indicates a Phase-to-Phase PD activity (contamination, spacing issue etc)

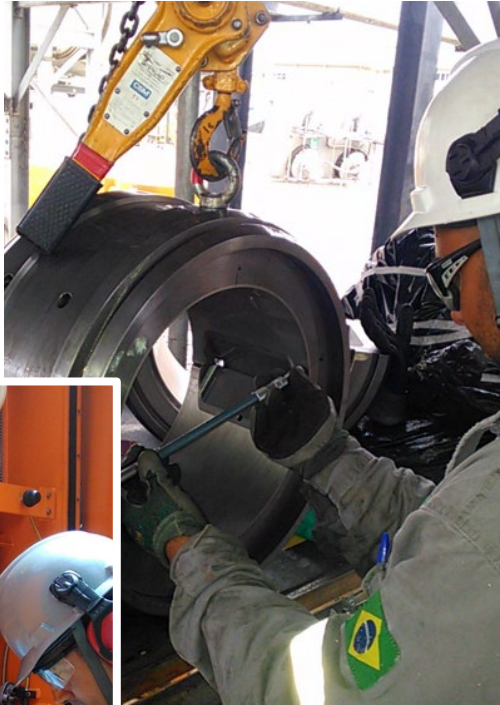
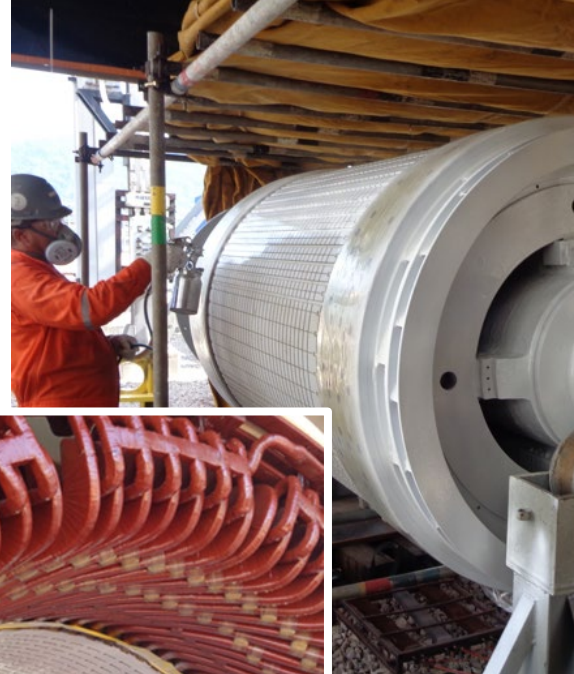
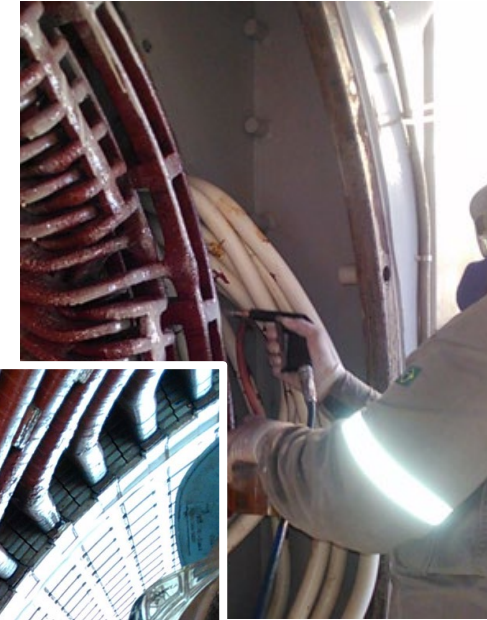
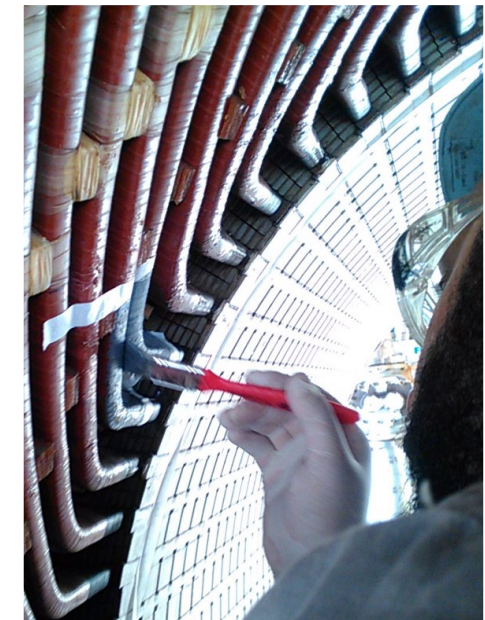
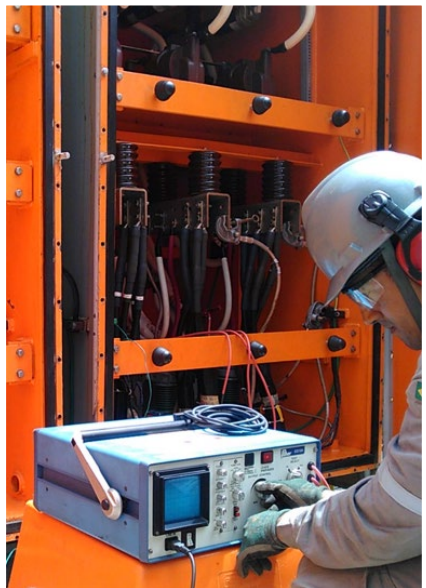
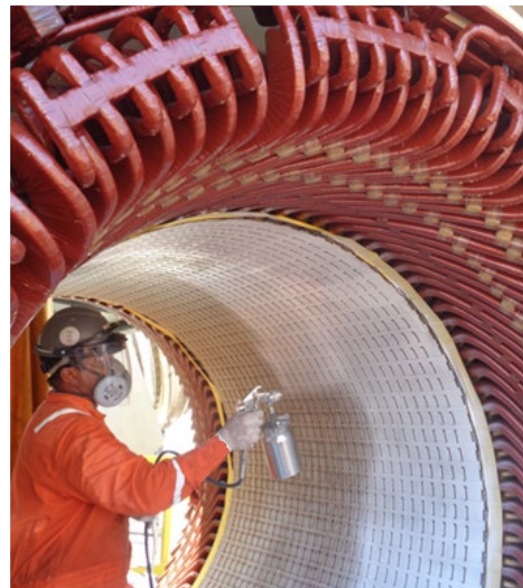
Electrical and Mechanical complete inspection. Bearing replacement (pitting corrosion found)

Complete cleaning and painting stator/rotor

Repair of damaged insulation surface

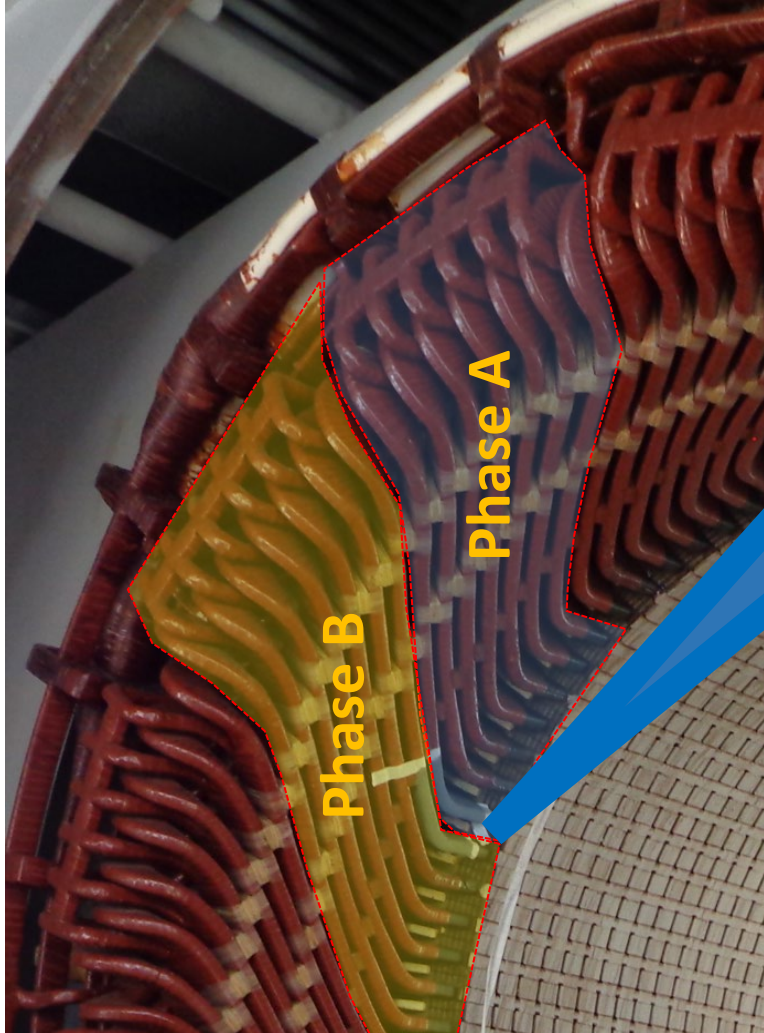
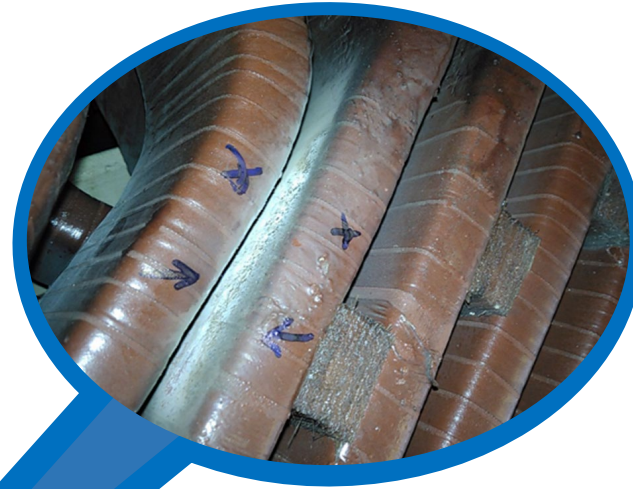
PD occurring between high voltage coils in two different phases

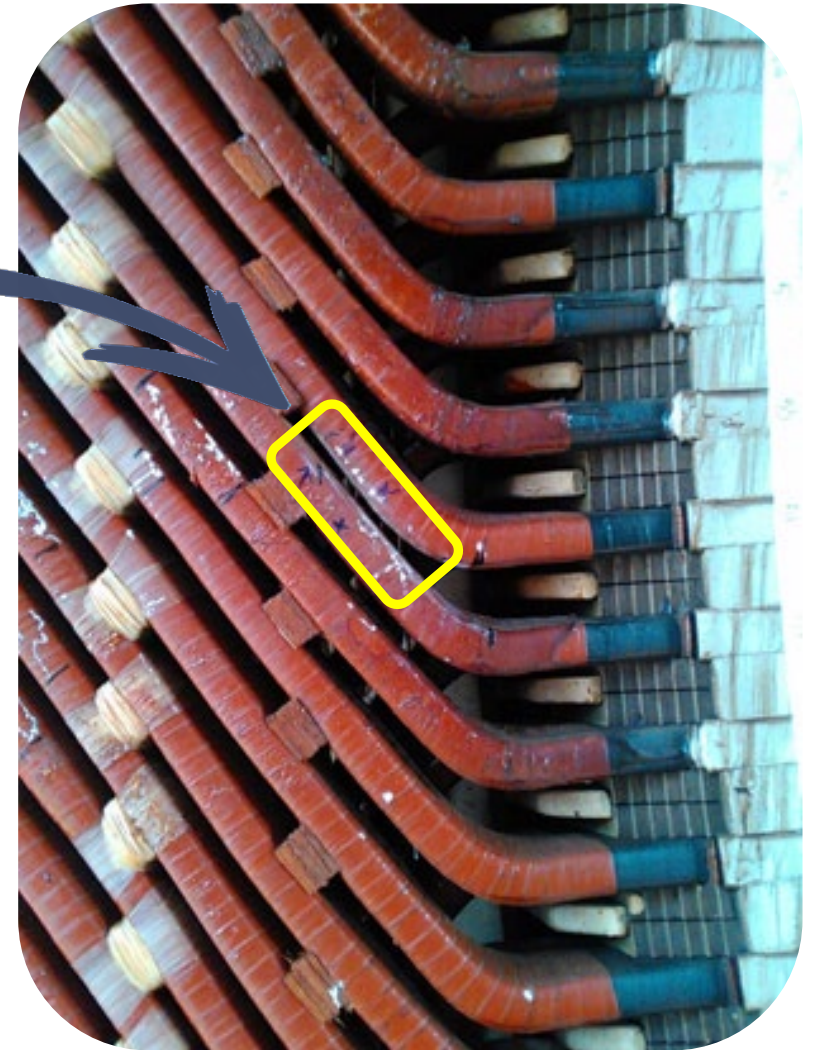
Two coils in different phases that were installed too close to one-another

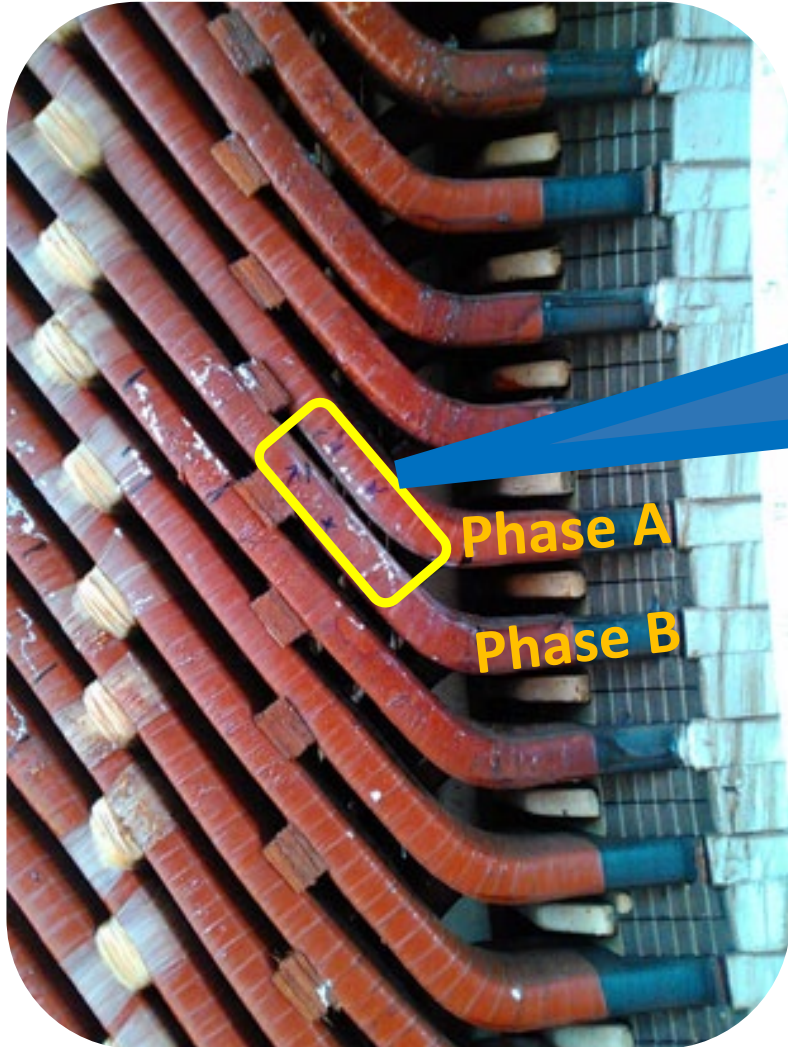
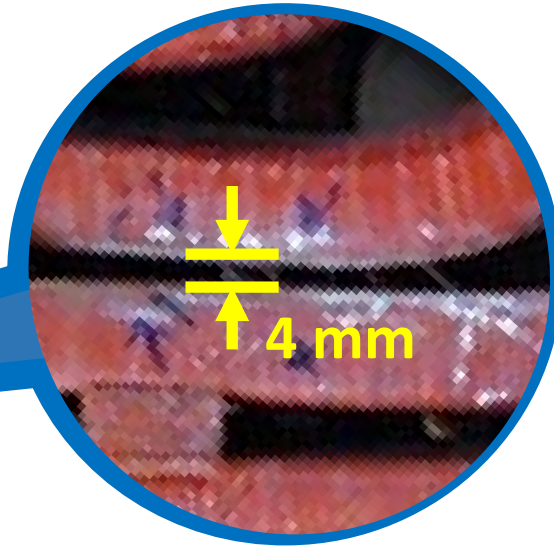
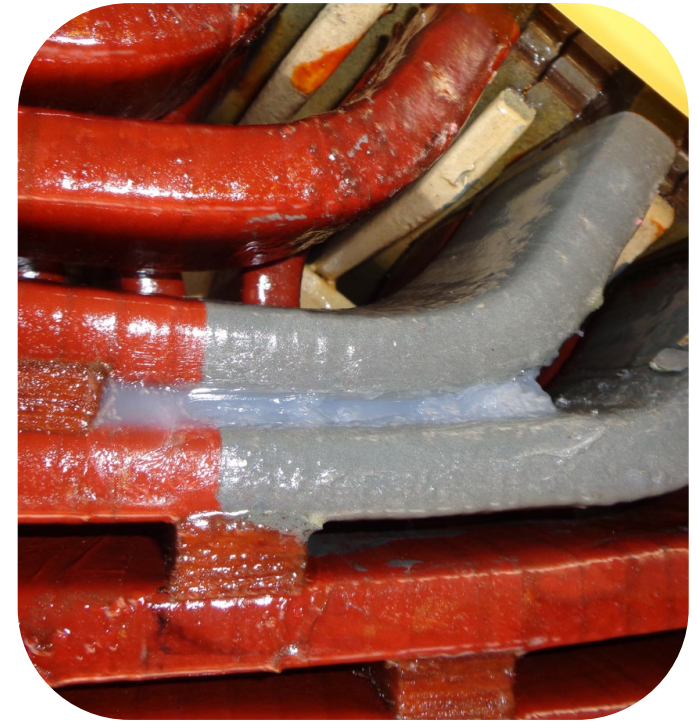
Spacing between coils = 4 mm  
 $V_{ab} = 13.8\text{kV}$  (stress of  $\sim 3.58$  kV/mm)

- Sanding and cleaning the surface damaged
- Reapplication of semiconductive coating
- Injection of Silicon rubber (Higher dielectric strength than air)

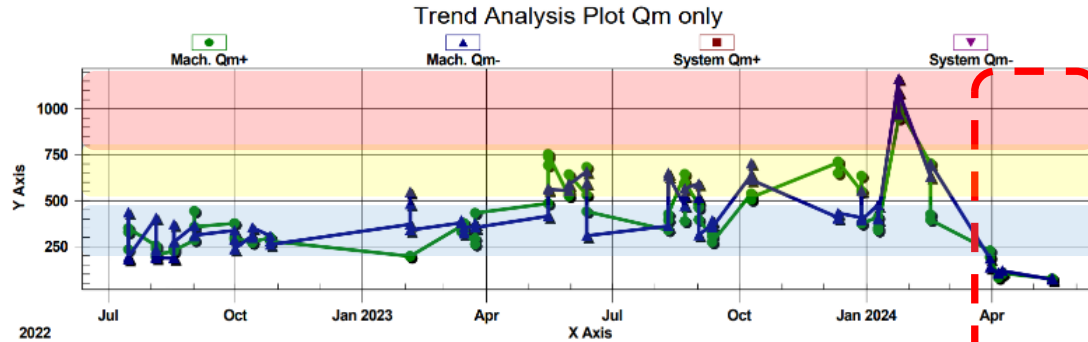
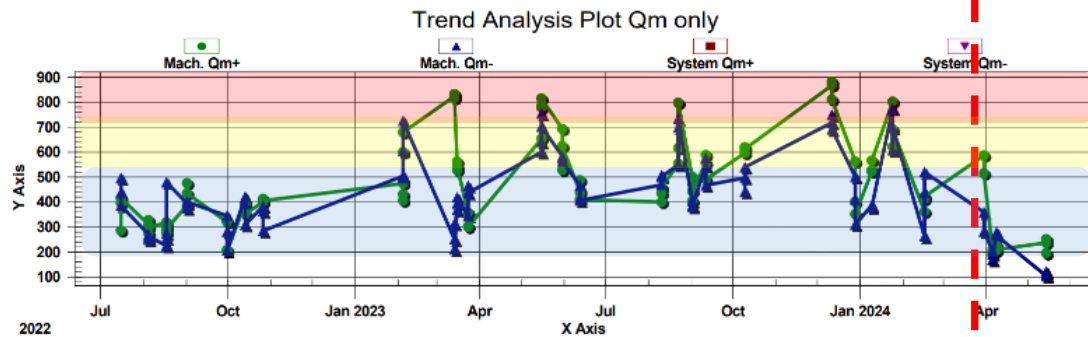
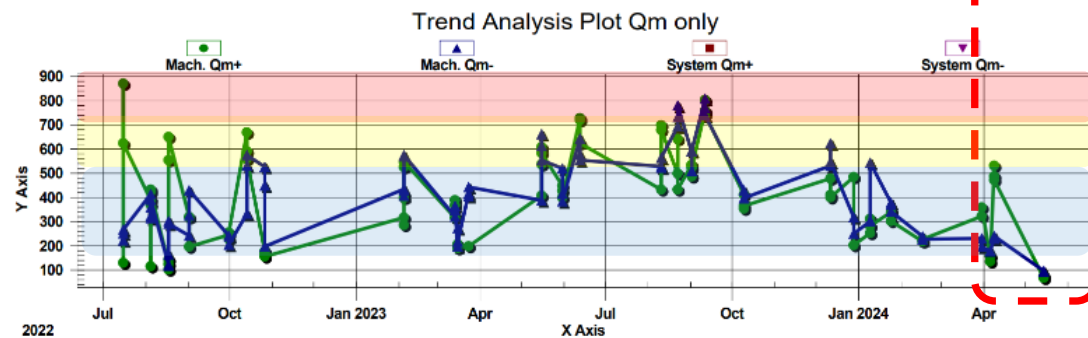
Trend plot shows a significant reduction in Qm values after Overhaul, being close to typical values compared to stators of similar machines.

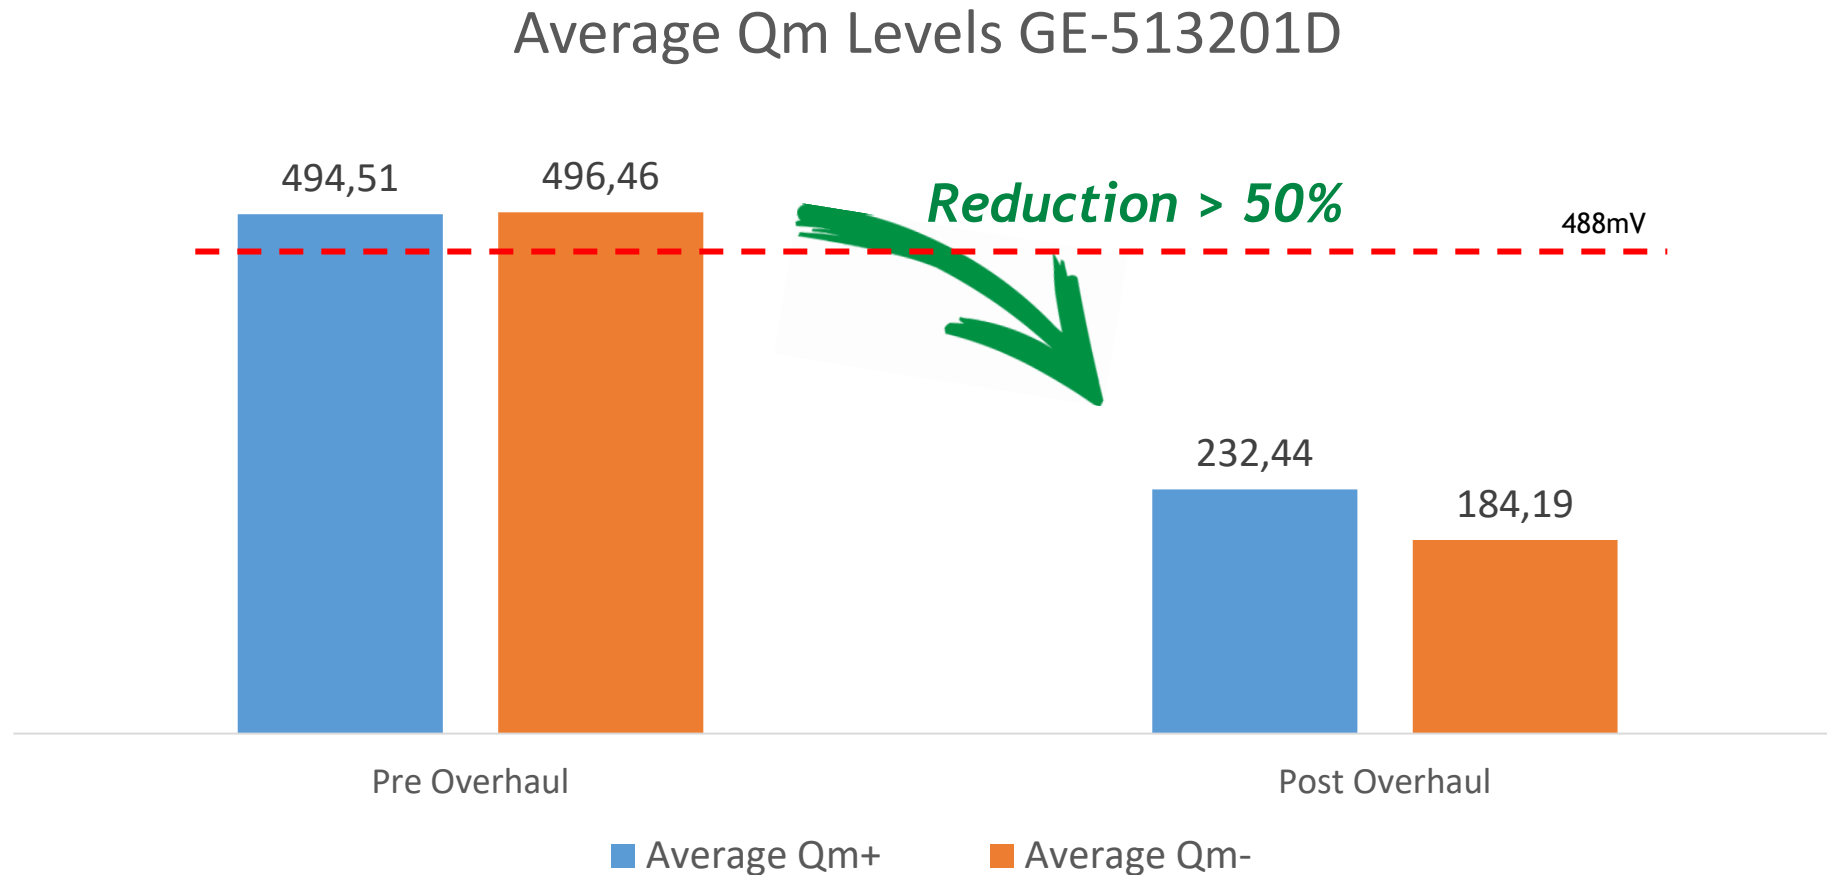
Average Qm values for GE-513201D shows a significant reduction in DP activity

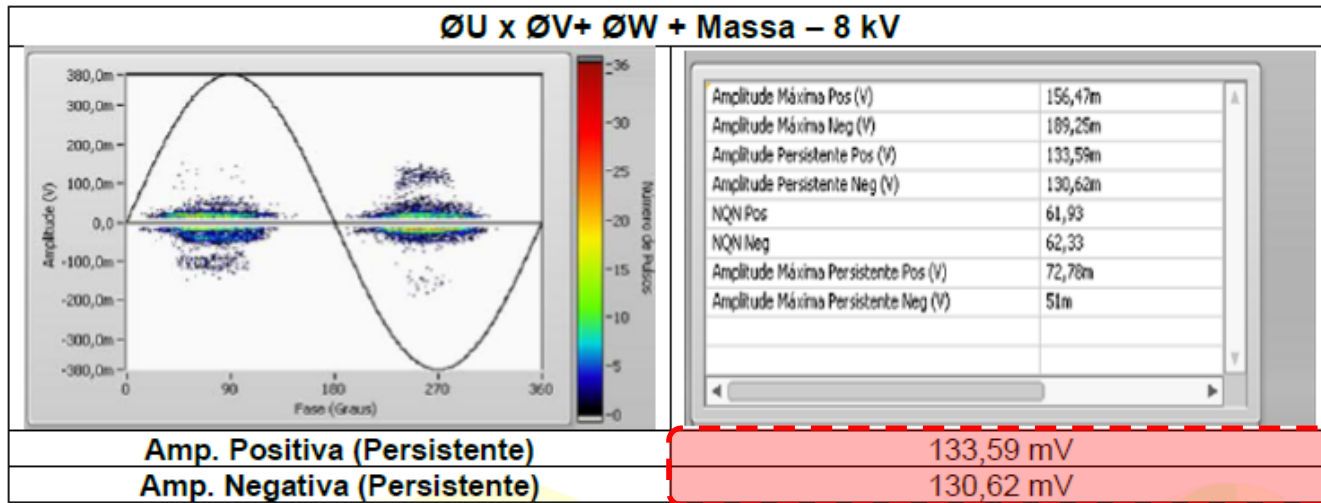
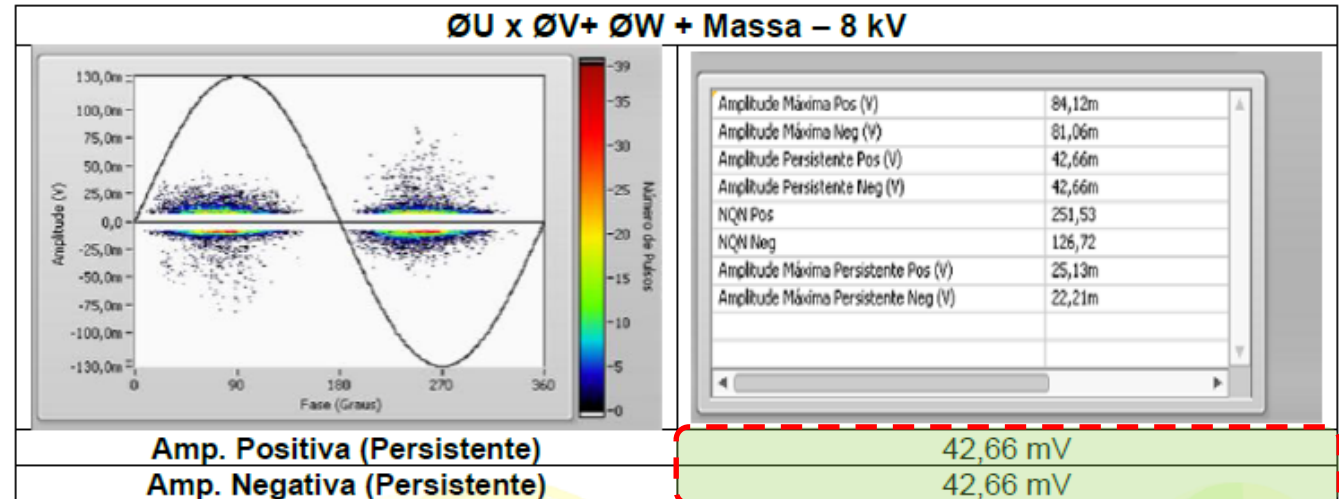
Offline PD readings obtained before the overhaul appeared satisfactory. This test is not impacted by load, temperature, vibration, and uses single-phase voltage, rendering it inadequate for detecting spacing issues between end-windings of distinct phases.

*nearly three-fold  
decline in offline PD*
