IRMC 2024

324 Generator Failure Discoveries, Concerns, & Repair

W. Howard Moudy
Director of Operations
National Electric Coil
hmoudy@national-electric-coil.com
724-787-4967
www.National-Electric-Coil.com

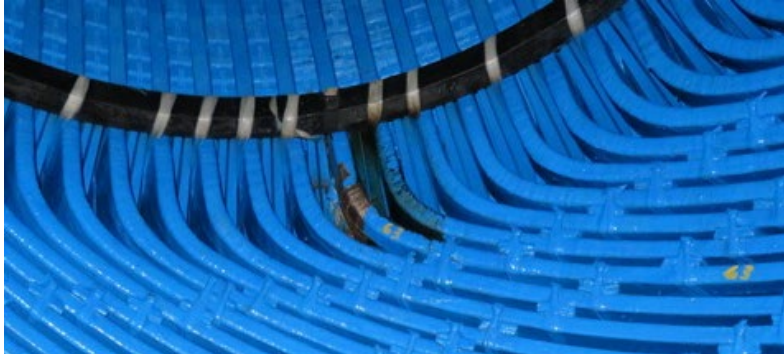
Inspection

- Bulging and signs of overheating near core and at Series Connection
- Potential issue in series connection possible source of overheating?

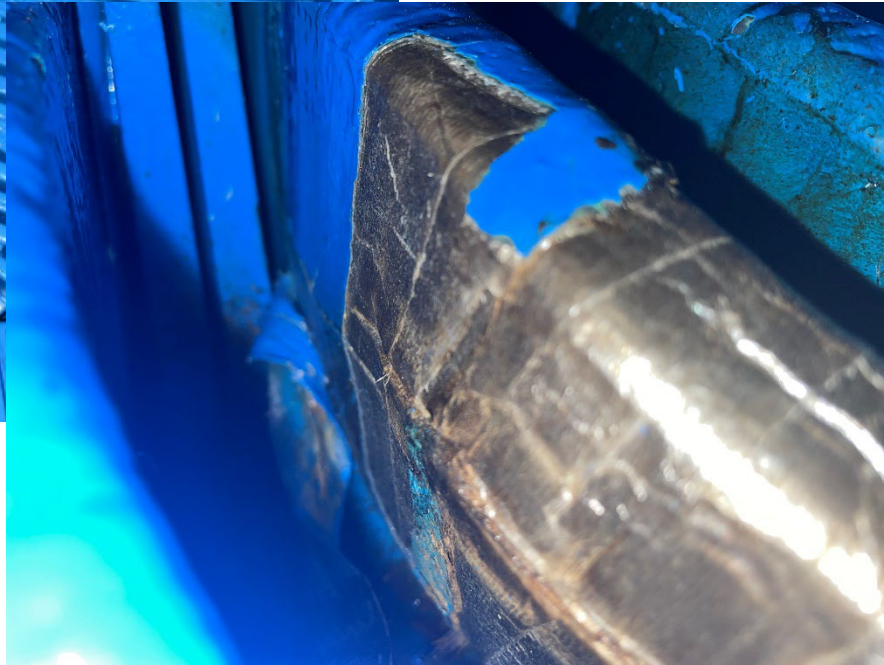
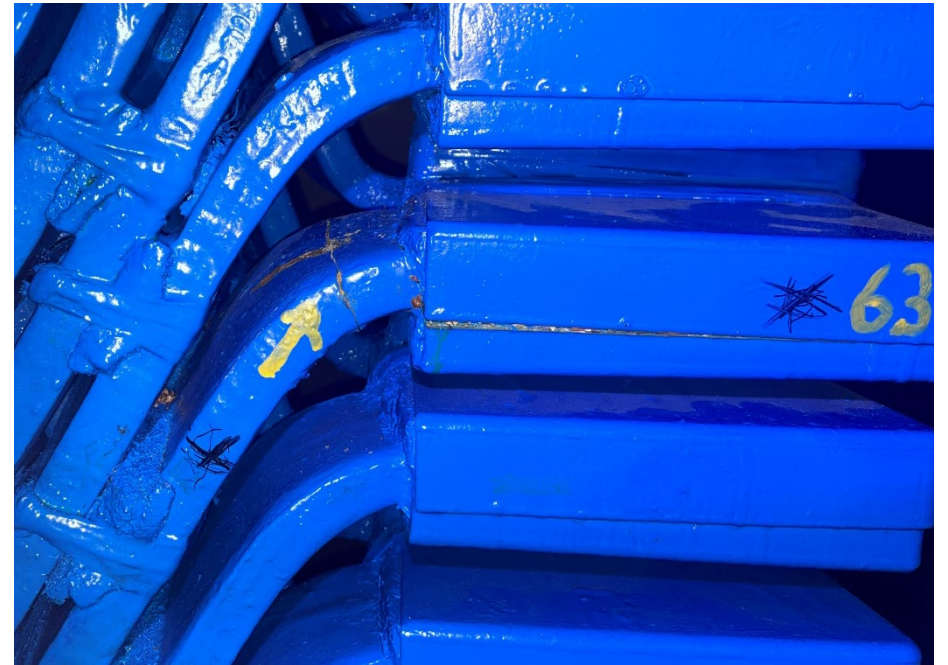
Origin of Overheating?

- Connection stripped to investigate.
- No indications of heat generation from the brazed series connection
- Heat effected area indications inboard of the series connection

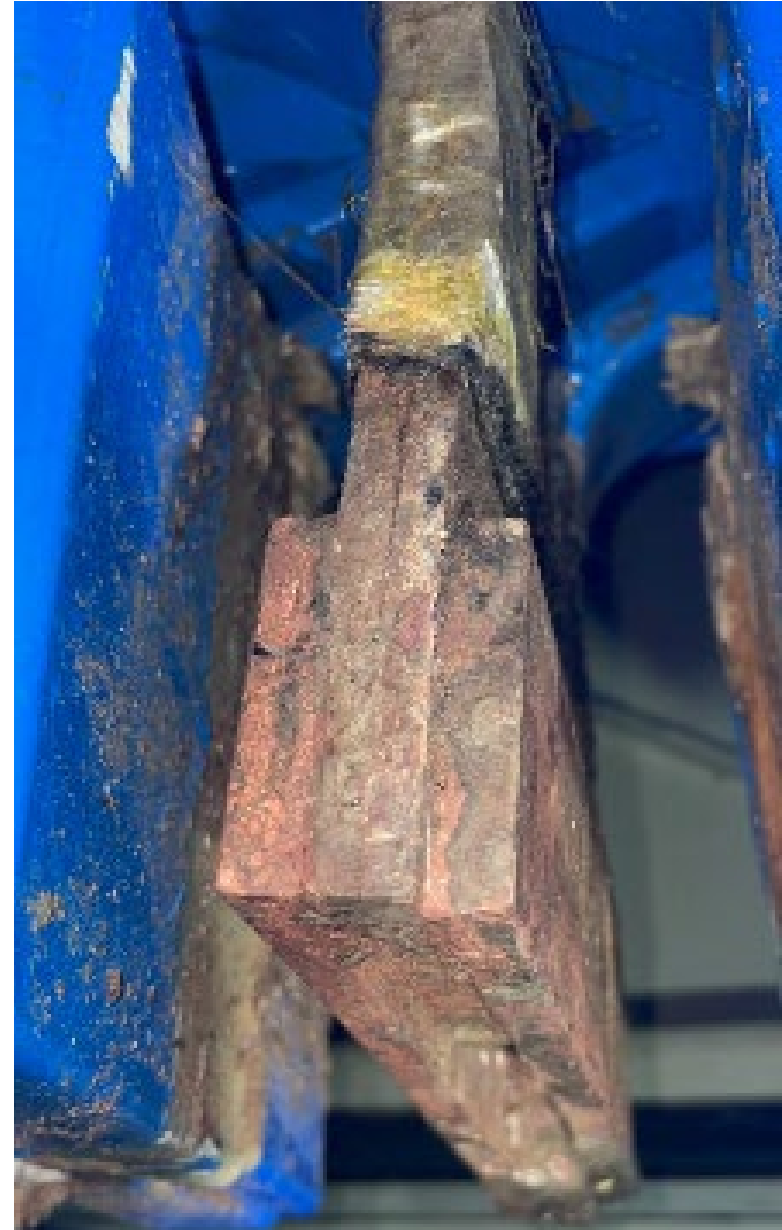
Origin of Overheating?

- Observation of overheating increased moving toward the core from the Series Connection
- Excavation of the bulge near the core
- Overheating evidence increased in proximity to the conductor stack

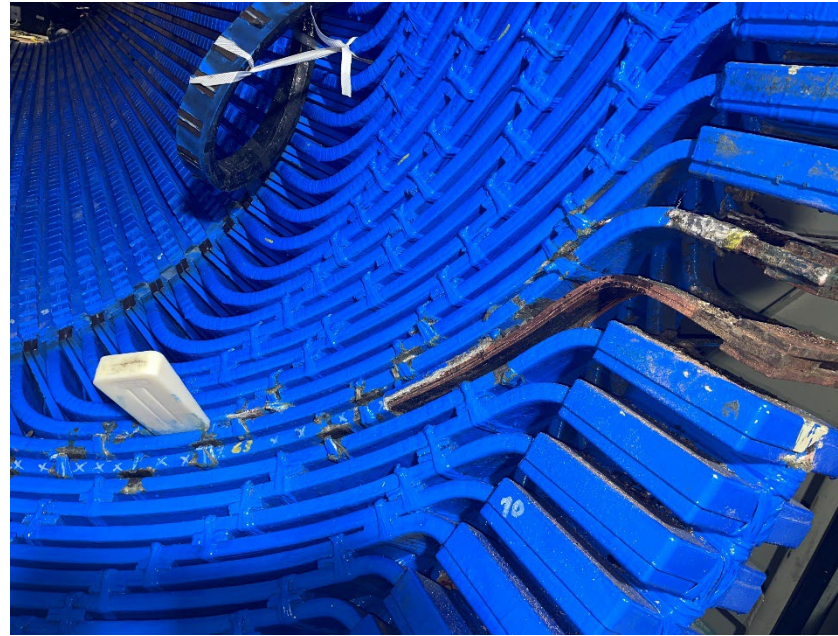
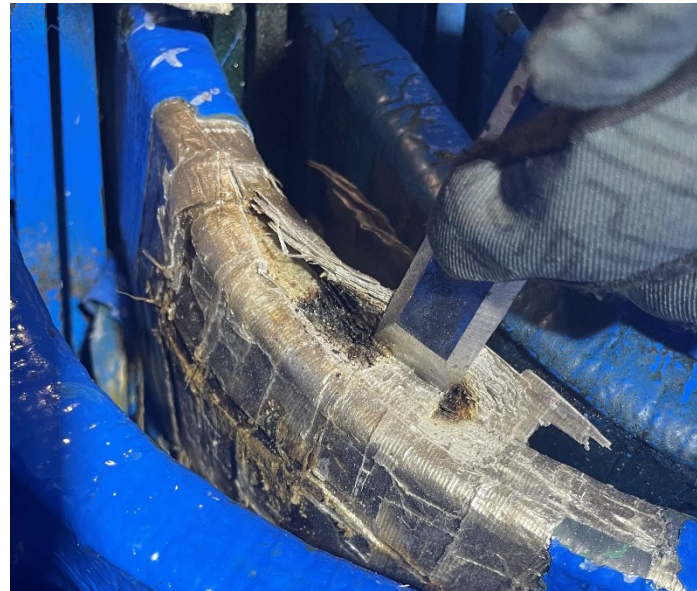
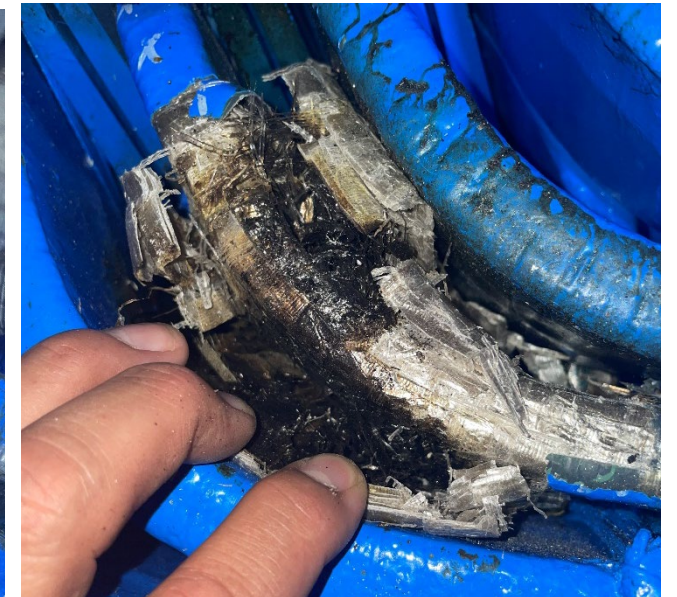
Origion of Overheating

- Slot 63 core wedges removed exposing top filler overheating indications.
- Lifting the top filler exposed signific signs of overheating on the top coil.
- Top coil indications extended approximately 4' into the slot from the turbine end with the worst indications between 10" to 18 " from the turbine end of the core.

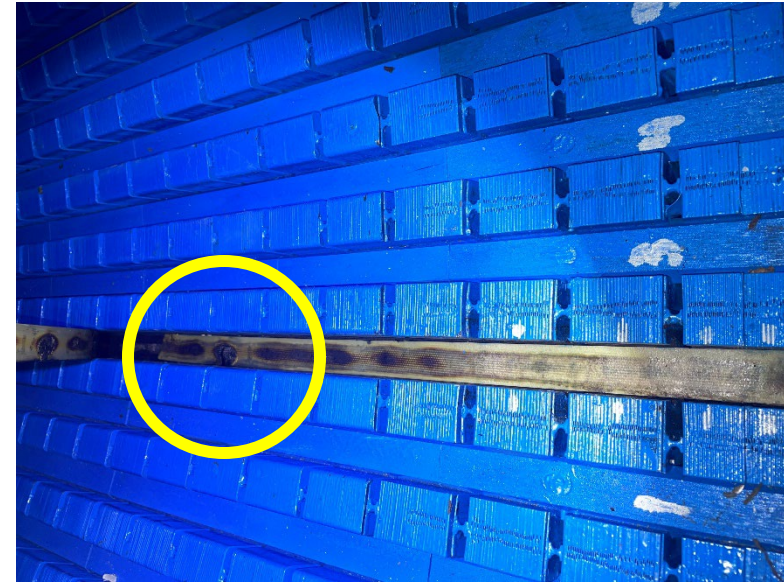
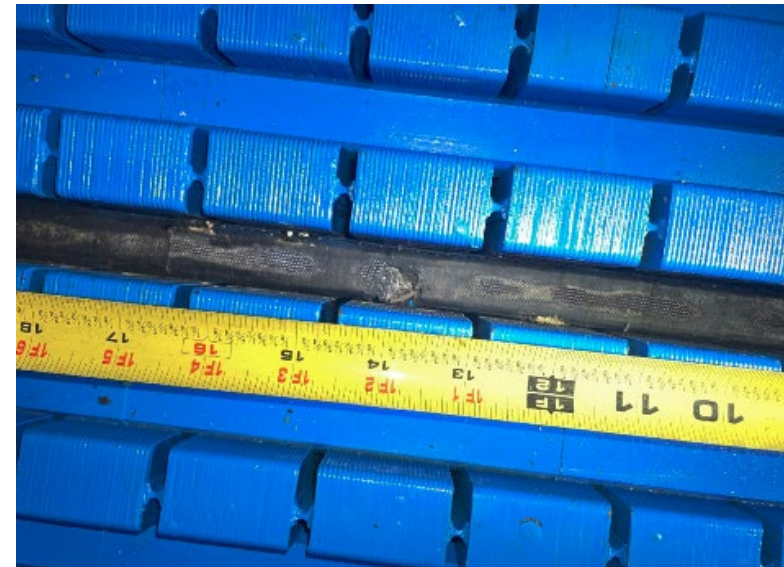
Probable Origin of Overheating & Point Of Failure

- Most significant burning found **14” from the TE of the core in slot #63**

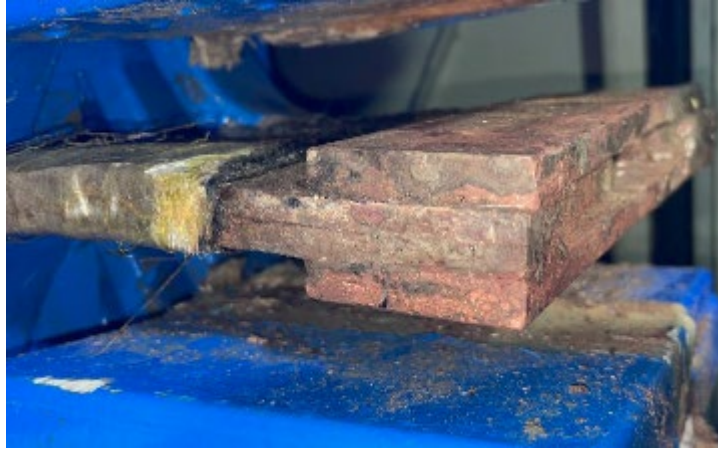
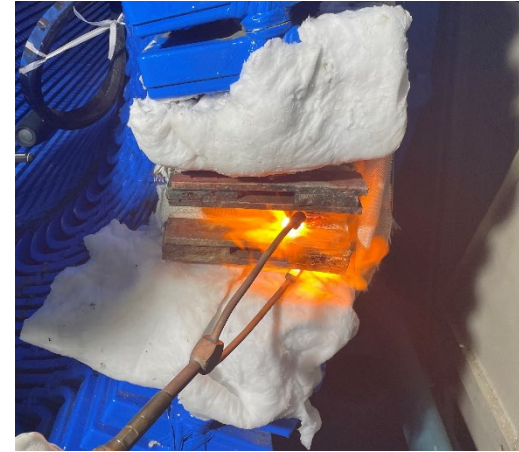
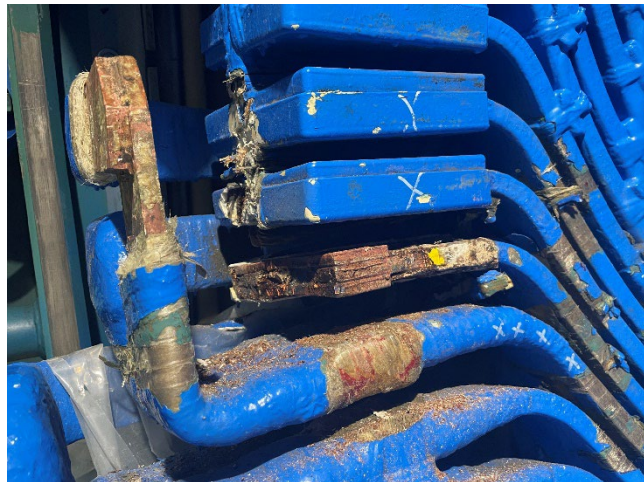
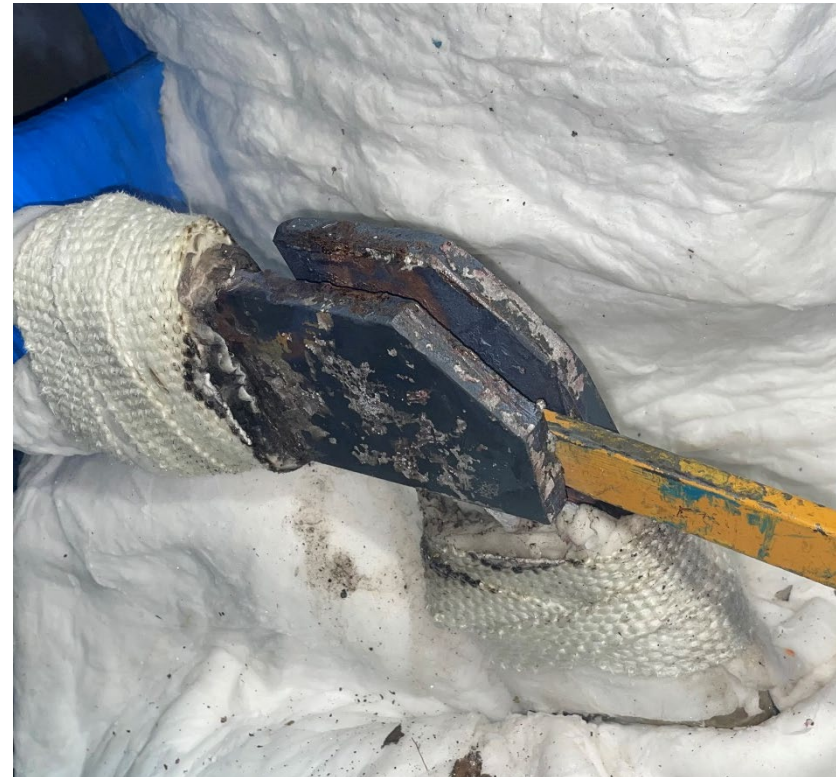
Isolation of Failed Coil #63

Top Coil Slot #63

Isolated from T2 – T5 Phase

- Good winding resistance (megger) testing results.
- Polarization Index (PI) - at 10 kV DC.
 - $PI = R_{10min}/R_{1min}$:
 - Phase A $PI = 21.7G\Omega/2.70G\Omega = 8.04$
 - Phase B $PI = 21.7G\Omega/3.57G\Omega = 6.09$
 - Phase C $PI = 15.6 G\Omega/3.03G\Omega = 5.16$
- A ramp test graded DC Hipot was performed on all three phases up to 37 kV DC with leakage measured at 37.0 kV DC:
 - A - 4.3 μ Amps
 - B - 5.0 μ Amps
 - C - 4.9 μ Amps.

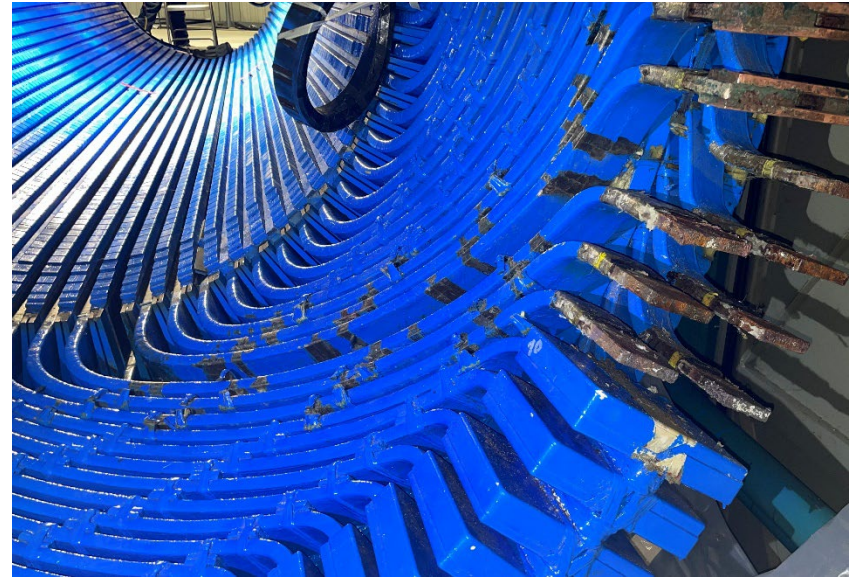
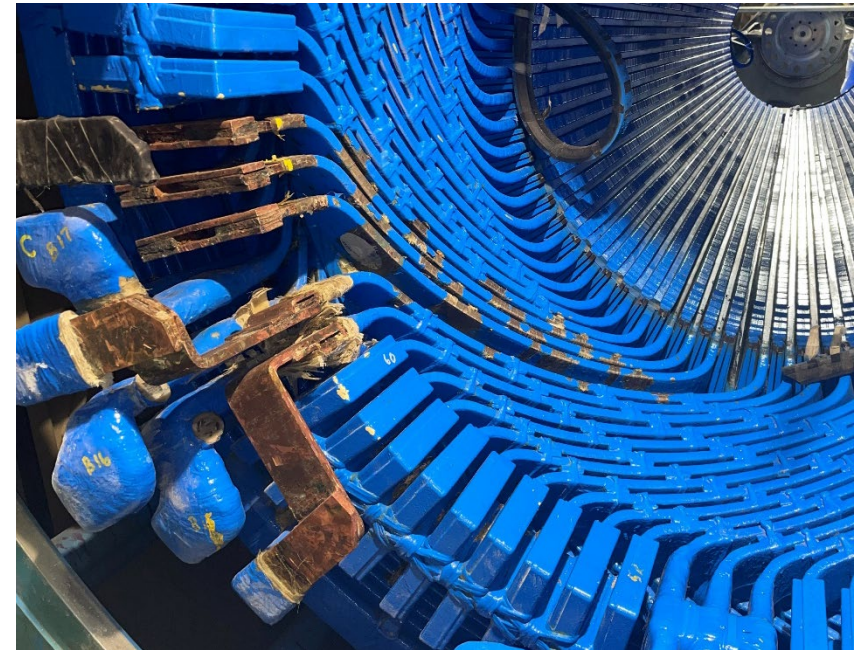
Side Ripple Filler Discovery

- Side Ripple Filler – Height
 - Significantly short
- Side Filler Material Preparation
 - Protruding corners, not rounded and/or oriented properly – “Birds Beaking”
 - Bar Abrasion

- Strand insulation discovery brings into question integrity of both top and bottom remaining bars.
 - Upgraded strand insulation and optimized losses should be part of future rewinds
- Side ripple filler discoveries present risk for ground wall insulation failure of untouched stator slots.

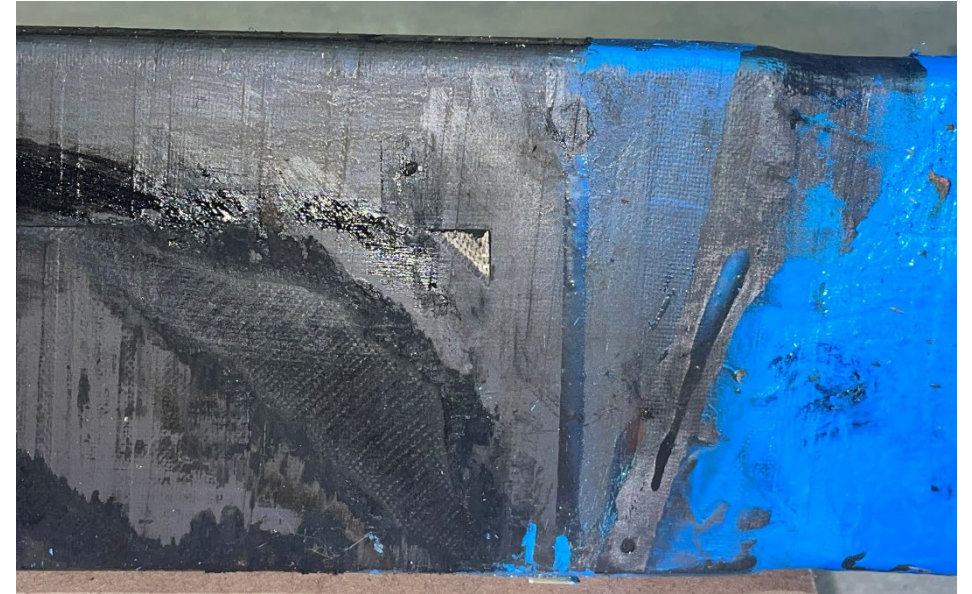
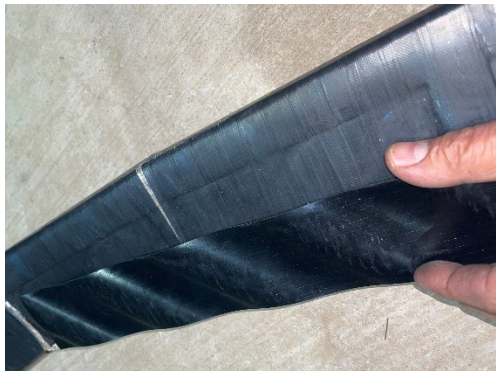
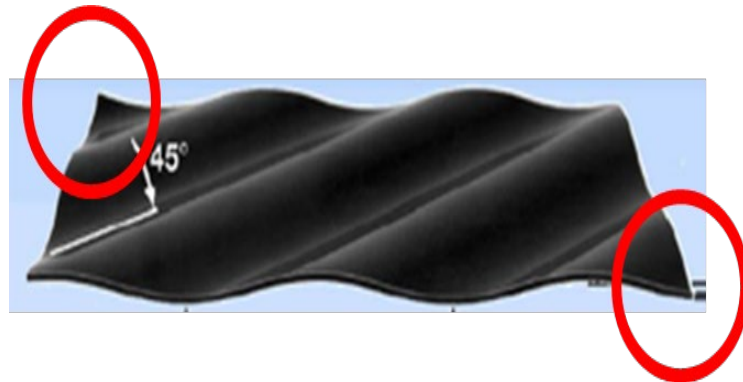
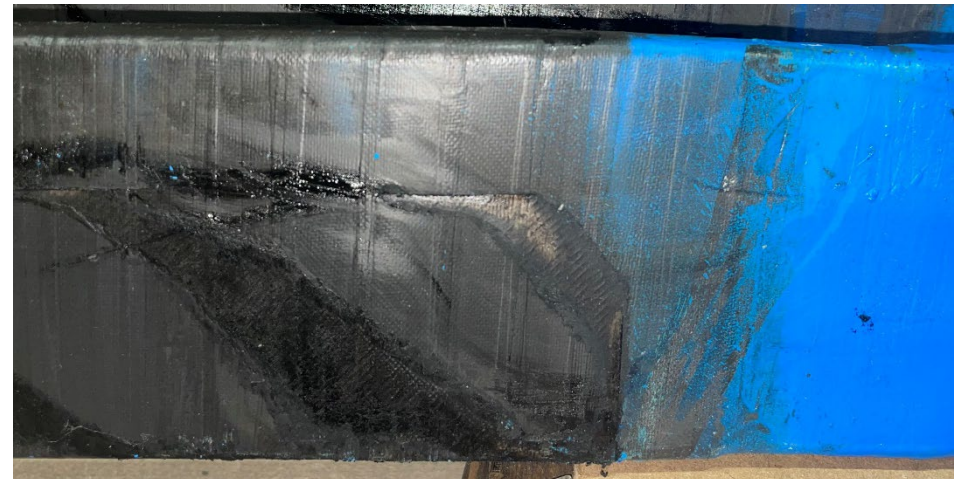
Coils Removed

- Failed Top Bar – Slot #63
- Three Adjacent Top Bars

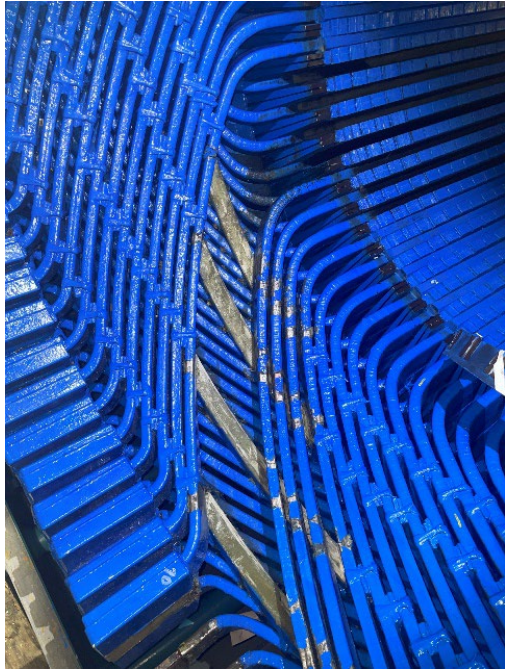
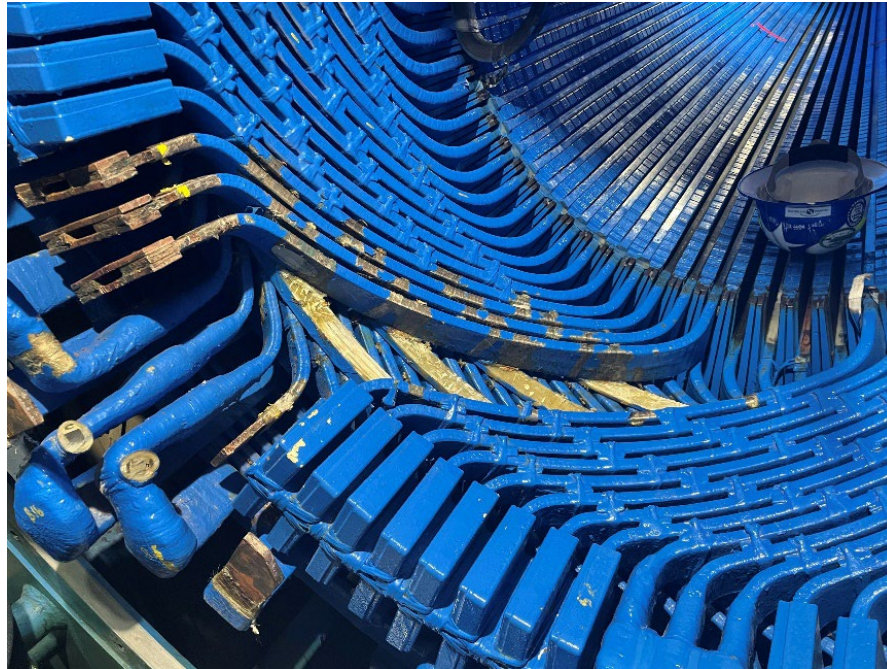
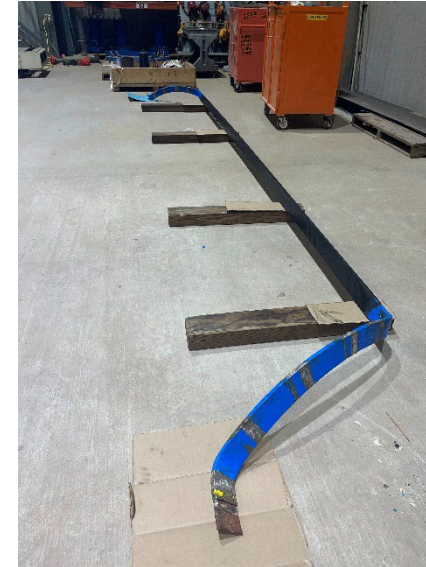
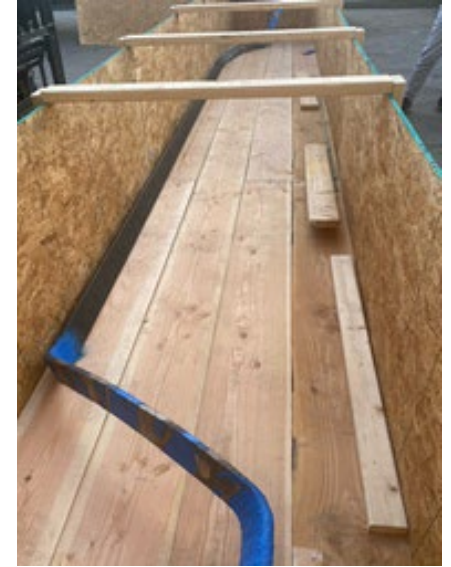
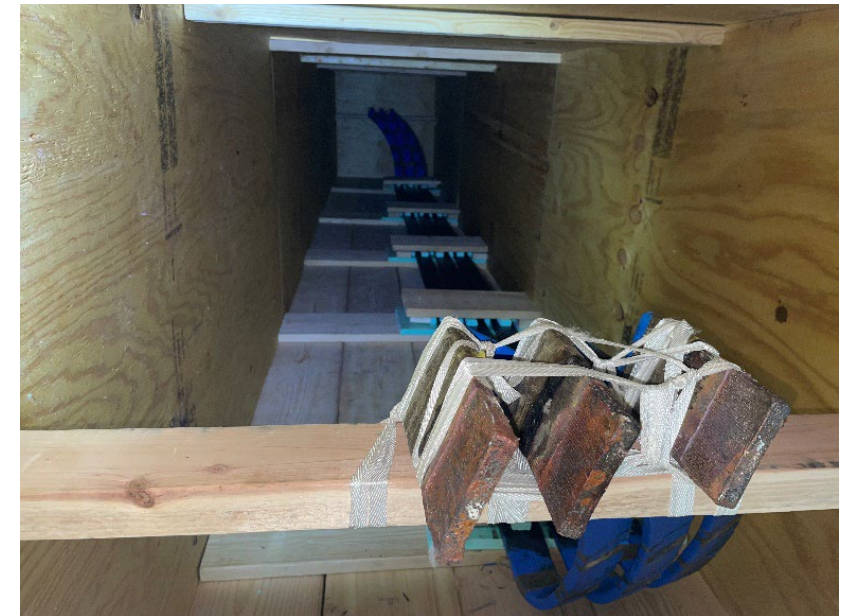
Failed Coil Arrival - Cracked Strand Discovery WHY?

- Cracks in shipment due to copper hydrogen embrittlement from extreme heat in the generator hydrogen atmosphere

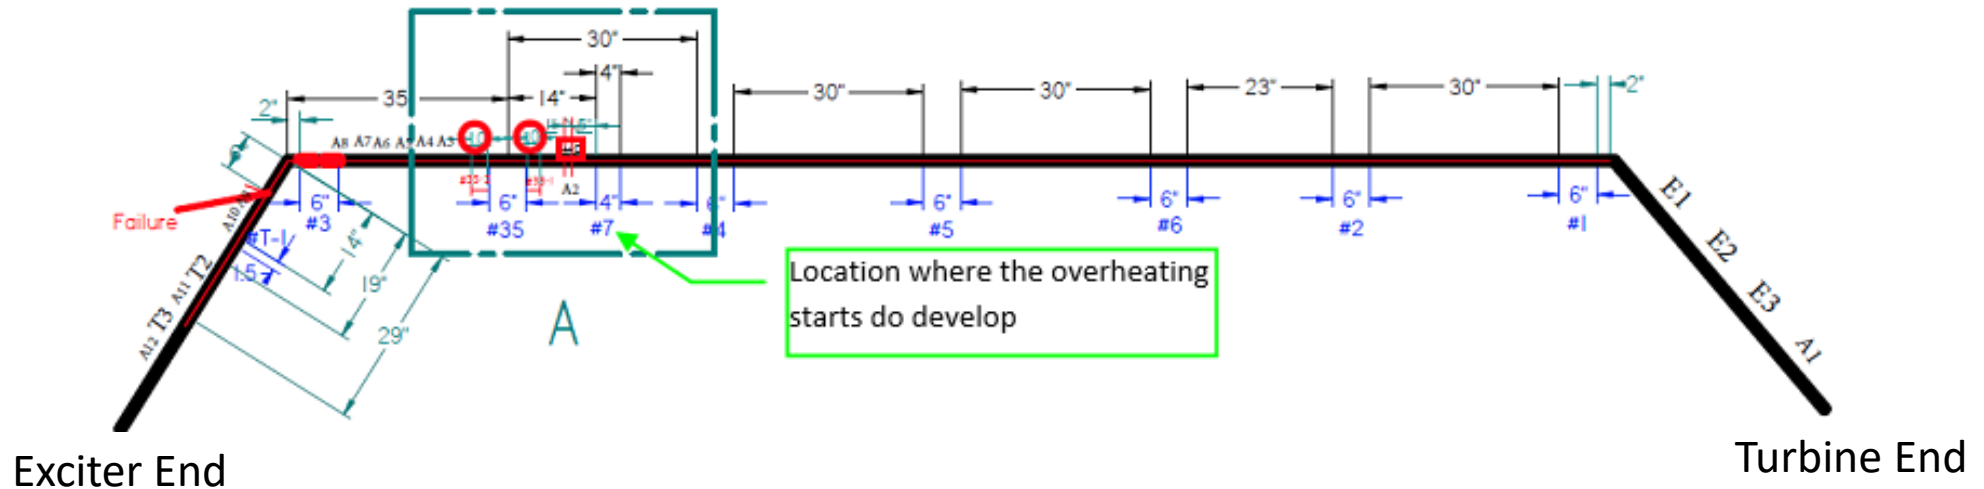
Failure Root Cause

Representative sample of strand coupons harvested from non-heat affected areas of failed bar #63

Root Cause – Shorted Strands:

- Compromised strand insulation of top bar #63
- Compromised strand insulation progressively shorted to adjacent strands, creating severe overheating
- The severe overheating damaged the bar ground wall insulation from the inside adjacent to the shorted strands outward to the bar surface.
- Eventually, ground wall deterioration allowed the ground fault failure.

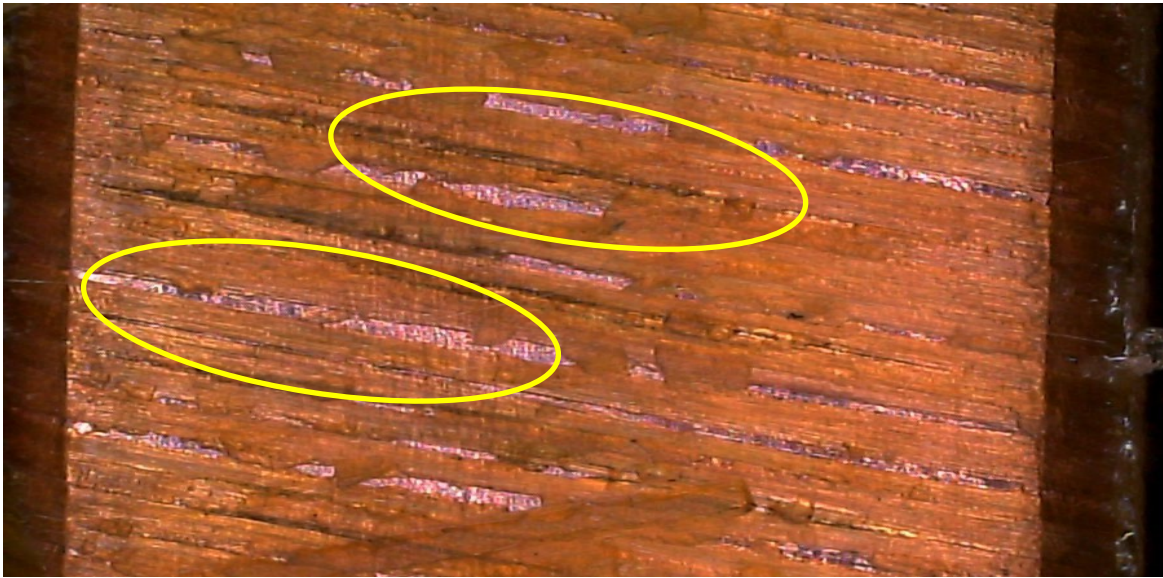
- Magnified Failed Strand

- Single serving Dacron glass
- Thin serving, no crosshatching
- Exposed conductor

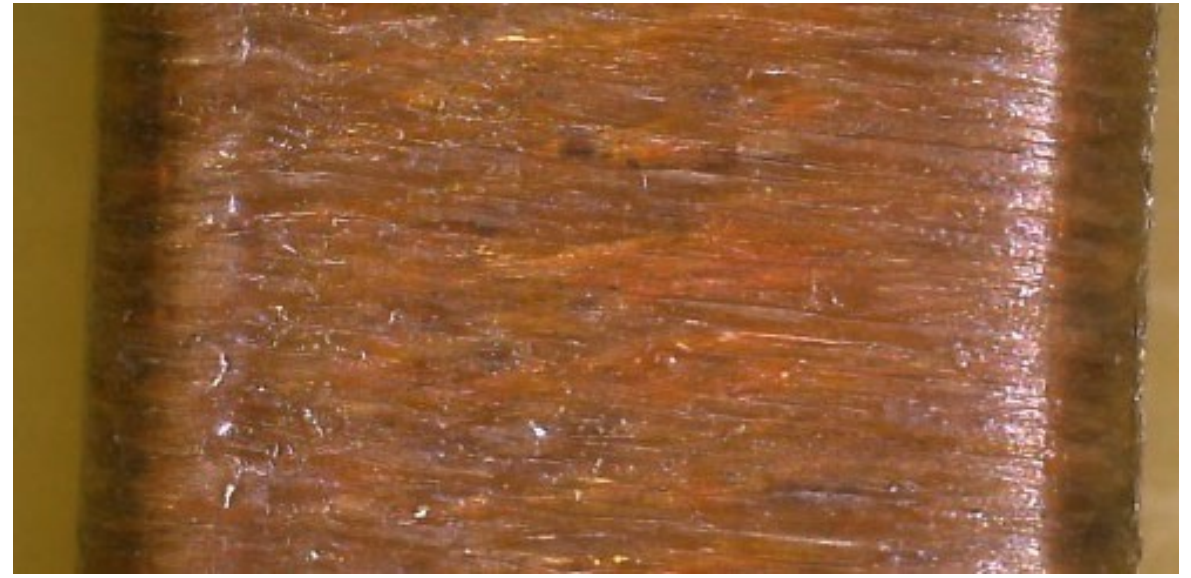
- Magnified Replacement Strand

- Double serving Dacron glass
- Crosshatched – increased coverage
- No exposed conductor

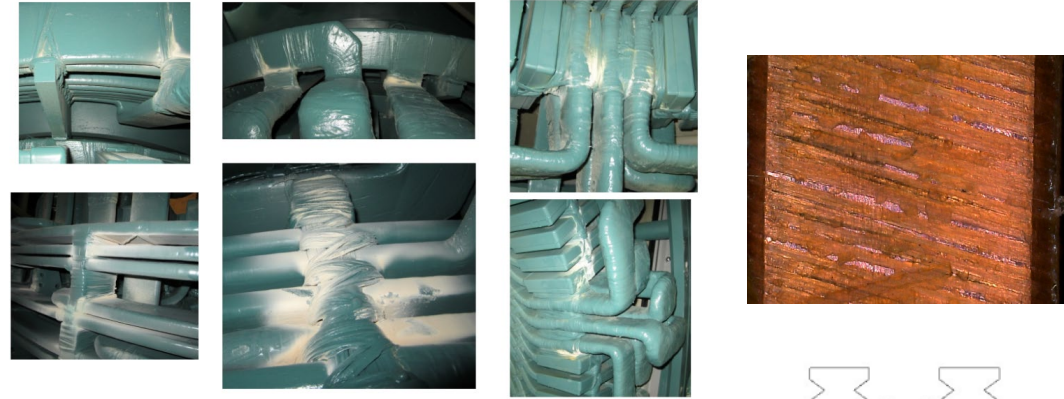
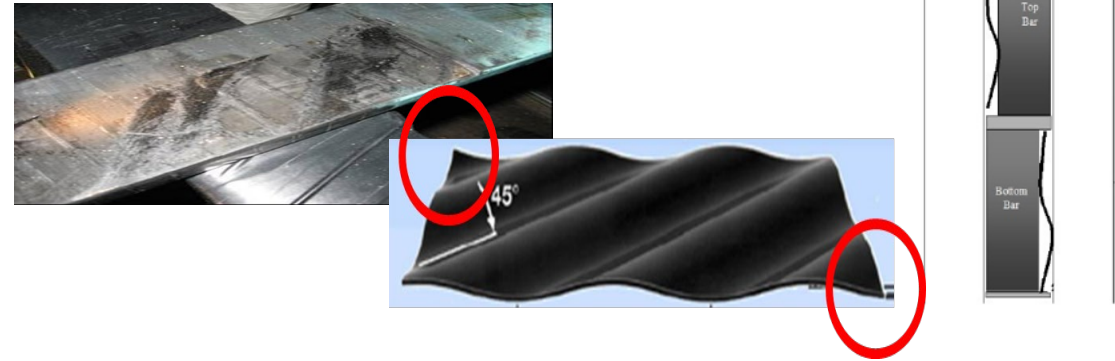
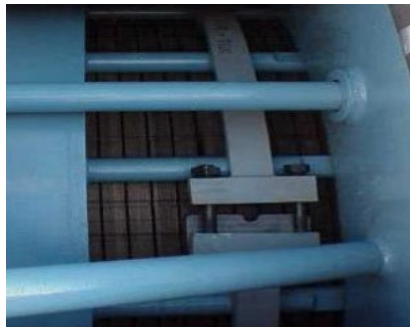
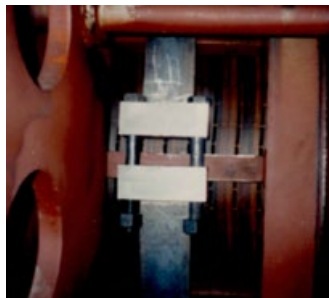
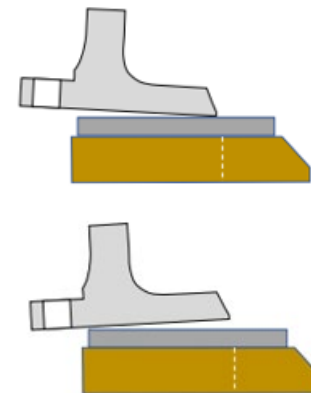
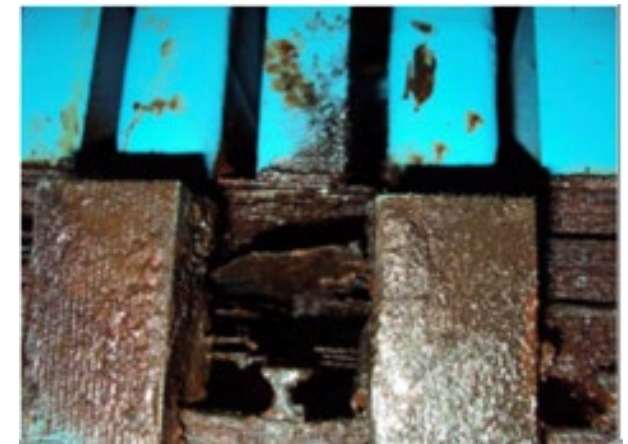
Known 324 Stator Issue Review

- End Winding Material Concern – Dry Tie Replacement – TIL 1764
- End Winding – Looseness, Resonance, Component Cracking, & Failure
 - TIL's – 1965, 1966, & 2417
- Core Compression Band Looseness, Cracking, & Key Bar Rattle
- Core Compression, Looseness, Lamination Movement & Fracture
- Slot Ripple Filler - Bar Abrasion
- Bar – Strand Insulation Failure

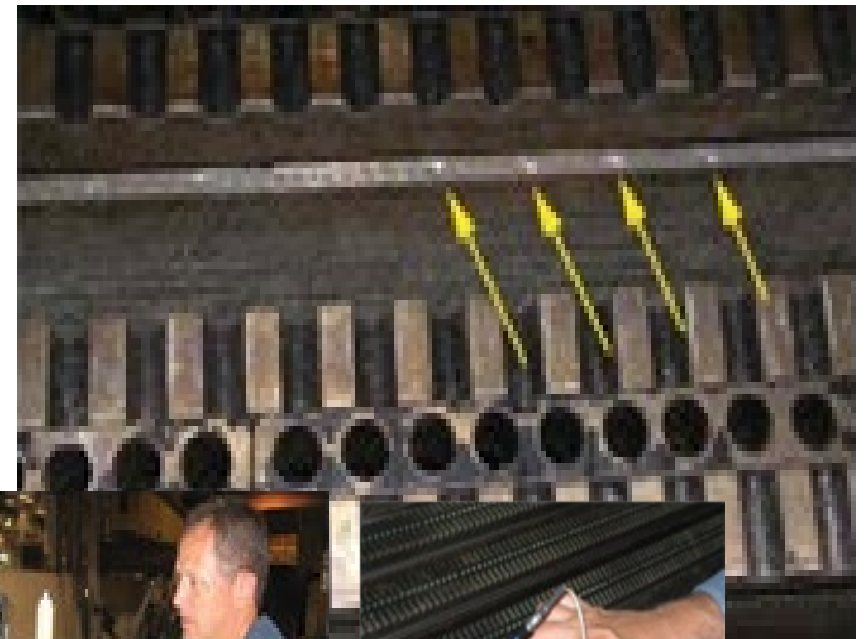
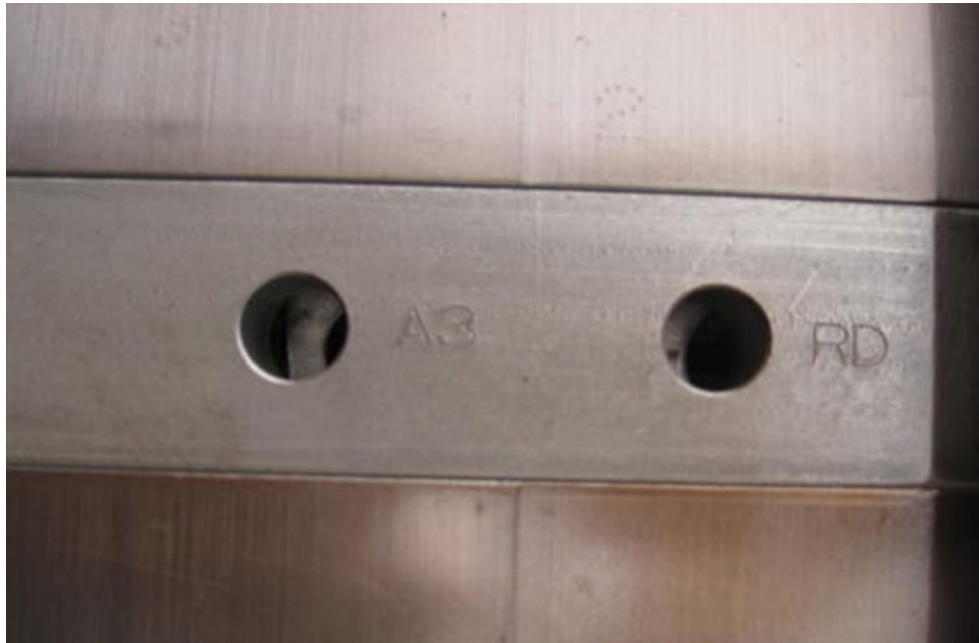
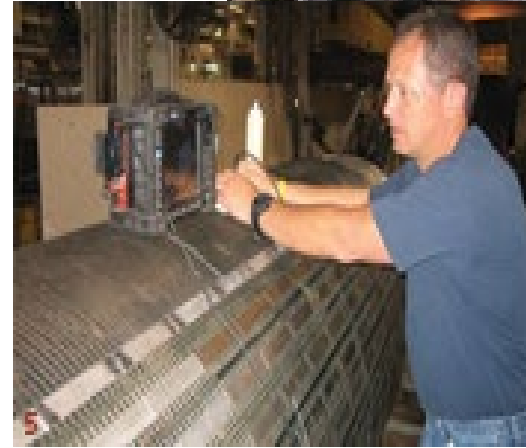
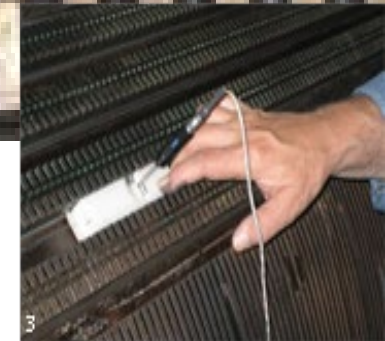
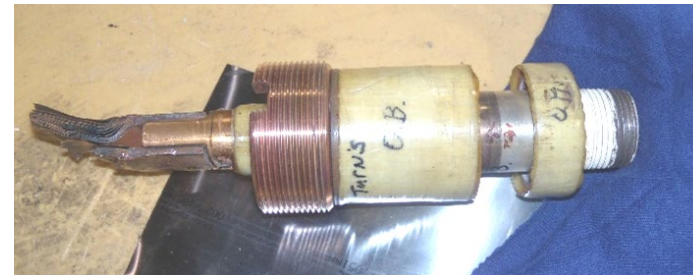
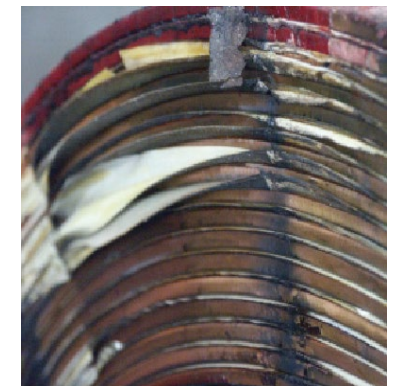
Known 324 Rotor Issue Review

- Rotor Forging Dovetail Cracking (TIL 1292)
- Rotor Amortisseur Migration
- Rotor Radial Lead Cracking & Failure
- Rotor Turn Insulation Migration
