CASE OF IPB VIBRATION MONITORED AFTER TWO WELD FAILURES

Company: Coal-fired Power Plant in Arkansas, U.S.A.

Machine: Unit 1, 25 kV 836 MW two-pole hydrogen-cooled generator in operation since 1983

Summary: Arc flash at welds on busbar adapter for flexible links at generator bushing

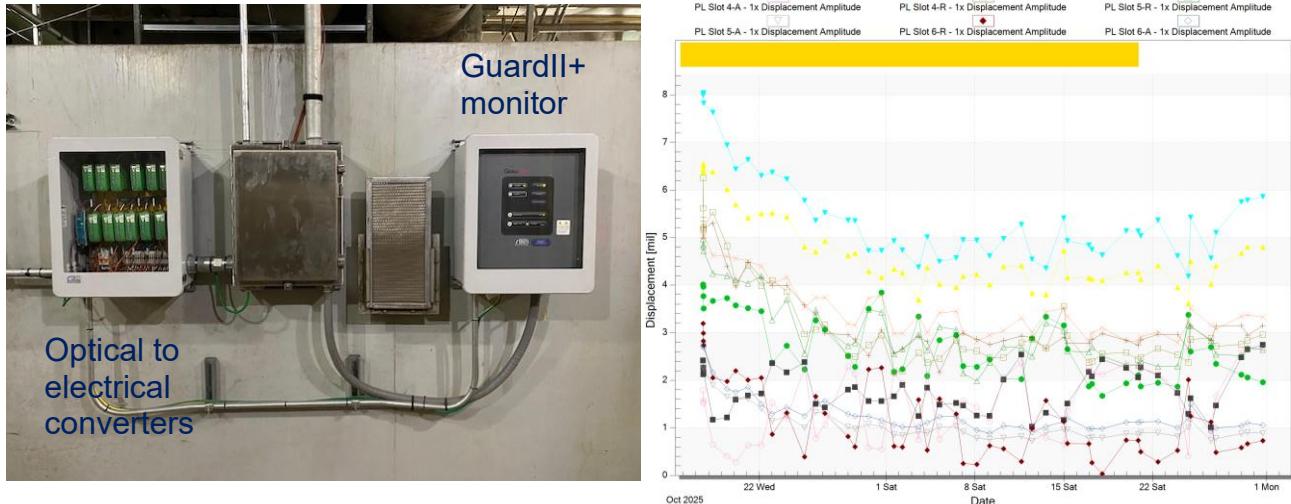
Figure 1 Short-term Trend Provided by Monitoring System

The initial data confirmed that phase C of the IPB had higher vibration than the other two phases, see the yellow and light blue curves in the trend graph, Figure 1.

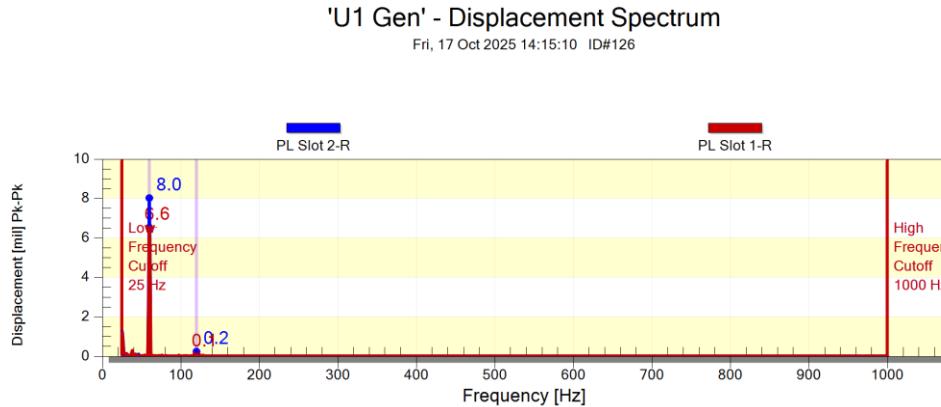
Figure 2 Spectrum Analysis of Vibration on Phase C IPB

Vibration is predominantly at line frequency of 60 Hz, Figure 2, and the trend was approximately stable.
