# CASE OF IMPROPER PROXIMITY SENSOR INSTALLATION DISCOVERED BY SHAFT CURRENT MONITORING

**Company:** Hydro Power Plant in Quebec, Canada

**Machine:** Unit 12, 13.8 kV 83.34 MW 128.6 rpm 56-pole hydro generator rewind in 2024

**Summary:** A shunt resistor that measures the shaft current was burnt due to high current

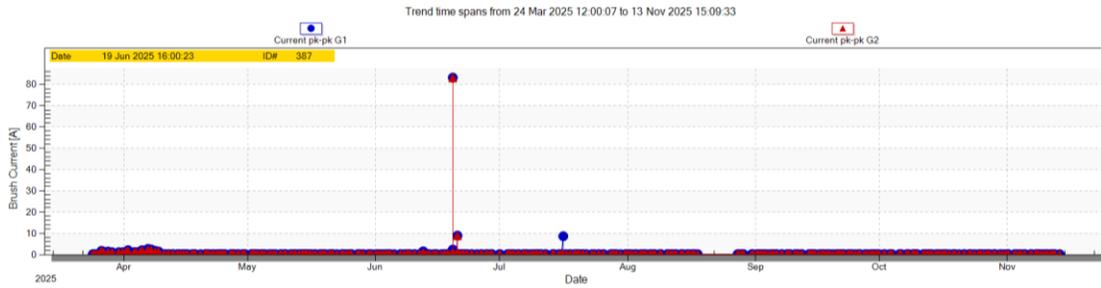
**Figure 1 Shaft Current Trend of G1 (Blue) and G2 (Red) Channels**

**End User Report:** The GuardII+ monitor captured an instance of very high shaft current of 83 A peak-to-peak at both current channels, as shown in Figure 1 and Figure 2. One of the shunt resistors was found to be burnt one day later. The resistance was 0.1  $\Omega$ , which was incorrectly used for a historically low shaft current. The shunt was replaced with a 1  $\Omega$  model after the incident.

**Findings and Confirmation:** A proximity sensor was improperly installed at the upper guide bearing. It was in contact with the shaft and was not insulated. This formed a current loop with the shaft and therefore caused a high current as well as occasional sparking. The customer fed back that the high current has not been recorded again by the GuardII+ monitor after the sensor was removed.
