Ensuring Quality in Hydro-Generator Rewinds

by Scott Cotner, P.E., M. Eng.

Hydroelectric Design Center

US Army Corps of Engineers
BUILDING STRONG®

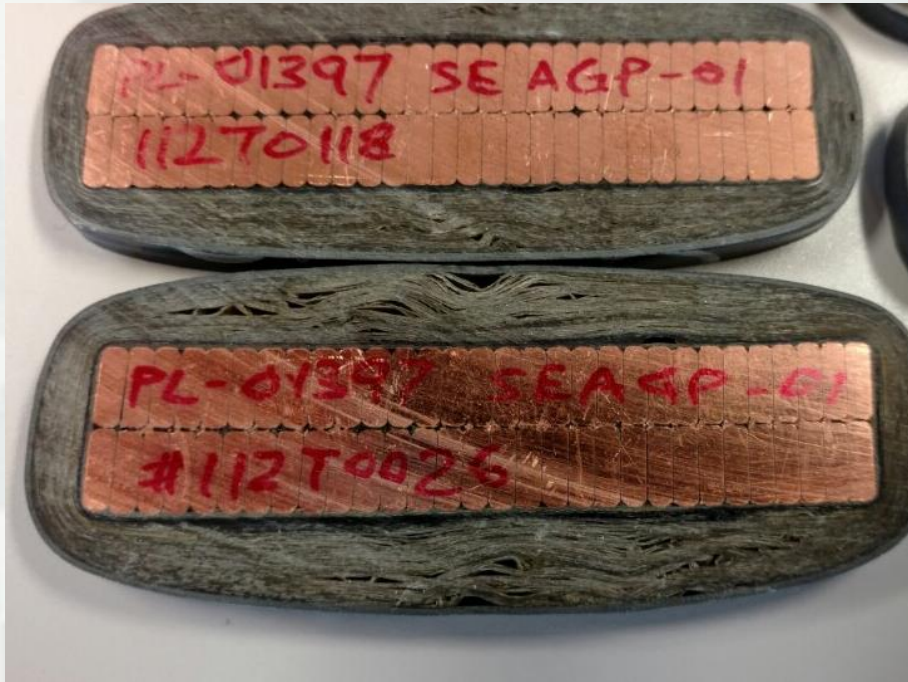
Prototype Coil Dissections

- Voids in insulation
- Replacement bars manufactured
- Revised locations of slices to be checked for voids in specifications

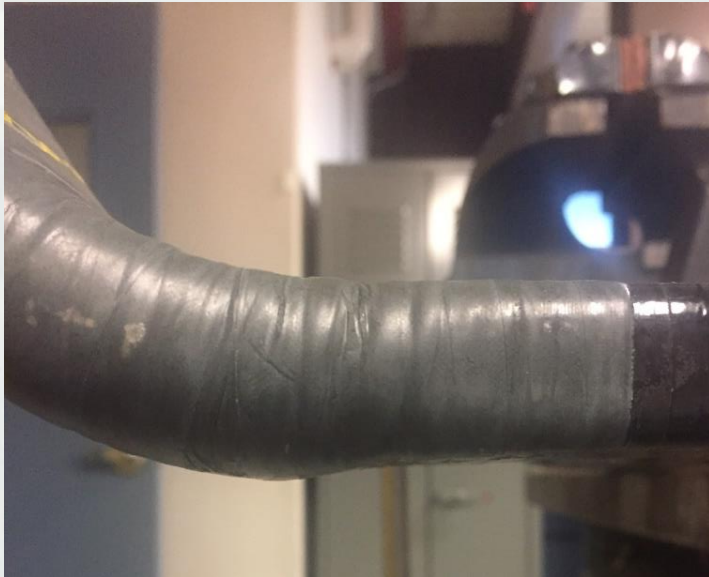
Bar End Arm Shape Control

- End-arm shape not well controlled
- Led to voids, and interference with adjacent bars
- Changed fitment test requirements in “dummy” core section in future specifications

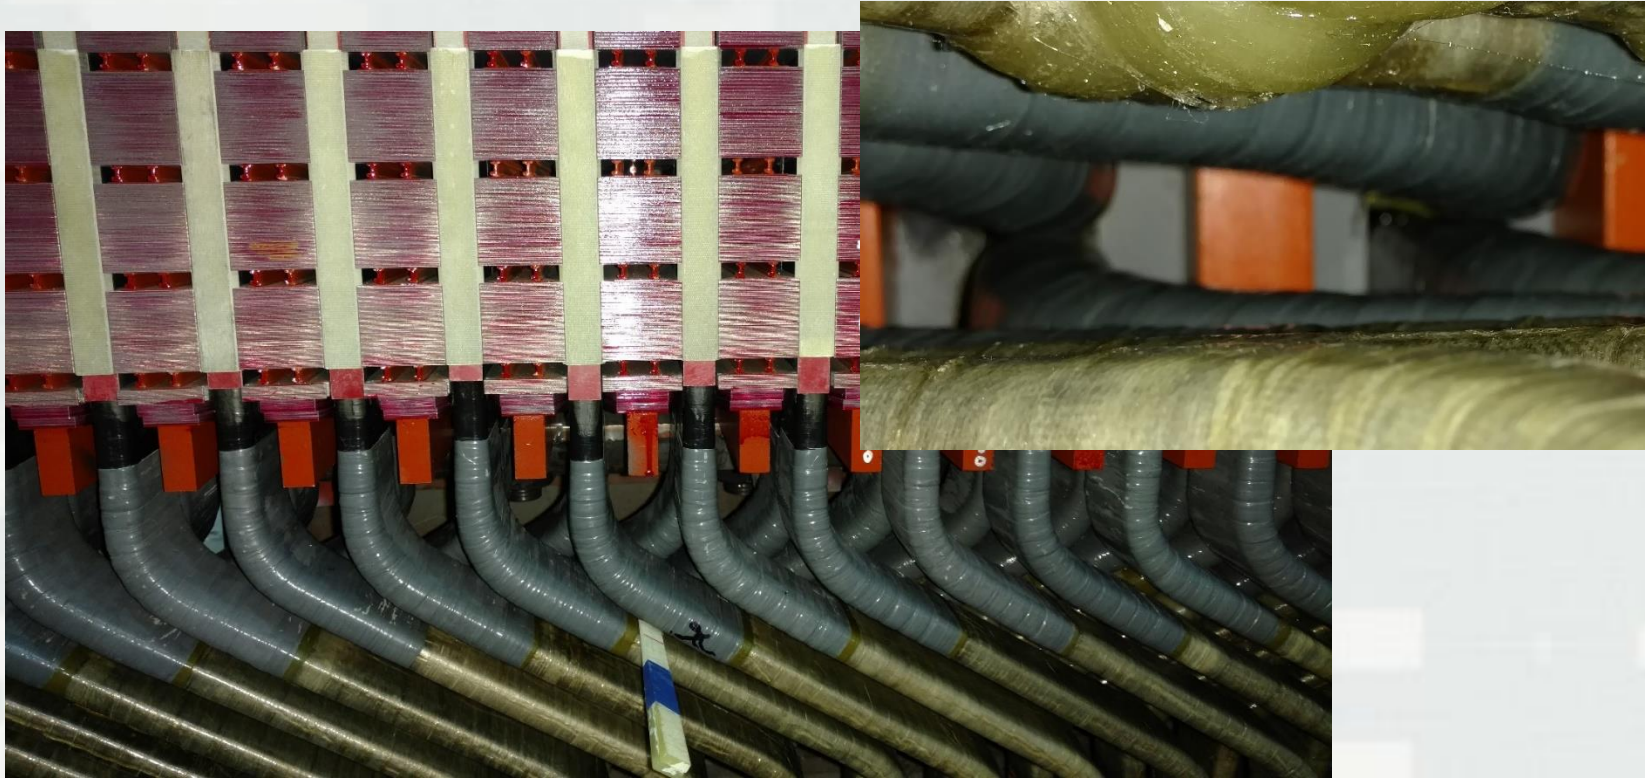
Bar End Arm Interference

Bars ends touched and top bars could not be seated in a dozen slots; new bars were manufactured.

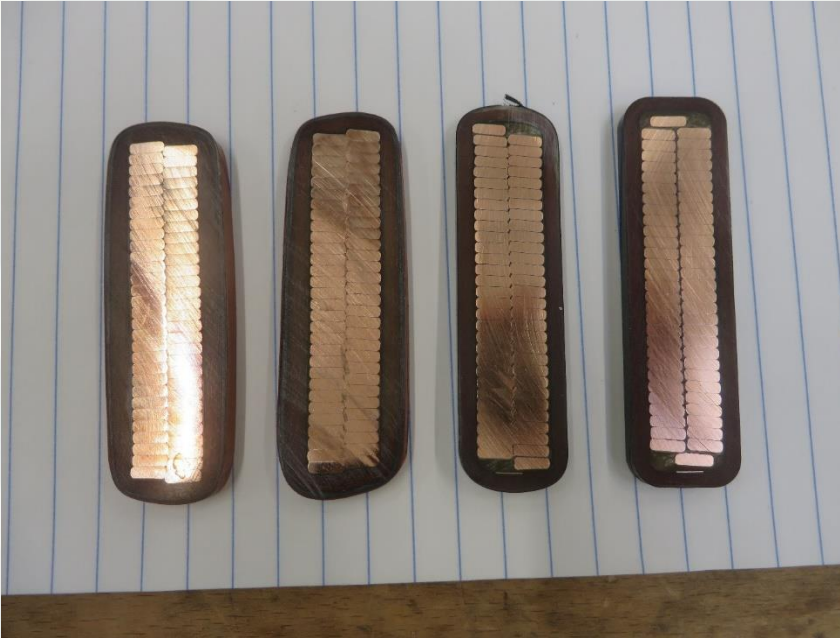
Prototype Coil Dissections

- No visible voids
- Good shape control
- No Problem!

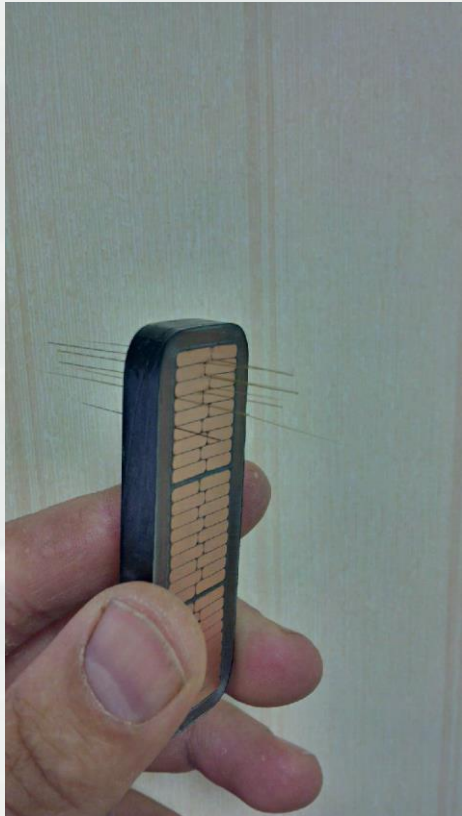
Production Coil Dissections - Voids

- Prototype coils were ok
- Face-to-face meetings conveyed requirements
- Manufacturing process reviewed
- Replacement coils were manufactured
- Specifications were edited to be more clear

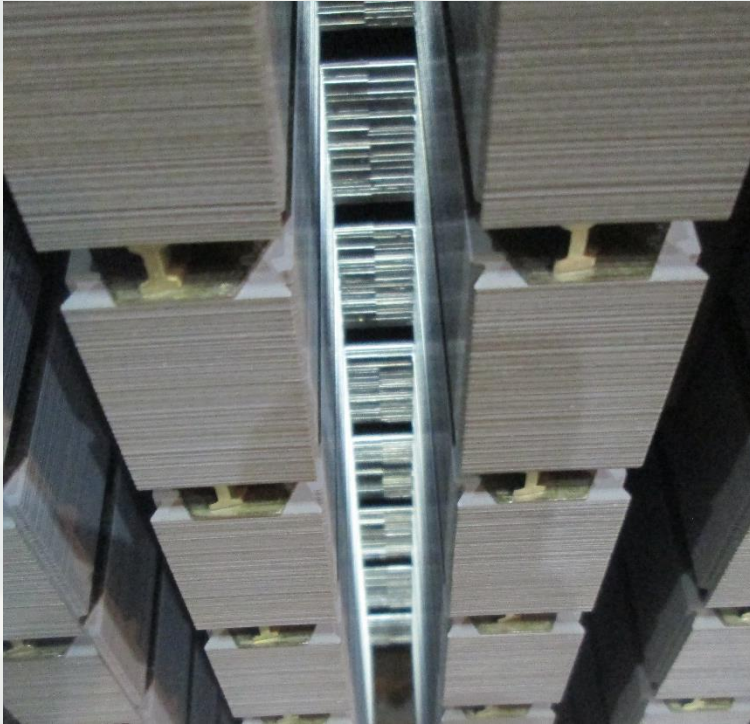
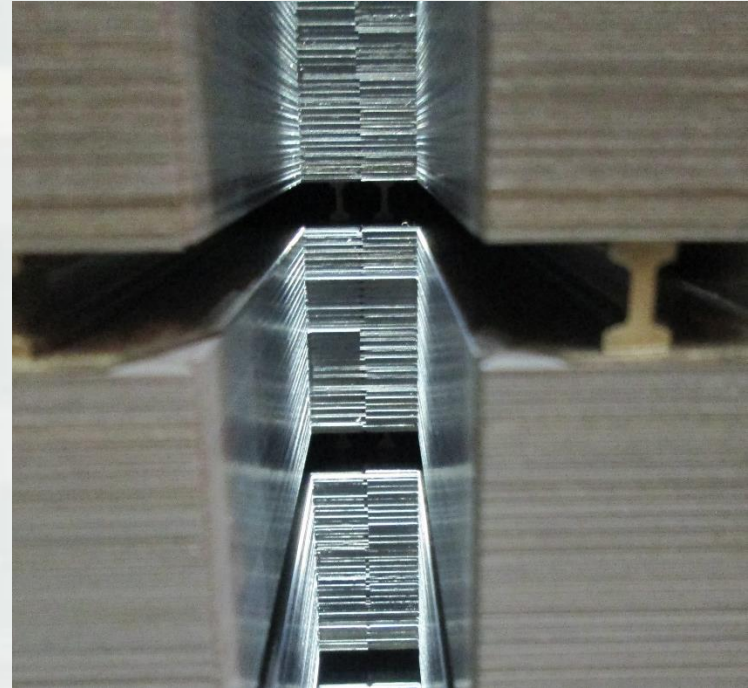
Re-piled Core

Required special bottom filler to protect bars

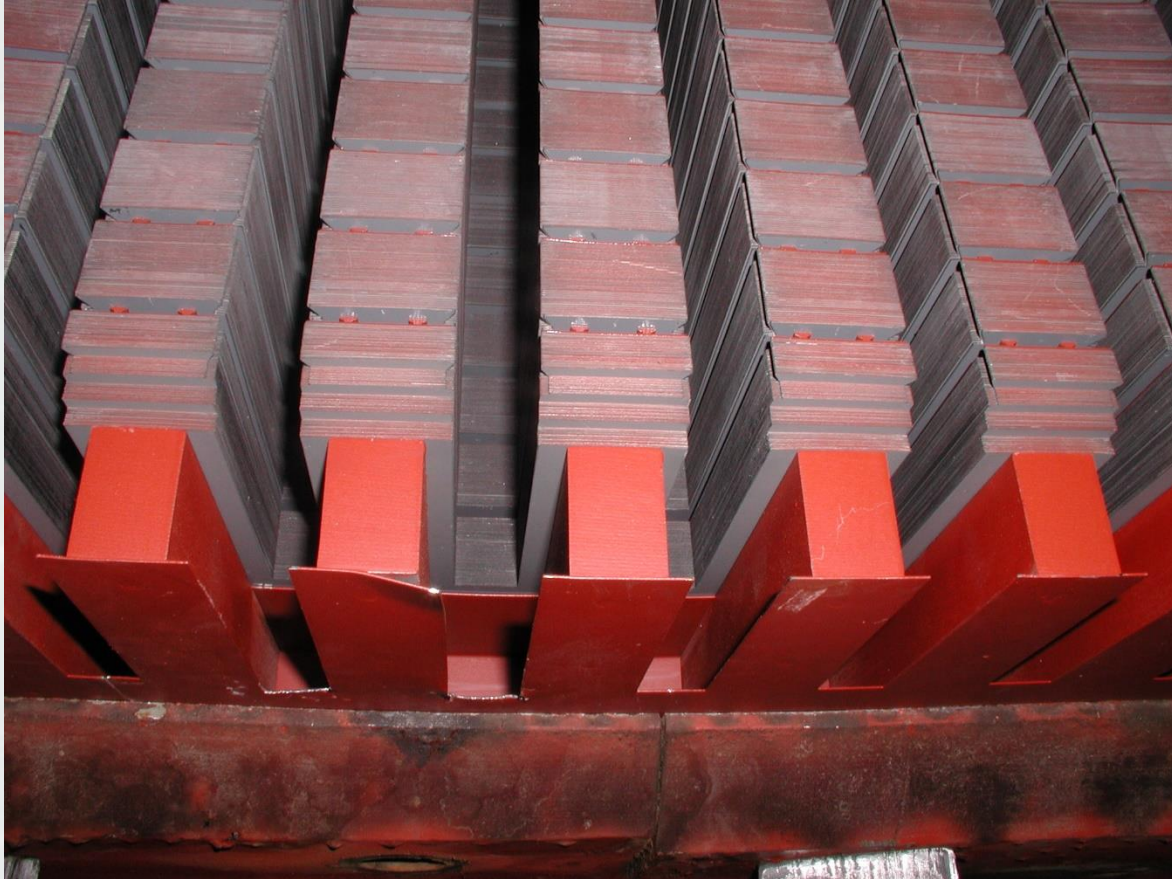
Wrong from the beginning!

- Different factory stamped serial number on opposite end of bar
- Resolution
 - ▶ Agree on procedures
 - ▶ Remove bars
 - ▶ Touch up surfaces and retest
 - ▶ Install right side up
- Prevent future occurrences
 - ▶ Pay attention to beginning of winding process – see that it matches the drawings!

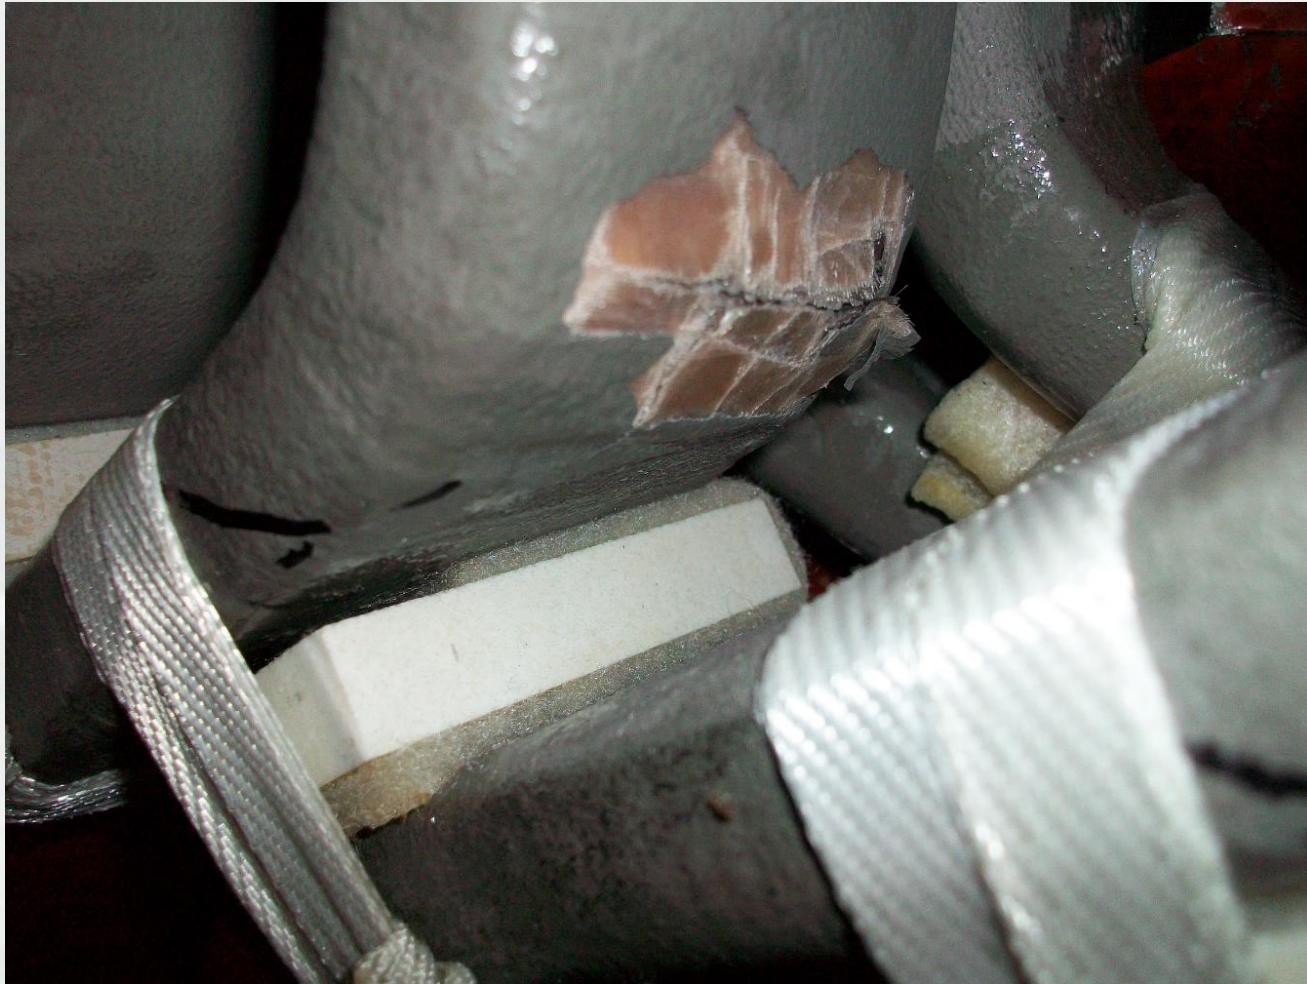
Coil Failed In-process Testing

- Damage went un-noticed until hi-pot
- Many coils installed over failed coil
 - ▶ 50-60 coils would be disturbed by lift to replace
- Half coil splices allowed in new winding to minimize schedule delays
 - ▶ Good coils needed to be cut to allow replacement of bad coil
- Closer adherence to ITP to prevent re-occurrences
