#### DISSECTION, CONDITION ASSESSMENT AND ANALYSIS OF STATOR WINDINGS TAKEN FROM FAILED IN SERVICE UNITS CEATI Project T082700-0356

Mladen Sasic Iris Power – Qualitrol msasic@qualitrolcorp.com

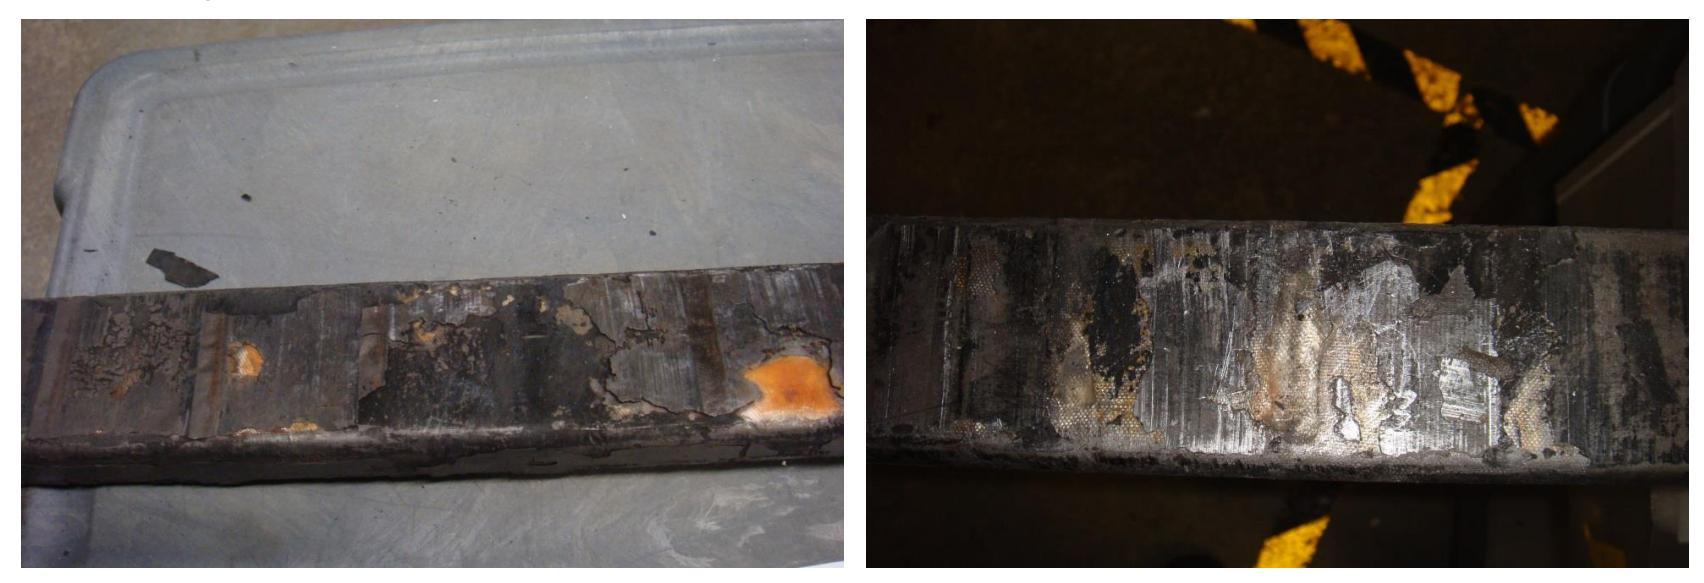
## Machine 5 – only bar with significant abrasion and surface PD

Eroded surface, PD attack. Rough surface typical of all samples.

Surface PD site

This is the machine with 25,000 starts

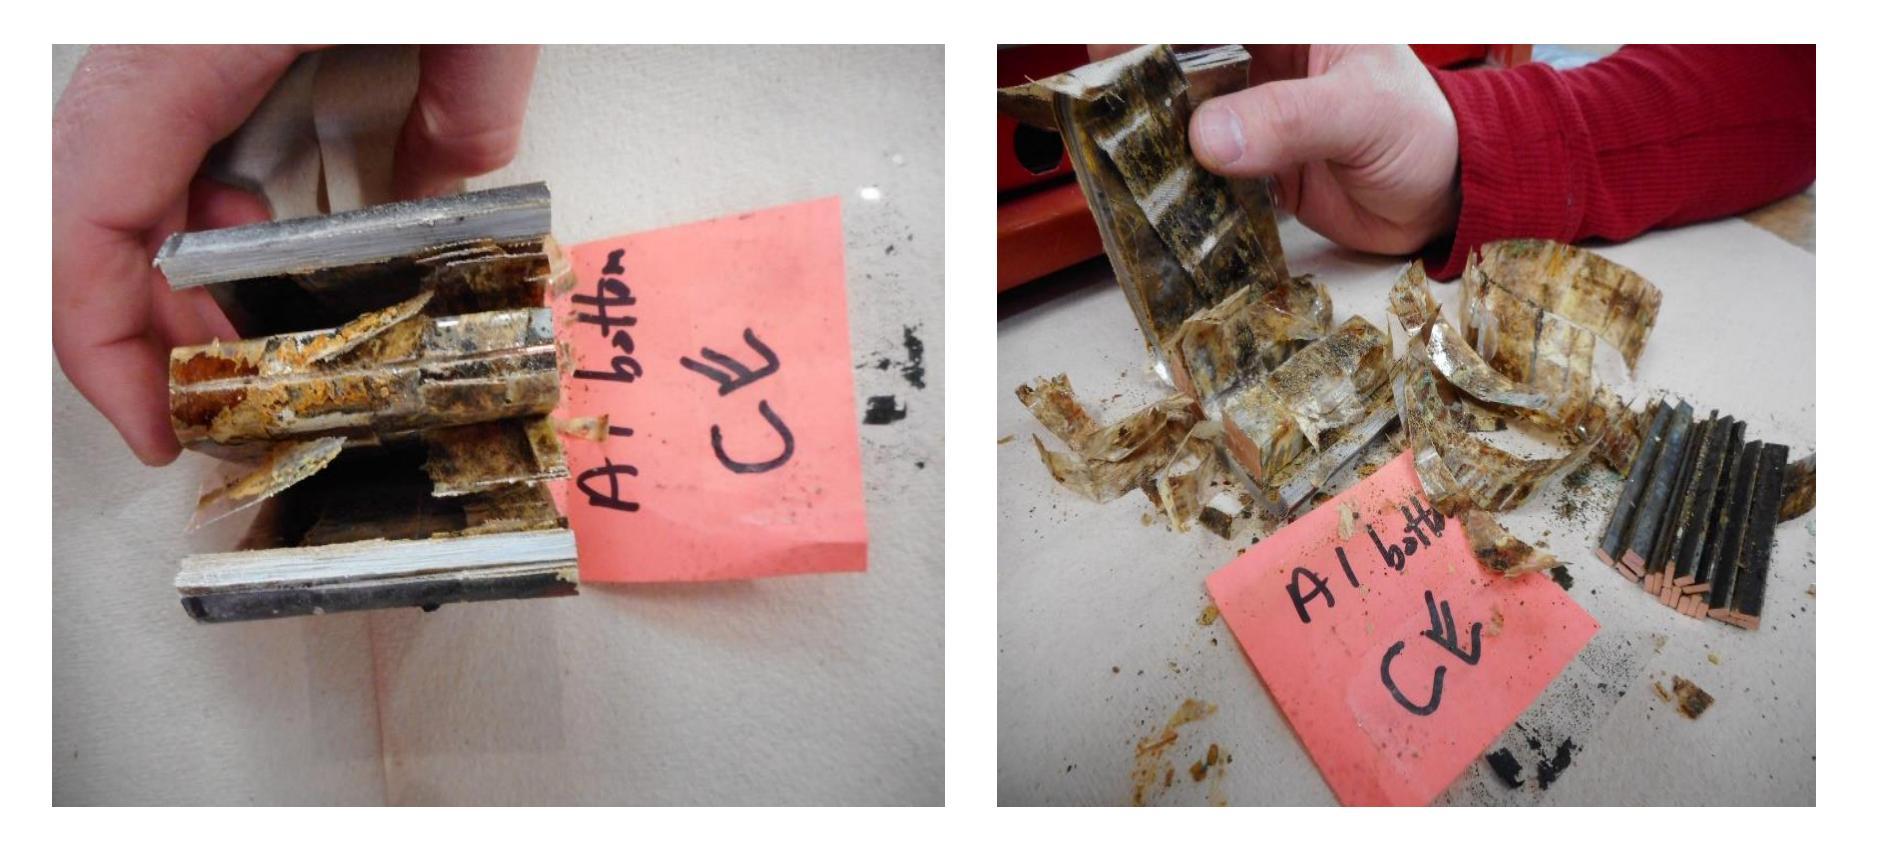
#### Machine 1 - the most deteriorated Severe overheating and PD, groundwall delaminated at end of life

This is the oldest machine -1962, 425,000 hours

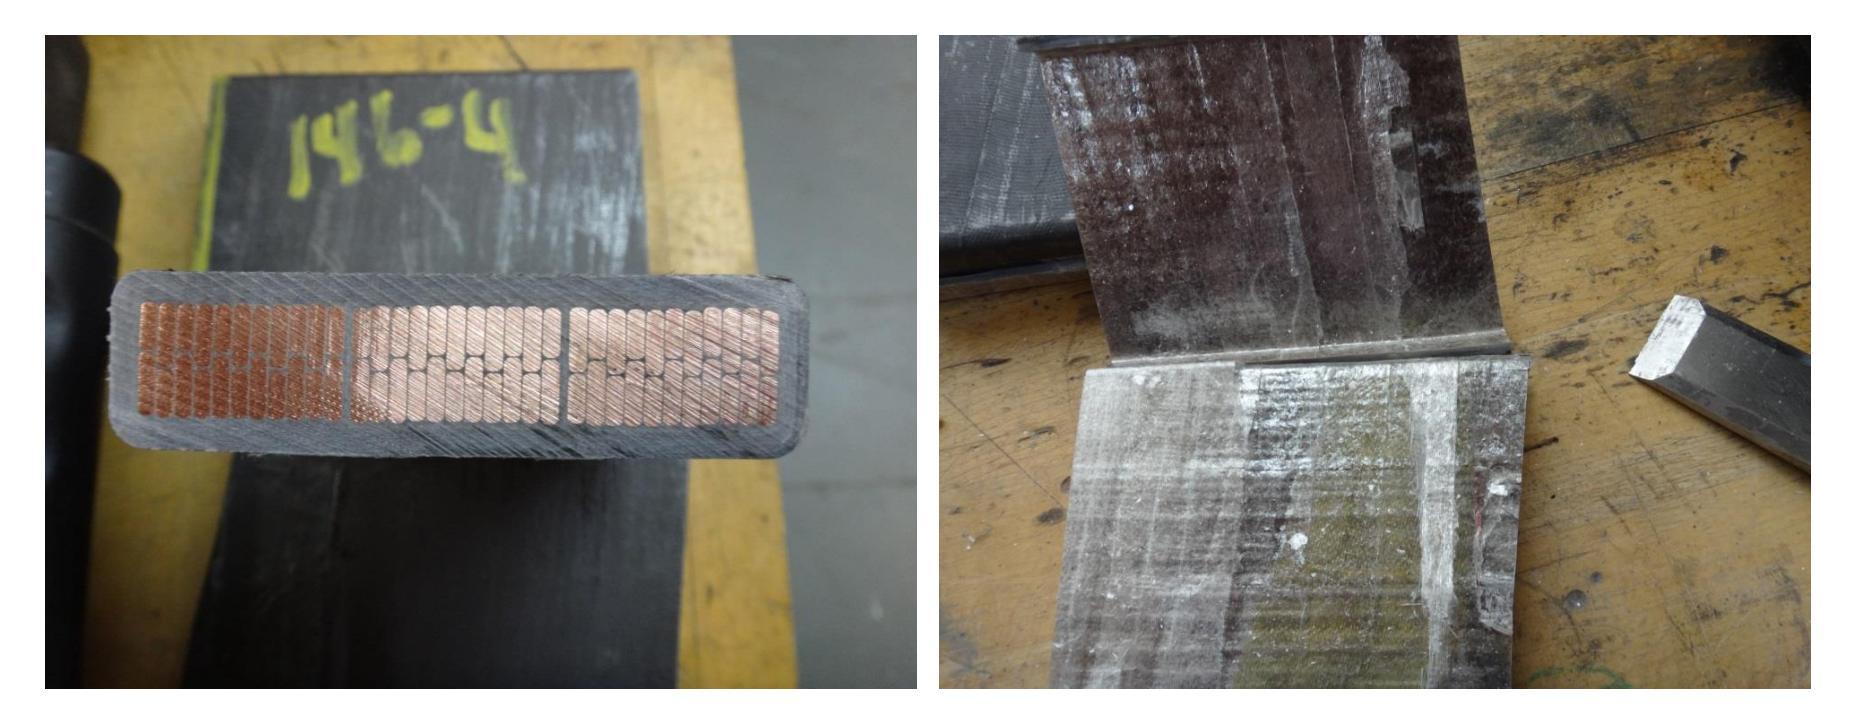
#### Machine 10 – showed no deterioration

Coil insulation well consolidated and difficult to separate. Good adhesion to turn insulation.

This is the newest machine - 5,000 hours only.

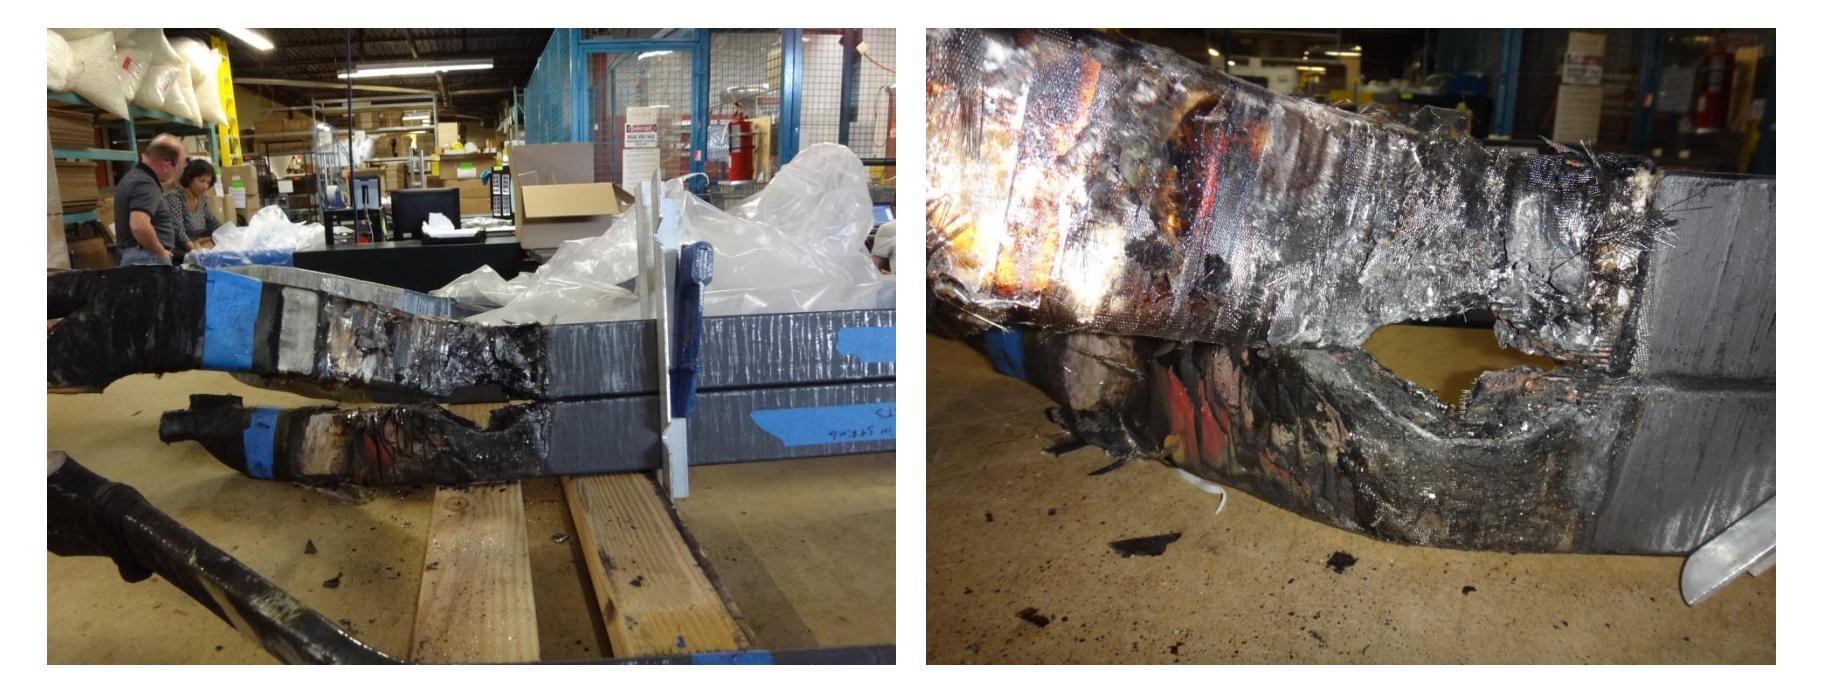
#### Machine 10 – failed after 5000 hrs.

Location right at core end and right at point where bulges may have caused insulation mechanical stress resulting in cracking of groundwall?
