Magnetic unbalance problem on 60 year old hydrogenator – analysis and solution

Jun 22nd 2021

Ozren Husnjak, Veski Ltd (Croatia)

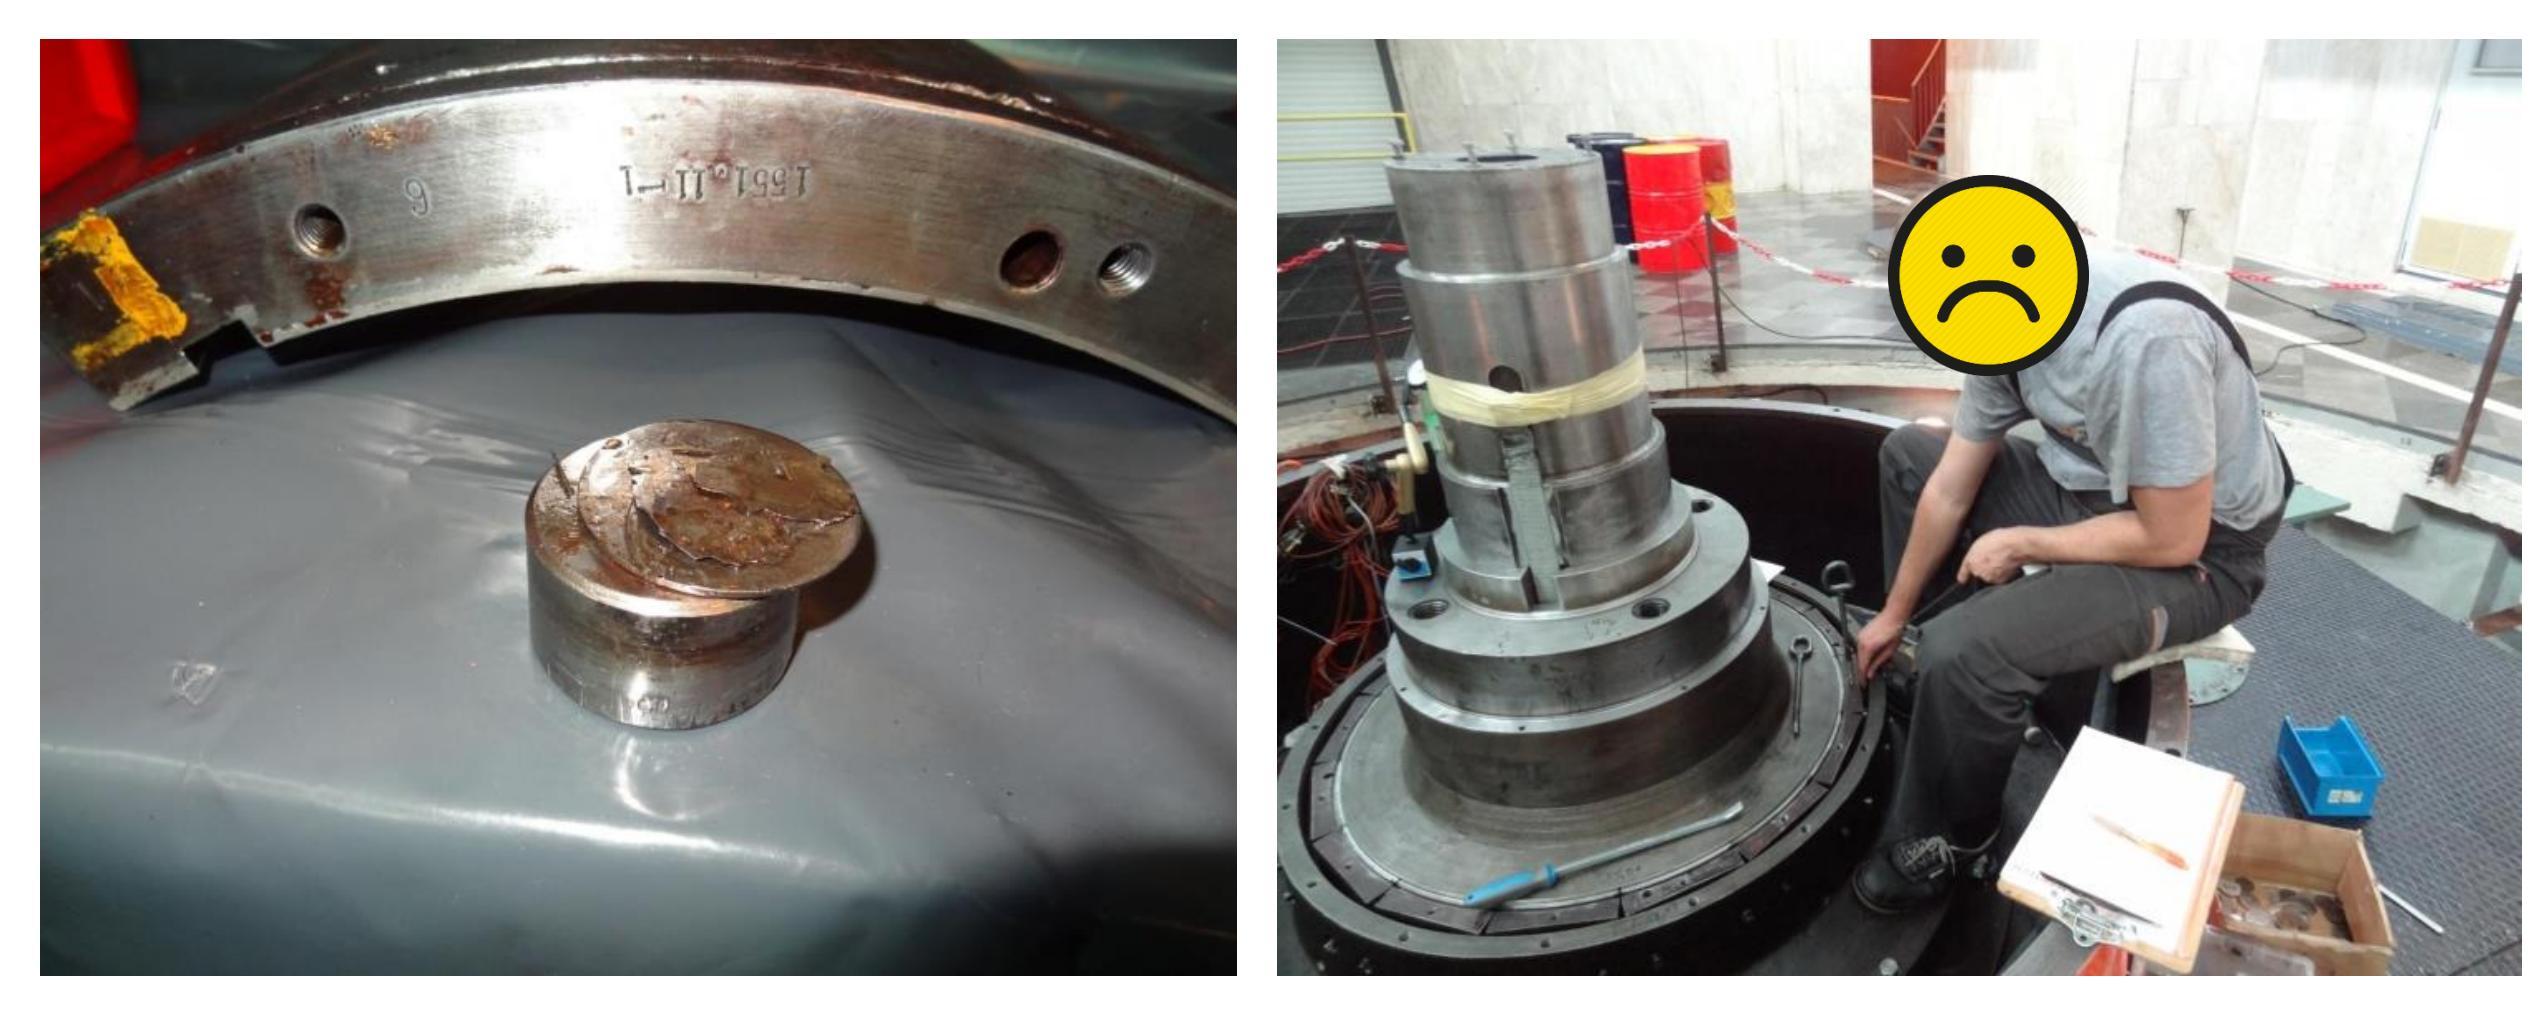
Prior to and during the overhaul on Unit 1

Vibration caused damaged pads (used to set bearing clearance) on LGB

UGB clearance setup during the overhaul

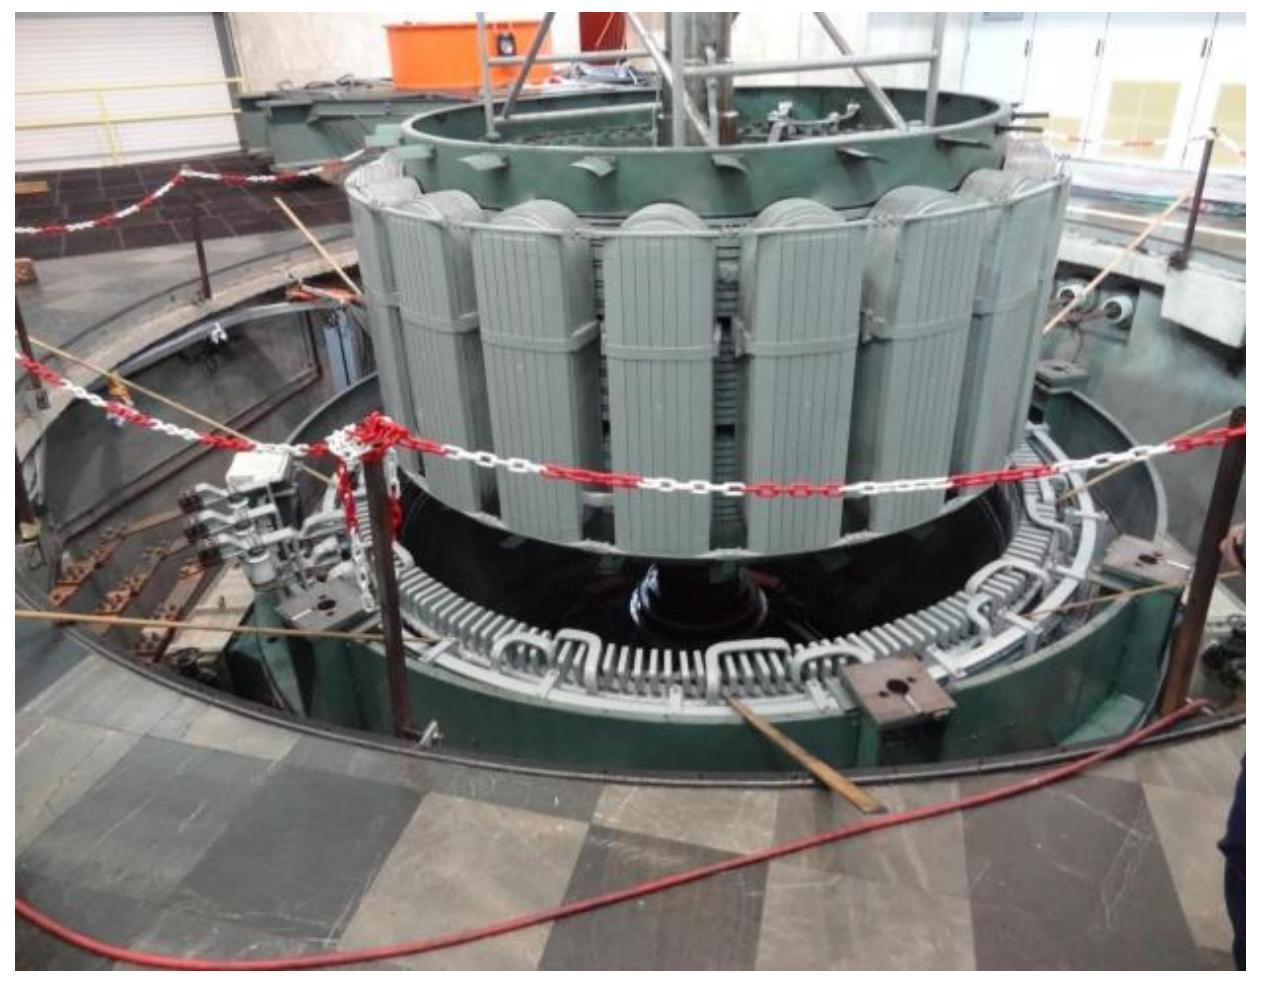
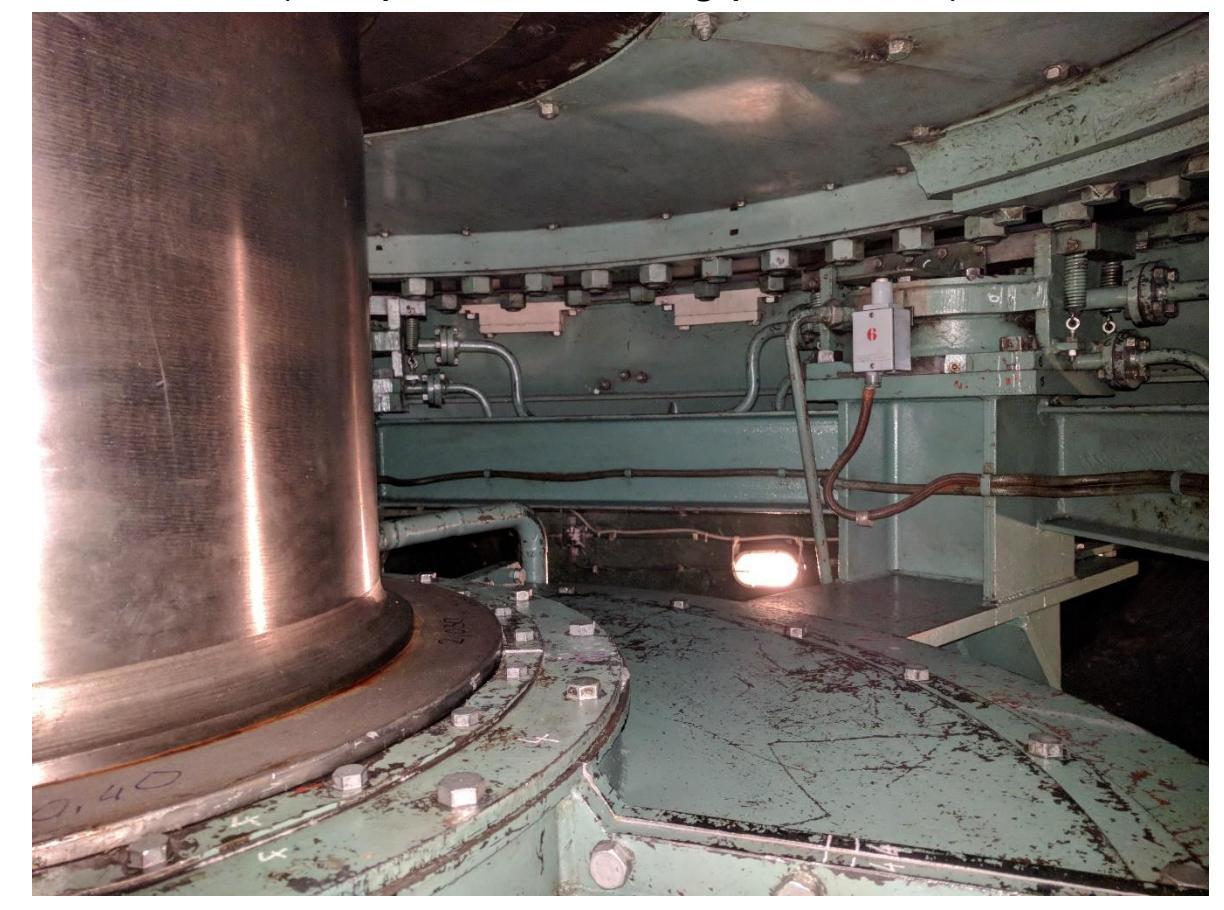
Prior to and during the overhaul on Unit 1

Rotor lowering

Balancing weights below the generator (two-plane balancing performed)

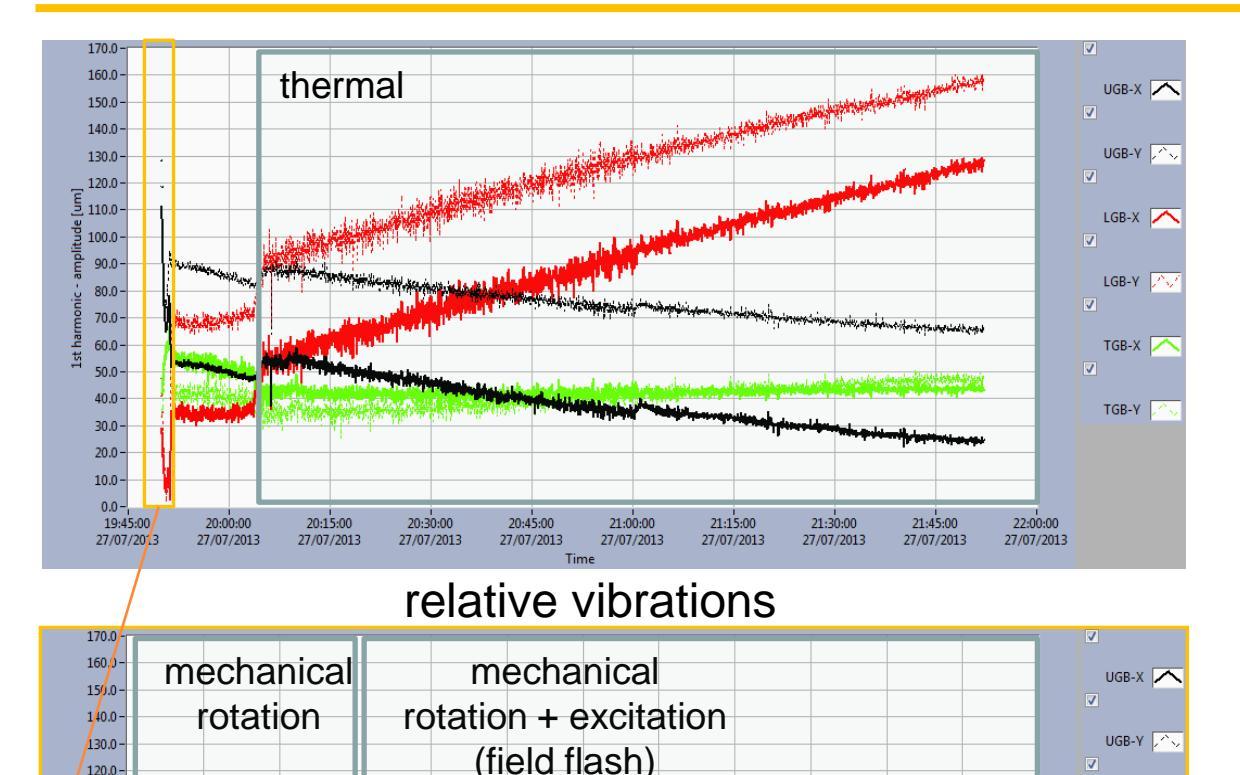
Year – 2013. / After the overhaul prior to balancing

- at LGB the vibrations increase due to electromagnetic and (later) thermal reasons
- similar changes (bet decreasing) visible at UGB vibrations

- zoomed in portion of the graph for mechanical ٠ rotation and excited state
- it is neccessary to balance the unit so that there are no more than 100 µm in all operating regimes
- (absolute vibration criteria was set to 0.5 mm/s)

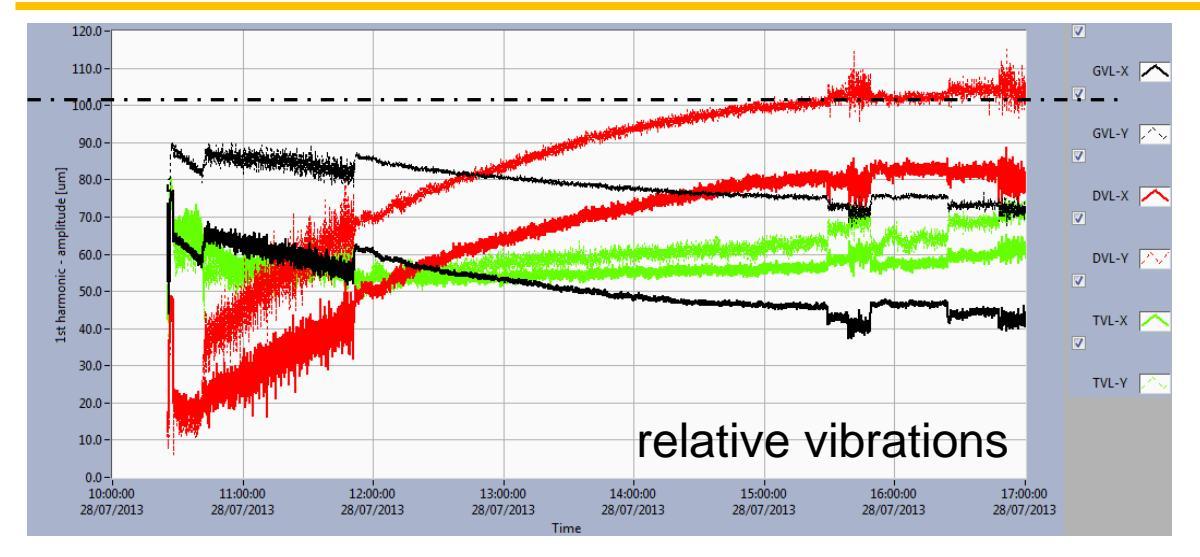
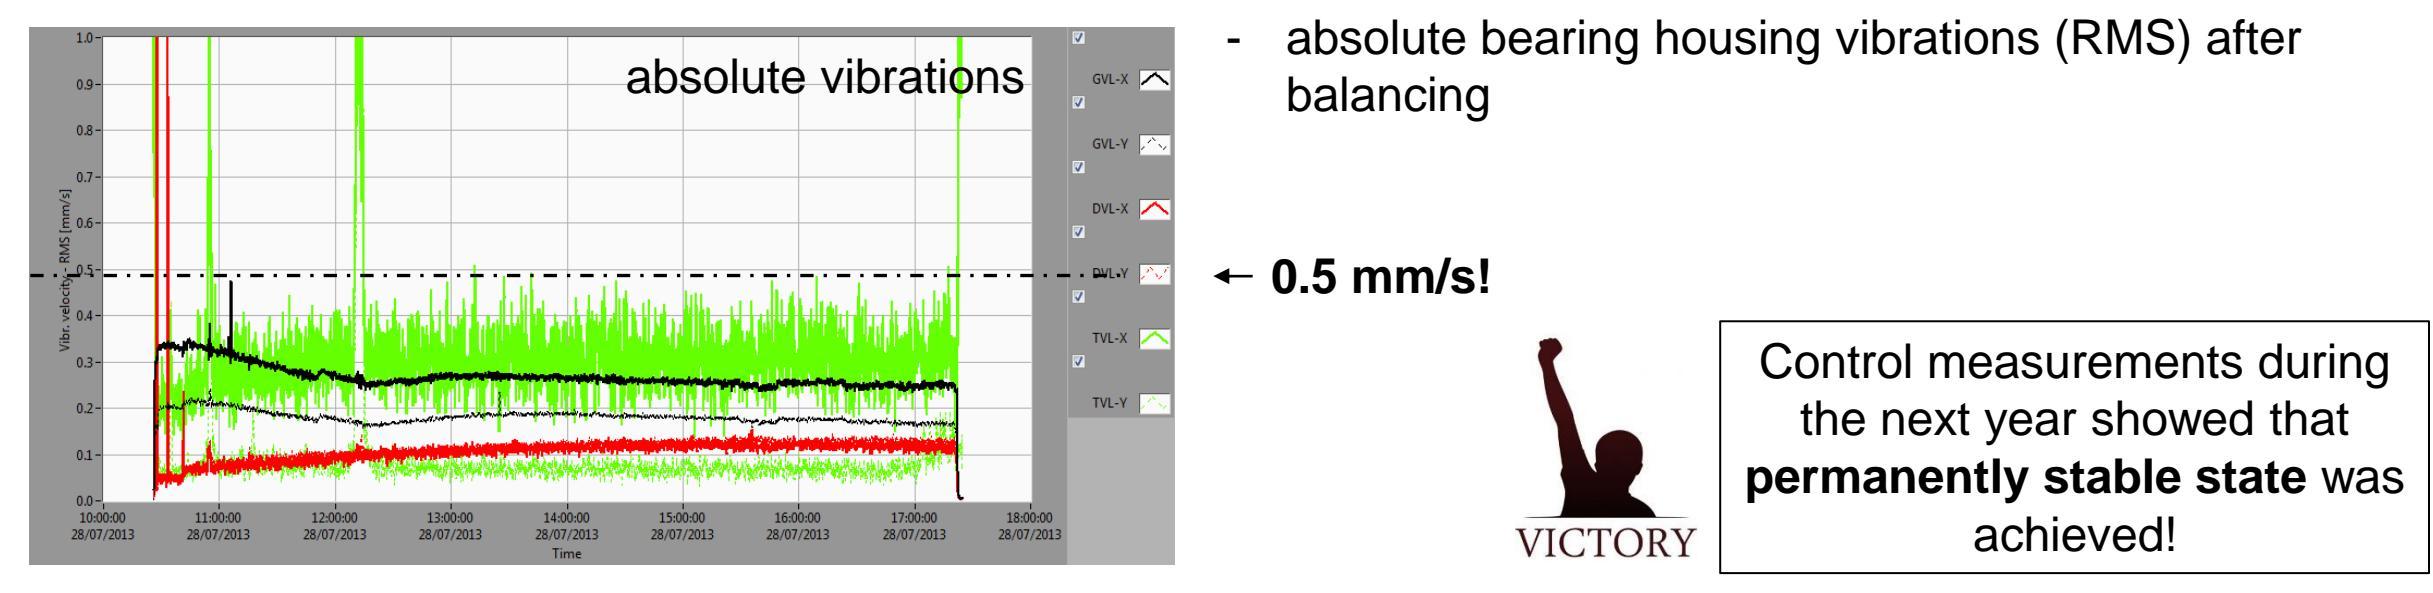
Year – 2013. / after the overhaul and after the balancing

← 100 µm!

- thermal effect for relative vibrations after balancing

Although, a better approach would be to minimize electromagnetic unbalance!

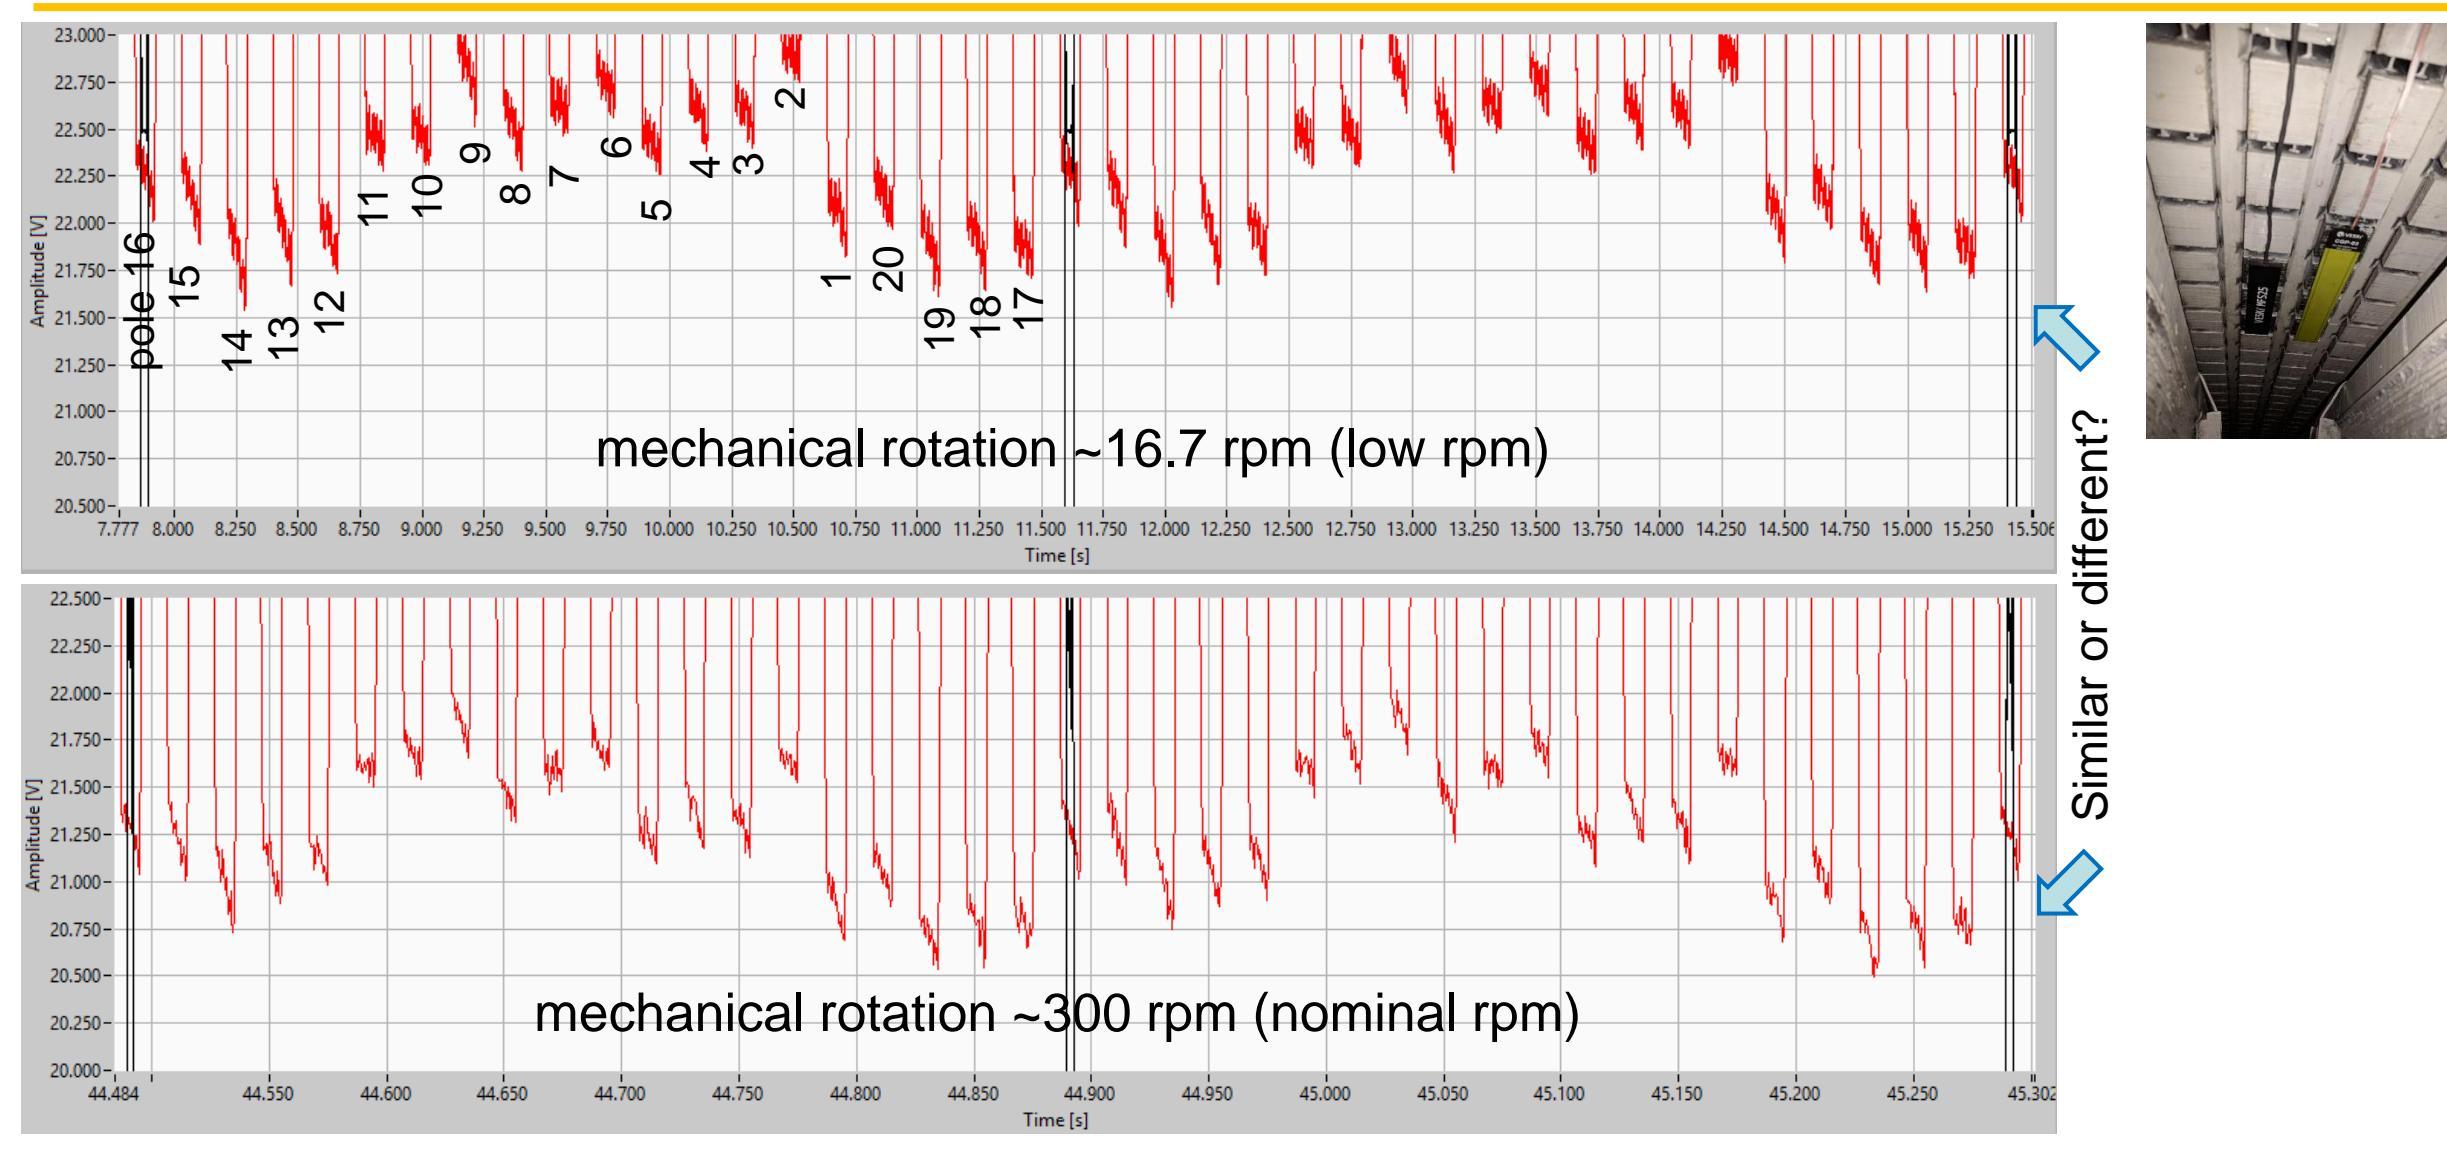
Air-gap measurements / Unit 2

(data from unit 2 – larger electromagnetic unbalance)

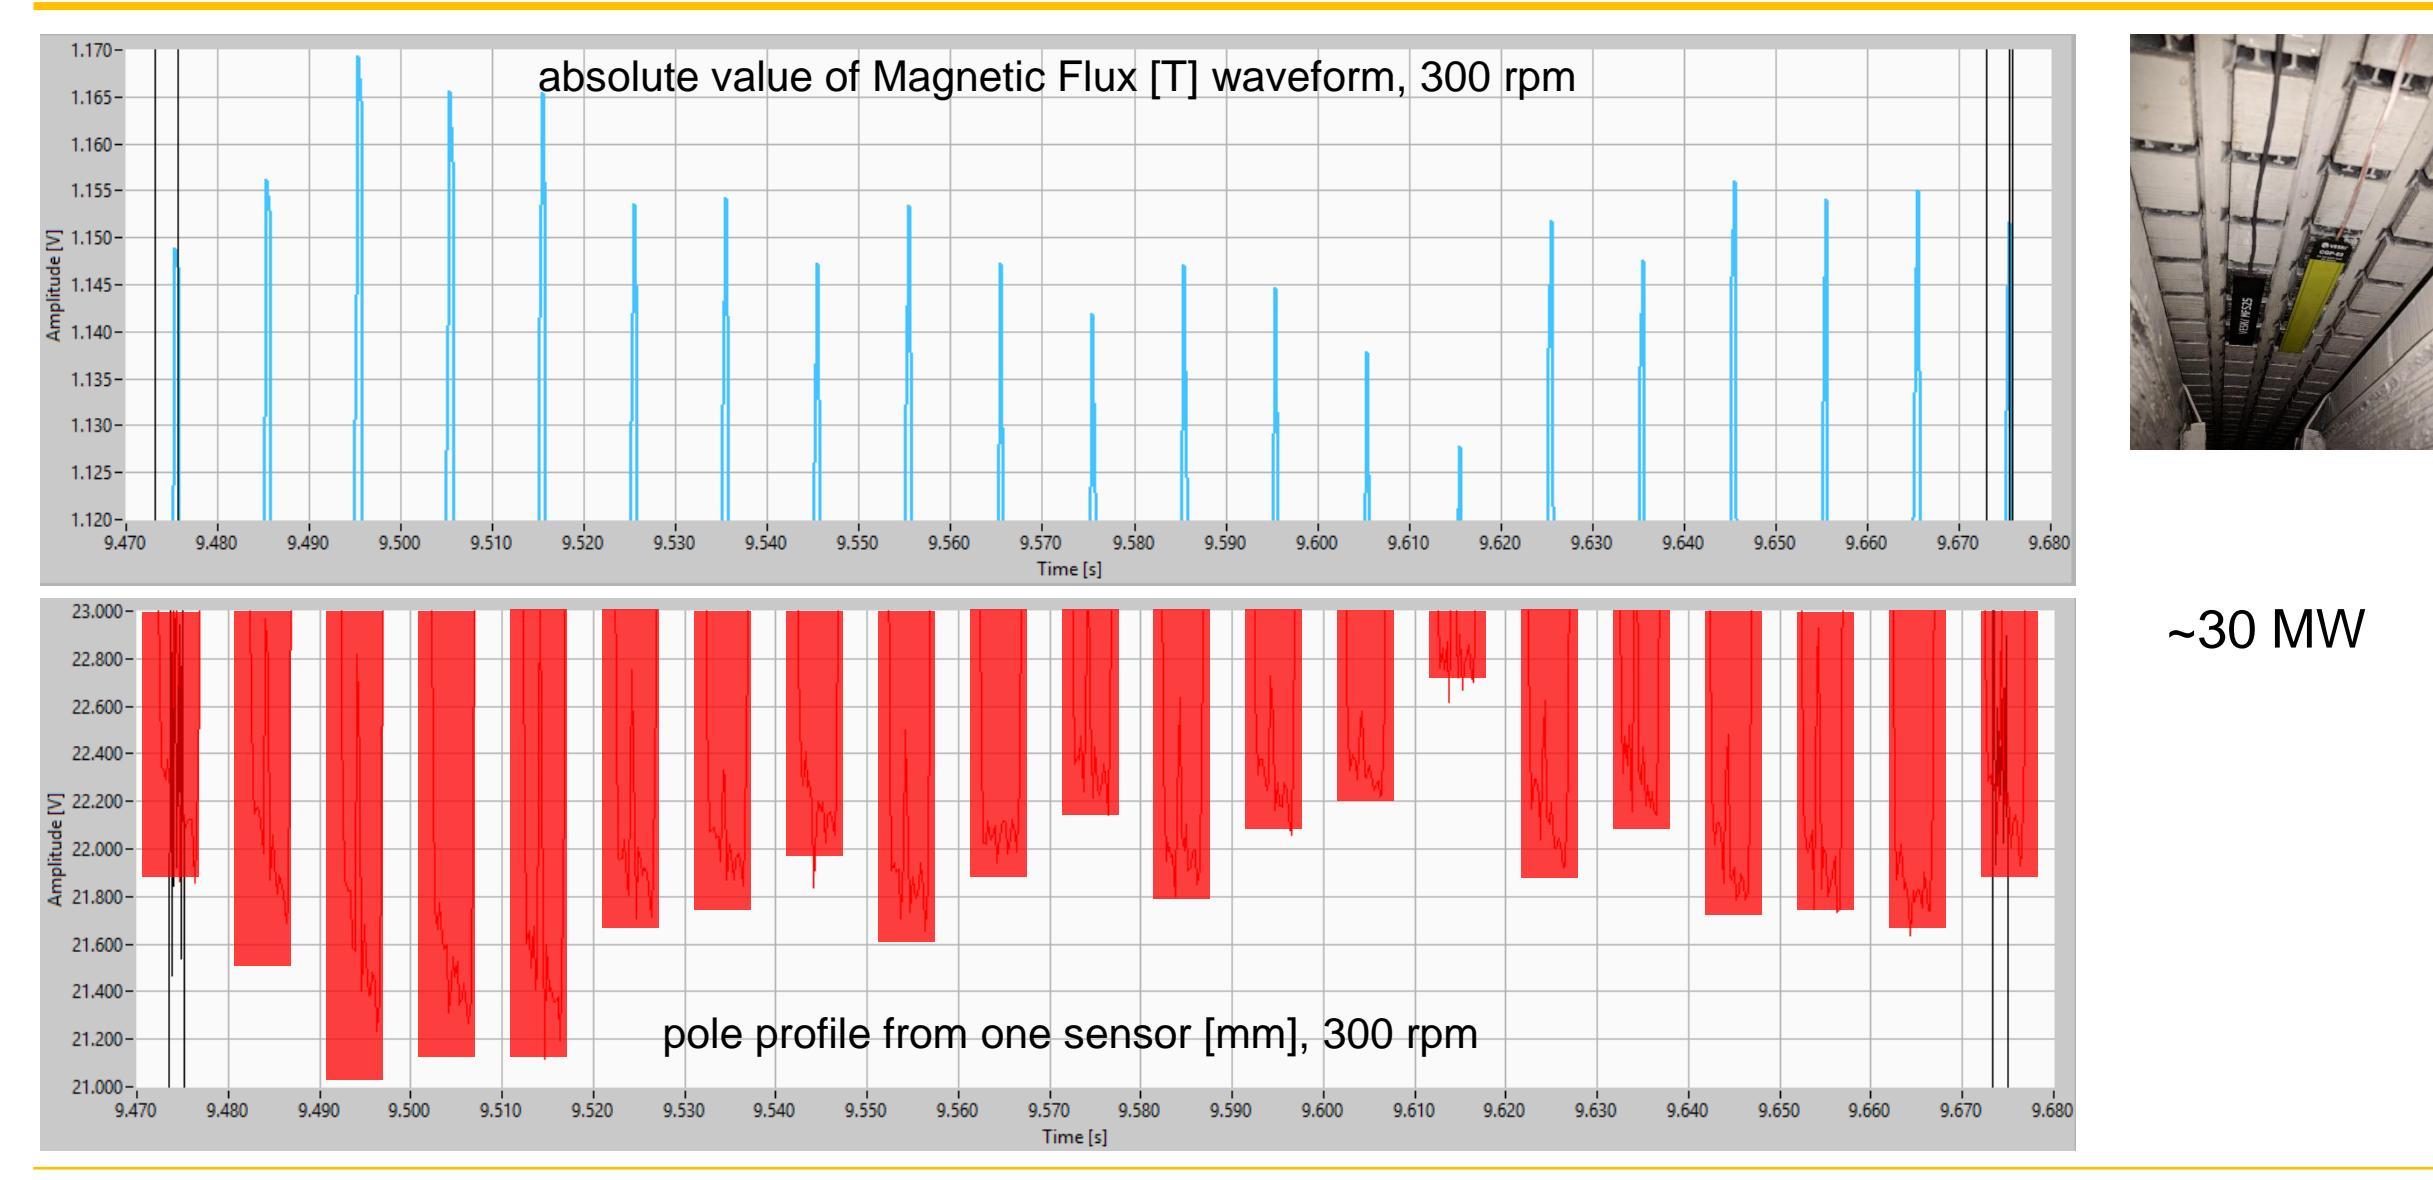
Air-gap + Magnetic Flux measurements (unit 2)

(data from unit 2 – larger electromagnetic unbalance)
