Large Air Cooled Generator Failure

Henry Tarnecky
AVP - Sr. Engineering Specialist, FM Global
2017 IRIS Rotating Machinery Conference

Case Study-Generator Failure

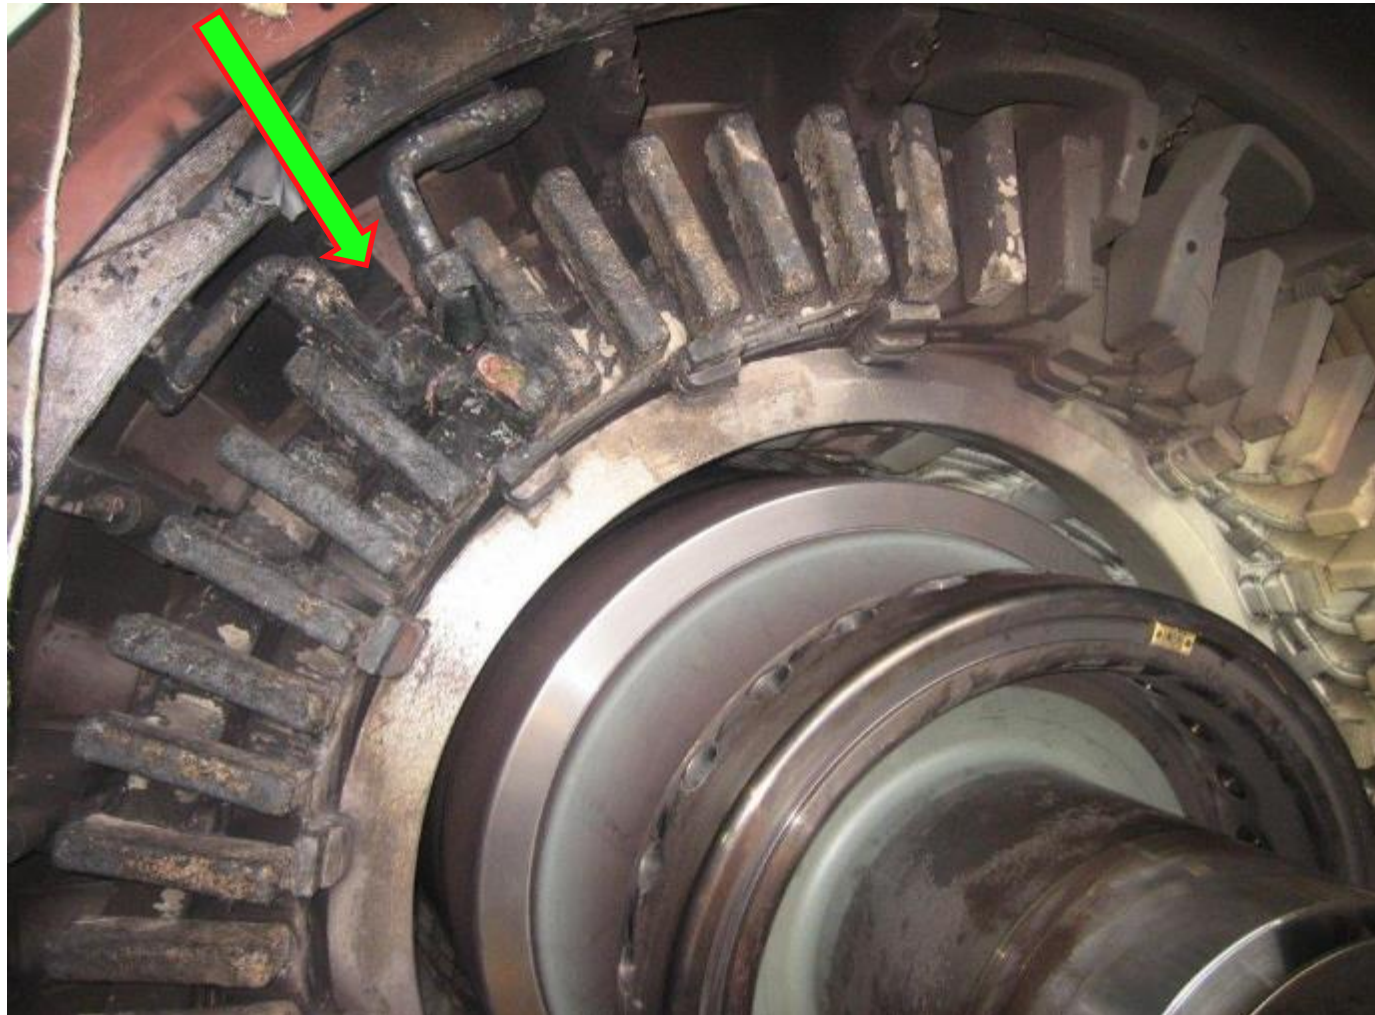
Severe arc fault damage top bar #4 at phase lead connection

- Damage assessment:
- Stator arc fault damage to “B” phase top bar # 4 insulation noting cracked phase connection (exciter end) flashed over to ‘C’ phase
- Operator restart attempts caused more severe arc fault damage and end winding physical movement after the initial fault
- Resulted in retaining ring, rotor forging & field coil overheating & metal loss damage

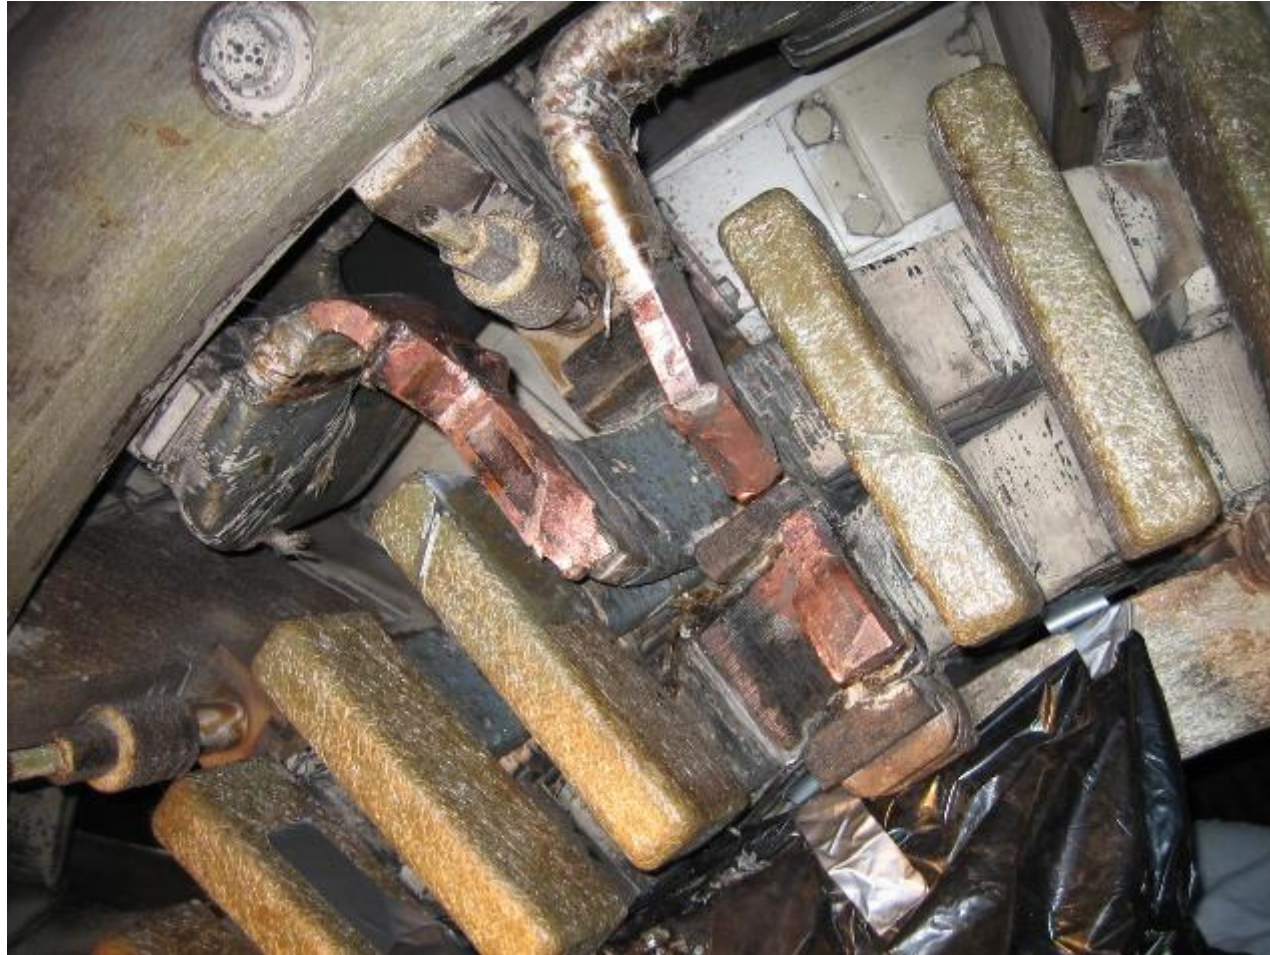
11 o'clock position where initial arc flash over occurred

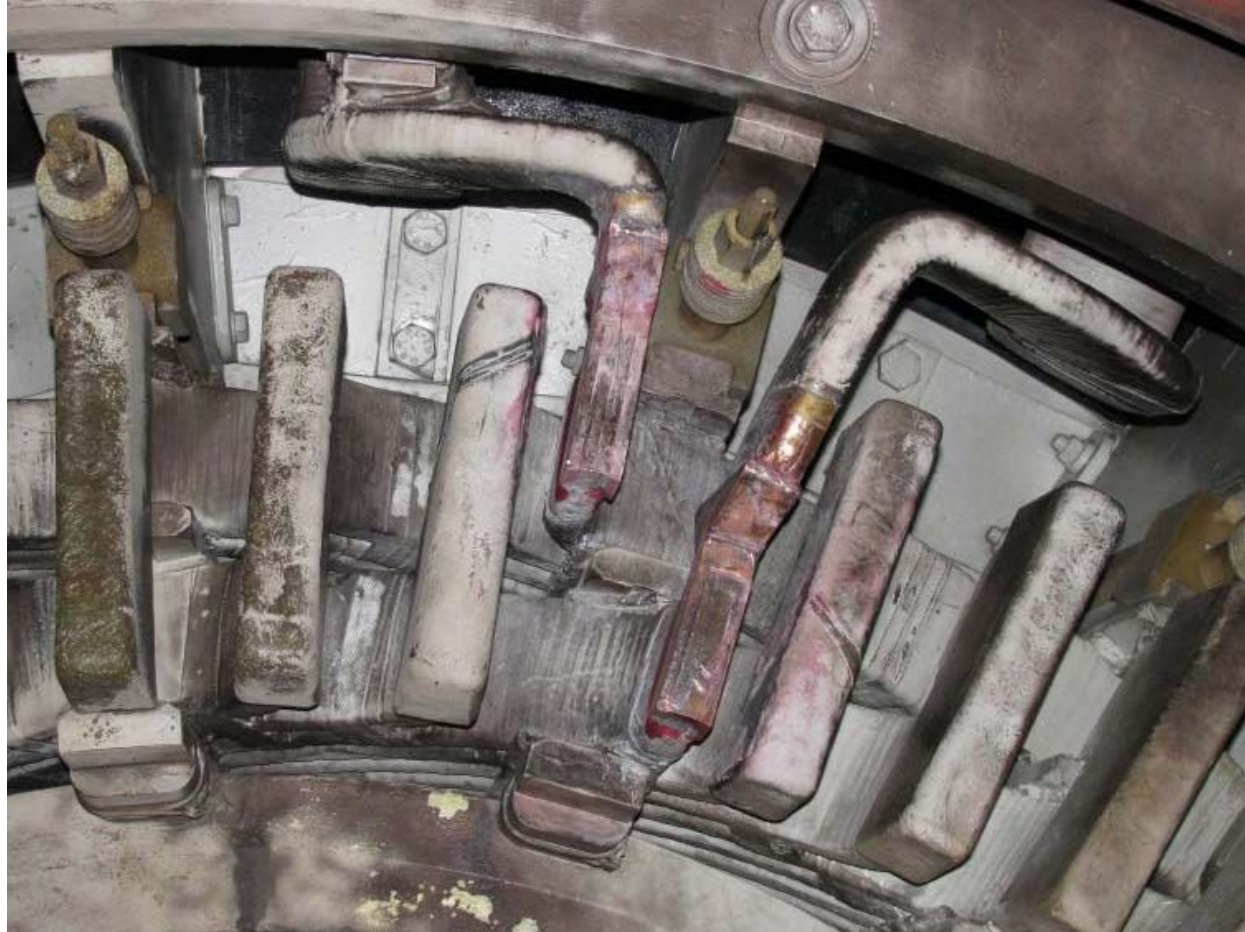
Other as found blocking & phase lead connection exciter end

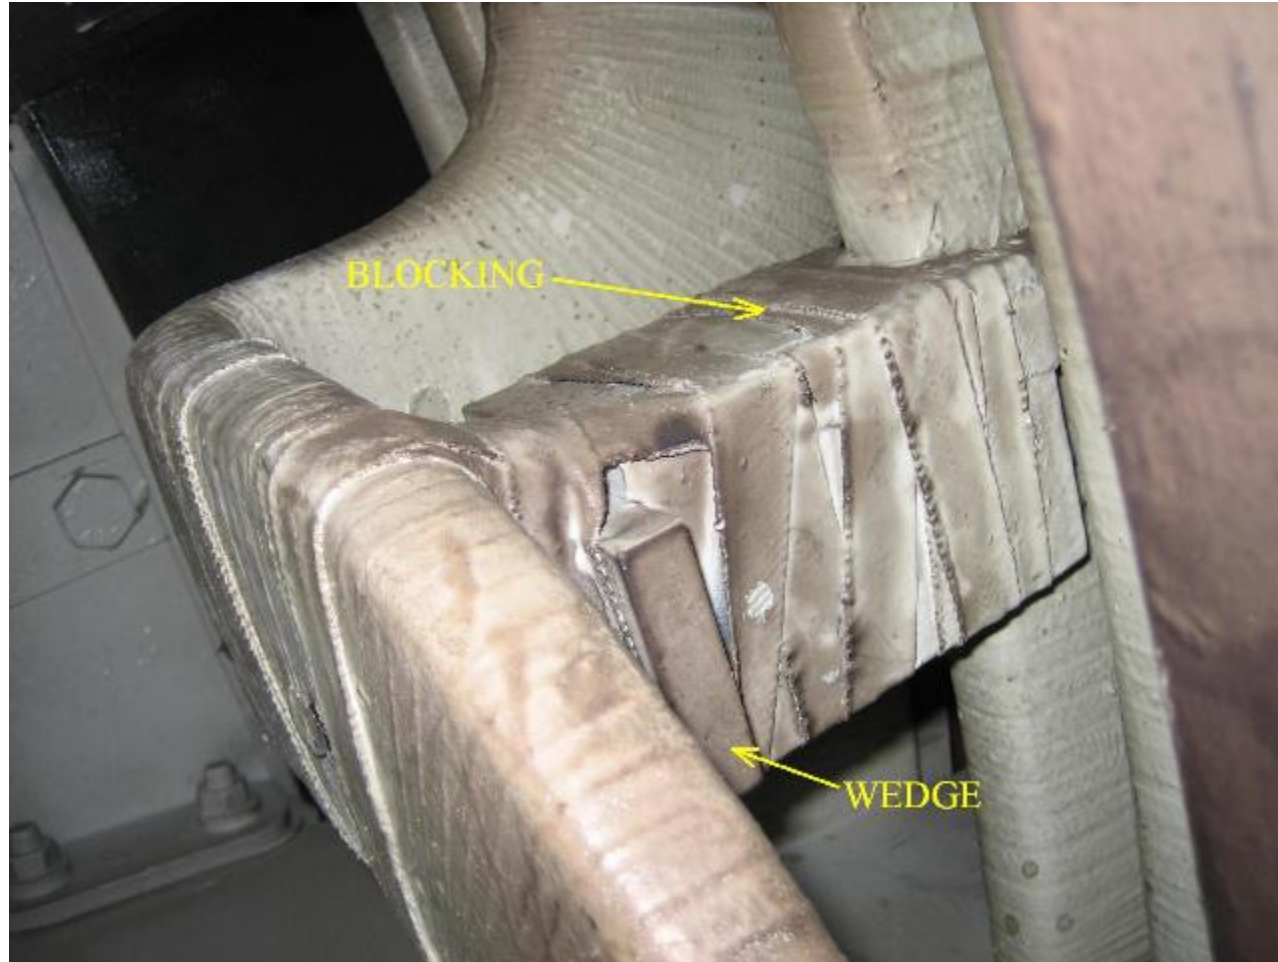
Phase lead blocking - note poor taping and displaced wedge.

- Found 4 of 6 phase lead connections cracked in the strand braze area where loose or no blocking evident
- Phase lead connections with secure blocking were not cracked
- Long term insulation vibration wear at failed bar # 4 noted
- Bump test found signs of 120 HZ resonance present in end winding suggesting “High Cycle Fatigue”
- Suspect rotor/field & retaining ring arc fault damage (removed for off site evaluation - repair)

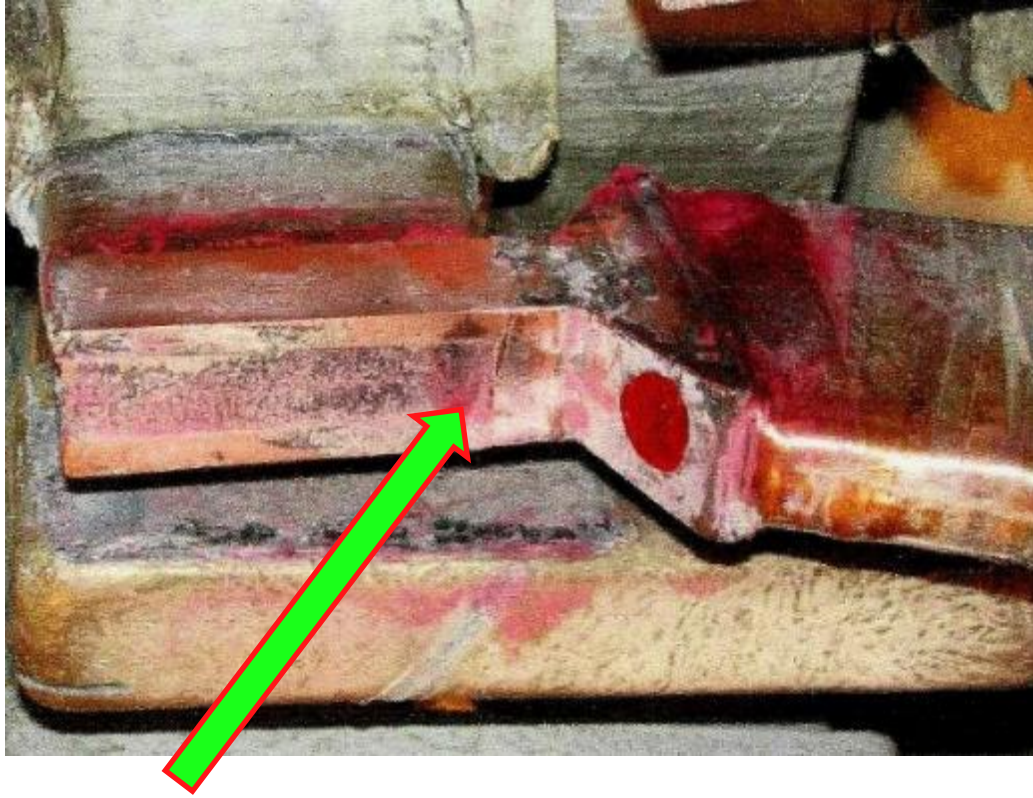
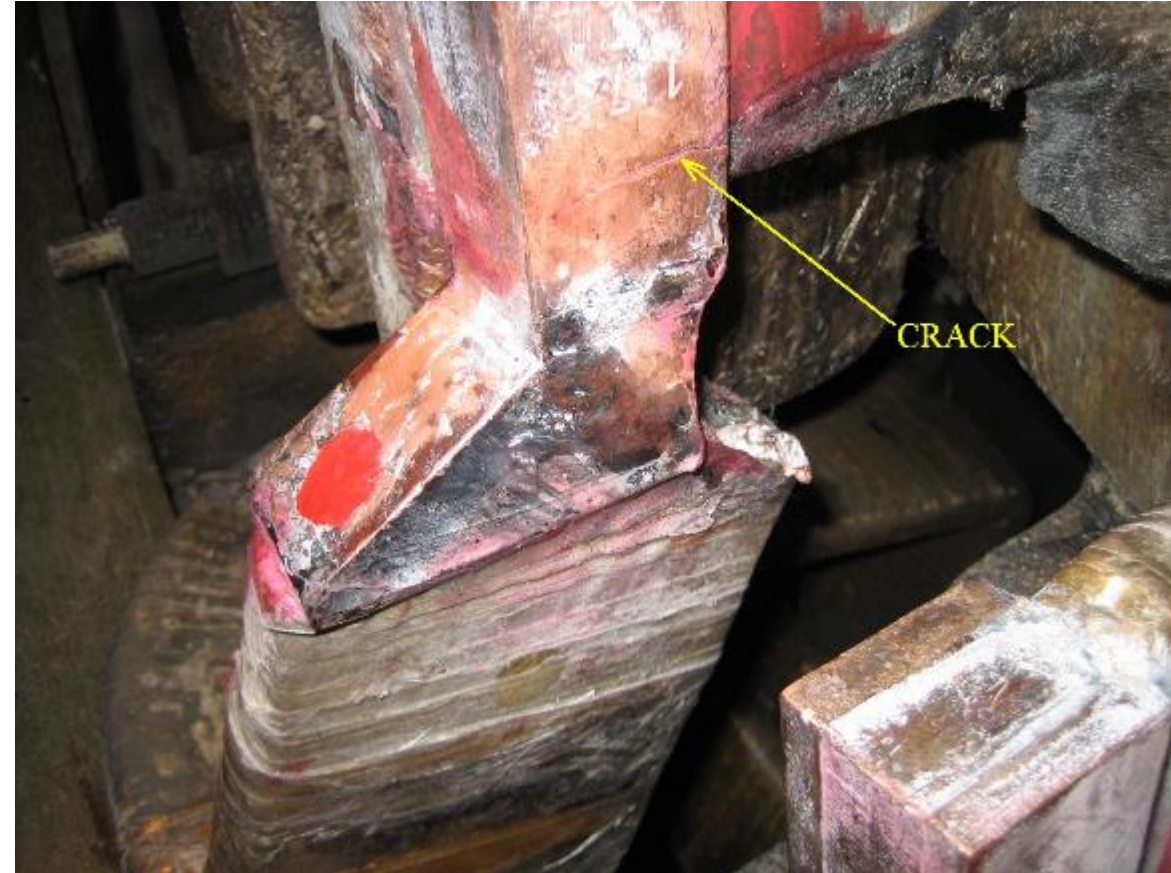
“Phase lead connection crack”

(copper lug brazed to the bar end - then trapezoidal intermediate piece & circular phase ring)

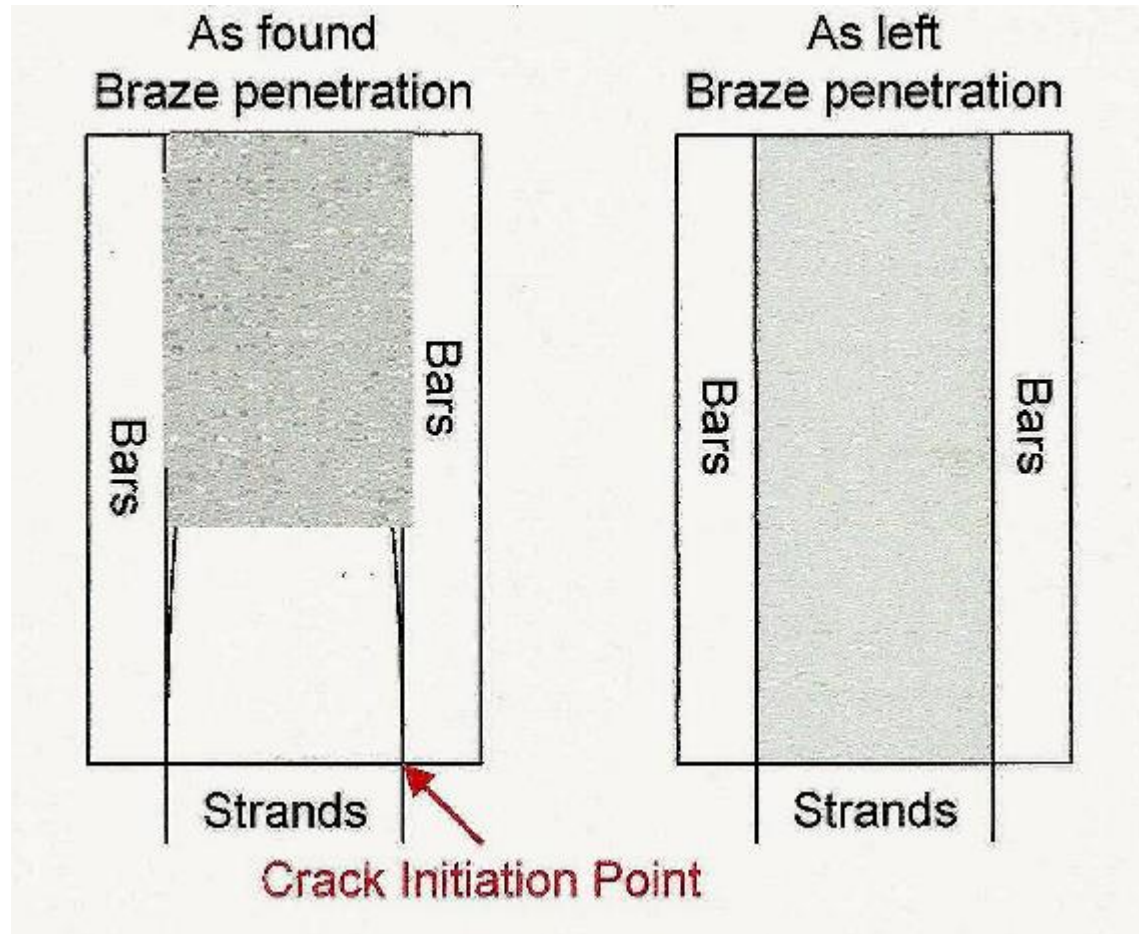
Stator - poor strand to phase lead braze connections

- Root Cause - High Cycle Fatigue due to 120 HZ resonance - induced end turn vibration damage
- Contributing Cause - Inferior strand to phase lead braze connections created crack initiation point and accelerated damage time line to failure.

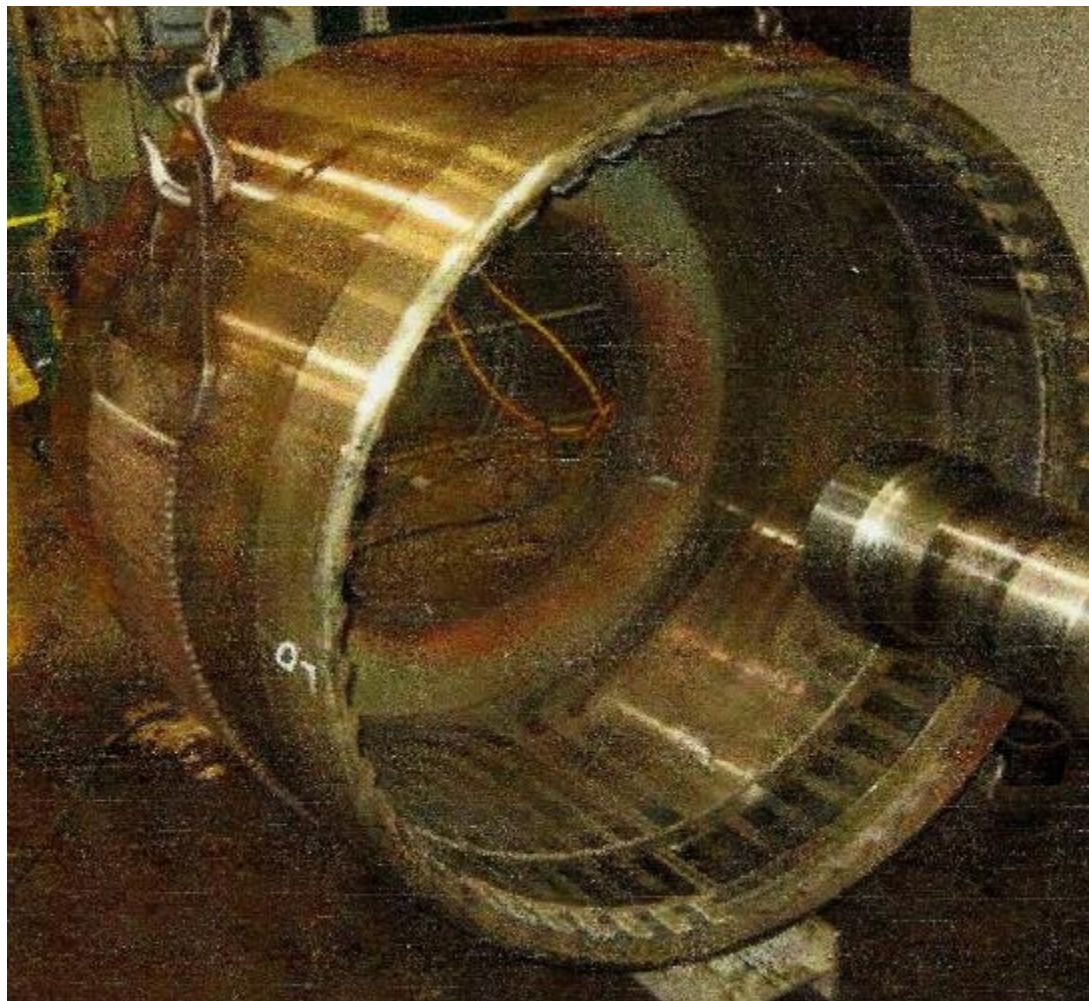
Retaining Ring Removed from Rotor at Repair Shop (exciter end)

- The retaining ring on the exciter end sustained arcing damage at the taper end.
- Splatter debris was found throughout the rotor.
- Ground fault (arcing damage) at exciter end through the damper winding to ground on the face of the slot tooth between coils 1 and 2 & on the same coil on the exact opposite side.
- Arc damage was also found on inboard pole coil Nos. 1 and 2 and outboard pole @ coil No. 1.
- Arc damage was found on a tooth on the forging.

- The rotor weighed approximately 130,000 lbs. and was considered a “super load”.
- Regulations about transporting a super load are strict requiring special permits and caused delays.
- Rotor became the critical path in terms of reassembling the generator. (4 months & 5 days later)
- Locating a replacement retaining ring was critical long lead item

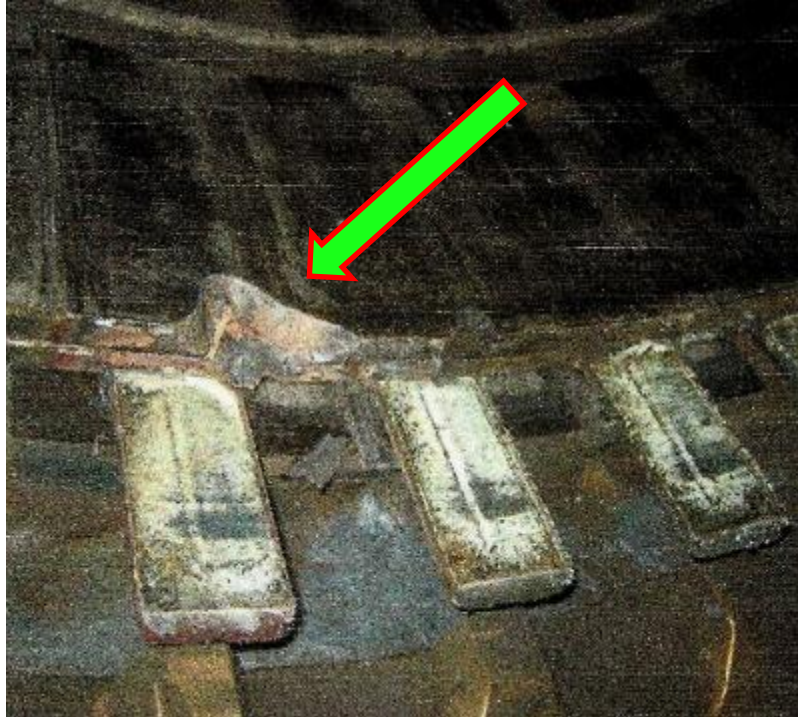
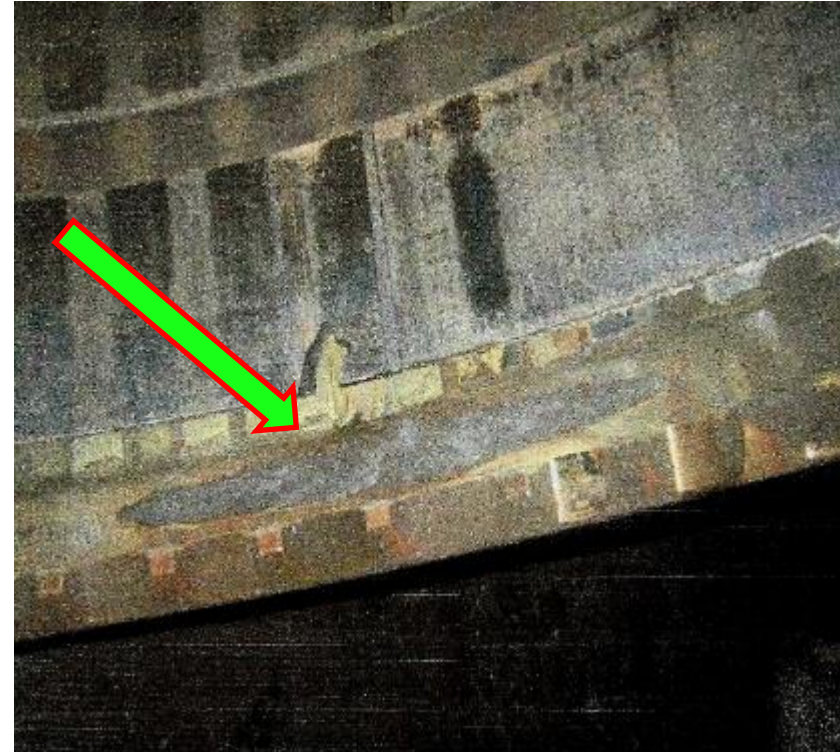
Retaining ring inside surfaces

Severe arc fault metal loss & overheating damage – ring required replacement becoming long lead time item

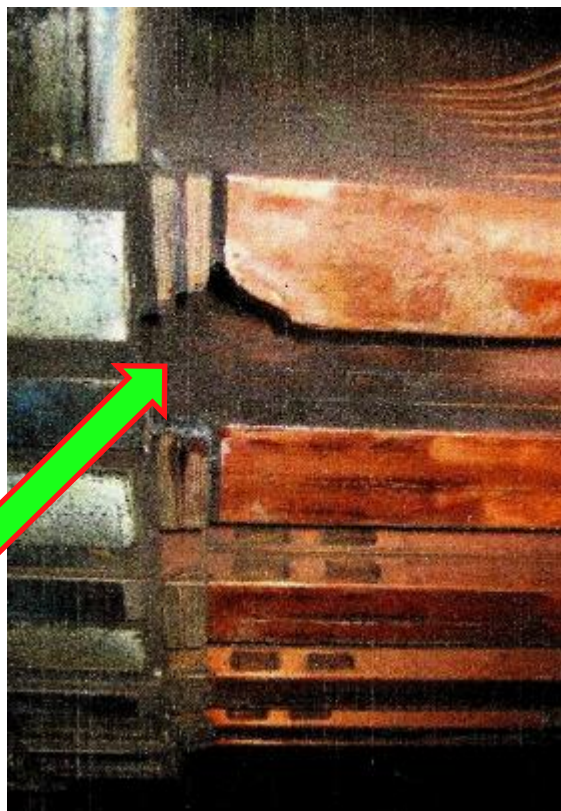
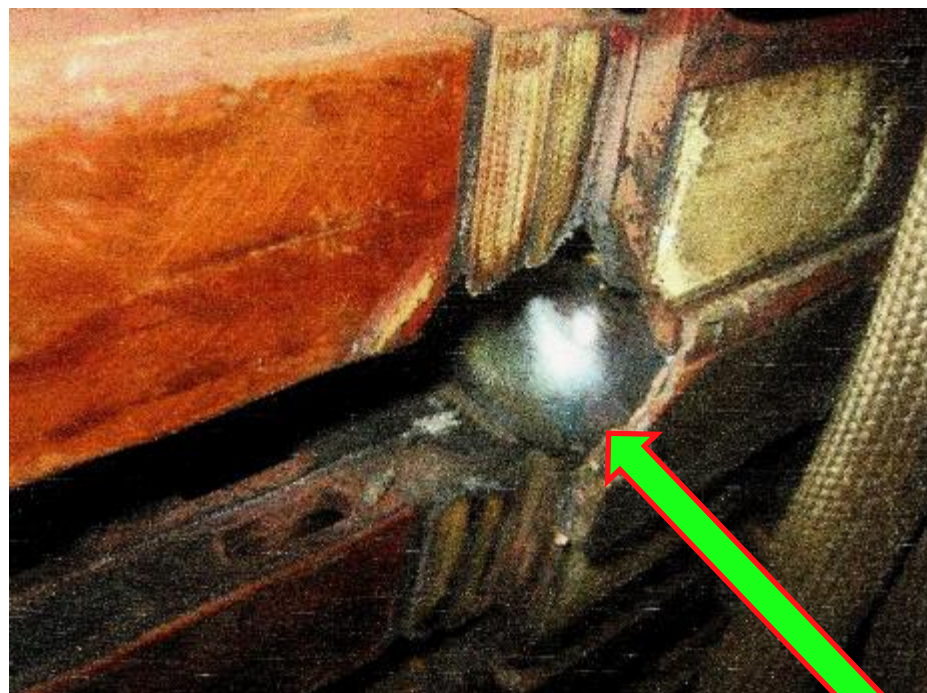
Rotor coil and forging arc fault damage (exciter end)

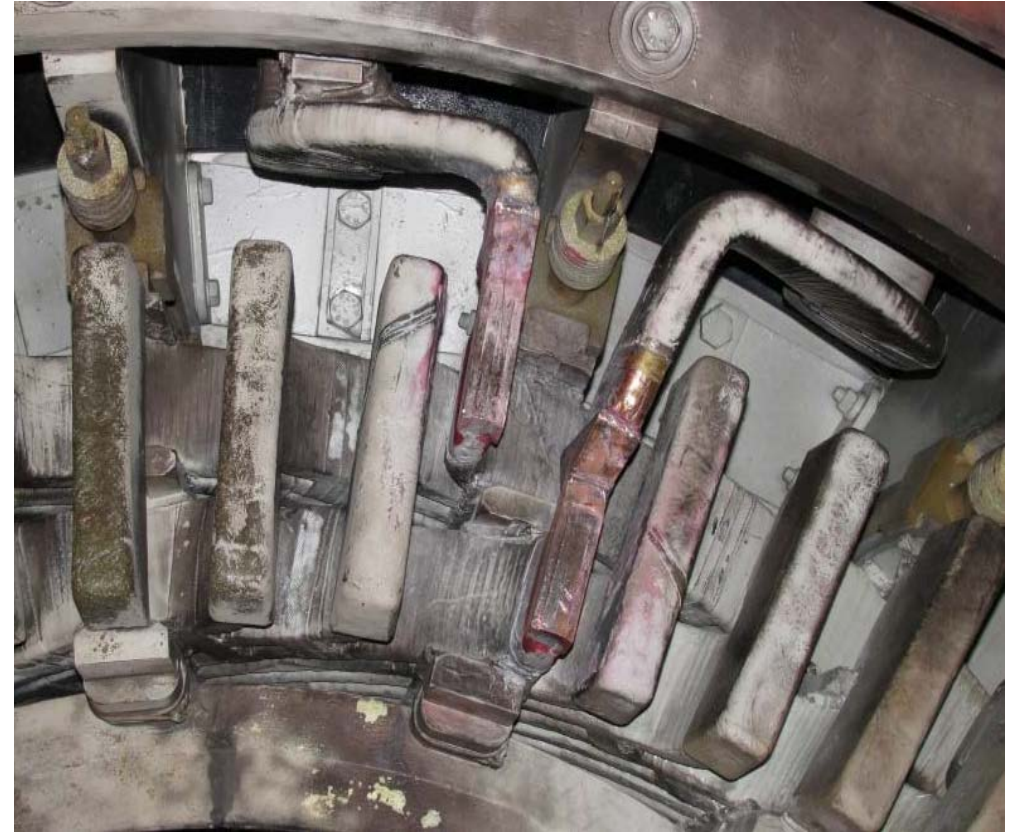
Original design
