Pitfalls in Modern HV Electrical Machine Procurement – Case Study

Sequence of Events N2 Compressor Motor

- N2 Liquefier Compressor Motor
- 5400 HP, 11000 Volts, 2 Pole

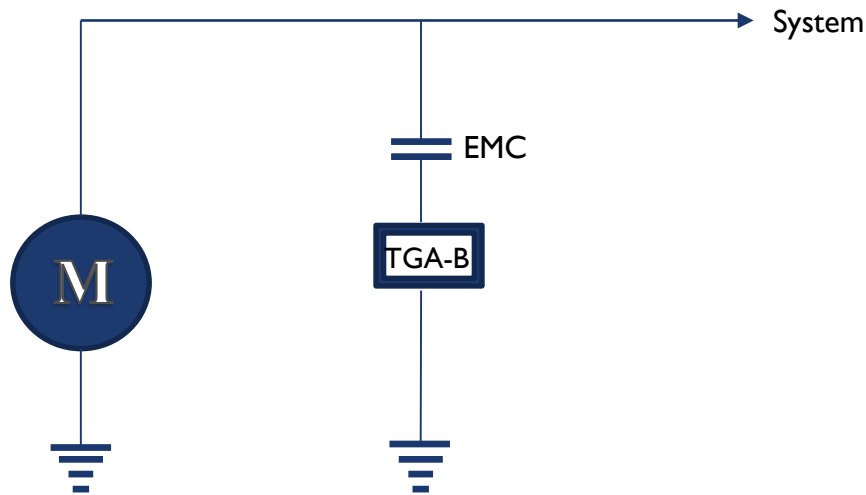
PD Configuration

Partial Discharge Installation

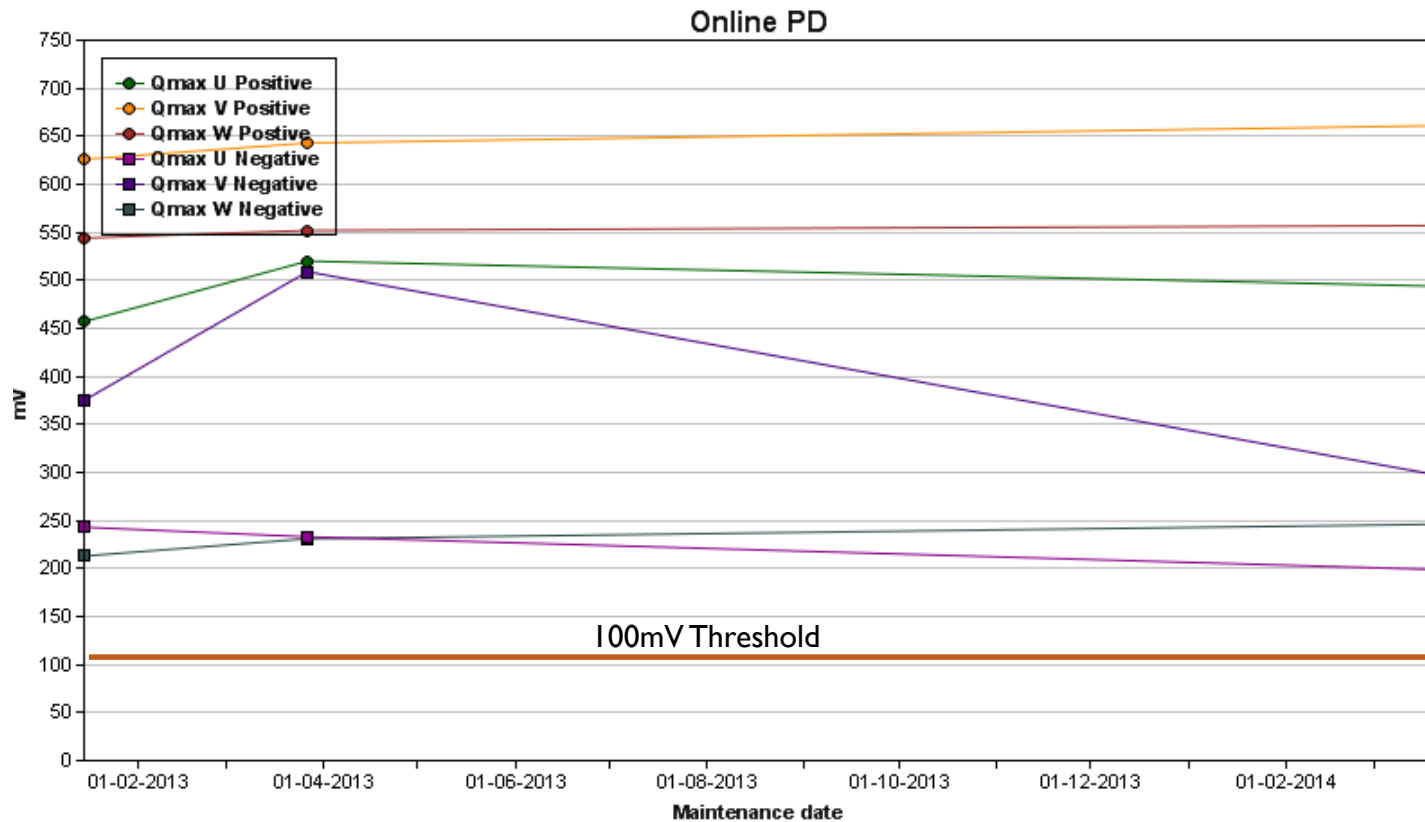
Machine PD Distribution

Partial Discharge Trend

Showing readings that have been measured in: Millivolts

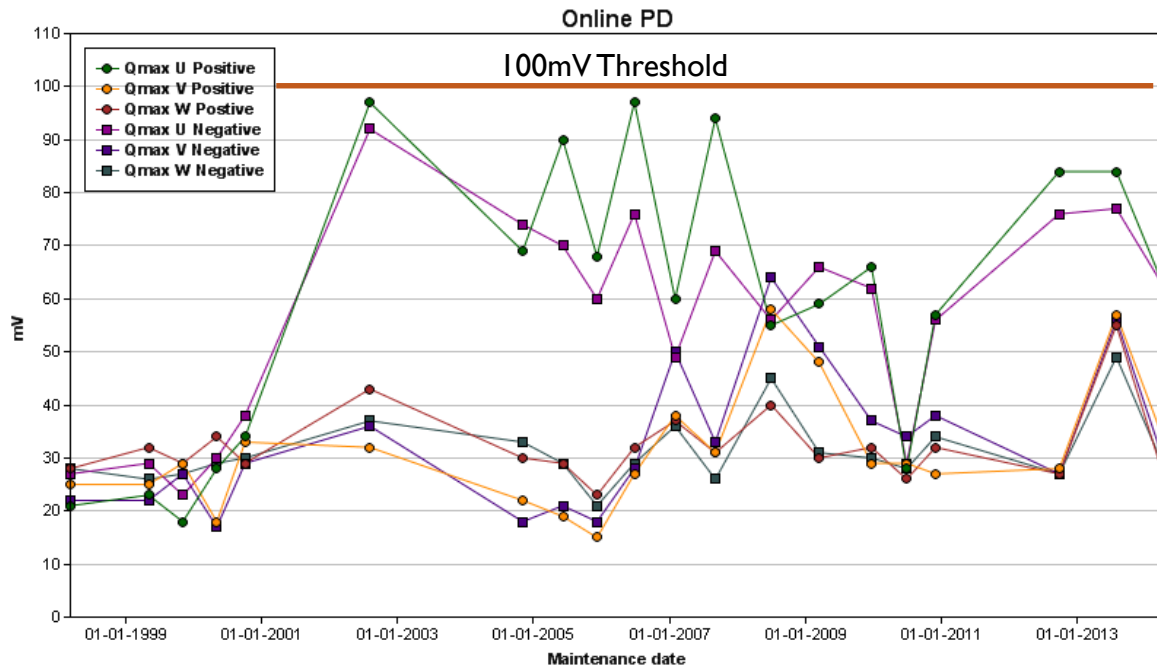
Typical Trend – 20 year winding

Machine PD Distribution

- Qmax U positive (mV)
- Qmax V positive (mV)
- Qmax W positive (mV)
- Qmax U negative (mV)
- Qmax V negative (mV)
- Qmax W negative (mV)

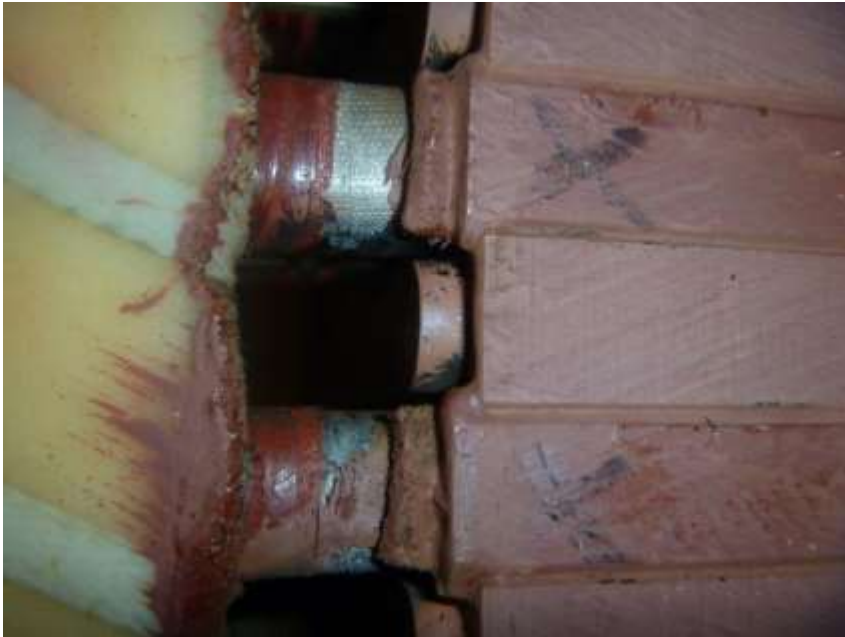
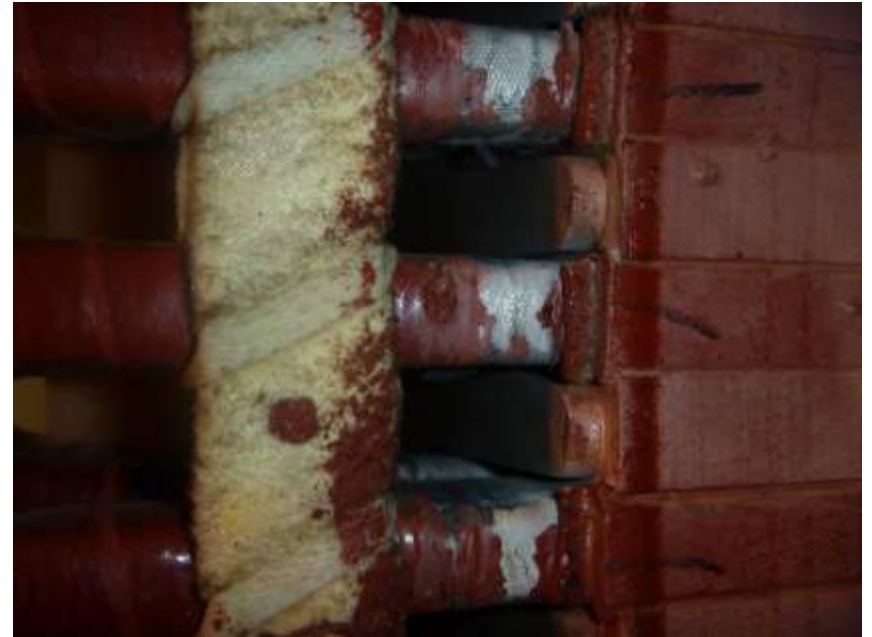
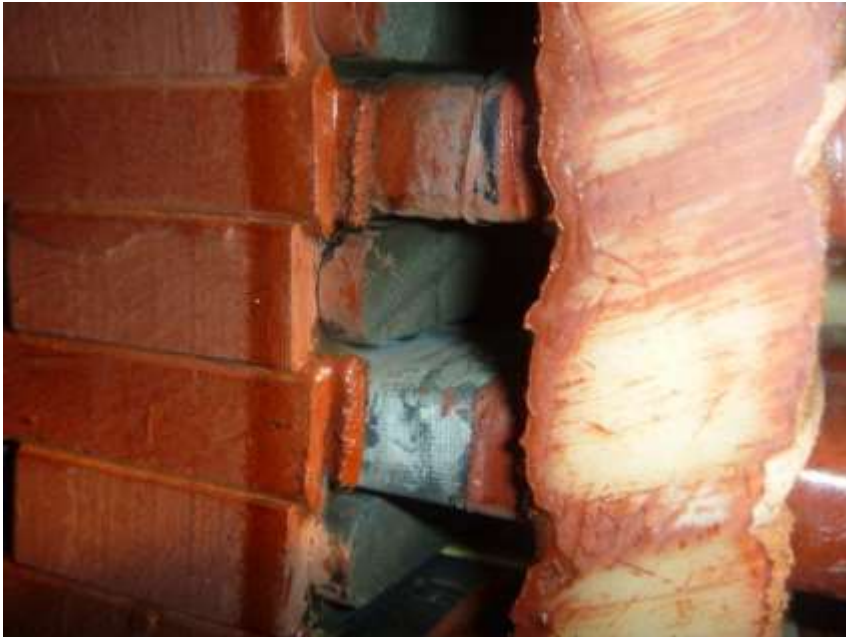
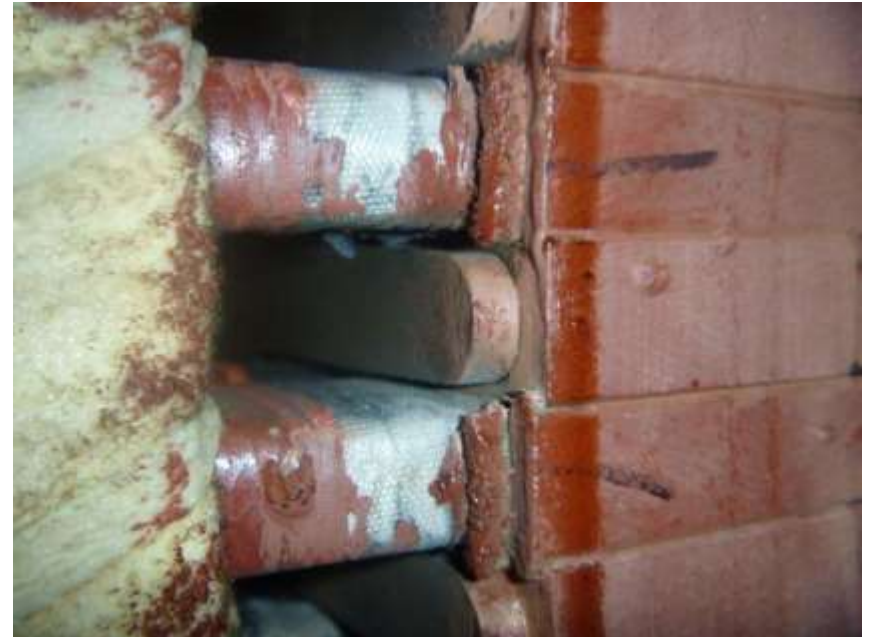
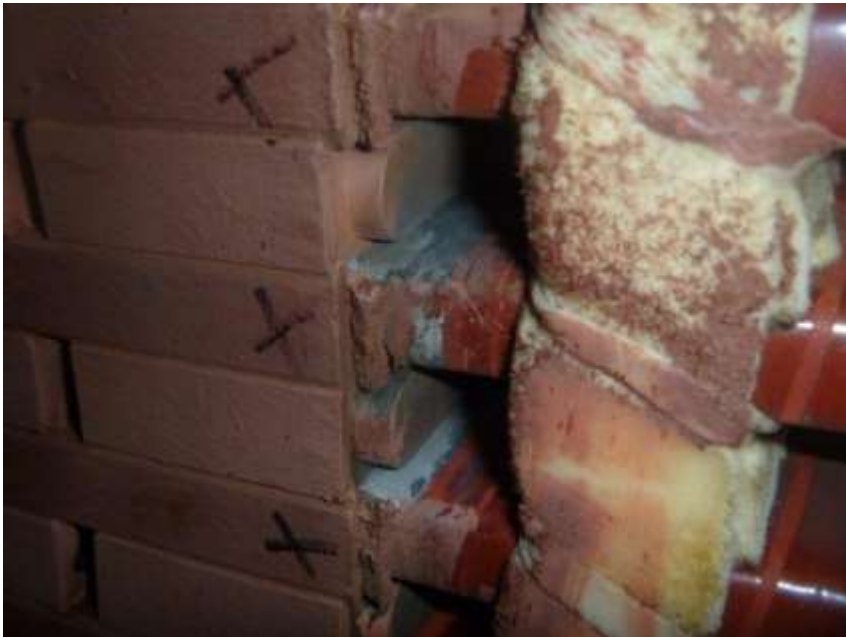
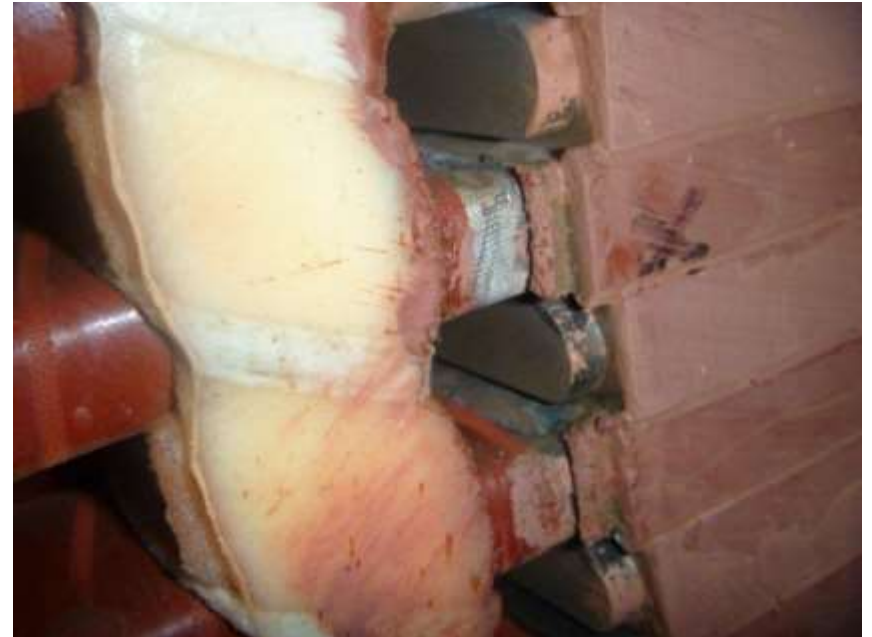
Inspection Images

- Void Discharges
- Grading Coat Discharges
- Slot Discharges Electrical
- Endwinding Discharges

2 Year
Service Life

IMPROPER
MANUFACTURE

- Modern high voltage stator winding manufacturing techniques can lead to susceptibility to early onset of partial discharge activity – buyer beware
- General specifications may not necessarily limit exposure to having stators delivered with partial discharge issues – be prescriptive
- Objective measurement through partial discharge monitoring and verification by visual inspection were conclusive in establishing dominant failure mechanisms within the two year old Air Liquide stator winding and other examples

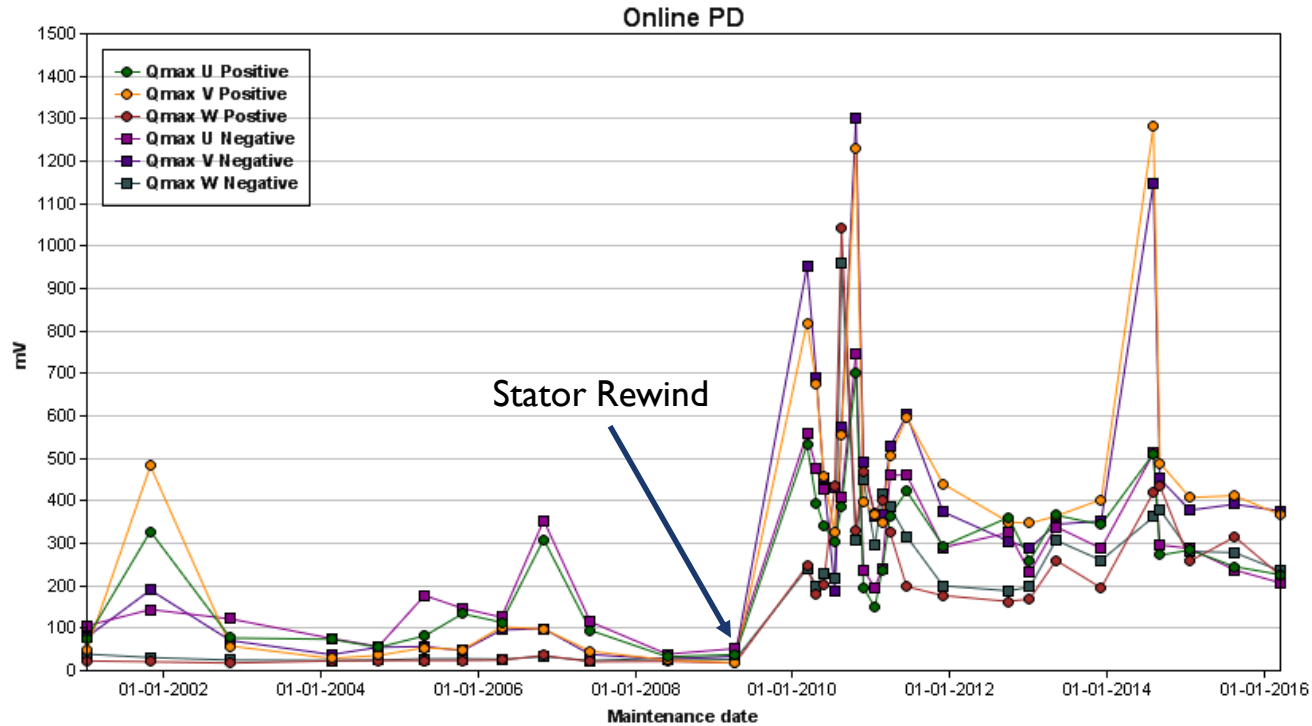
Similar Issues Other Plants

Showing readings that have been measured in: Millivolts

- Qmax U positive (mV)
- Qmax V positive (mV)
- Qmax W positive (mV)

- Qmax U negative (mV)
- Qmax V negative (mV)
- Qmax W negative (mV)

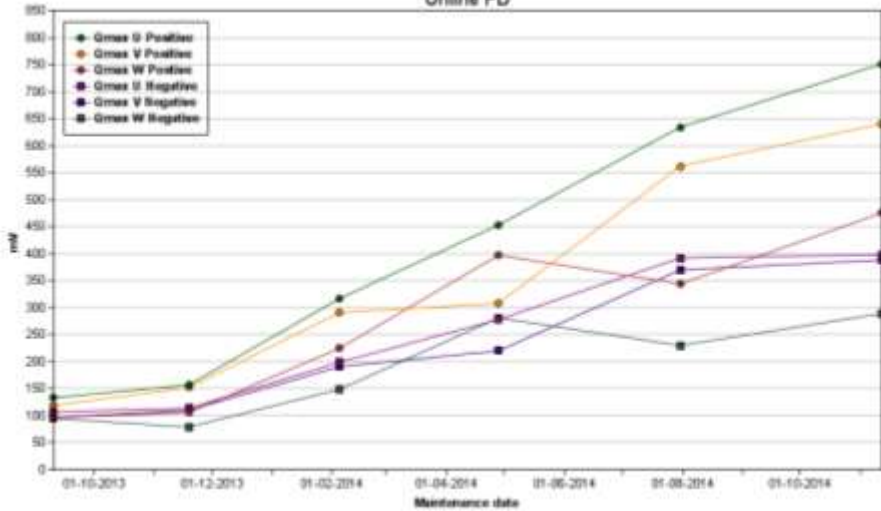
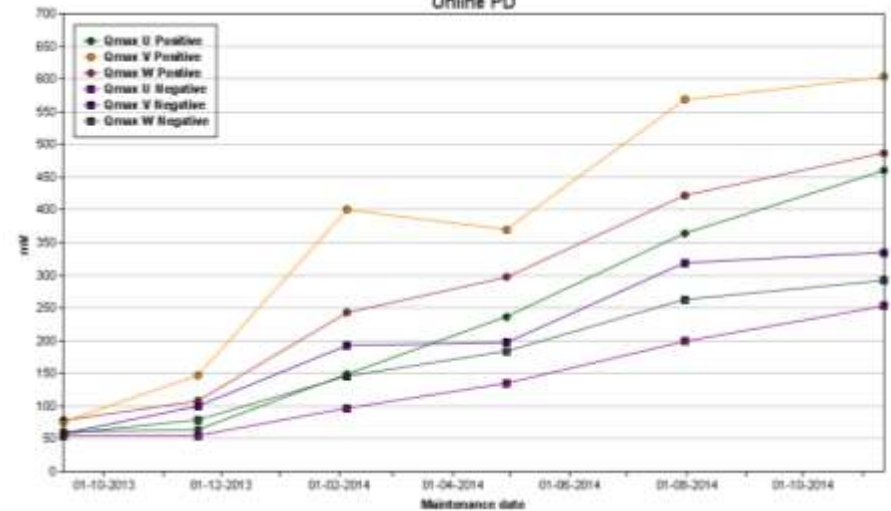
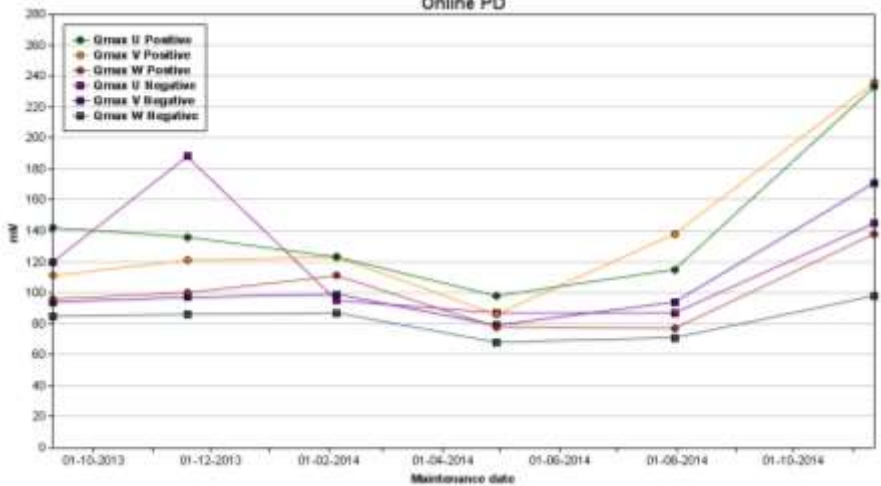
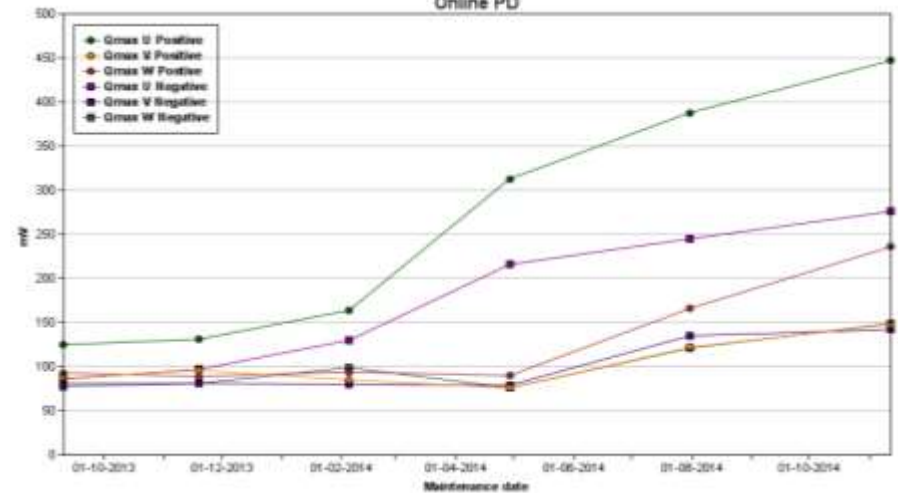
The Problem - Geo Thermal

Online PD
