High-Voltage Insulation Aging under Service and Laboratory conditions

IRIS Rotating Machine Conference - Orlando, USA, 2017-06-20-21

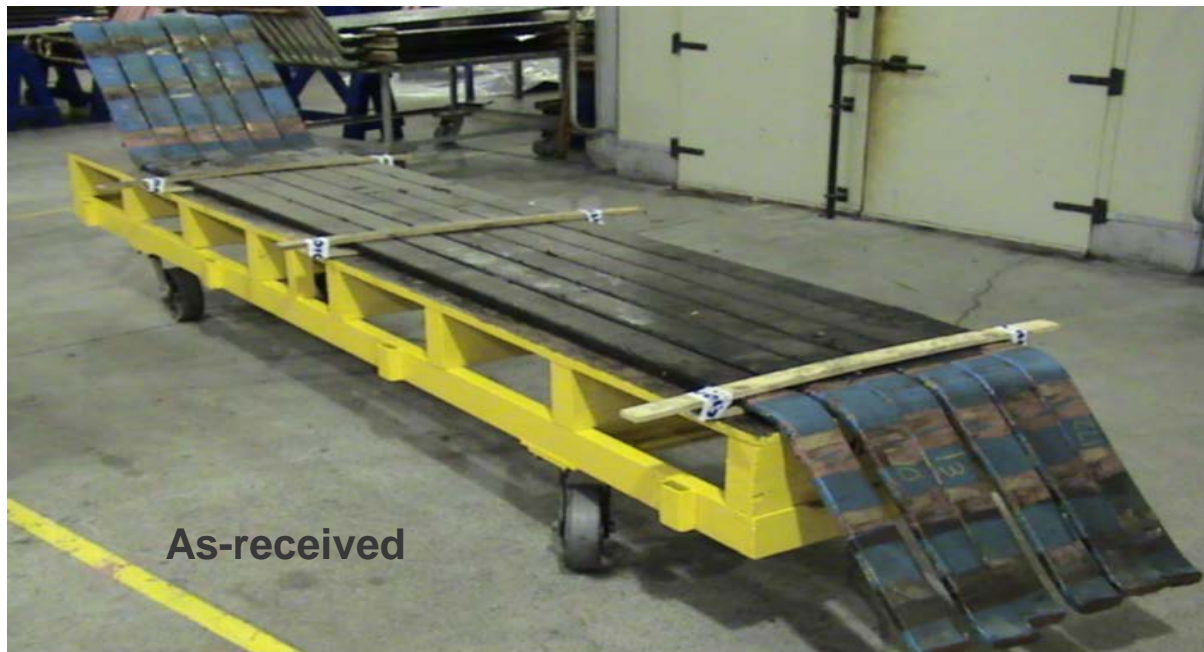
1. *No severe damage visually detectable;*
2. *No critical damages caused by the removal of the bars from slots;*
3. *Recover of corona protection systems (slot and grading) needed.*

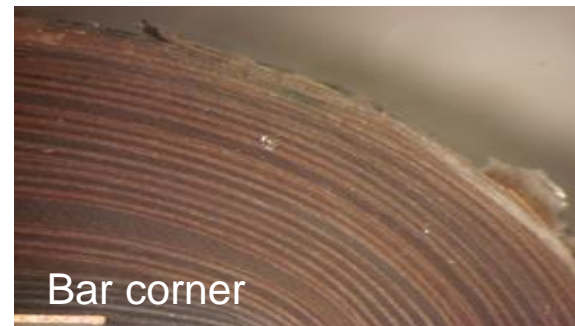
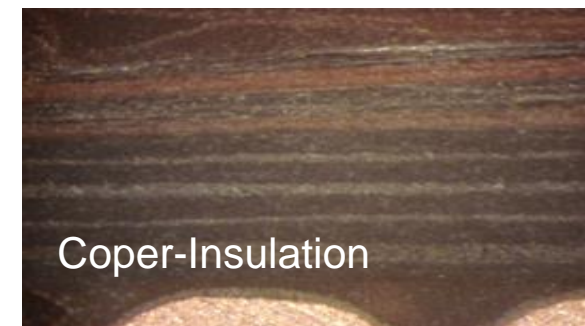
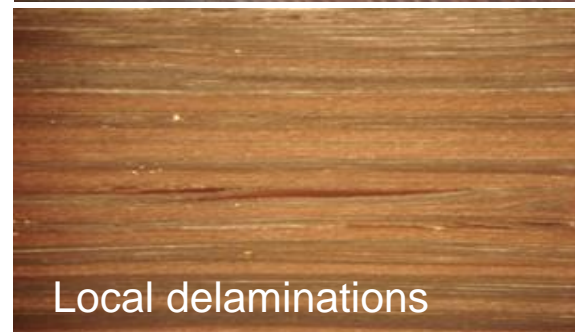
Overall morphology is fine, but with several local delaminations at the mica layers.

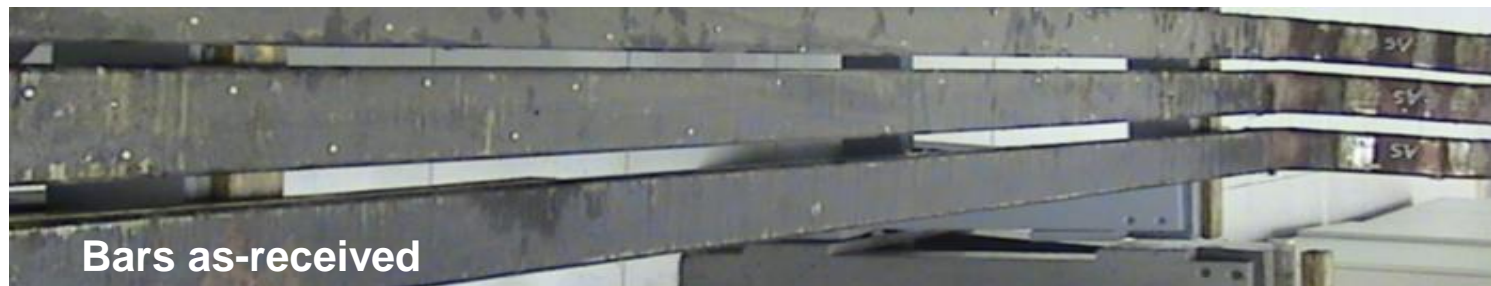
1. *From “outside”, nothing special could be detected;*
2. *Touching or tapping the bars revealed a type of “hollow” sound all the way along the whole length.*

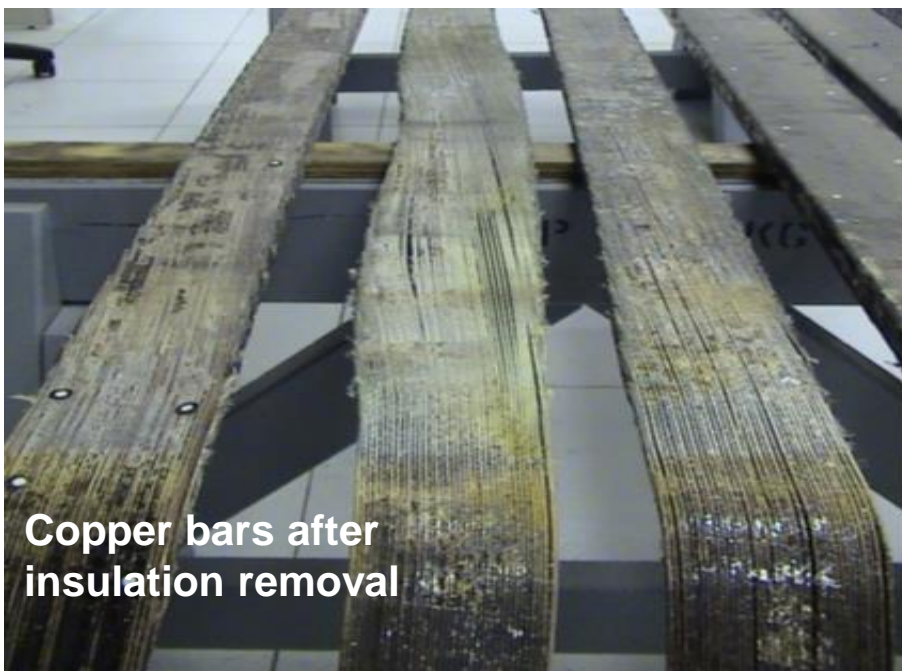
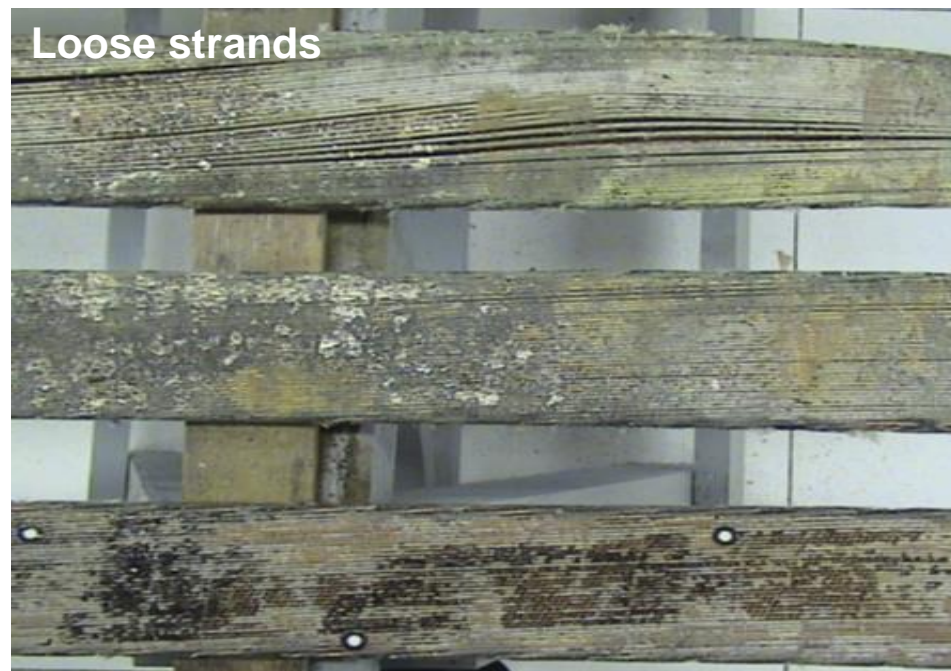
1. *Copper bars “loose”;*
2. *Strand insulation is “gone”;*
3. *Groundwall insulation is fine.*

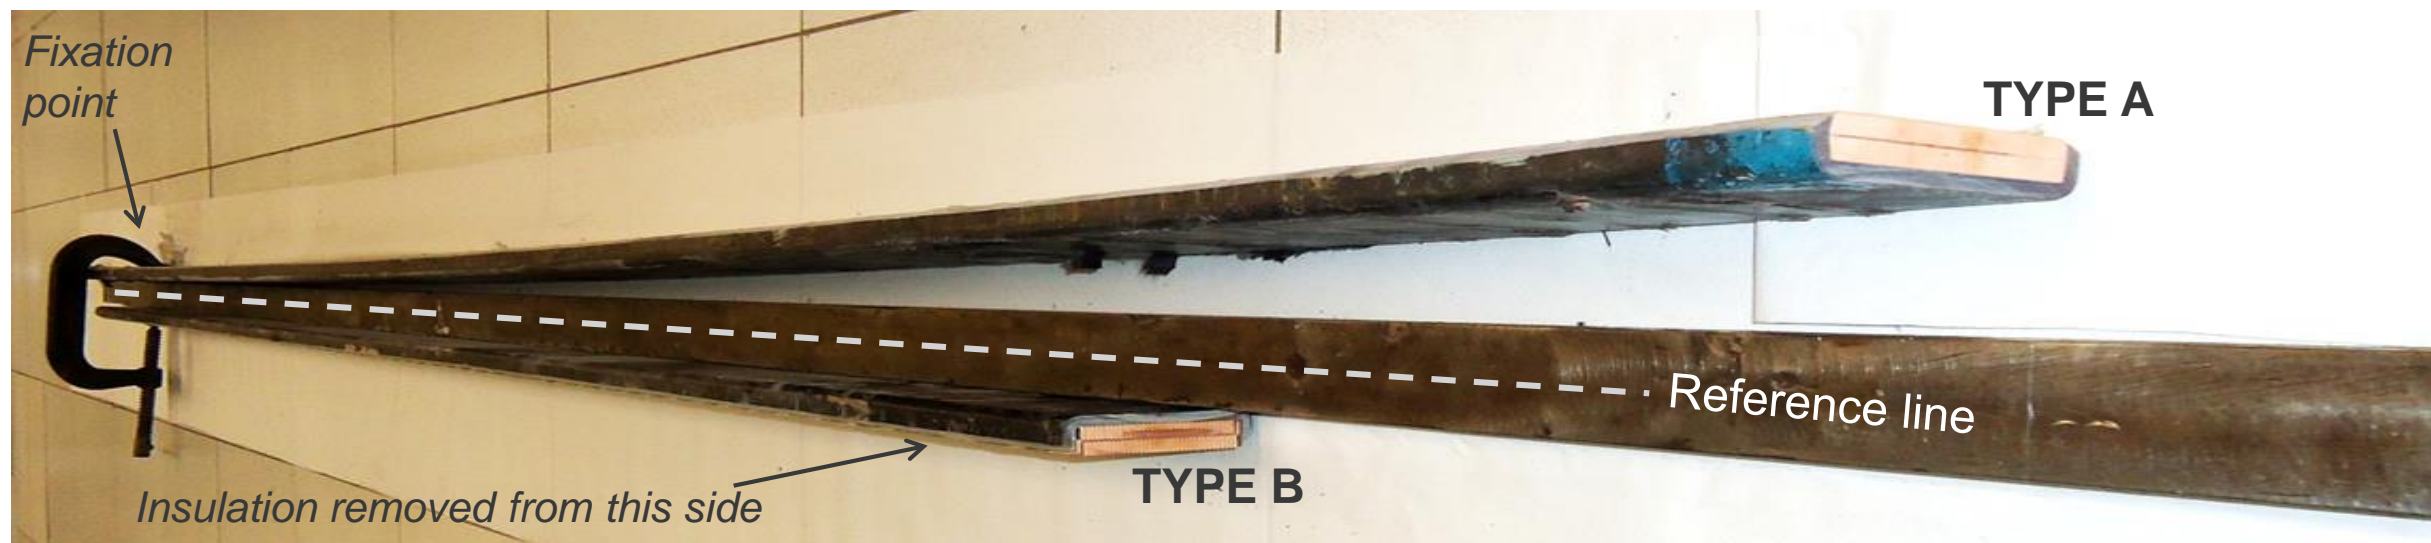
Copper-Insulation interface completely decoupled for TYPE B bars.

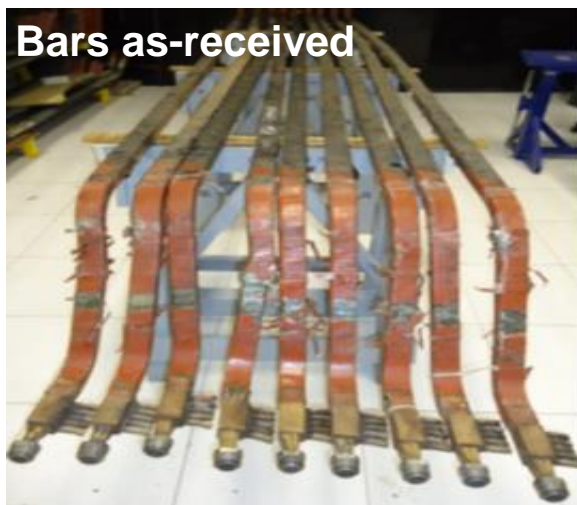
Bars as-received

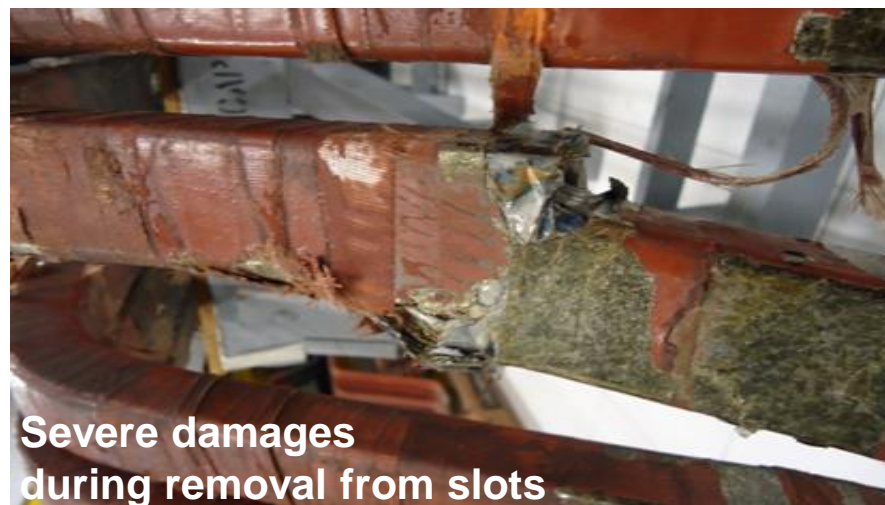
Severe damages during removal from slots

1. Severe damages caused by the removal from slots;
2. 1.5m-long segments prepared for testing;

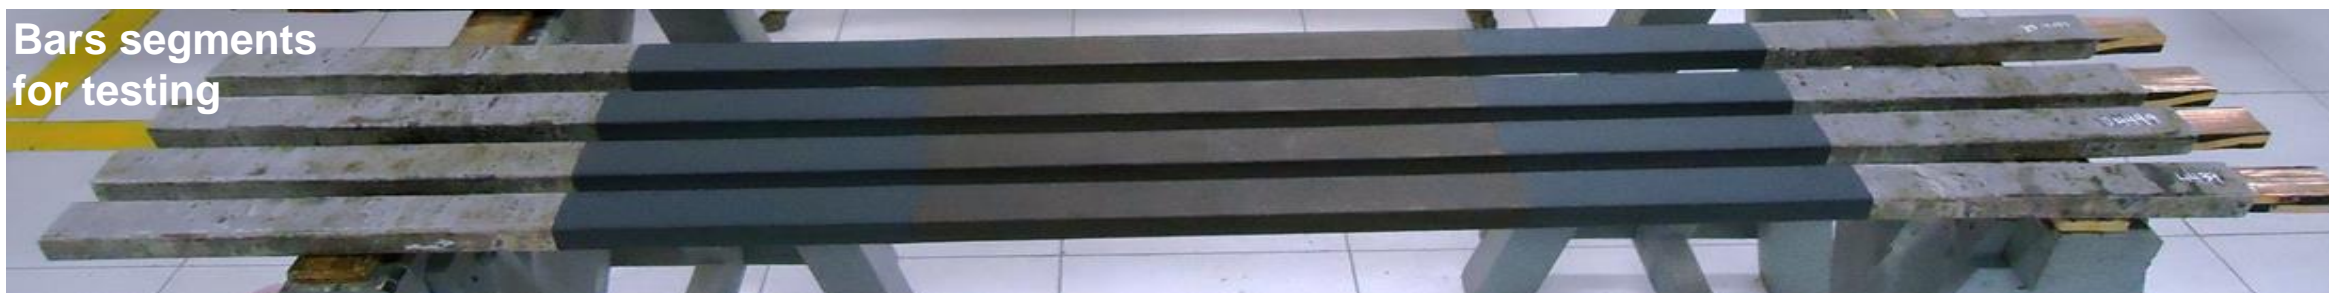
Bars segments for testing

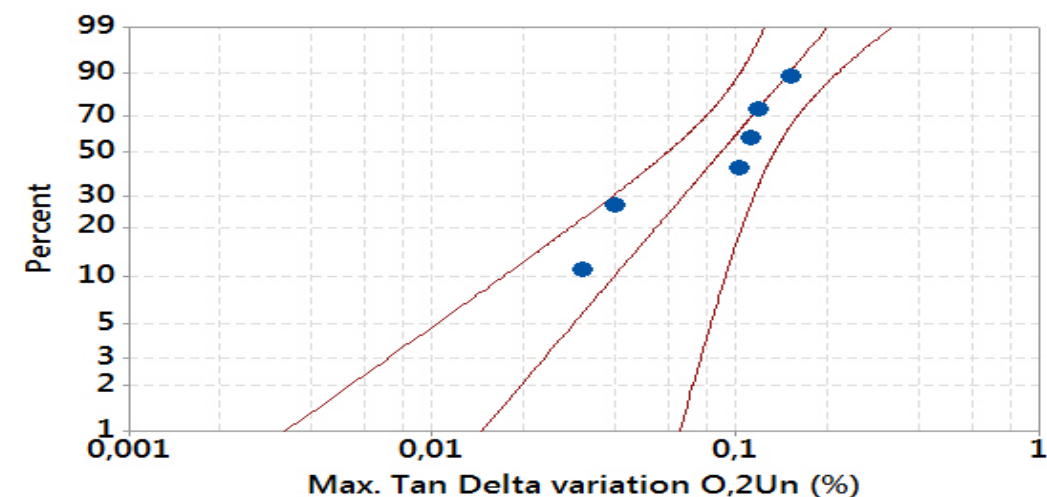
Dissipation factor and tip-ups suggest good conditions for the groundwall insulation.

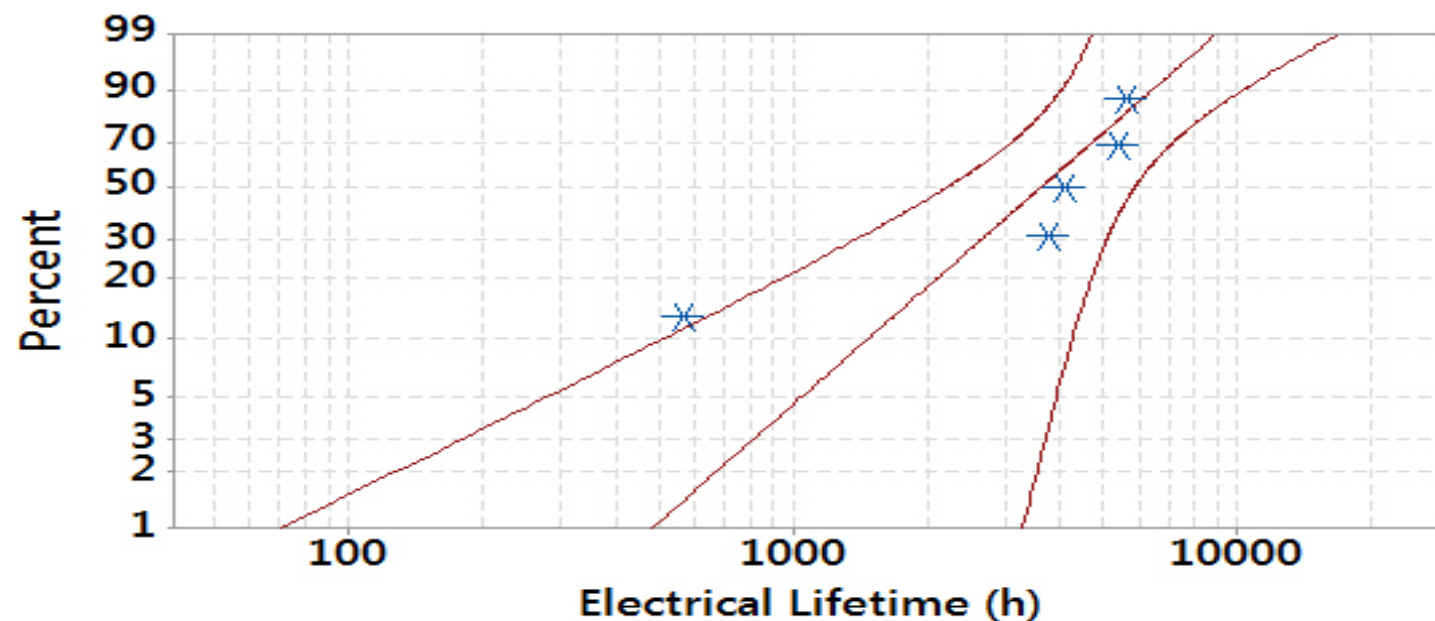
39kV VET
Weibull - 95% CI

Voltage endurance tests at the level of IEEE 1553 Schedule A shows average of about 3000h.

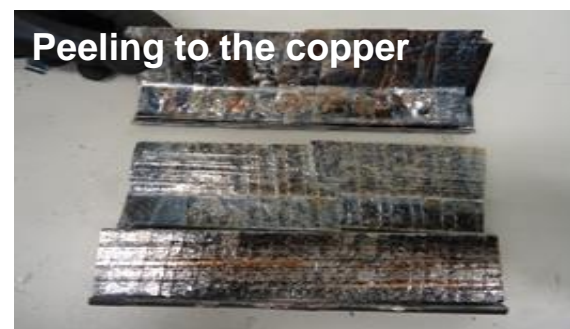
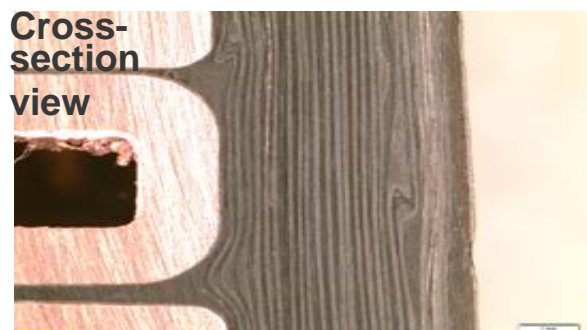
1. *Overall morphology on groundwall insulation is fine;*

2. *Layer-by-layer dissection showed good consolidation;*
3. *No local delaminations found in cross sections.*

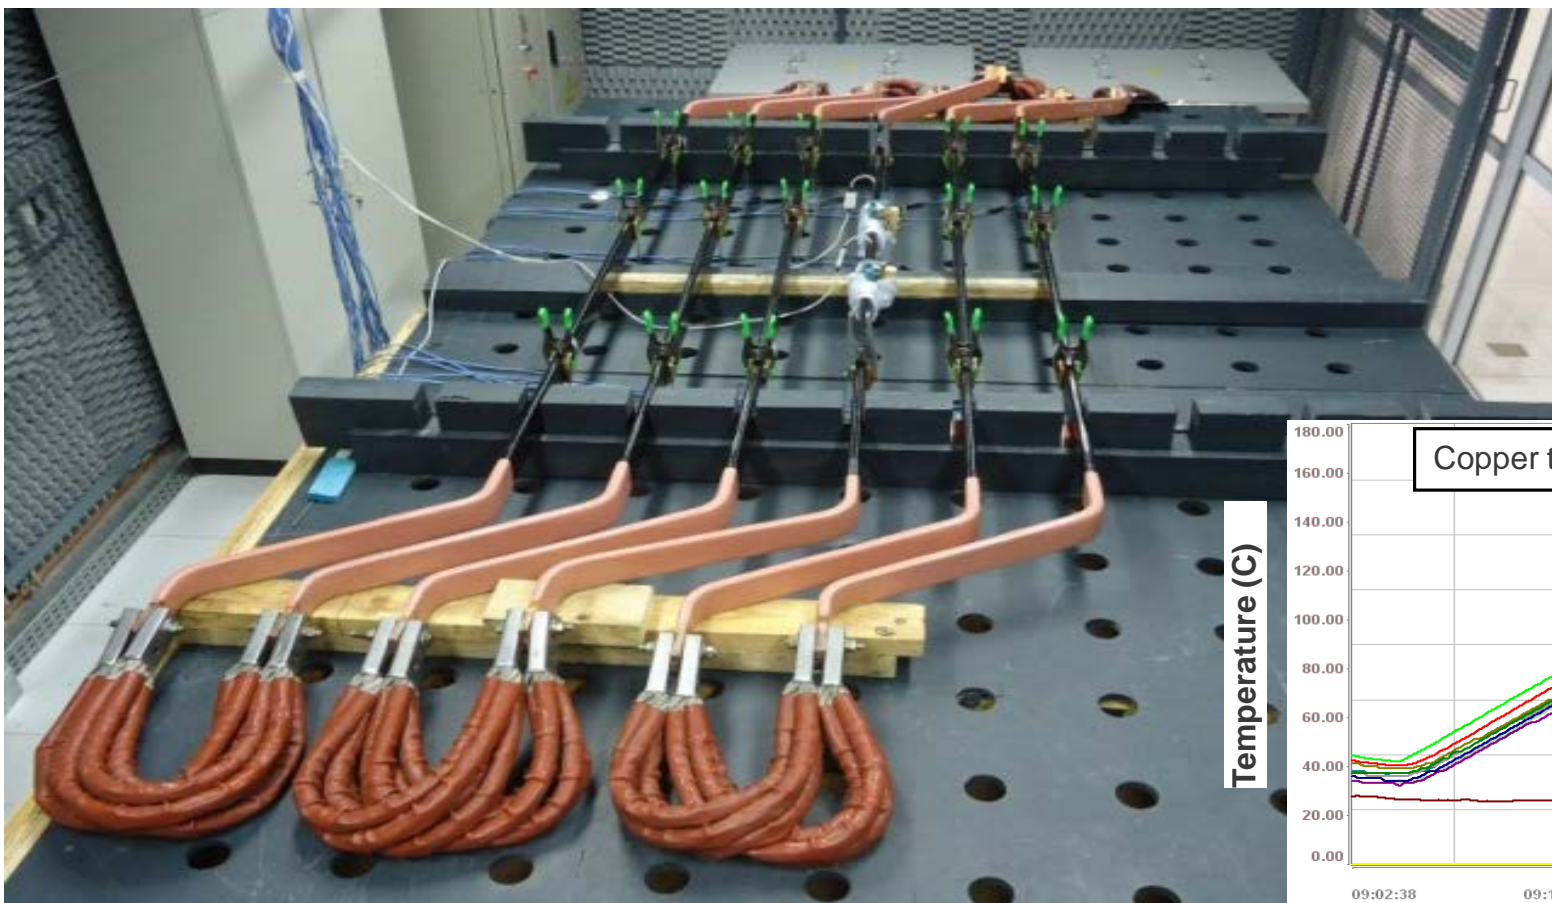
✓ 500 Cycles

✓ 40 to 155 C

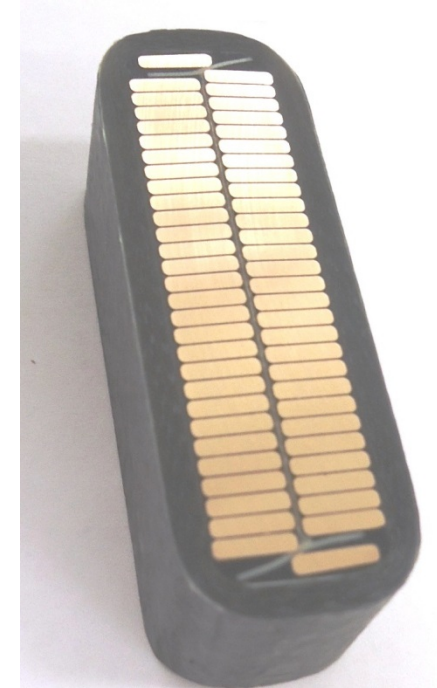
1. *Overall morphology on groundwall insulation is fine;*
2. *No local delaminations found in cross sections.*
