Time Delay Technique for Pinpointing PD Noise on Combined Cycle Systems

Troy Coleman, Plant Technical Services

Puget Sound Energy

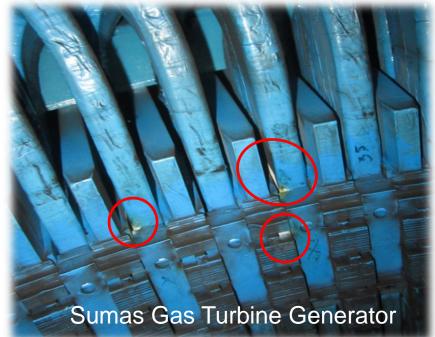
Generator Stator Partial Discharge

- Record data every 6 months → TGA-BP
- Pulse Qm (Magnitude) and NQN (Quantity)
- Check for changes in PD over time
- Doubling of PD in 6 months → Severe

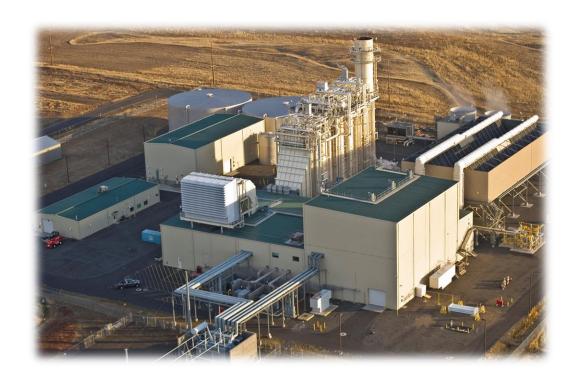
Goldendale, 1:1 Combined Cycle

GE 7FA Gas Turbine

- 168 MW
- 18 kV

Siemens Steam Turbine

- 84 MW
- 13.8 kV

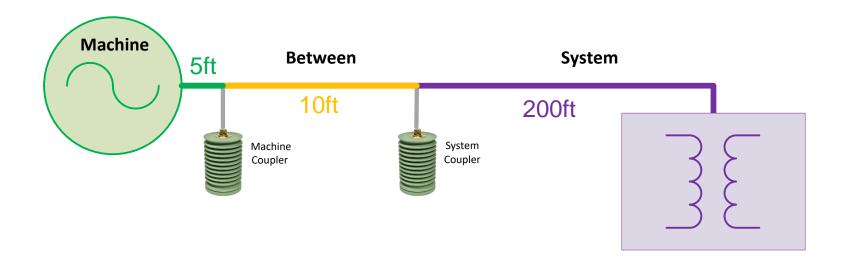
Hunting the elusive PD signal

High System PD throughout plant 230 W 13.8 kV 5 kV 480 Switchgear 84 MW Steam Turbine s Turbine Generator enerator **PUGET**

Need distance between both couplers

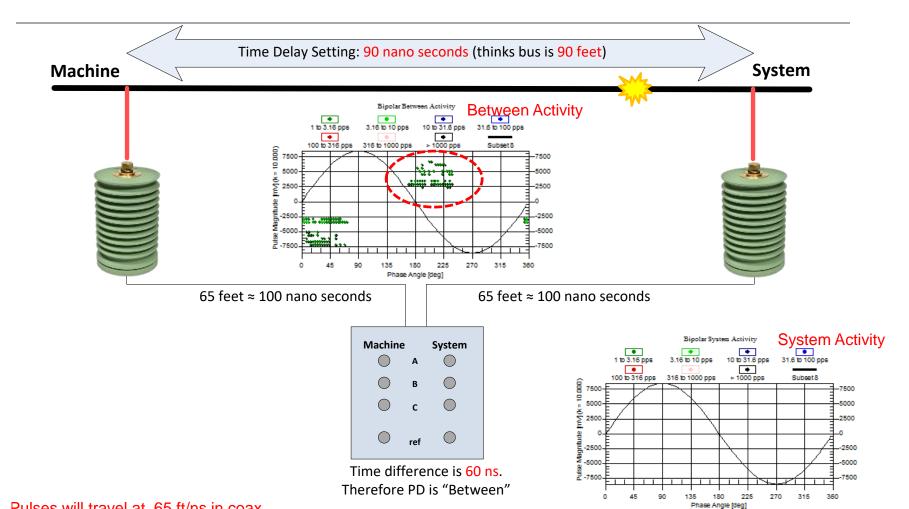
Adjusting Time Delay Settings

Pulses will travel at .65 ft/ns in coax Pulses will travel at 1 ft/ns in bus

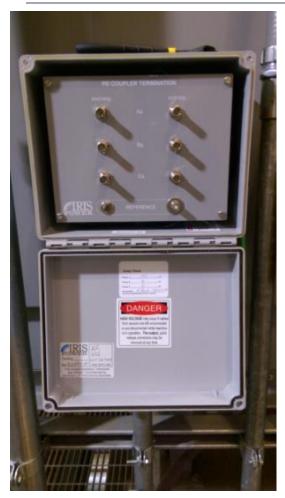
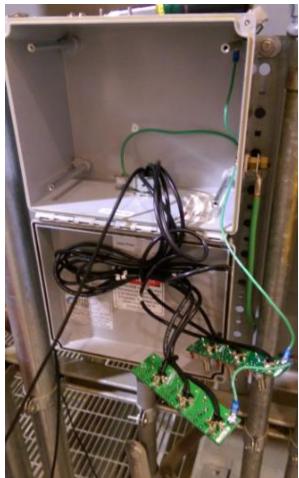
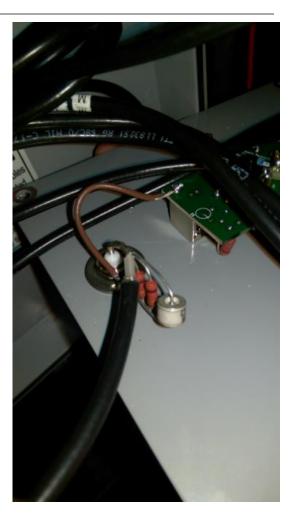
Adding Additional System Coupler

Creating Equal Lengths

- Existing couplers had 24' coax cables.
- Our new* system coupler had a 88' coax cable.
- To create "equal" lengths, we needed a temporary 64' coax cable.

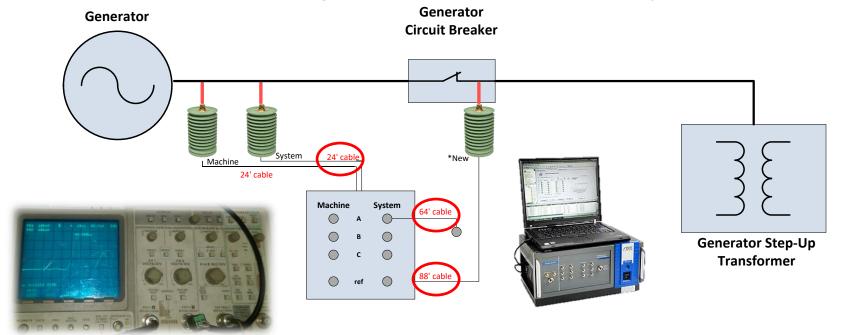
Off by 48.6 ns (Bus Length)

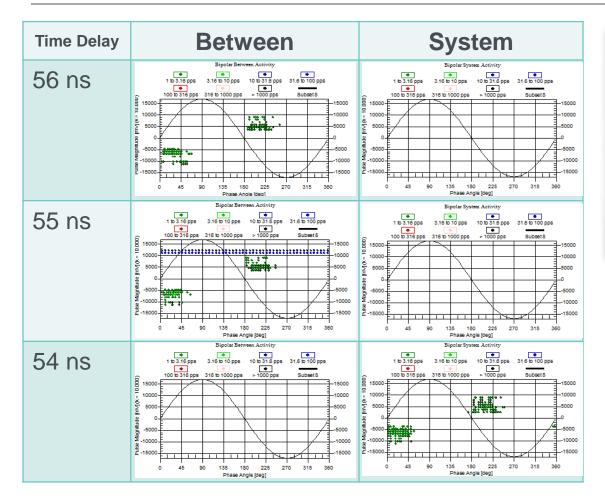
Changing Time Delays (59 feet apart)

Shifted the Time Delay by 5ns.

The noise is occurring a few feet from the coupler, which puts us in the circuit breaker

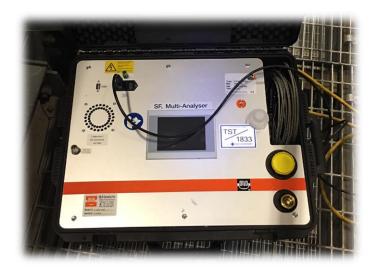
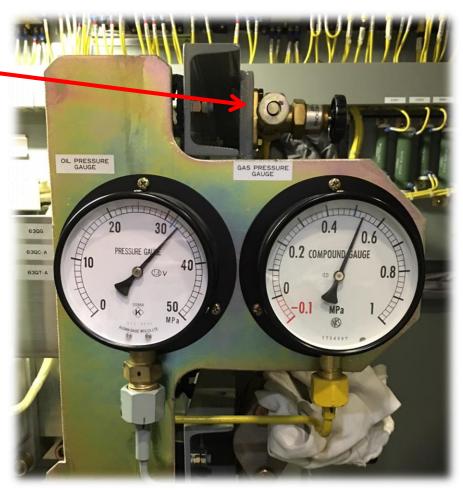
SF₆ Gas Testing

The gas tested normal:

- 99.9% Purity
- < 200 ppm dew
- 0 ppm SO₂
- 71.3 PSI

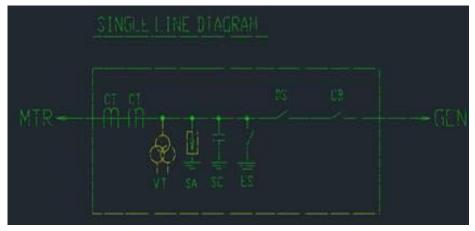
Visual Inspection – Aux Equipment

Tested all the auxiliary equipment:

- **Disconnect Bushing**
- Surge Arrester
- Capacitor
- Voltage Transformer

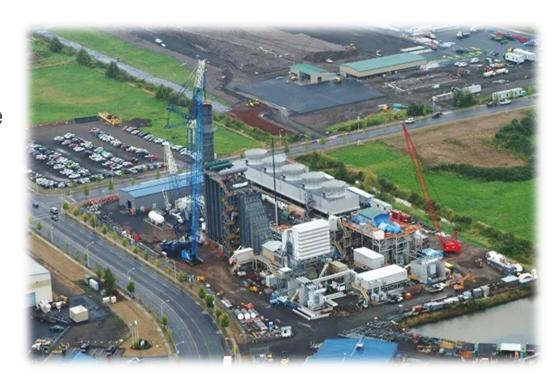
Mint Farm, 1:1 Combined Cycle

GE 7FA Gas Turbine

- 174 MW
- 18 kV

Fuji Electric Steam Turbine

- 86 MW
- 13.8 kV

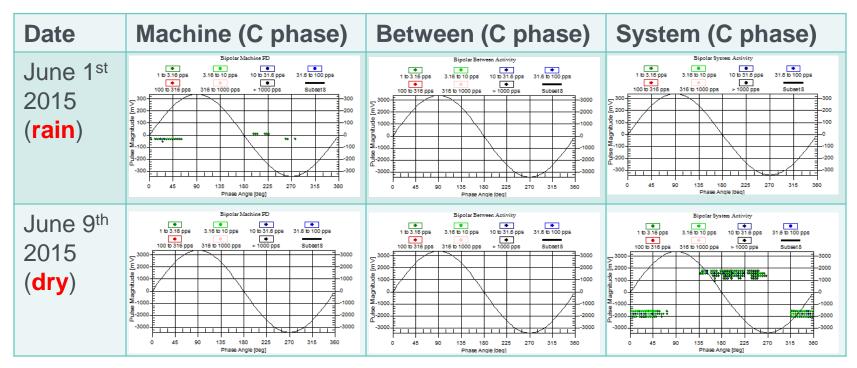
Hunting for Discharge

No Machine or Between PD, so we decided to add an additional coupler further down the bus to increase our "Between" distance.
