CONFIRMATION OF HIGH PDA AND CORONA PROBE READINGS ON A LARGE HYDRO GENERATOR

Igor Chichkin, P.Eng

BC Hydro, Generation Maintenance – Electrical

GMS G3 GENERATOR

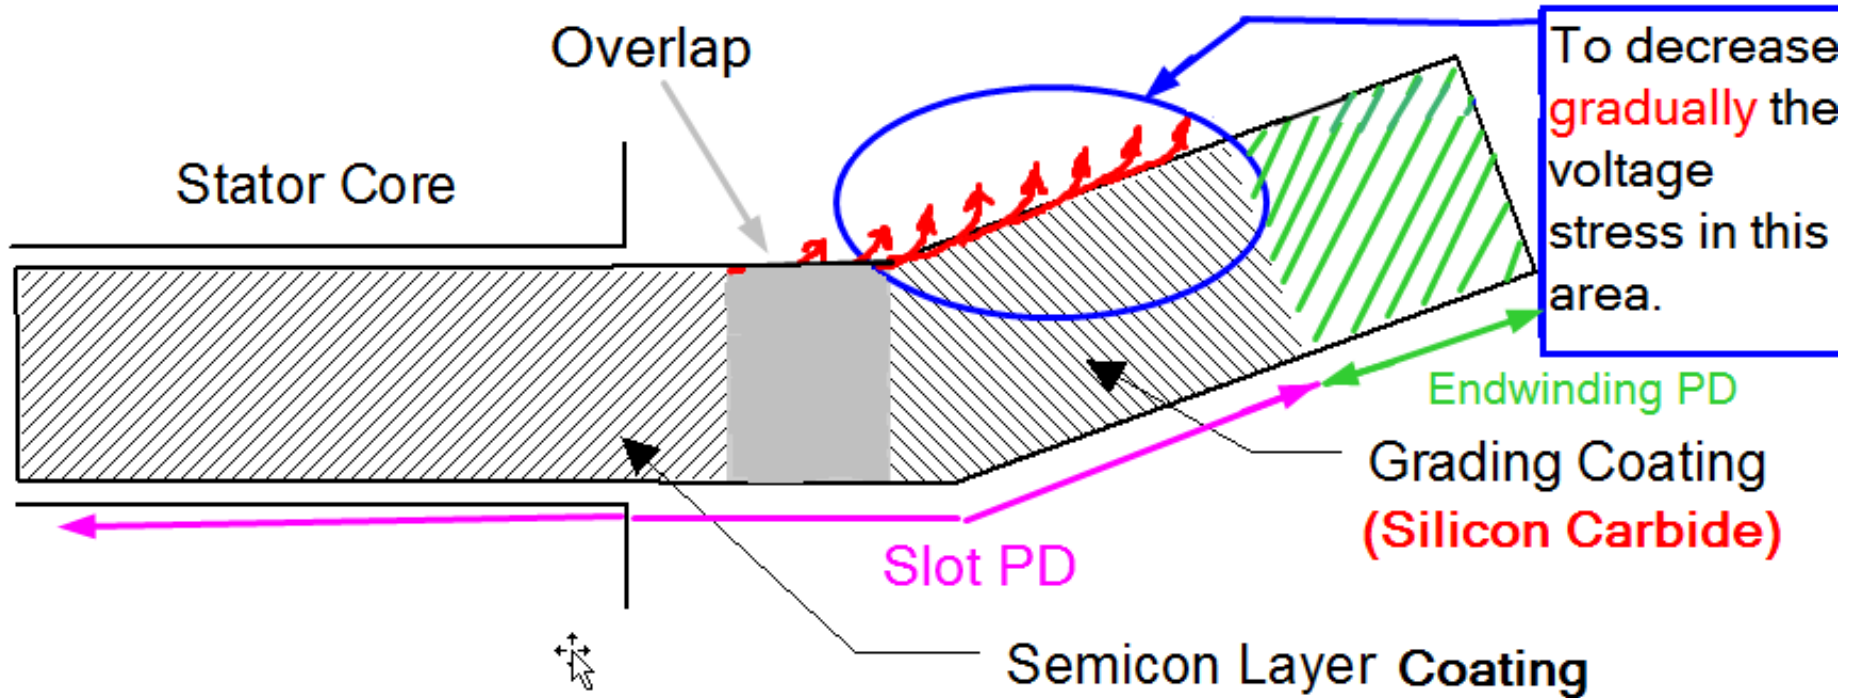
End-winding

- The silicon carbide material has a non-linear resistive property (the resistance decreases with the applied voltage).

- **Purpose** : **gradually decrease** the high voltage in the end-winding to ZERO at the grounded semi-conductive slot coating ,thus avoiding discharges on the surface.

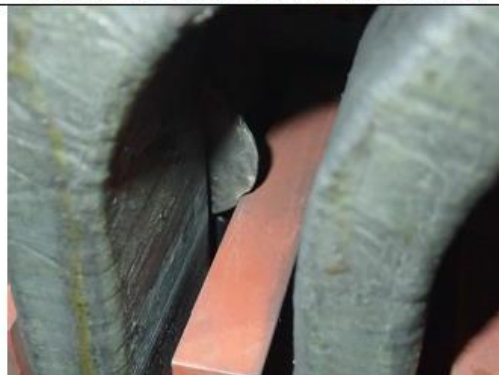
P03: A washer found between front and back bar in slot 245

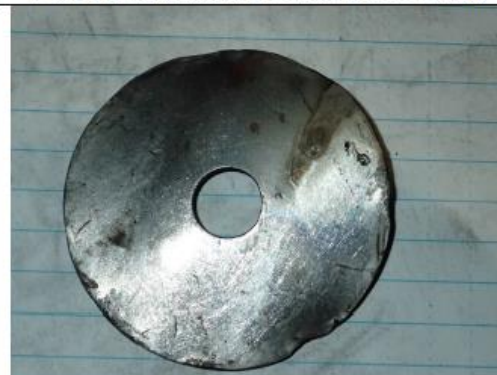
P04: The washer and burn marks possible due to pd between the bars

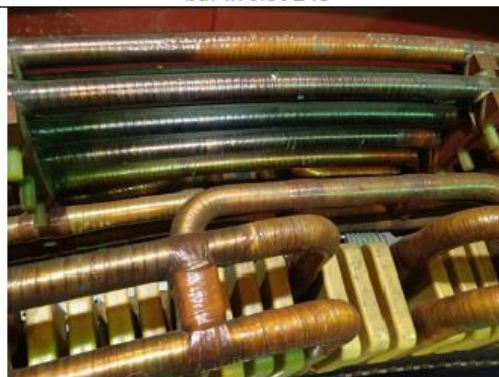
P05: Sections of circuit ring bus discolored

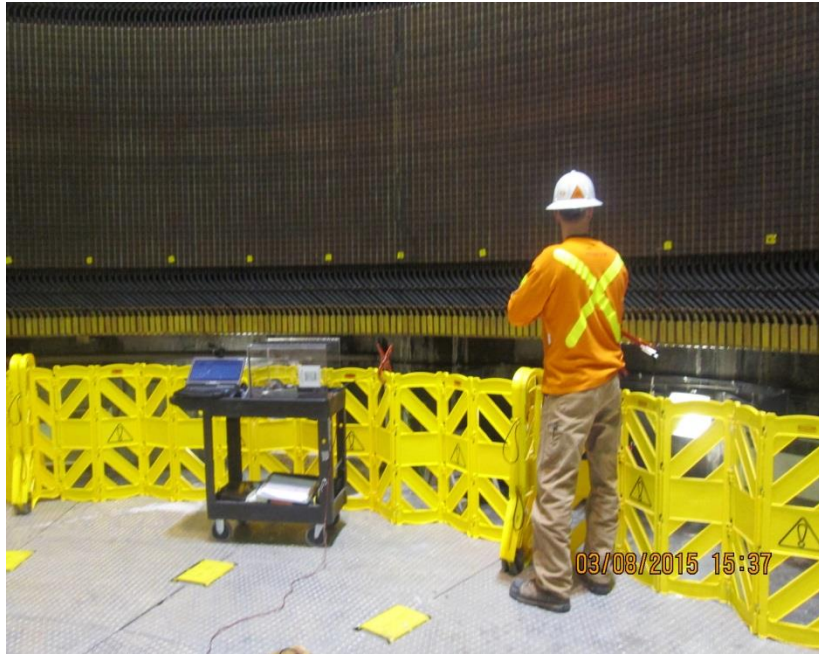
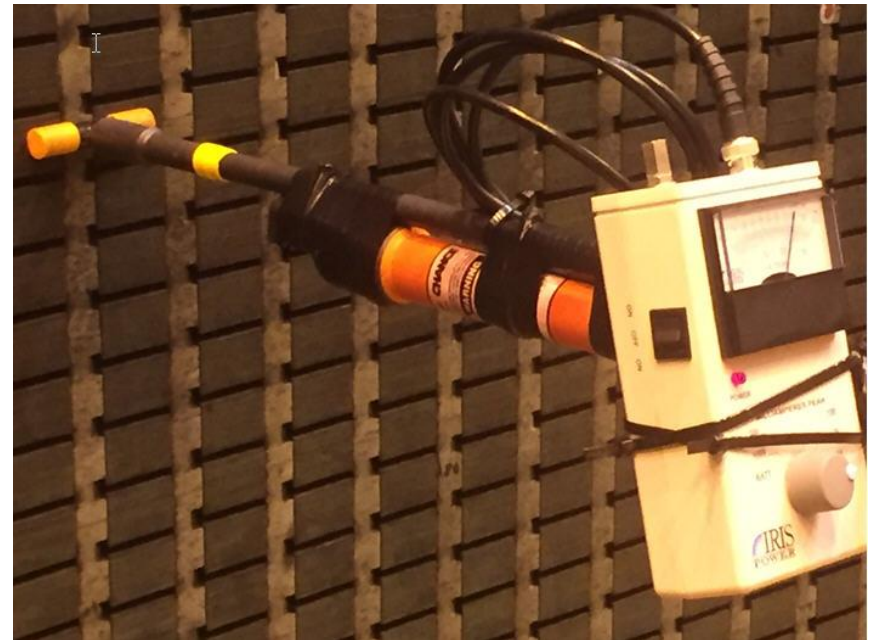
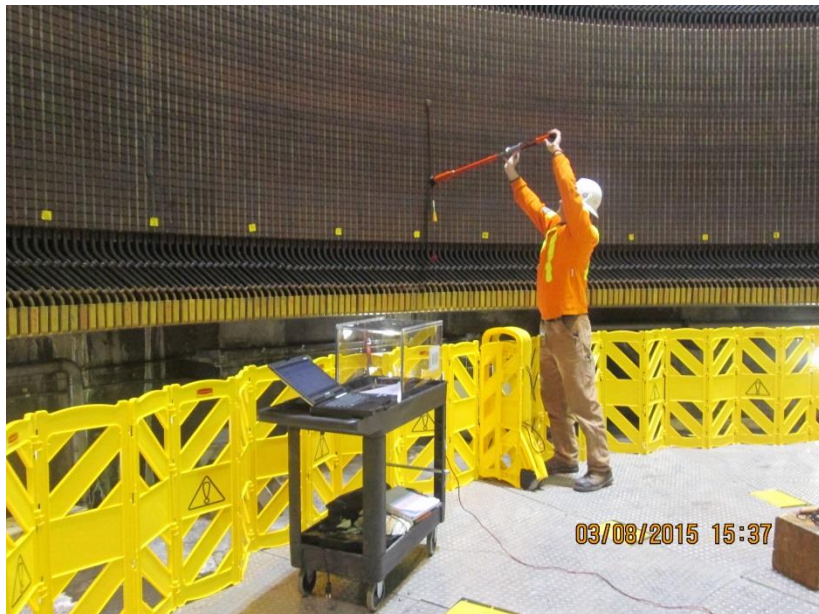
GMS G3 Corona Probe Test

Corona Scope stator end-winding test was performed at different voltage steps: 4.0 to 9.0 kV and Black Out test was performed at 9.0 kV to ground. Both tests showed no PD activity except very little PD discharge at the end-portion of the winding in a few spots only. The Apparatus testers will provide a chart for these tests at a later date.

Based on the currently obtained off-line test results, it is not possible to conclude with good accuracy which bar to remove for dissection on this particular machine. It could be one of the top 10% line-end bars in Phase A circuits: T1-3, T1-4, T1-6 ; or in Phase B circuits: T2-5, T2-6 ; or in Phase C circuit: T3-1. All of these circuits experience high PD activity during on-line operation but show very low or no PD activity during off-line testing. More investigation, including thorough top-end winding visual inspection (by erecting scaffolding or inspecting with the rotor in place) and generator on-line testing is required to make a conclusive recommendation for which bar to remove.

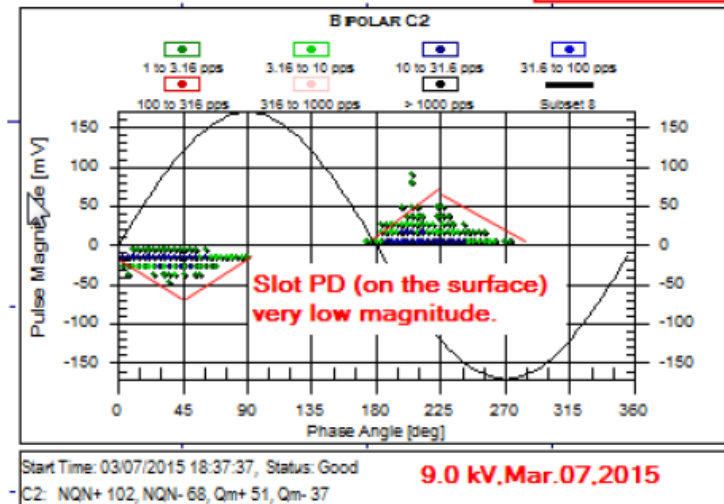
Fig.2 PD Off-line test of the same T1-4 (A4) circuit : On March 07 and March 08
(Notice the difference in PD magnitude of the tests taken on March 07 and March 08)

(Qm+) decreased from 211 mV to 28 mV
(Qm-) decreased from 80 mV to 33 mV

Note : Test conditions and winding setup were the same during both days of testing.

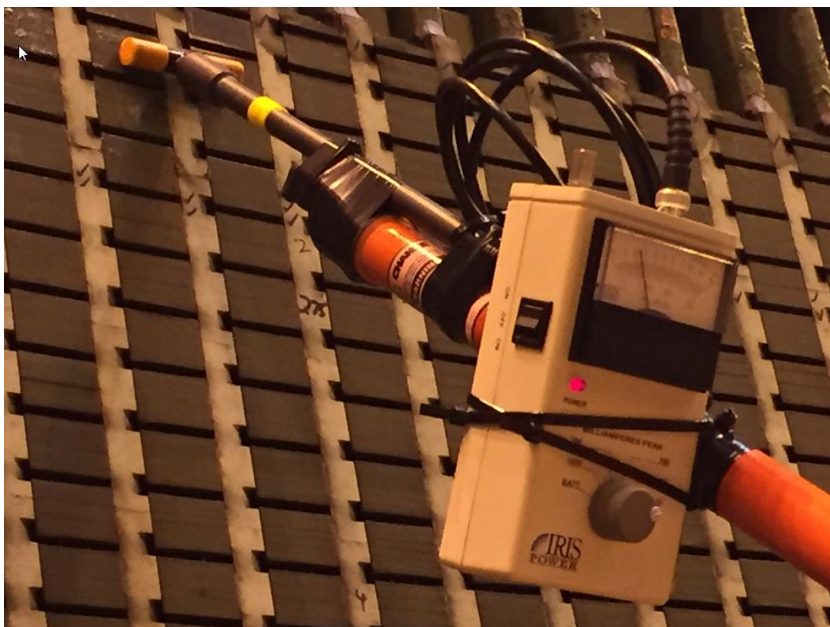
REV G4 Corona Probe tester

Cct in T1 Phase A	kV	BAR		Corona Probe	Corona Scope	PD in Cct	
		Front or Back		(mA)	(visual)	Off-Line	On-line FLH
			F	B			+Qm/-Qm
A1	9	615		120		+1156/-1315	+2722/-3333
A6	8.3	343		105		No PD coupler installed	
A2	8	12		99		No PD coupler installed	
A4	9	225		88		+396/-555	+428/-637
A3	8.3	109		65		No PD coupler installed	
A7	7.2	286		62		No PD coupler installed	
A1	1.2	327		58		+1156/-1316	+2722/-3334
A5	9		235	48		+126/-145	+464/-267
A6	8	324		48		No PD coupler installed	
A2	8.3	31		40		No PD coupler installed	
A7	9	459		38		No PD coupler installed	
A5	8.7	284		36		+126/-145	+464/-267
A1	8.8		606	34		+1156/-1315	+2722/-3333
A3	4.2		21	32		No PD coupler installed	
A1	9.2		1	31	Bottom right side	+1156/-1315	+2722/-3333
A4	6.9	111		31		+396/-555	+428/-637
A8	4.6		352	31		+238/-265	+428/-NA

Cct in T2 Phase B	kV	BAR		(mA)	(visual)	Off-Line	On-line FLH
		Front or Back					
		F	B				
						+Qm/-Qm	+Qm/-Qm
B2	7.6	19		140-200	Audible	No PD coupler installed	
B5	8.3	291		120 /190		+84/-100	+176/-132
B3	7.6	97		100		No PD coupler installed	
B2	8	38		90		No PD coupler installed	
B1	9	17		89		+292/-413	+132/-119
B1	8.7	622		80	Repaired in the past	+292/-413	+132/-119
B1	8.3	603		70		+292/-413	+132/-119
B3					+		
	4.9	48		62		No PD coupler installed	
B8	9.2		573	60	Repaired in the past	+218/-282	+268/-242
B8	8.7	544		52		+218/-282	+268/-241
B2	8.7	76		50		No PD coupler installed	
B4	2.3	20		45		+120/-159	+182/-242
B6	6.9	293		44		No PD coupler installed	
B1	9.2		27	42		+292/-413	+132/-119
B2	8.5		67	42		No PD coupler installed	
B2	6.9	605		40		No PD coupler installed

Cct in T3 Phase C		BAR		Corona Probe	Corona Scope	PD in Cct	
	kV	Front or Back		(mA)	(visual)	Off-Line	On-line FLH
		F	B			+Qm/-Qm	+Qm/-Qm
C1	7.6	552		130 / 80		+99/-101	+281/-197
C4	9	238		60		+344/-404	+234/-225
C6	7.2	299		52		No PD coupler installed	
C6	8	337		52		No PD coupler installed	
C2	9	82		45		No PD coupler installed	
C7	5.6	309		34		No PD coupler installed	
C8	6.9	436		32		+82/-104	+185/-189
C7	9	472		30		No PD coupler installed	
C3	6.9	46		28		No PD coupler installed	
C6	5.6	231		26		No PD coupler installed	
C4	6.9	124		24		+344/-404	+234/-225
C4	7.2	143		24		+344/-404	+234/-225
C4	7.6	162		24		+344/-404	+234/-225

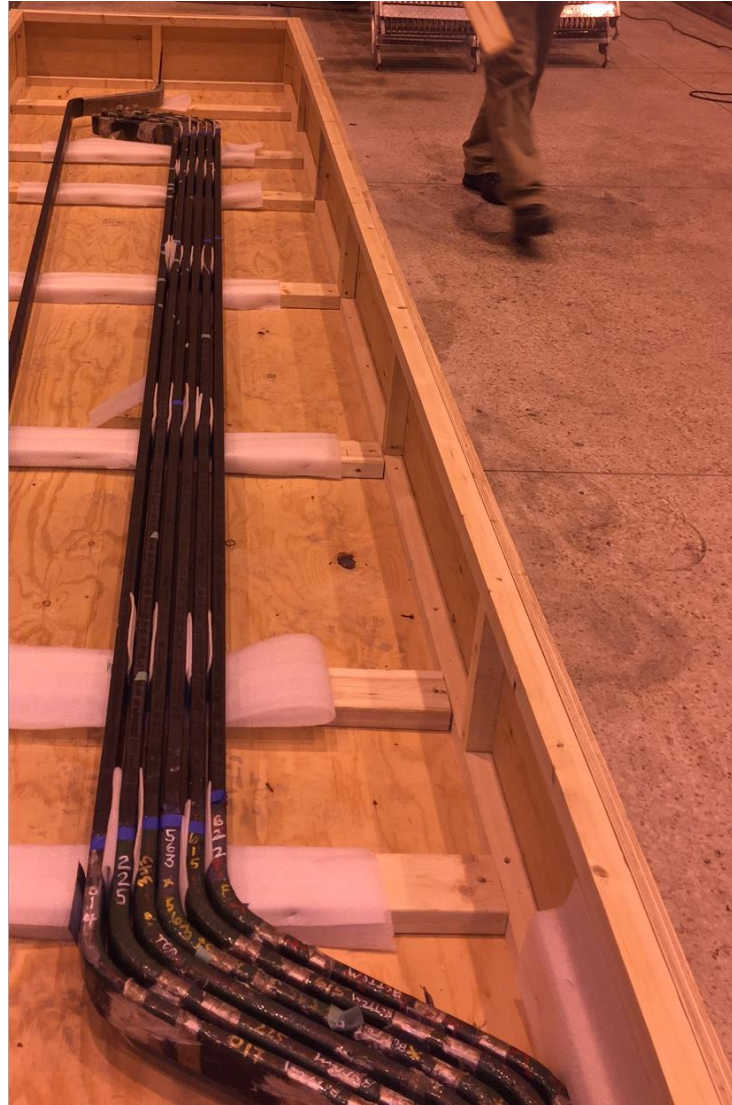
6 bars removed (+ 1 spare bar)shipped for testing at the Powertech Labs

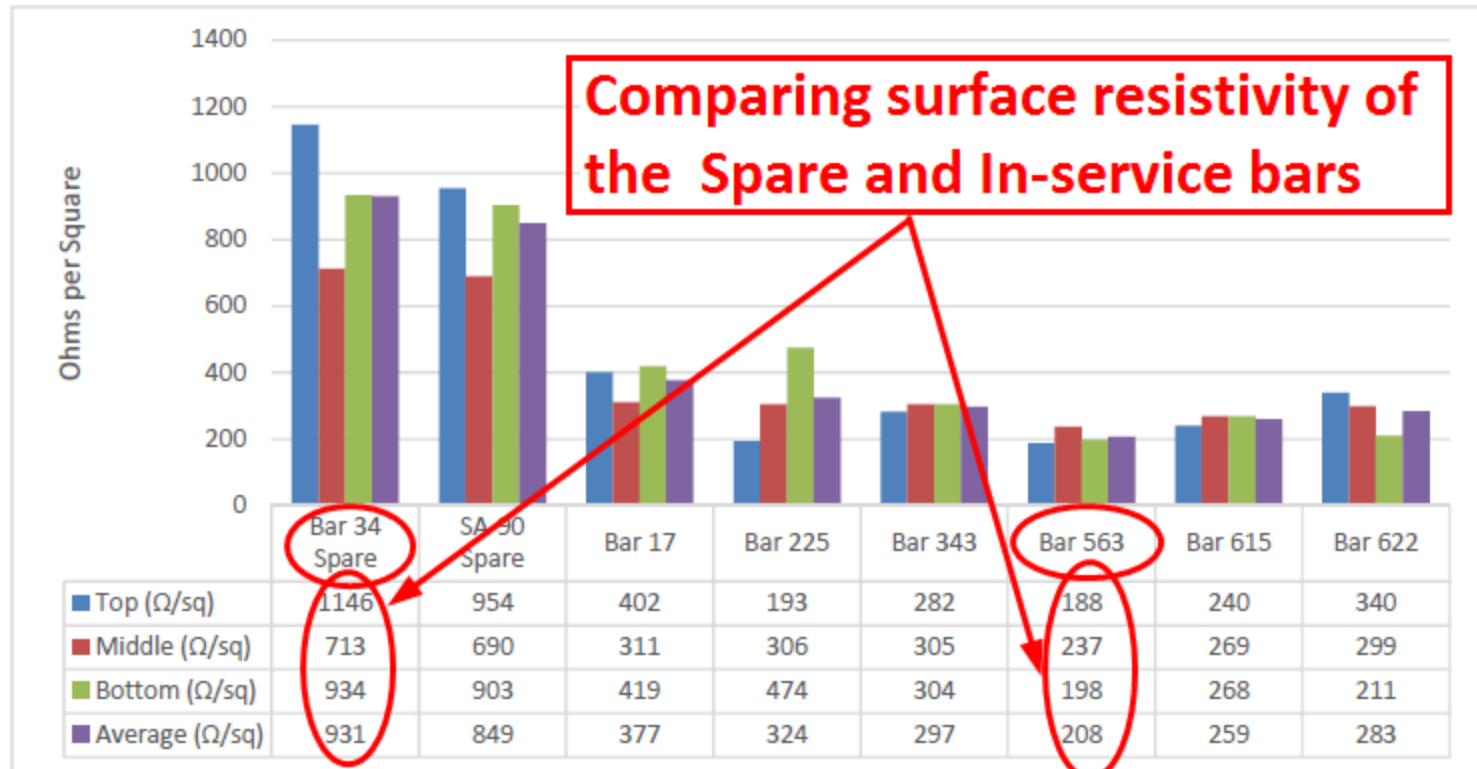
Surface resistivity of the semi-con paint in the slot section

Spare bars have 2-3 times higher surface resistivity compare to the service-aged bars.

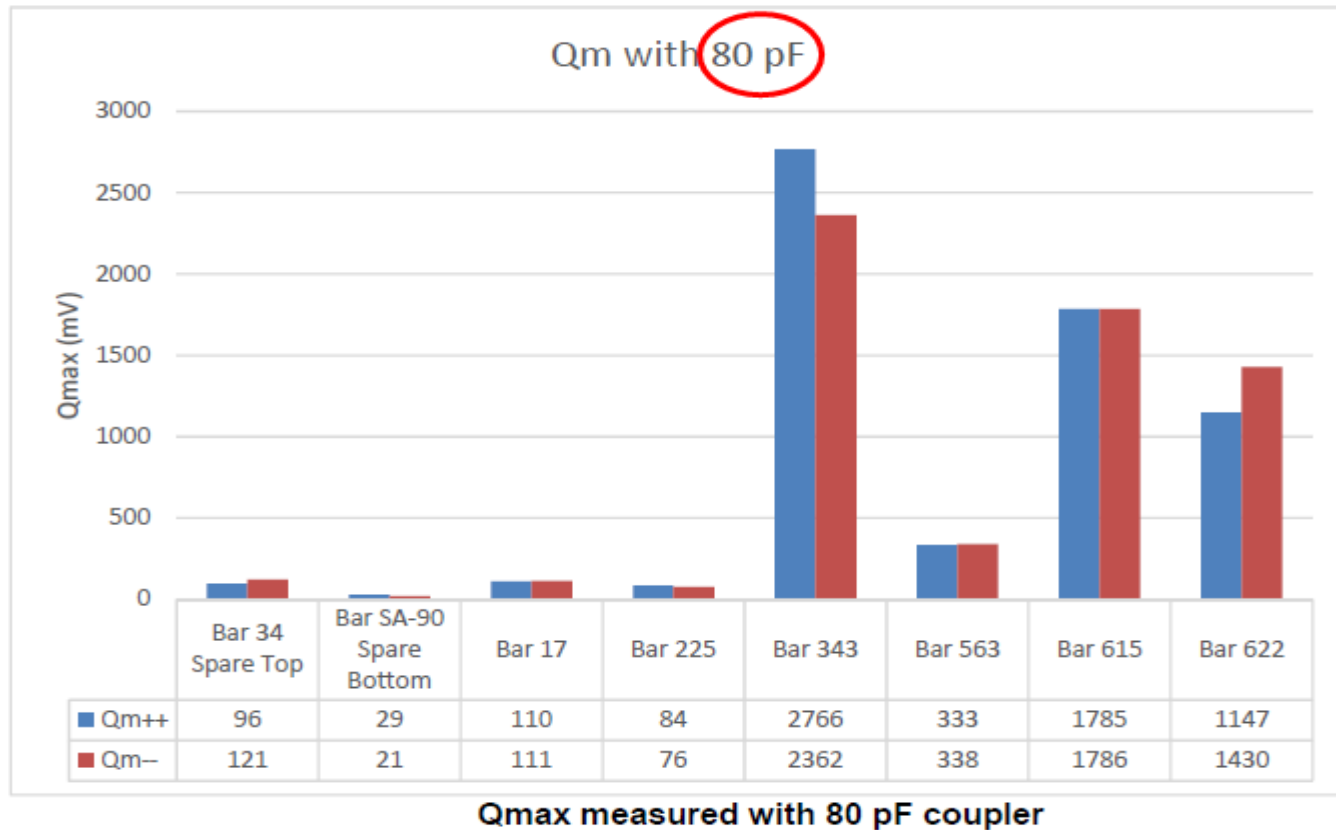
PD testing at the PowerTech Labs

Test Voltage was selected 10 kV that is slightly higher than 9.24 kV to compensate for temperature difference between operating and test conditions.

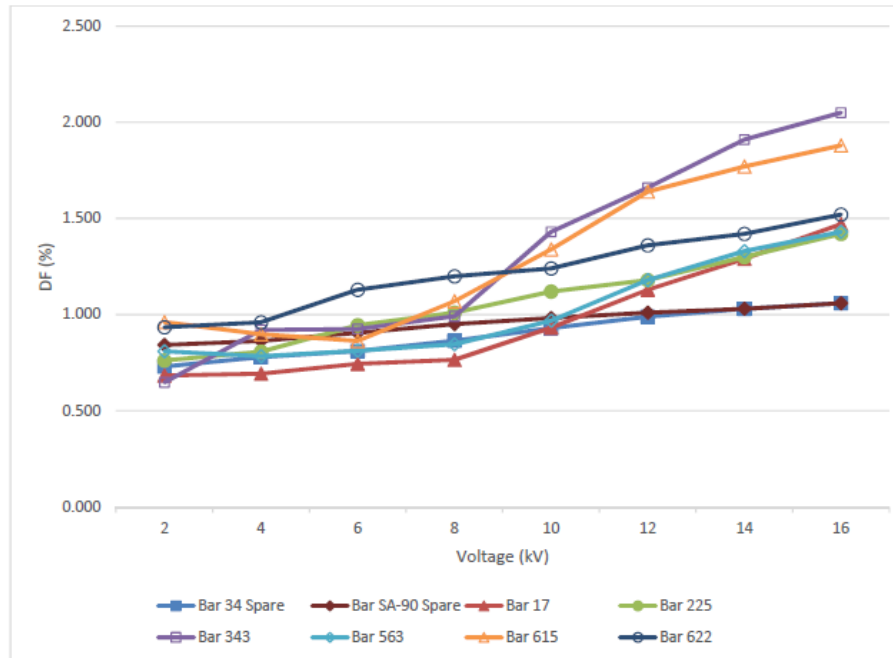
Dissipation Factor (DF) and tip-up

Absolute dissipation factor (%) as a function of applied voltage

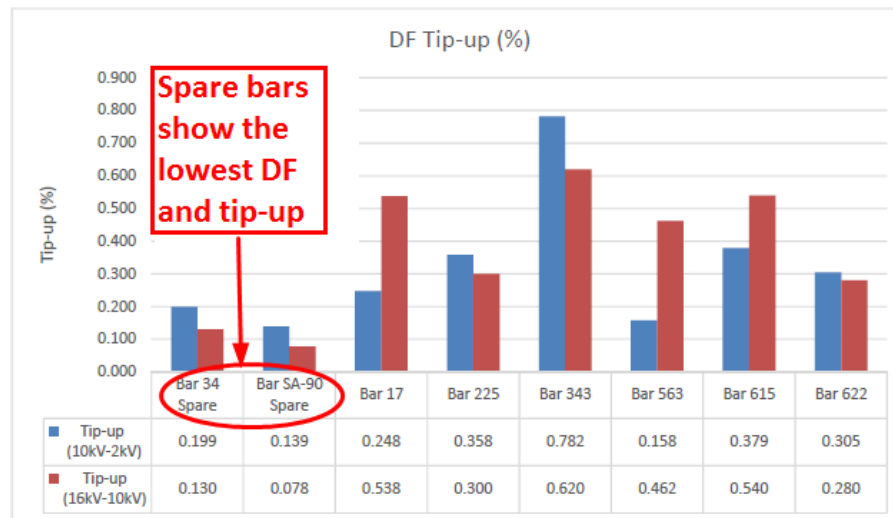
Dissipation factor tip-up between 10 and 2, and 16 and 10 kV

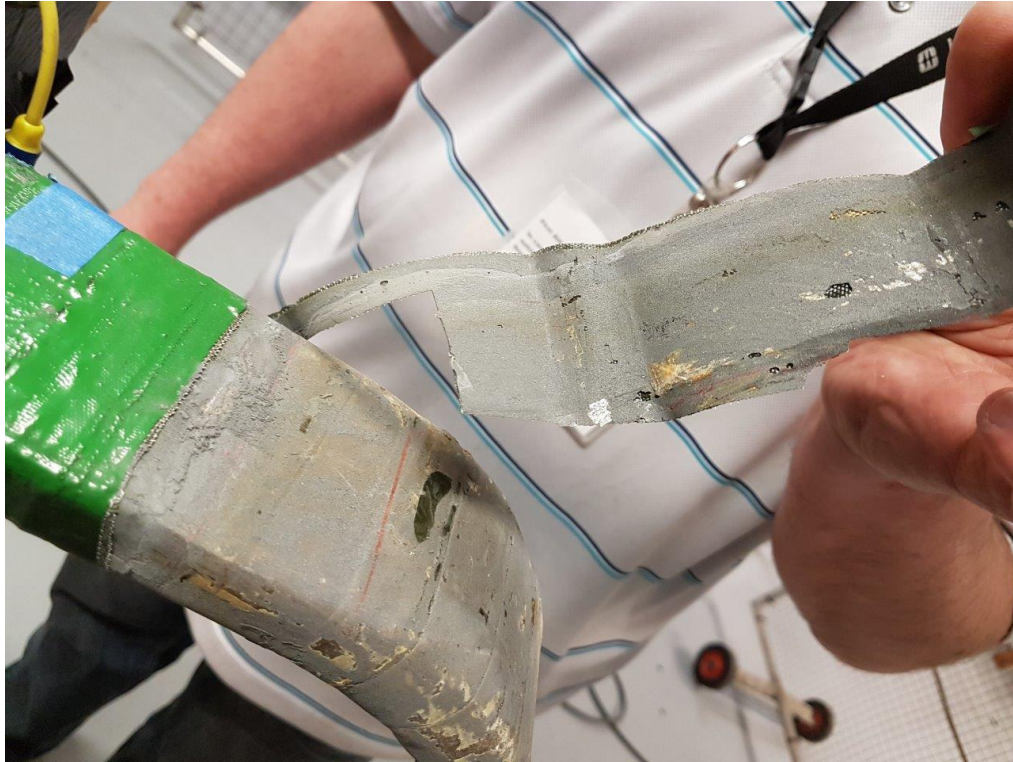
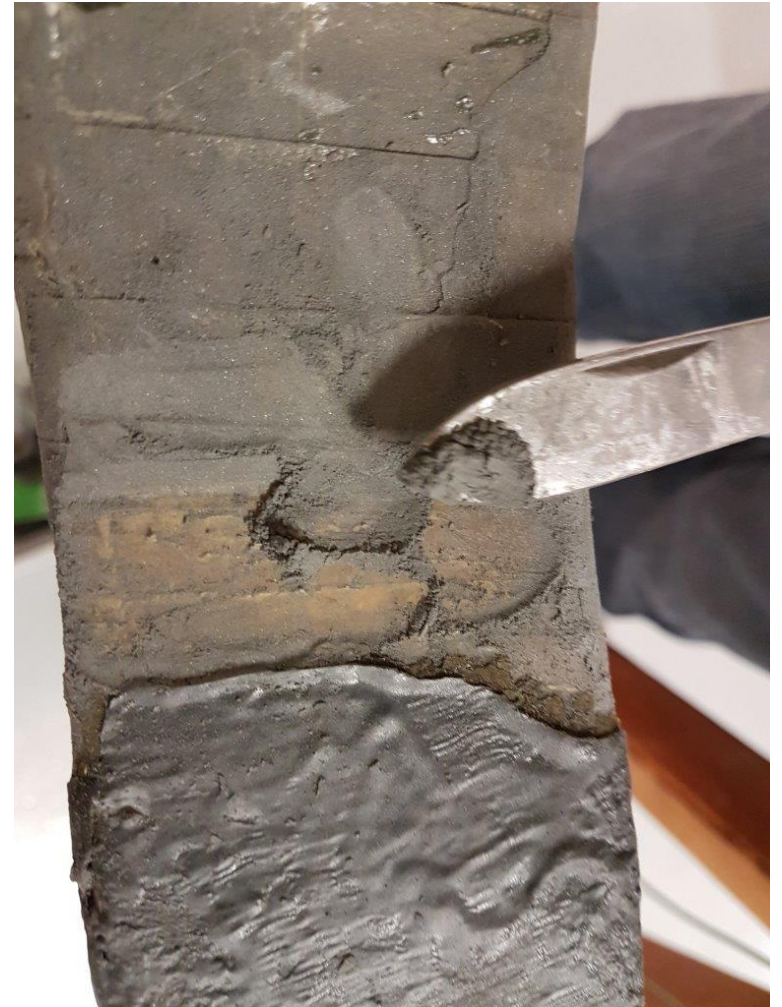
REV G4 bar semi-con /grading interface deterioration

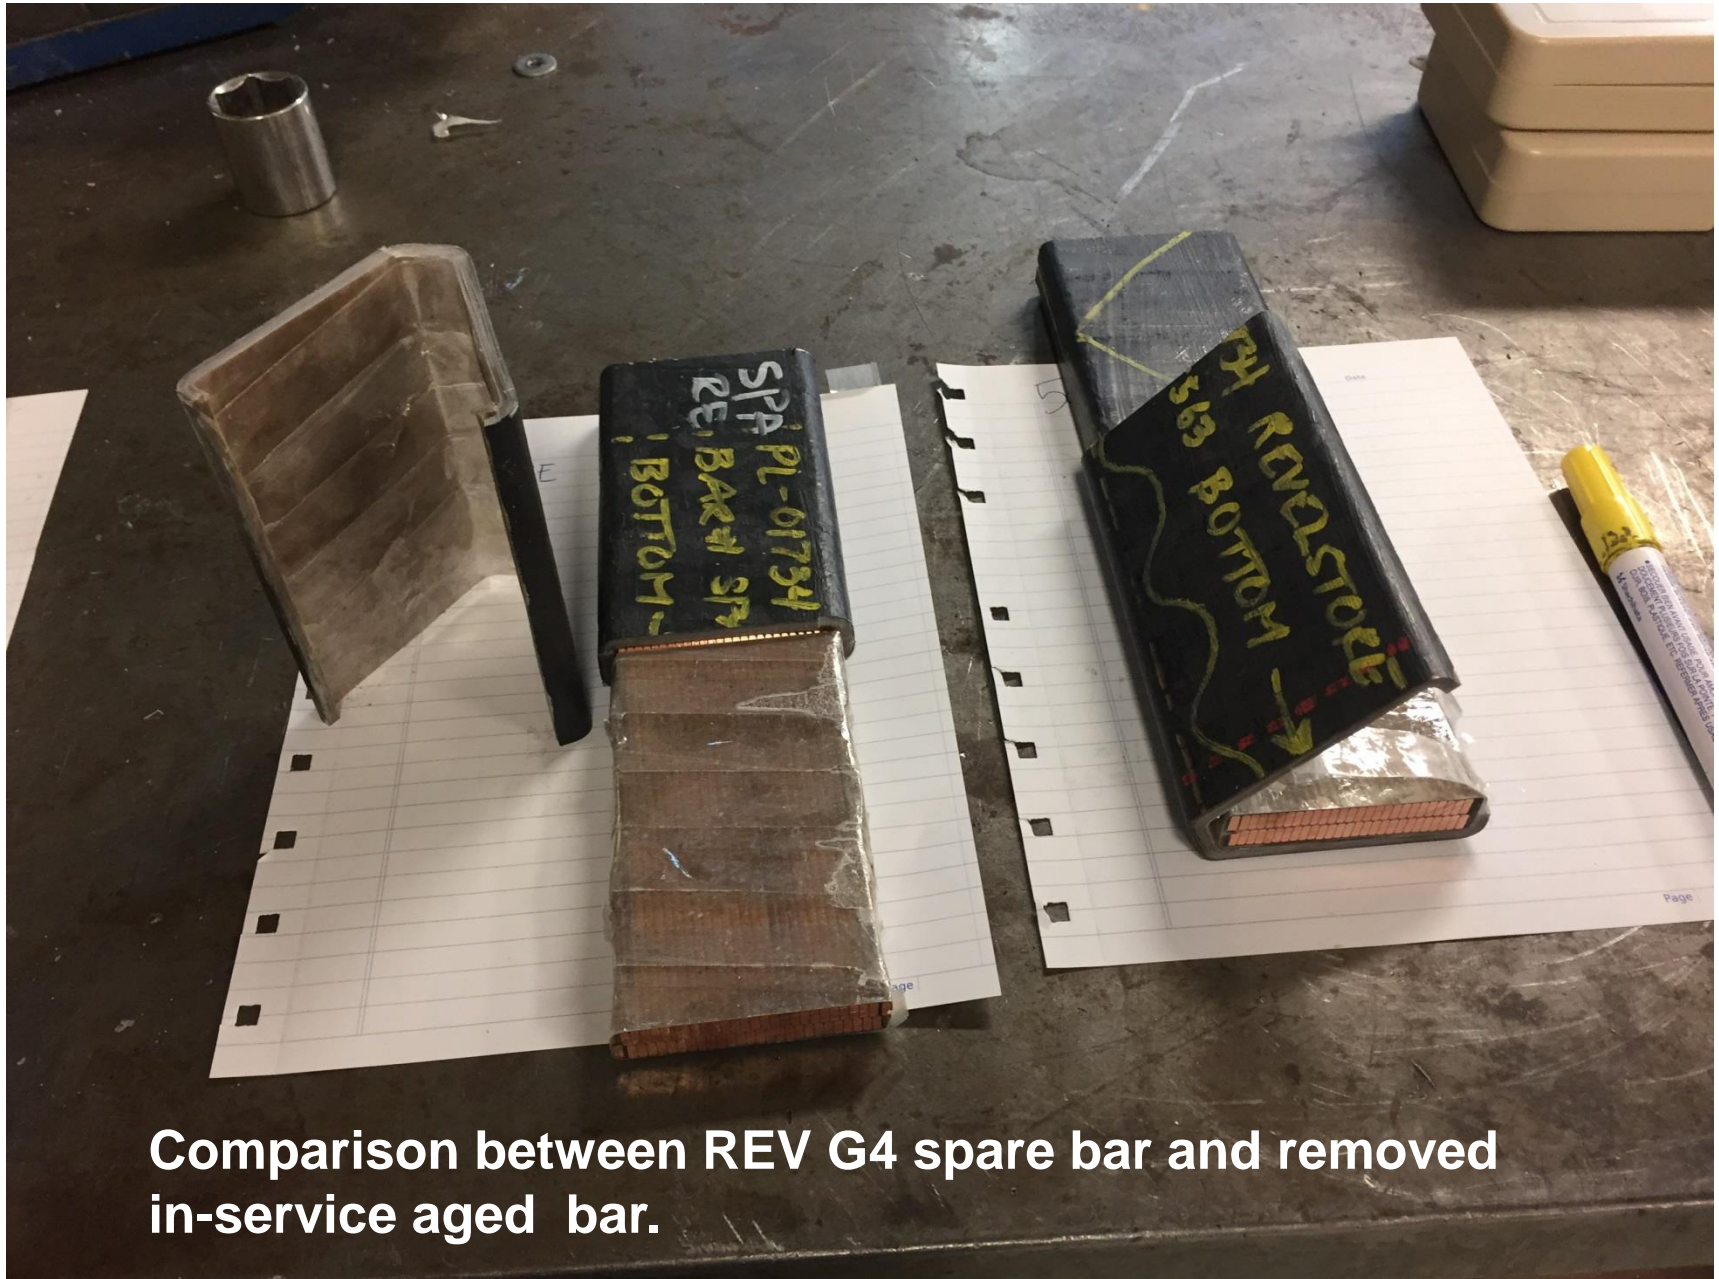
Comparison between REV G4 spare bar and removed in-service aged bar.

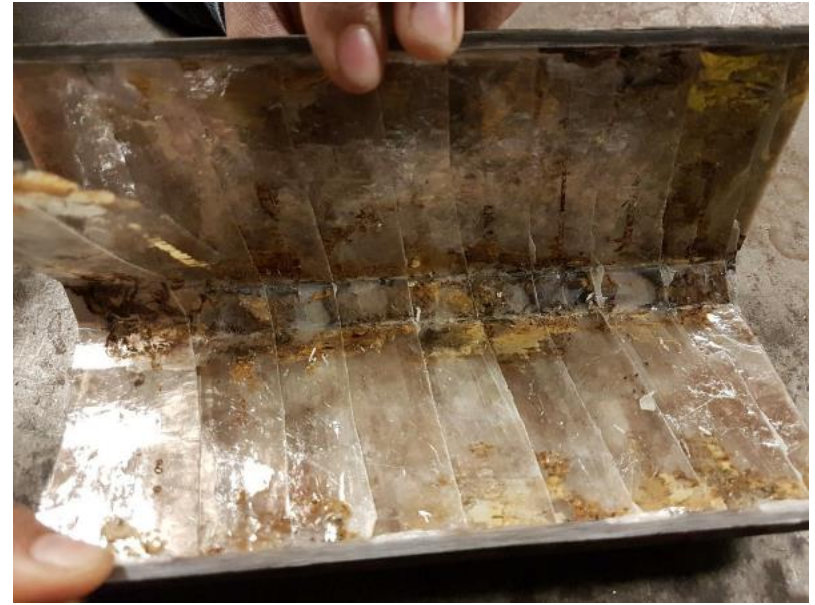
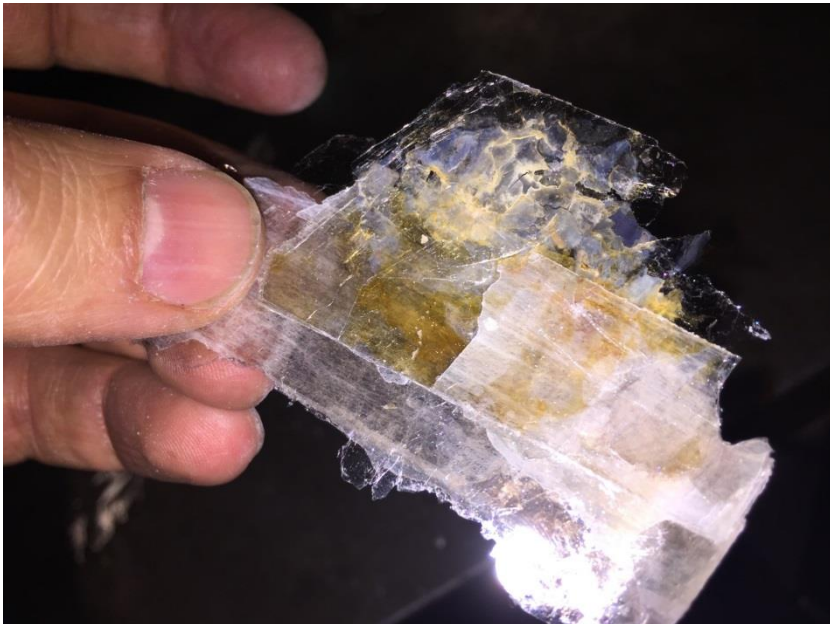
PD closer to copper strands
