STATOR ENDWINDING VIBRATION IN TWO-POLE MACHINES

Copyright Material IEEE
Paper No. PCIC-2018-51

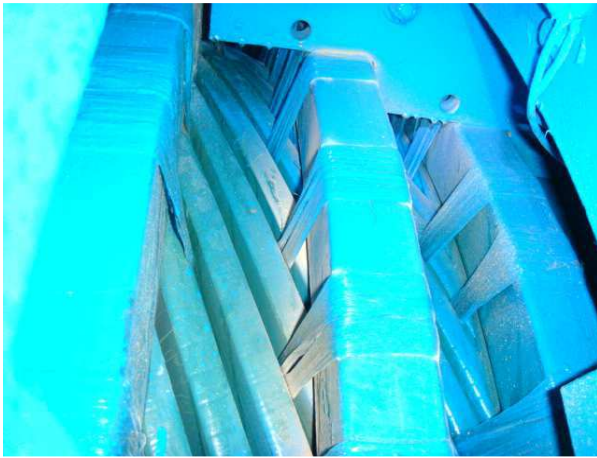
Fig. 2 Photo of insulation abrasion (white powder caused by fretting) caused by relative movement between the coil, support ring, and support brace

1. The vibration can lead to relative movement between endwinding components – for example, fiber glass rope affixing the coils to the support rings and braces may abrade the coil insulation (Fig. 2). Eventually the abrasion can be severe enough to expose high voltage copper conductors within the coil. If partly conductive contamination is present, it may result in a phase to ground fault.

Visual inspections of the endwinding and surrounding support structure are generally considered the main tool to detect evidence of excessive movement [12]. The dusting that results between components that are supposed to be held tightly together is an indication that they have come loose and are rubbing against each other resulting in the insulation to fret (Fig. 2).

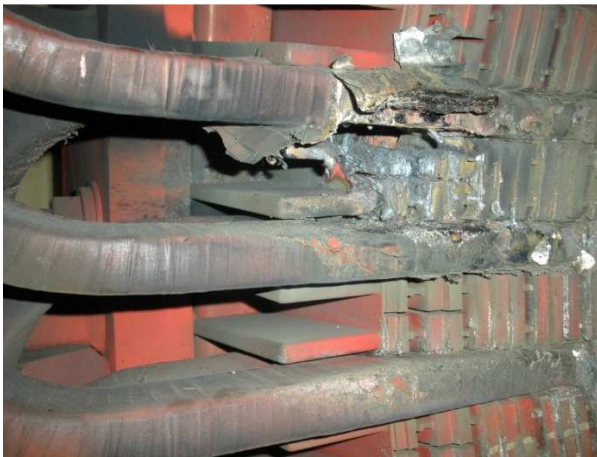
Fig. 3 Collateral damage to the stator winding and core caused by fatigue cracking of the copper conductors due to severe endwinding vibration

3. In the most extreme case, if the copper conductors within the coil vibrate enough, the copper conductors will fatigue crack. If all the conductors in a coil fatigue crack, the stator winding current continues to flow through the coil by forming a plasma at the severed copper, which causes extreme heating of the conductors, melting of the copper and nearby components, and often complete destruction of the stator winding (Fig. 3).

In the early 2000s, reports of catastrophic stator endwinding failures similar to that shown in Fig. 3 were being discussed at utility conferences by several operators of air-cooled turbine generators rated up to a few hundred megawatts. The endwinding failures were apparently occurring on several different brands of machines, often after only a few years of service. In addition, many cases of fretting (for example Fig. 2) were being found in modern air-cooled two-pole generators and greasing in hydrogen cooled two-pole generators. This led the Electric Power Research Institute (EPRI) to commission a report educating end users on the design of 2 and 4-pole generator endwindings, and possible failure mechanisms [4]. Various researchers also published papers on the recent increase in endwinding vibration issues [5-10]. In 2010, FM Global, a large insurance company used by generating stations, published a presentation where they indicated that in the period 2000-2010 they paid out more in claims for generator failures caused by endwinding vibration, than all other claims of generator failures combined [11]. About the same time, machine manufacturers decided that an IEC standard was needed to educate end users about the endwinding vibration issue, and ways to determine if a problem exists. This resulted in the 2016 publication of IEC 60034-32 [1].

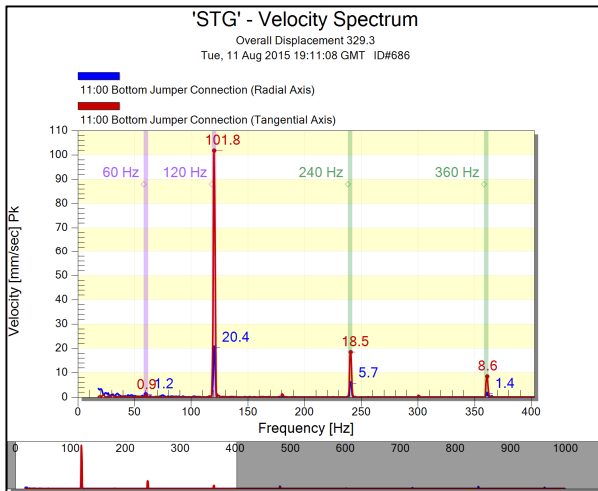
Fig. 7 Velocity spectra just prior to visual inspection confirming looseness

harmonics in the frequency spectrum. For comparison, below are displacement and velocity spectra at the onset (Figs. 4-5) and leading up to (Figs. 6-7) endwinding support structure looseness identified during a visual inspection (Fig. 8) [9]. Not only is the dominant frequency at 2f (120 Hz for 60 Hz machine) which is considered typical endwinding vibration, but the harmonics present are indicative of mechanical looseness. When comparing the relative amplitudes at 240 and 360 Hz to the fundamental 120 Hz they are more easily identified when viewing the velocity.

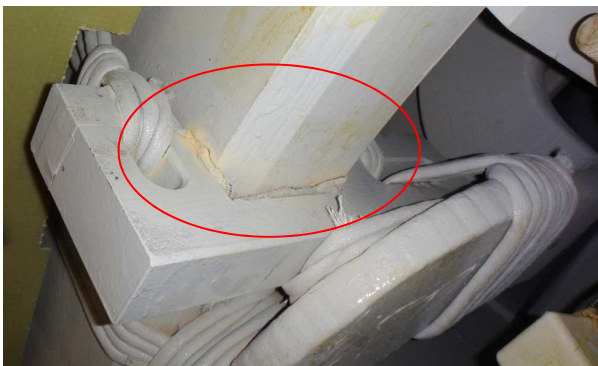
Fig. 8 Visual inspection showing looseness between the support block, circumferential support ring and connection between the winding and circuit ring [9]
