DETECTING FAILING JOINTS IN A POWER PLANT USING ELECTROMAGNETIC INTERFERENCE (EMI) EQUIPMENT

Clyde V. Maughan
Schenectady, New York 12306 USA
clyde@maughan.com

James E. Timperley
Galloway, Ohio 43119 USA
j.e.timperley2@gmail.com

POWER PLANT ELECTRICAL EQUIPMENT DETERIORATION

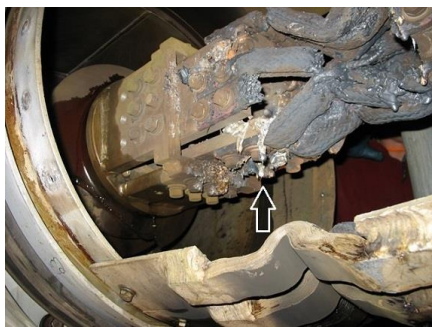
A more serious joint failure is shown in Photo 4. Restoration of this condition would involve local cleaning, replacement of lost metal and reconditioning of the plated surfaces. Costs in outage time and repair would be modest.

Photo 4. Failing flexible connection joint.

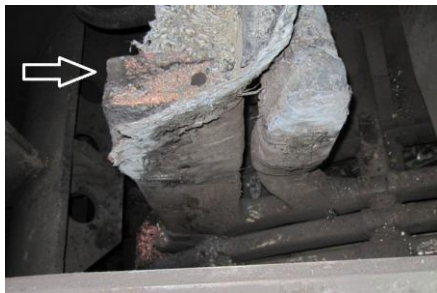
At the extreme high end of the damage spectrum is the failure of a new 900 MW generator shown in Photos 5-7.

Photo 5. Remains of failed connection.

Repair of this failure involved installation of a new stator winding, field rewind to facilitate cleaning of winding, and extensive difficult cleaning of the core and frame. The total costs for repairs and 6 months of replacement power were remarkably high.

A particularly important case involved a large generator that had extensive repairs to the bushings in the terminal box. (The case discussed in Photos 5, 6 & 7.) After the machine was returned to service, the plant electrical maintenance superintendent was concerned about the bolted joints of the new connections. An expert operator was retained to bring in a Radar Engineers 246 instrument in order to check the newly installed bolted joints. Significant EMI signal was readily detected from arcing of the

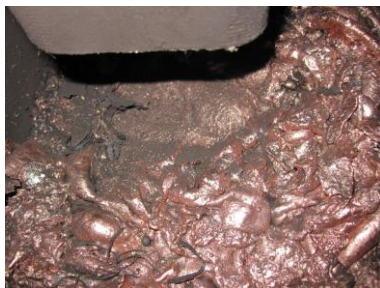
Photo 6. Many pounds of melted copper from this connection failure.

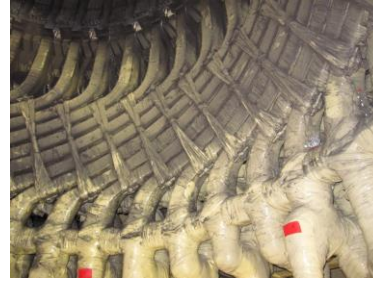
Photo 7. Resulting contamination to stator winding.

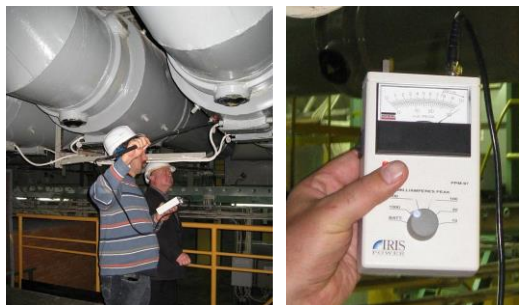
Since the generator was not in operation, the IPB scan was performed with one phase energized at the time, to 4000 V. (Line-to-neutral voltage on this unit is 9090 V) The source of high PD was quickly found to be at the location of line current transformers on C phase, with readings higher than the maximum measurement range of instrument. Photos 10a and 10b.

Photos 10a & 10b. PPM 97 measuring a bus EMI source.

Visual inspection confirmed evidence of arcing between the current transformer supports and the bus conductor.

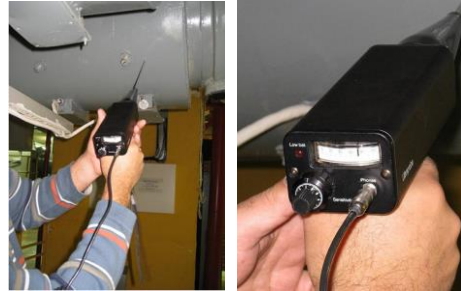
This finding was verified by another tool, an ultrasound probe made by UE Systems, as shown in Photos 11a & 11b.

Photos 11a & 11b. Using the Ultraprobe™ assessing the acoustic noise that accompanies EMI

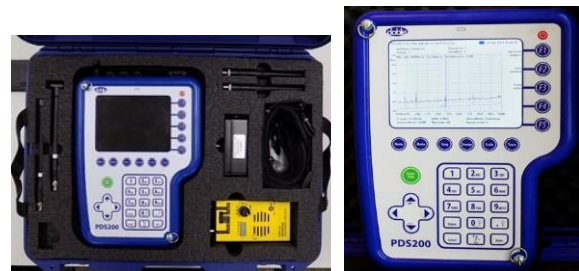
Relative to EMI testing for joint deterioration, their EMI instrument is the EMI Surveyor, a PDS-200. Photos 12a and 12b. (In the Surveyor package they also include the Radar Engineers 246 equipment, to be discussed later.)

Photos 12a and 12b. Doble PDS-200 EMI Surveyor.

The device can be used to scan for radiated EMI or used with an RFCT for EMI signature analysis. Data is collected following the international standard, CISPR 16. This permits direct comparison with data collected from other instruments that follow this protocol. The frequencies covered are shown in Table I. The band from 50 kHz to 100 MHz is the most useful for electrical equipment found in industry.

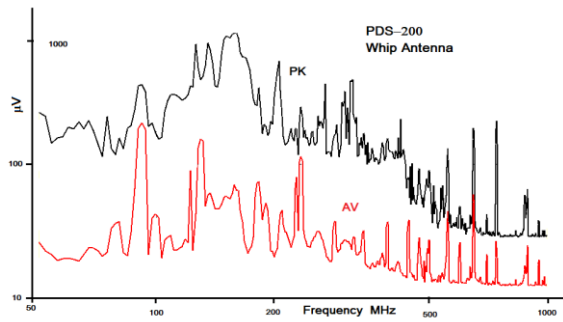
A useful Doble feature is the comparison of data collected with different detectors. The curve below shows the 50 MHz to 1000 MHz ambient signals outside a plant. The peak, PK and average, AV detectors are used. The AV detector is useful in identifying transmitters. These are the spikes on the curve. Those on the far right are cell phone towers.

Spectrum curves with different detectors.

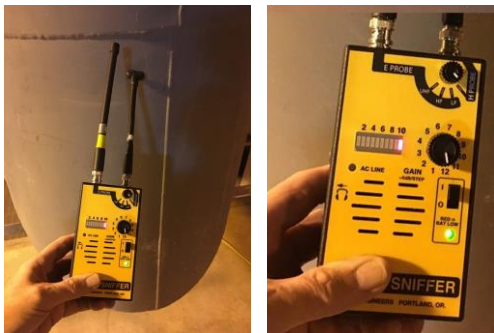
The present instrument is identified as 246A, and is shown in Photos 13a and 13b.

Photos 13a and 13b Radar 246A instrument.

This is a small device weighing less than a pound. It is versatile and can be used in the low sensitivity

range on the magnetic, H field antenna. The higher sensitive is with the LF/HF/UHF, electric or E field antenna. It has 12 ranges of gain and a 10 LED bar graph; both are log scales resulting in a wide sensitive range.

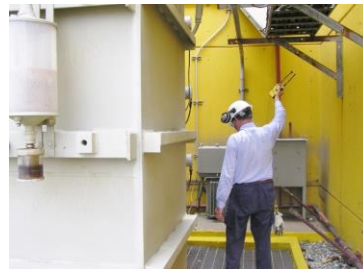
Searching for EMI emissions with this hand-held device simply involves walking around the plant equipment in question and observing the output of the device. Photo 14. A typical generator or bus can be scanned in a few minutes. Historical experience suggests that roughly 90% of typical equipment failure modes emit detectable radiation EM energy, thus accounting for the extreme value of the test.

Photo 14. Ambient Radiated Survey with 246.

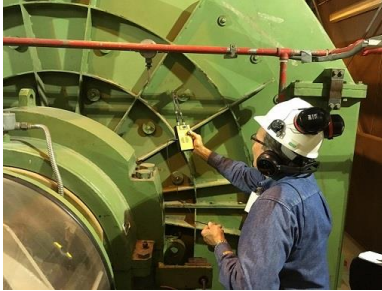
With careful following of the instructions supplied with the device, an operator can perform the necessary scans throughout the power plant. Photos 15 and 16.

Photo 15. Checking the end of a generator for radiated EMI.

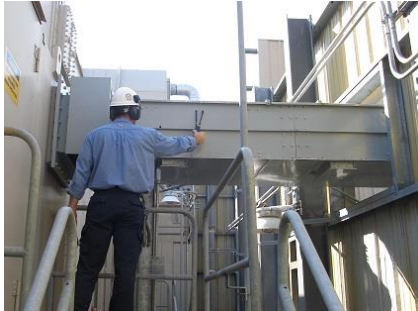
Photo 16. Checking a bus for radiated EMI.
