Dynamical loads and the consequences in the Rough Load Zone Operation – case studies

SUMMARY

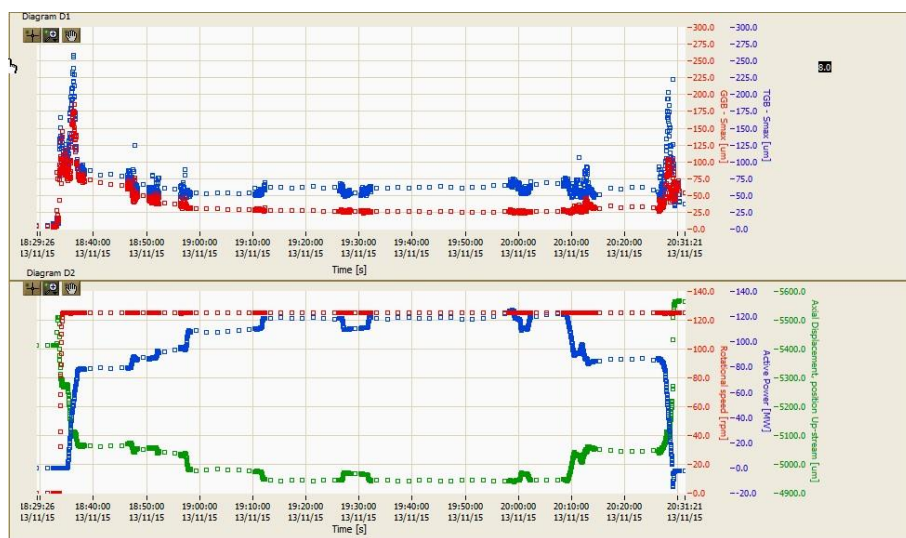
Figure 2 shows the Smax trend data in two radial bearing planes (GGB and TGB) alongside operating condition indicators recorded during same period. In the zone of 50 MW operation the vibration amplitudes were much higher than the amplitudes recorded during full power load. It appears that the machine passed through the RLZ twice 1) during load increase and 2) during the shut-down process. At 50MW, the TGB vibration amplitudes (Smax) reached a maximum at ~300 µm

Figure 2 - Upper diagram: Smax @ GGB & TGB; Lower diagram: RPM, Active Power (P) & Axial Displacement.

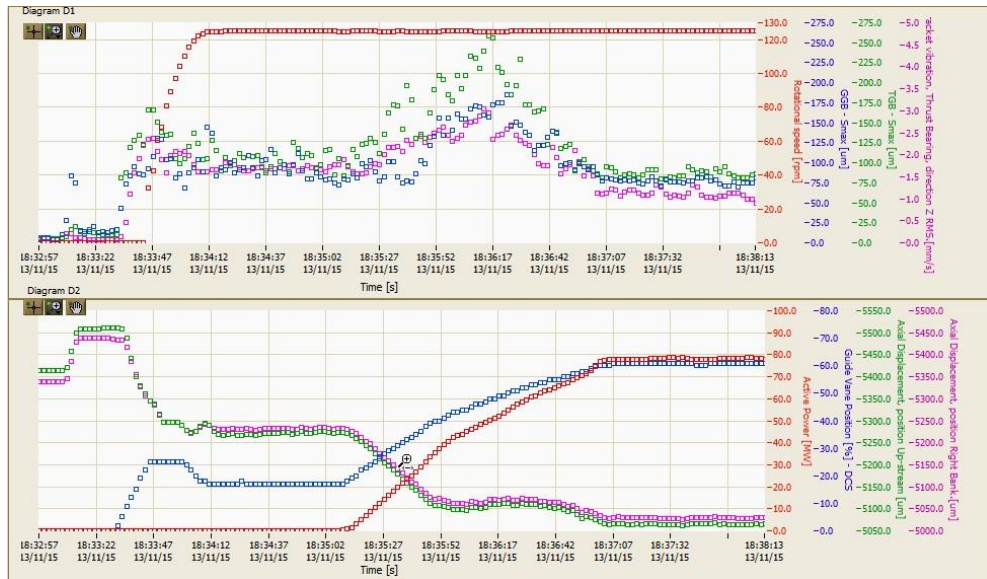
Further analysis required a more detailed observation in that particular power span. Figure 3 is zoomed in while the machine passes through RLZ during the load increase process. The parameters shown are:

- Smax on radial bearings (TGB and GGB),
- RMS on axial (thrust) bearing Vrms (vibration velocity),
- Active Power,
- Guide vane opening,
- Axial displacement

Figure 3 – Upper diagram: *RPM*, *Smax* on *GGB* & *TGB*, *Vrms* on *ThrB* in axial dir; Lower diagram: *P*, *Guide vane opening*, axial displacement *US* (Upstream), and *RB* (Right Bank).

Since RLZ operation can lead to large vibration response in the axial direction it is important to analyze the behavior of axial displacement signals. The axial displacement sensors were located below the rotor so as the rotor moved away from the probe the signal increased. It was visible that during standstill the axial displacements increased by ~100 μm , which was likely an effect caused by the oil lift circulating in the axial bearing. As the machine started to rotate the axial displacement signals decreased as the water pushed down on the rotor. When the machine was in mechanical free run the axial displacement signals were stable.

The axial displacement signals started decreasing with load as more water increased the force acting downwards on the rotor. This was visible during 0 to 40 MW load operation, but more significant results were after 40MW during RLZ operation when the axial displacement increased and achieved a stationary state until the machine reached 60 MW load. After that the axial displacement decreased again as expected, achieving a constant value at a steady load of 80 MW. At the same time, the *Smax* vibration levels on the *TGB* increased from ~80 to 100 μm before the RLZ to over 250 μm at ~50 MW during the RLZ occurrence. Similar behavior with smaller amplitudes were recorded on the *GGB*. Absolute vibrations *Vrms* signal (axial) on the thrust bearing increased up to ~3 mm/s RMS at ~50 MW and then decreased to 0.5 mm/s RMS with load increase.

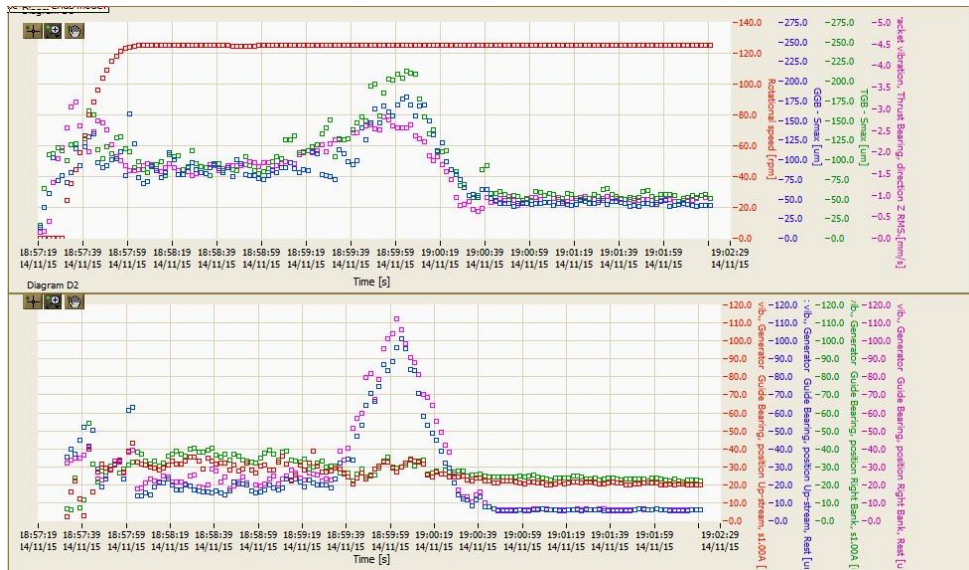
Figure 4 shows vibration *Smax*, *S1n*, and *Rest* comparisons with the intention of focusing on specific frequency ranges for further data analysis. *S1n* vibrations did not experience any changes during RLZ, whereas the *Rest* signal components completely follow the *Smax* behavior and increased during RLZ operation.

Figure 4 – Upper diagram: RPM, Smax on GGB i TGB, Vrms on ThrB in axial dir; Lower diagram: s1.00A on GGB US and RB, and Rest on GGB US and RB.

It should be noted that similar response was present on the Turbine Cover axial vibration but are not presented since Figures 4 and 5 sufficiently describe the machine behavior. It can be concluded that during RLZ operation high vibration amplitudes occurred at specific frequencies not related to the machine rotation. This event represents dynamic instability which requires further analysis in the frequency domain to completely understand the machine behavior, the impact of this instability to the machine, and whether this poses any danger to the reliability of the machine.

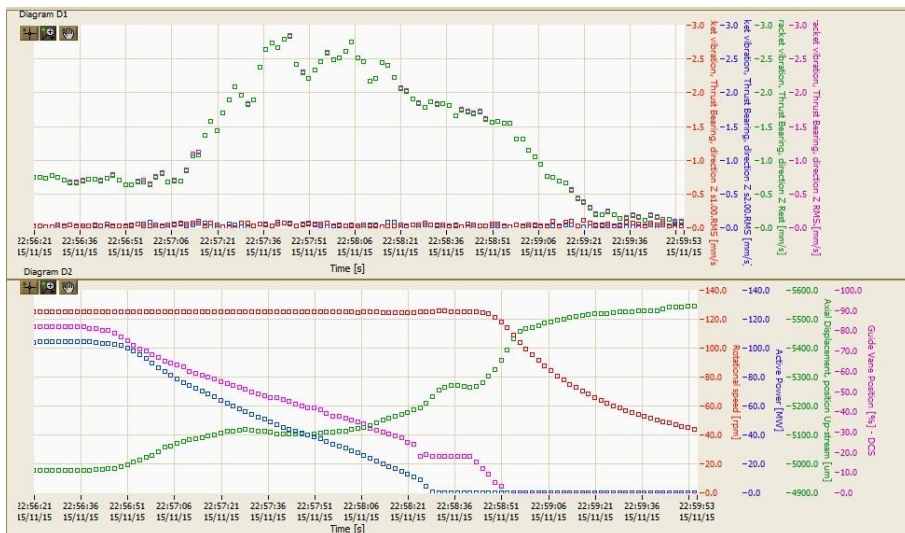
Similar behavior can be identified in Figure 5 where the axial vibrations S1n, S2n, Rest, and overall RMS signal of vibration velocity show that the order related amplitudes did not experience any difference during RLZ whereas the Rest signal component increased in the axial bearing vibration.

Figure 5 – Upper diagram: Axial (ThrB) – s1.00A and s2.00A, Rest and RMS; Lower diagram: RPM, P, Ax displ US, Guide wane opening.

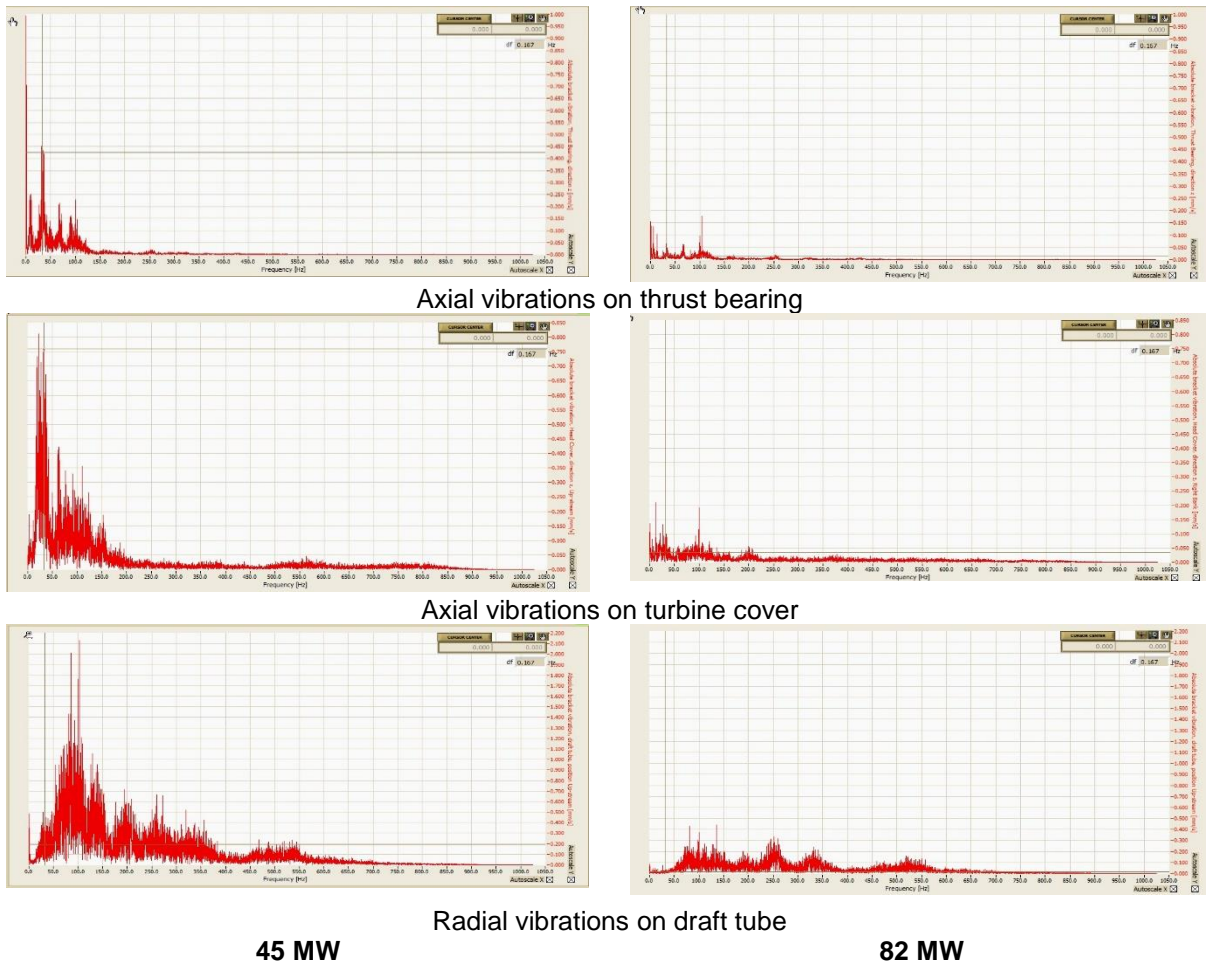
The monitoring system recorded both the condition vector⁸ signals (history trend) and raw data which was streamed in case of an event or additional analysis was required. This allowed for post processed analysis using tools such as FFT, as can be seen in Figure 6 with the vibration velocity spectrum

Figure 6 – FFT spectrum diagrams: LEFT SIDE: 45 MW, RIGHT SIDE: 82 MW.

Spectra were recorded during RLZ operation and during steady state operation.

- **Draft tube:** There were a lot of frequencies present, up to 600 Hz. This showed that overall RMS was high but evenly distributed mostly between 50 to 100 Hz. A peak at 0.5 Hz was present with lower amplitudes.
- **Turbine cover:** Dominant frequencies were up to ~150 Hz. A peak at 0.5 Hz was present with lower amplitudes.
- **Thrust bearing bracket:** Visible frequencies were up to ~120 Hz but was most dominant at ~0.5 Hz. Since no signal component was visible at other positions, it can be assumed that there was likely resonance in this area of the construction.

- **Draft tube:** Spectrum up to 600 Hz with lower amplitudes at 45 MW which is somewhat typical for hydraulic measurements due to water flow impact on the structure.
- **Turbine cover:** Similar conclusion as for Draft tube
- **Thrust bearing bracket:** there was no 0.5 Hz component outside RLZ.

It can be concluded that on the turbine and draft tube higher vibrations were present due to hydraulic components and water turbulence which were at multiple frequencies as high as 600 Hz. On the Thrust Bearing there were low frequency components present that carry much higher energy and only appeared during RLZ occurrence. To determine the exact behavior more detailed analysis of lower frequencies was required.

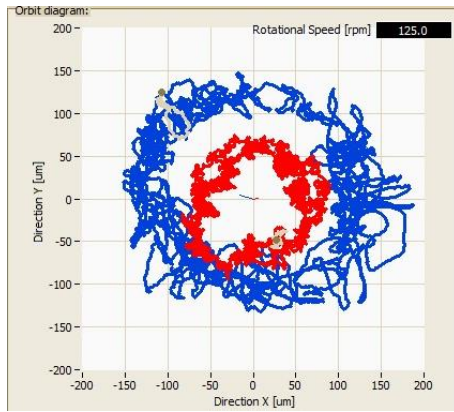
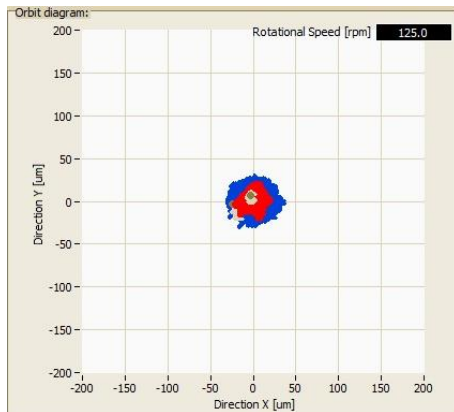
Analysis of the shaft orbits in Figure 10 supports the precession theory. Orbits display the X and Y signal plots from two perpendicular shaft displacement sensors in one bearing plane. Orbits represent the shaft displacement position (both dynamic and steady state) inside the bearing and represent directly the bearing clearance during dynamic operation of the machine. Therefore, they can be an important indicator of how much RLZ affects the bearings. In Figure 10 the orbits recorded during various load operations (50 and 82 MW load) are shown. On the left side, the complete signal duration is shown as X and Y plot from two probes (raw orbits). On the right side, are the orbits averaged per single machine revolution. It appears that low frequency components were affecting the shaft position significantly, but it is not visible from turn to turn. To display the real movement of both the wobbling frequency and the rotational speed simultaneously at least 4 rotations are needed since the wobbling frequency was $\frac{1}{4}X$ the rotational speed. Comparing the left and right diagrams the low frequency component had significant impact during RLZ occurrence. When the machine operates outside the RLZ (at 82 MW) the wobbling disappeared, and the shaft orbits were at the frequency related to machine speed so both the raw orbit and the averaged orbit were practically the same.

Figure 10 – Orbit diagrams (raw and averaged per turn) on two load conditions (50 MW, and 82 MW), GGB and TGB

The wobbling was present due to the vortex generated under turbine runner, however the response in this case was mostly related to the machine design and the precession movement around the rotor mass which caused large displacements in the radial direction as a result of axial vibrations. The new standard published in 2018 for the measurement and evaluation of vibration in this type of machinery, ISO 20816-5 indicates that shaft orbits (peak-to-peak values of relative shaft vibrations) should not exceed 70% of the cold bearing clearance. In this case the shaft orbits were near this value meaning that there was a significant load on radial bearings in the RLZ. To support this conclusion, cracks have formed in the concrete foundations at the axial bearing thrust bracket supports shown in Figure 11 on another unit of the same design in this power plant that had experienced the same issues while operating in the RLZ.

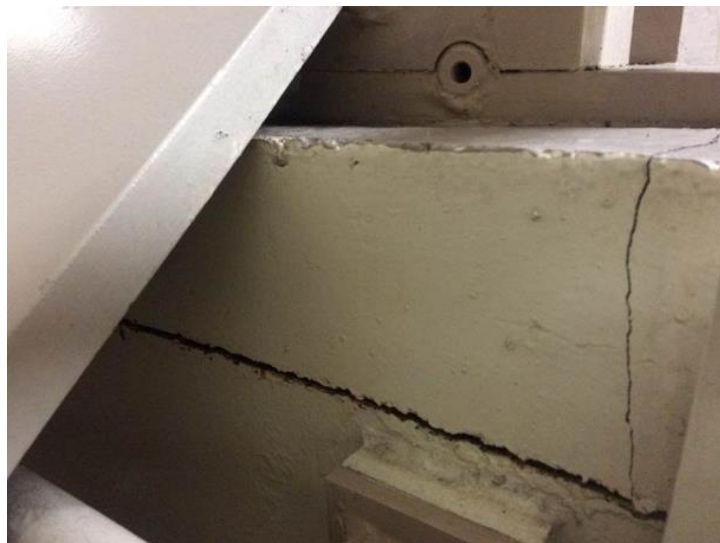
Figure 11 – Cracks in bearing to foundation supports on other unit in the same plant

On the 120 MW machine case study the RLZ effect was posing a threat to the machine condition and reduced machine operability/availability. Cracks in the axial bracket to foundation support were found on a sister unit in the same plant. It was found that bracket deflections reached 2 mm peak-to-peak at 0.5 Hz. There was considerable stress in the thrust bracket which led to significant stiffness reduction and machine operability problems. Also, during RLZ occurrence the radial vibrations increased significantly, reaching values of bearing clearance limits as recommended by ISO 20816-5.

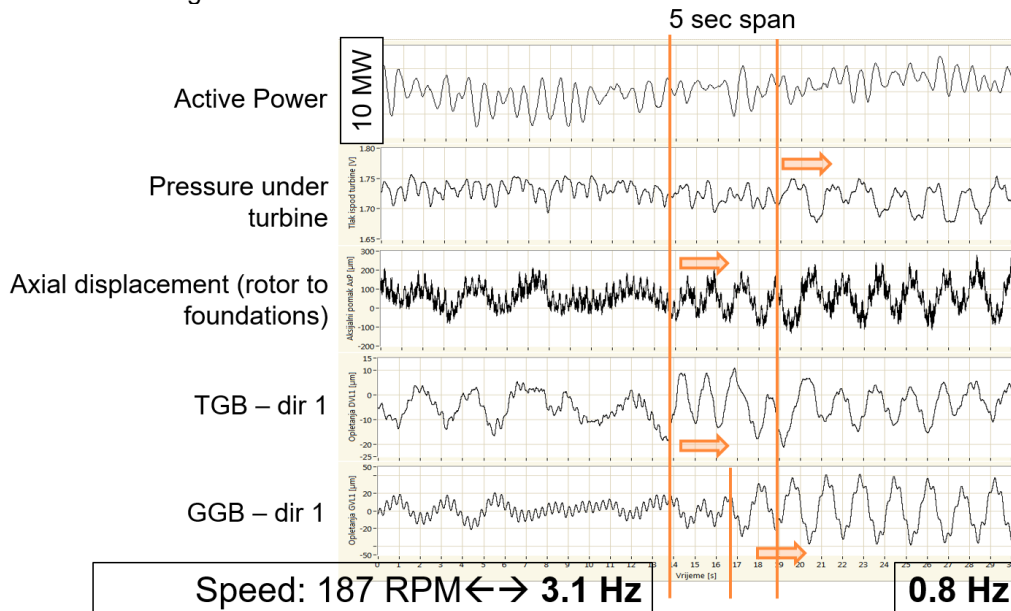
Figure 13 – Raw data recorded during RLZ operation on 10 MW

This 30 second data record represents the start of a vortex and the low frequency wobbling/pulsations at 0.8 Hz. Active power was 10 MW, showing approximately 1 MW fluctuations at 1.2 Hz throughout the complete data record. The most interesting result was the pressure pulsation signal

fluctuation. The pressure started to fluctuate at 0.8 Hz about 5 seconds after the rotor axial displacement and the shaft radial displacements on turbine bearing. The radial displacement on the generator bearing followed the axial and turbine displacement which started at the same time. Pressure pulsations at 0.8 Hz started 5 seconds later. These results were different than expected, as previous experience indicated that the pressure caused the rotor movement. It seems that these results show the opposite and that the axial rotor movement caused the pressure pulsations under turbine runner. Self-excited vibrations may be the cause of this phenomenon due to inadequate energy transformation on the turbine. In RLZ operation water flow on the turbine blades can lose its stability and the turbine does not effectively transfer the water kinetic energy to momentum. The left-over energy must be converted which triggers self-excited vibrations resulting in dynamic instability of machine.

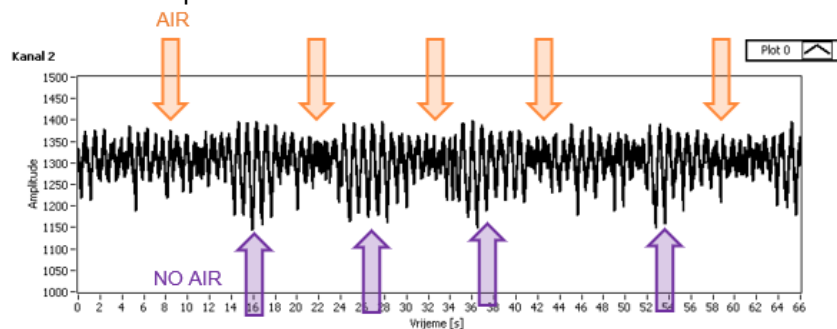
Since RLZ phenomena is related to turbine design and manufacturing there is little that can be done to remove it once present. It can however be mitigated with air admission under the turbine to eliminate the vortex and reduce the vibrations. Data was recorded during that experiment to observe the effect of the air admission on pulsations. Figure 14 shows the shaft displacement amplitude with air blown intermittently into the vortex to test the vortex elimination. The vibrations decreased during the air admission and increased when air was not present.

Figure 14 - Shaft displacement waveform at 8 MW - experimenting with air under turbine

This paper also briefly considers several methods of reducing the effect of instability which are referenced below for a detailed description. Using the air admission under the turbine can collapse the vortex and effectively reduce the vibrations. Feedback between the monitoring system and the air admission system should be established for this system to work effectively.
